23 February 2024

## **2023 Groundwater and Spring Review, Pakenham Quarry**

AECOM Australia Pty Ltd (AECOM) was engaged by Holcim (Australia) Pty Ltd (Holcim) to conduct annual monitoring and review of groundwater levels and spring flow/quality at the Mt Shamrock Quarry (WA174) in Pakenham, Victoria (the site) (see **Figure 1**).

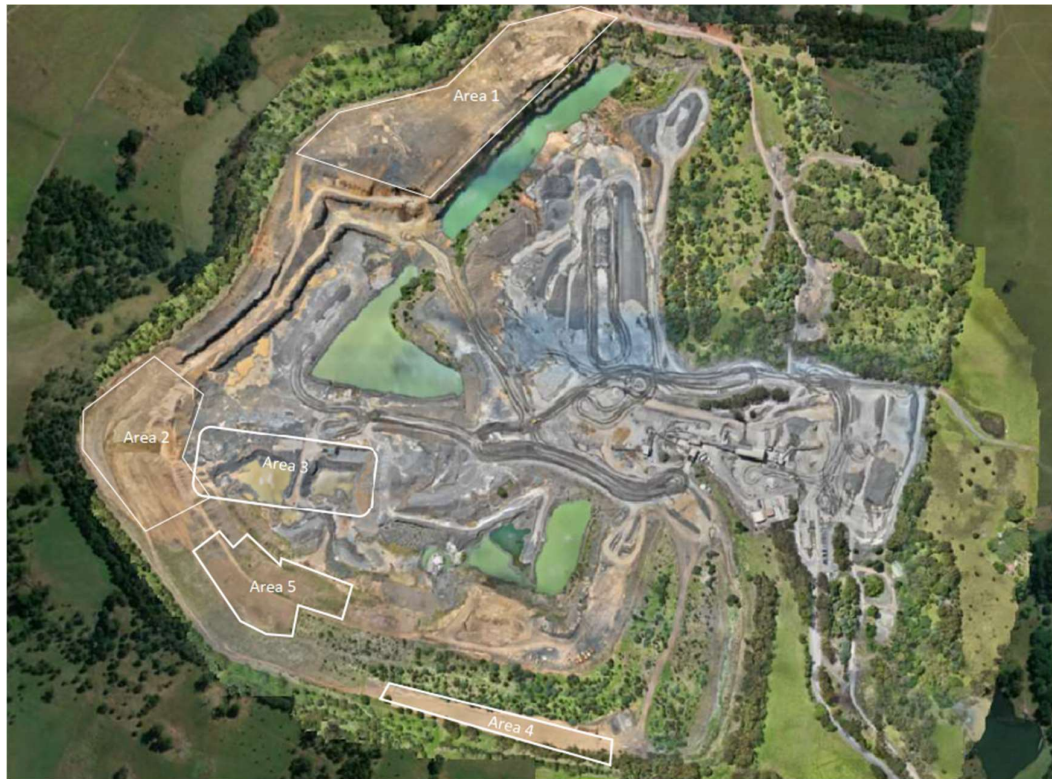
- MB03B and MB05B which are located close to Area 2 displayed a consistent decrease in water levels, to the lowest levels recorded since monitoring began, in March 2023 (approximately 167 m AHD). This appears to be related to the extraction which occurred in the western corner of the quarry (Area 2 in Plate 1).

**Plate 1** Areas of works 2023 (image from October 2023)

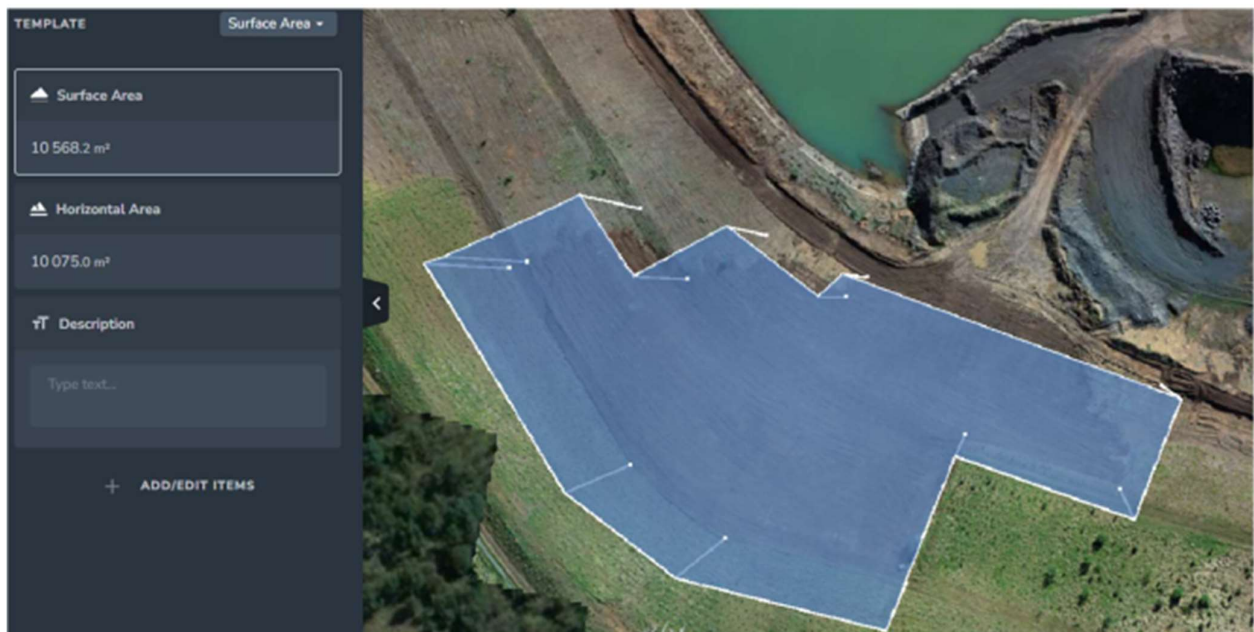
**Plate 2** 1.1 Hectare revegetation zone

Holcim continued revegetation and progressive rehabilitation works at the quarry in 2023 as shown in Plate 2 (blue shading). There continues to be no observable trend in levels that can be attributed to revegetation. Revegetation areas are relatively minor in comparison to the overall quarry footprint and any change in infiltration from an increase in evapotranspiration is likely to be minor at this time.

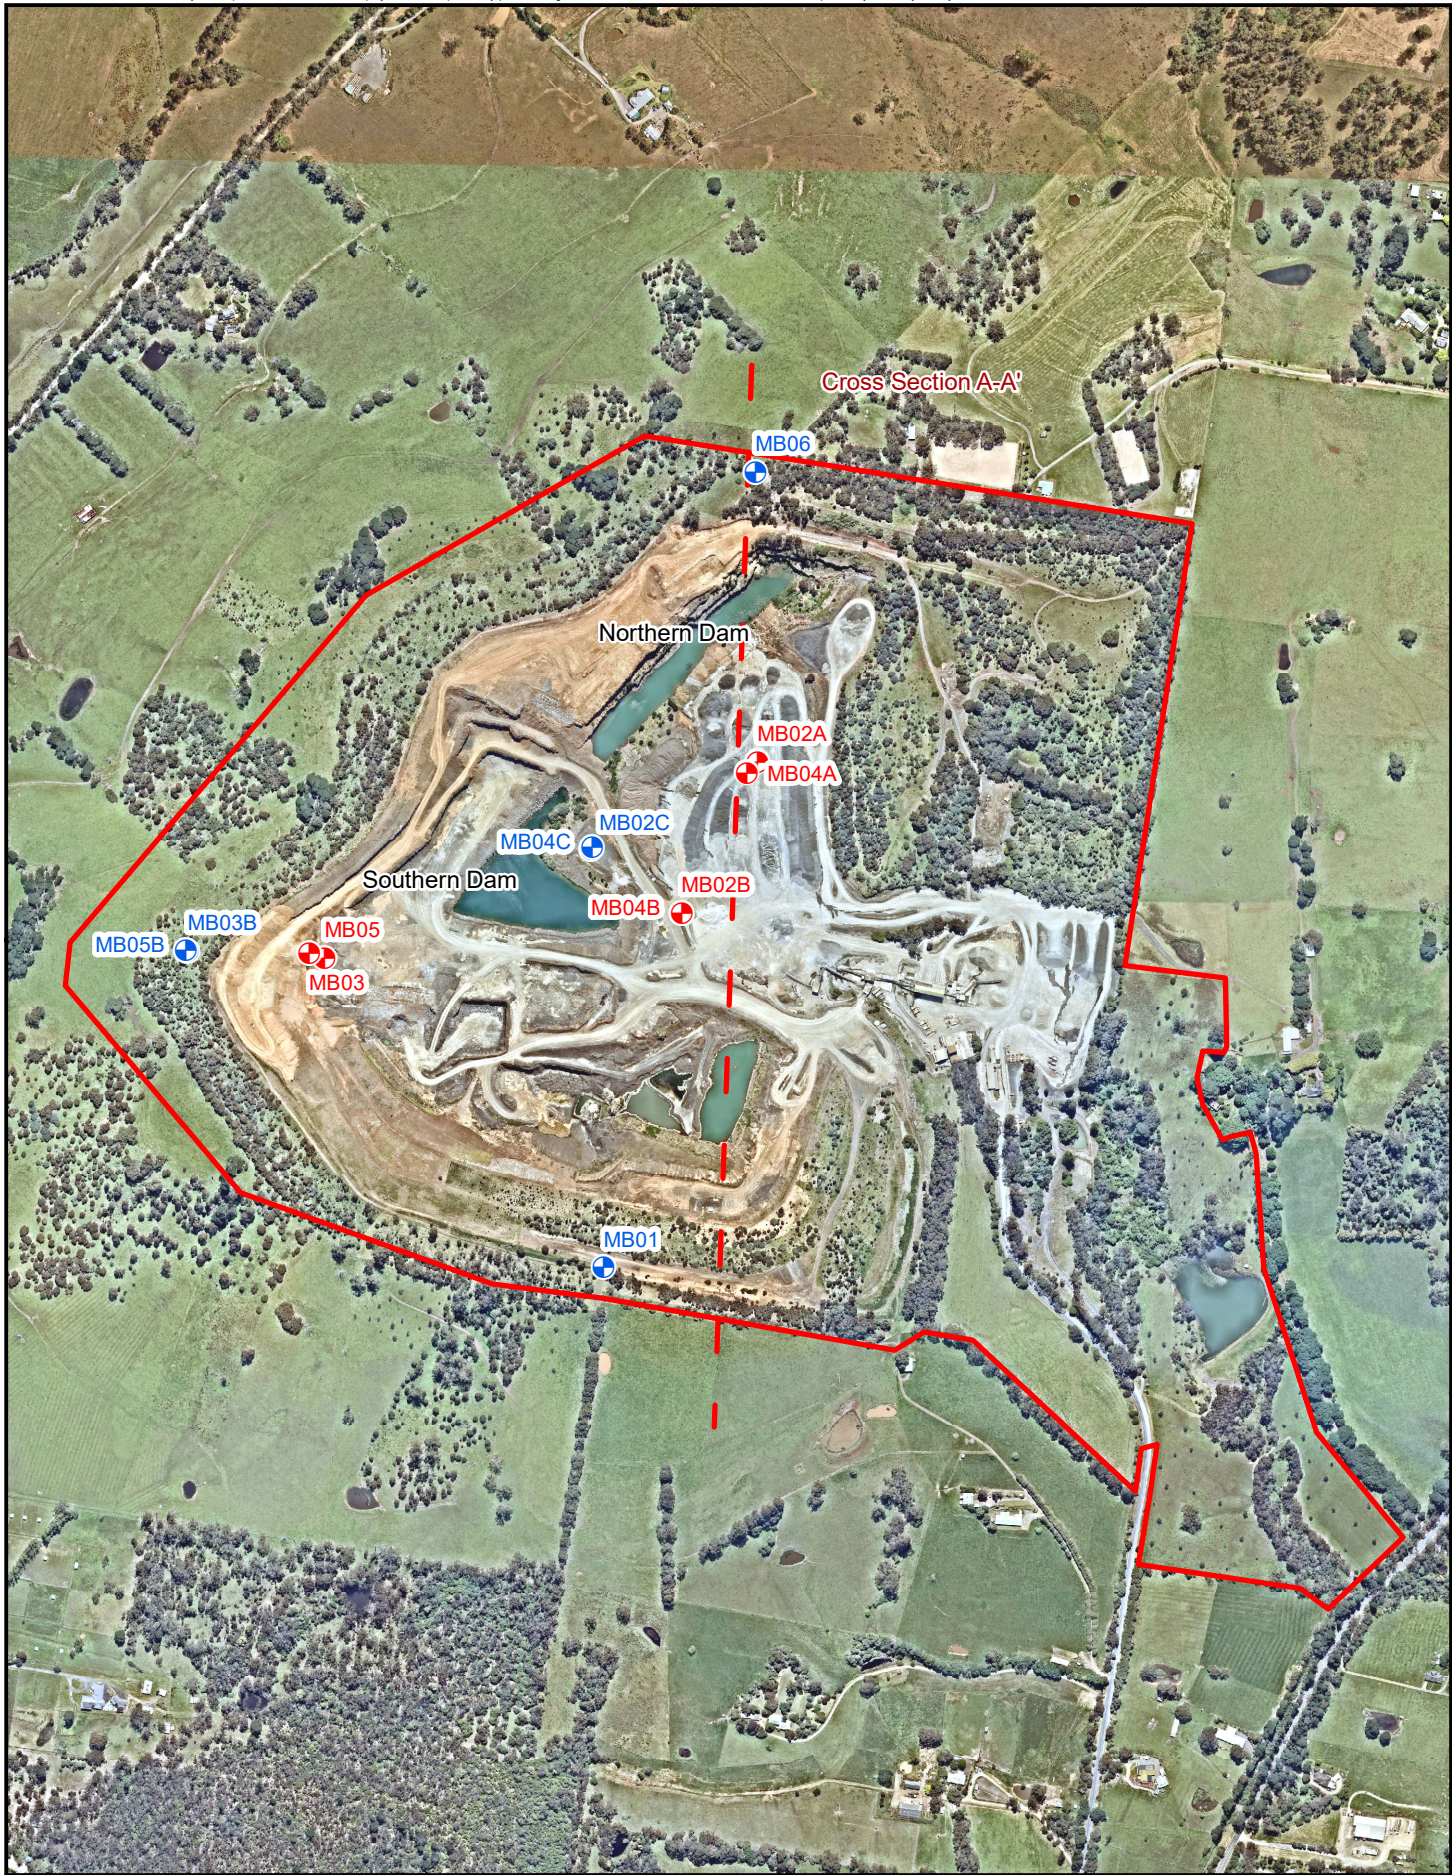
The bore network (including both the existing operational network, and the former bores) is presented on **Figure 2** and **Table A1** summarises the bore locations, screened interval and aquifer.

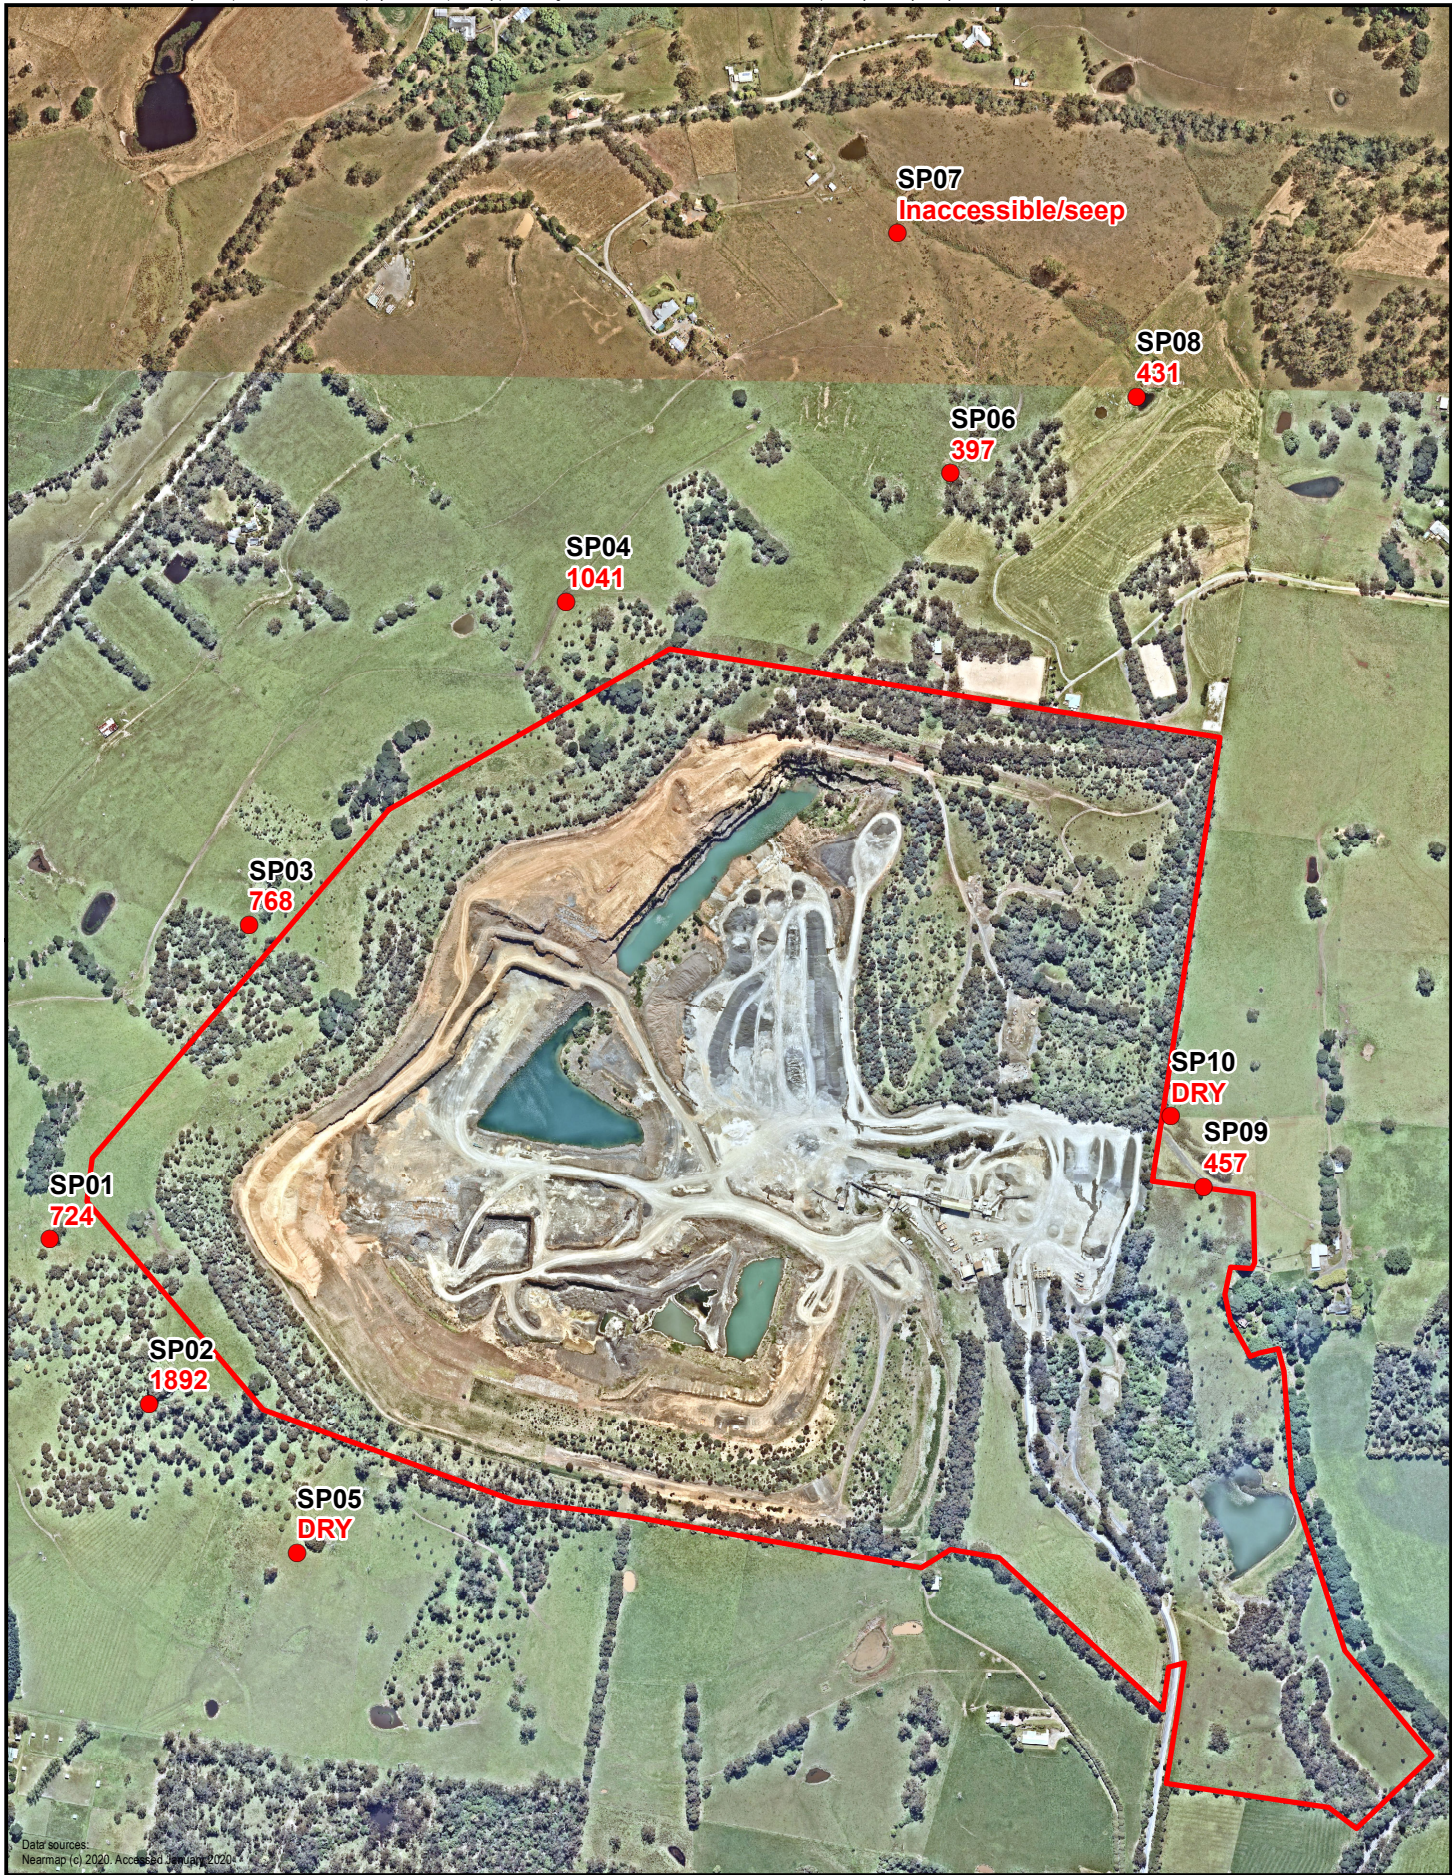
The locations of all mapped seepages/ springs are presented in **Figure 3** and the data is provided in **Table A4**.

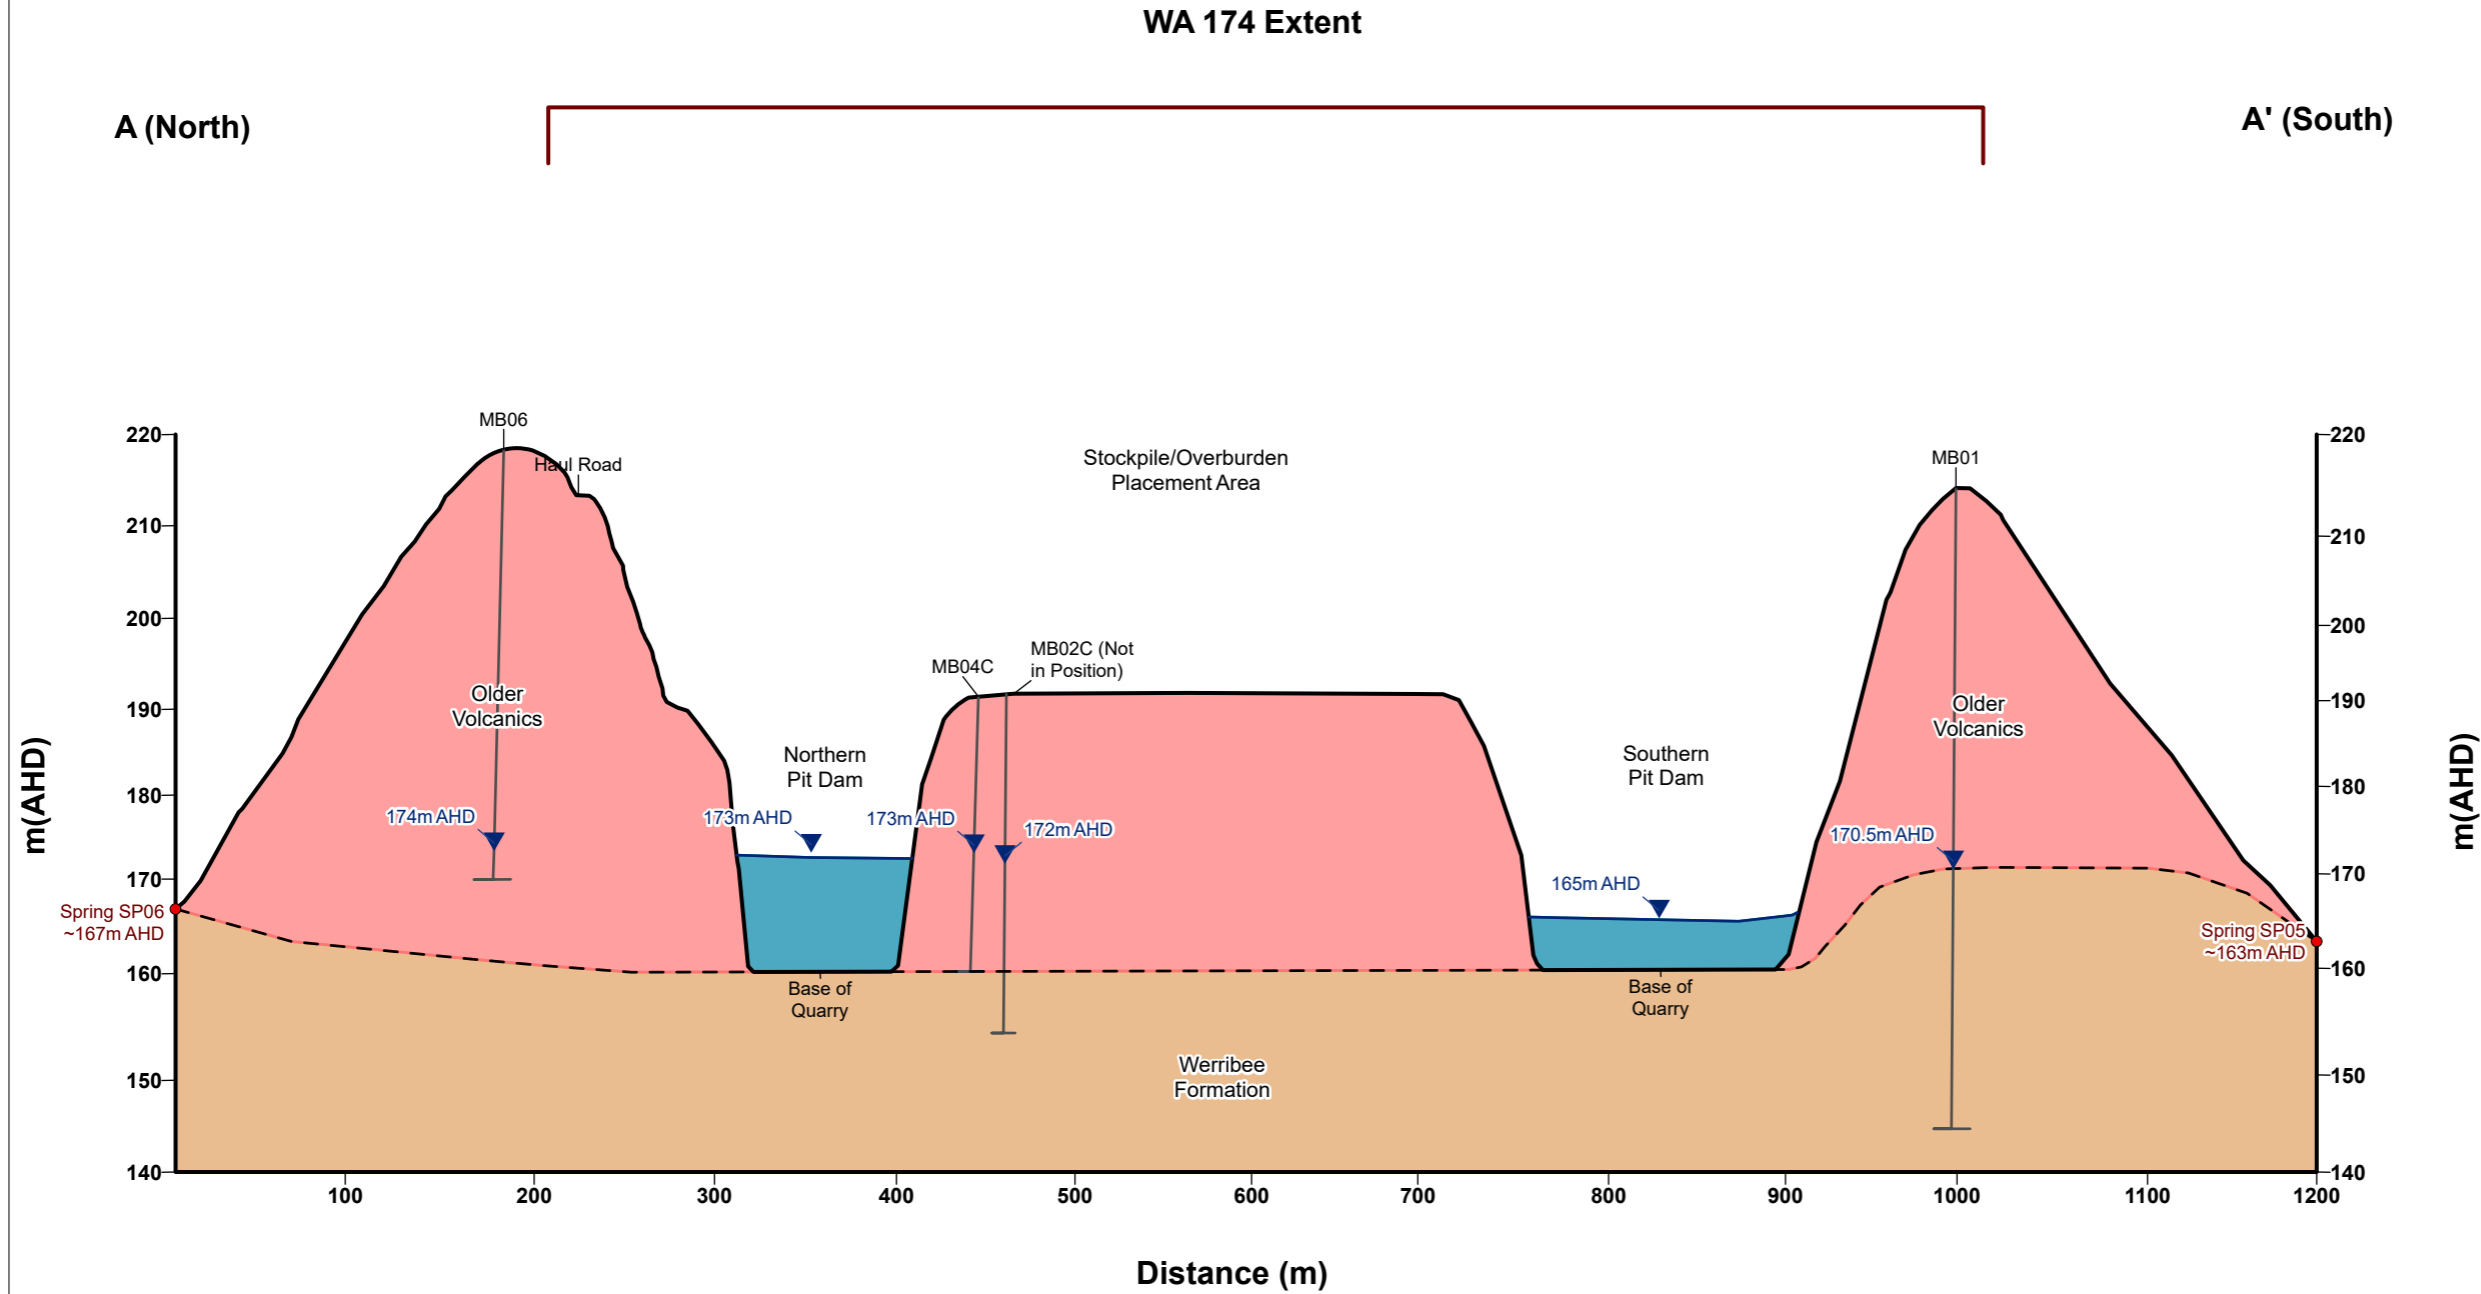
Cross Section A-A1 North - South  
Water Levels and Topography Data  
from January 2024

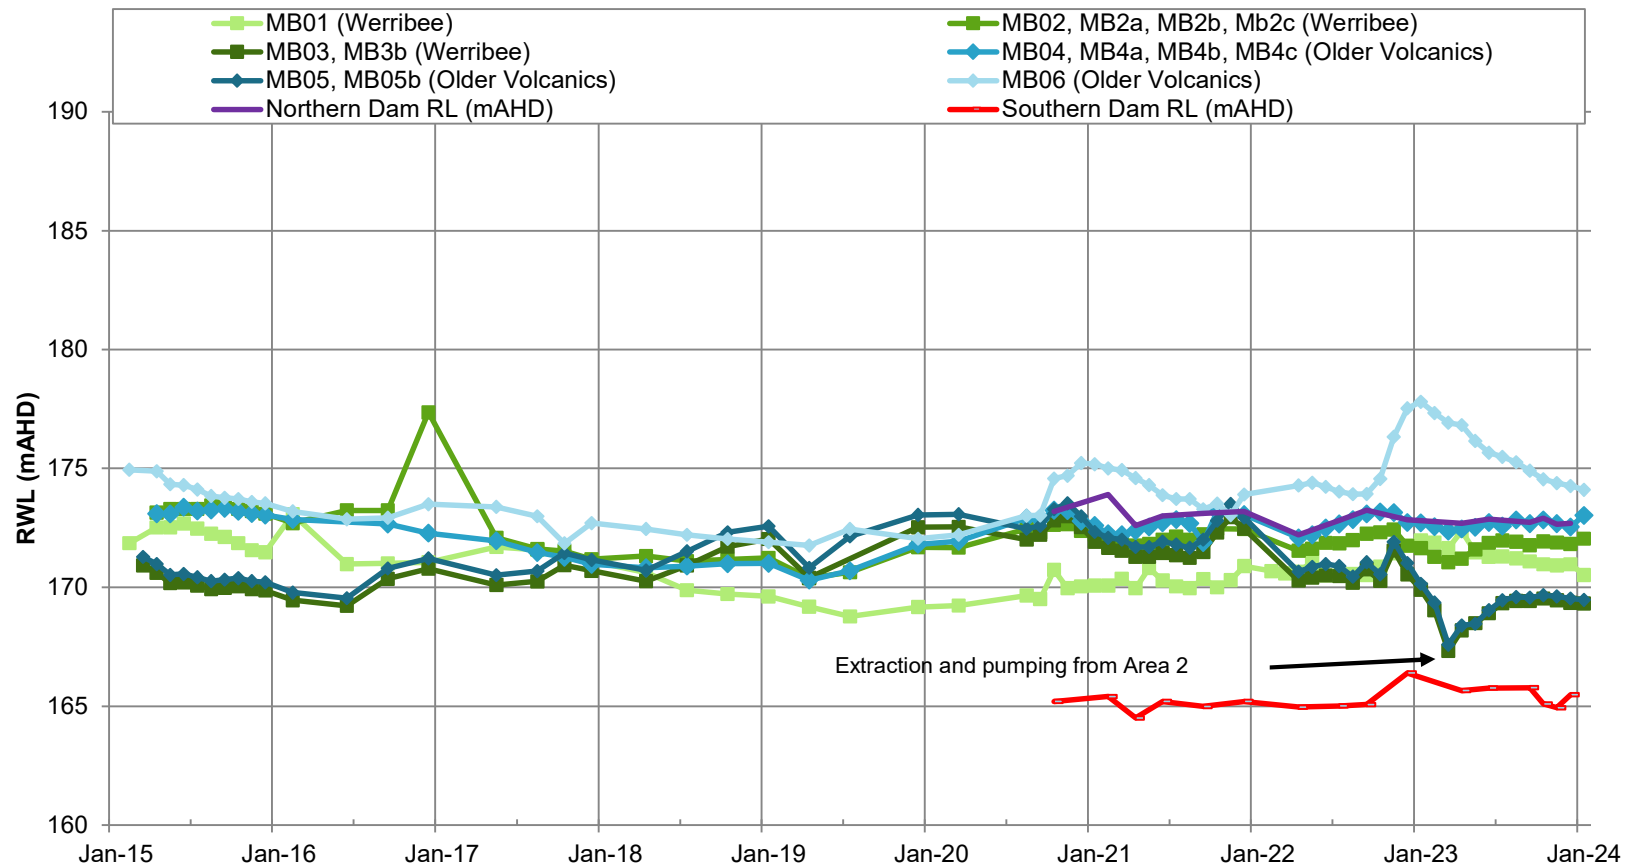
- the same pattern as that observed in MB06 has been seen in MB01, located downgradient of the quarry, albeit in a more subdued fashion (see Chart 1c). This suggests that the trends are a regional as they are displayed in both aquifers.

Chart 1c- Groundwater elevations (MB01 and MB06)

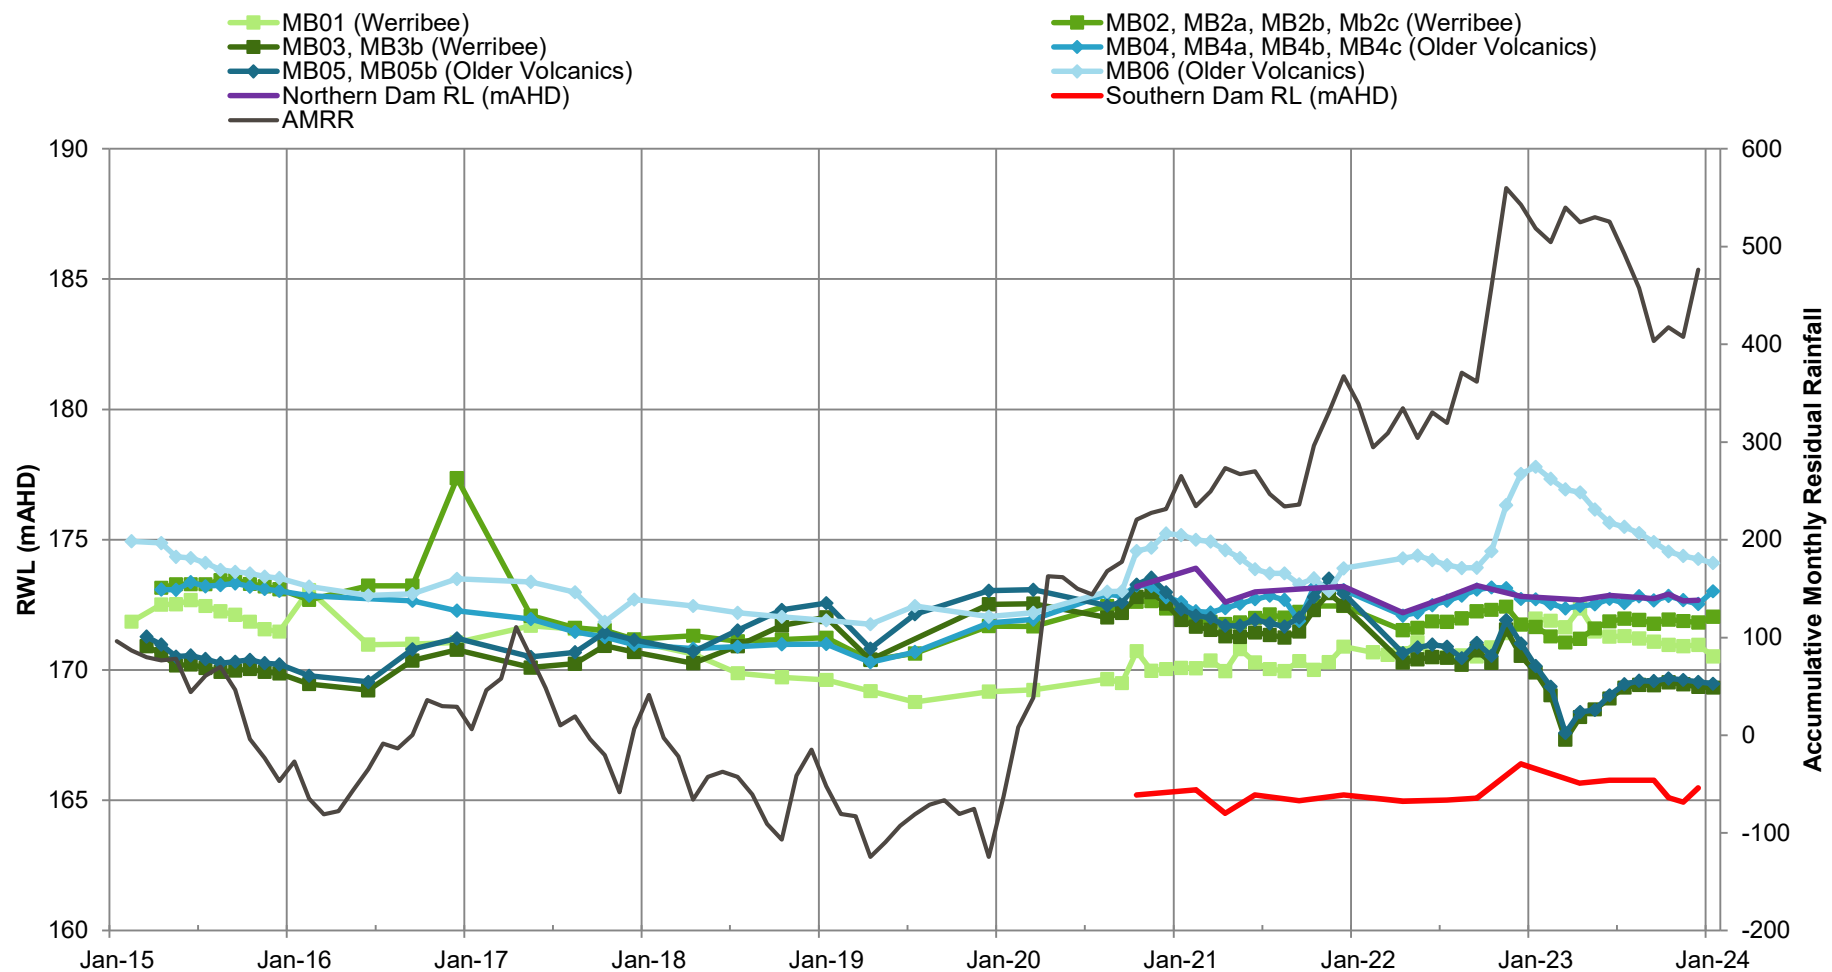
- chart 3d shows the AMRR since 2020 plotted with groundwater levels from MB01 and MB06. Groundwater in both wells appear to reflect the AMRR with some degree of lag time, as the December 2023 upward trend in AMRR has not yet been observed in the groundwater wells.

Chart 3d Groundwater elevations vs. AMRR (MB01 and MB06, 2020 to 2024)

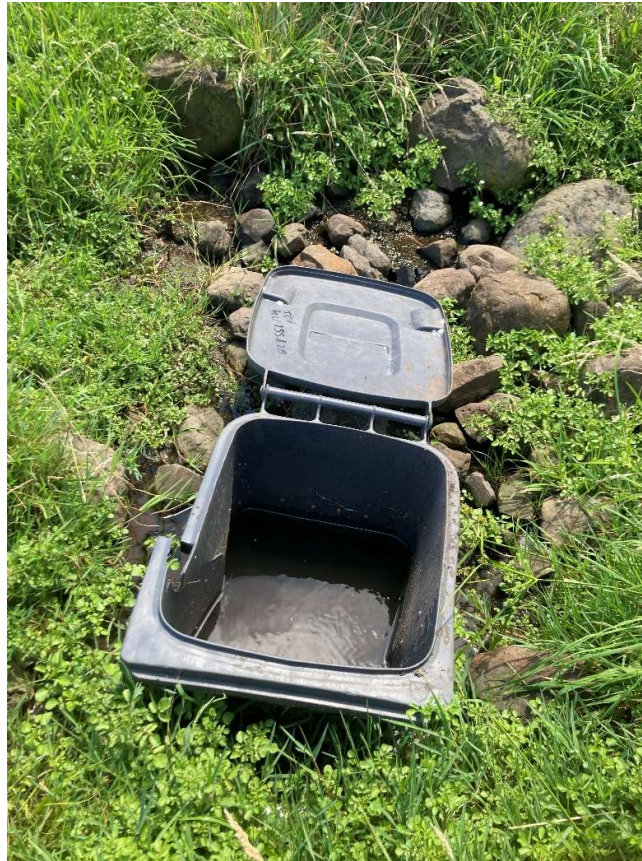
**Plate 1 Spring 1  
January 2024**

SPRING ID/Use (if any)	Location/history/use/changes	EC (µS/cm) January 2024	Observations January 2024	Flow rate January 2024 (m³/day)	Flow rate December 2022 (m³/day)
SP01	West of quarry Provides irrigation and stock water to a number of properties in the local area	724	Water flowing into bin, losing some water which misses the capture system.	10.3	19
SP02	West of the quarry historically been observed to be a small dam fed by groundwater and surface water runoff from a relatively steep slope above  Previous rounds underestimated flow at the bore due to the addition of a pipe to divert flow from the spring to the tank which was not taken into account. Flow is now measured at the pipe outflow to the tank.	1892	Audible flow, healthy and thick veg around spring.	15.1	2.5
SP03	West of the quarry Vegetation has historically, and continues to be, healthy	768	Water flowing around bin. Heavily vegetated.	0.3	3.0

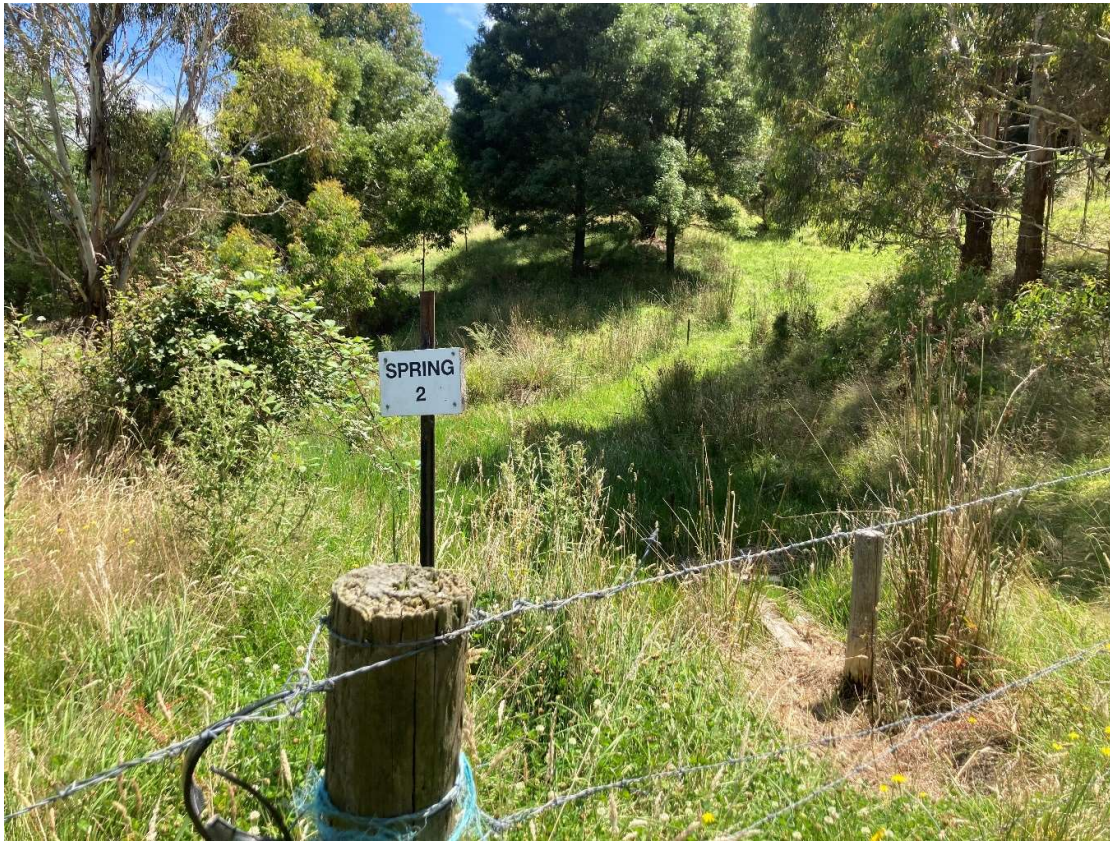
Plate 2 Spring 2  
January 2024

- SP02, southeast of SP01, has reported significantly increased flow during sampling in January 2024;
  - Combined, SP01, SP02 and SP03 were measured to have marginally increased flow in January 2024. In line with the GHD recommendations (Pakenham Quarry, Hydrogeological Review June 2023) metering devices fitted to these piped springs and more frequent capture of this flow data will assist in giving confidence around this data;

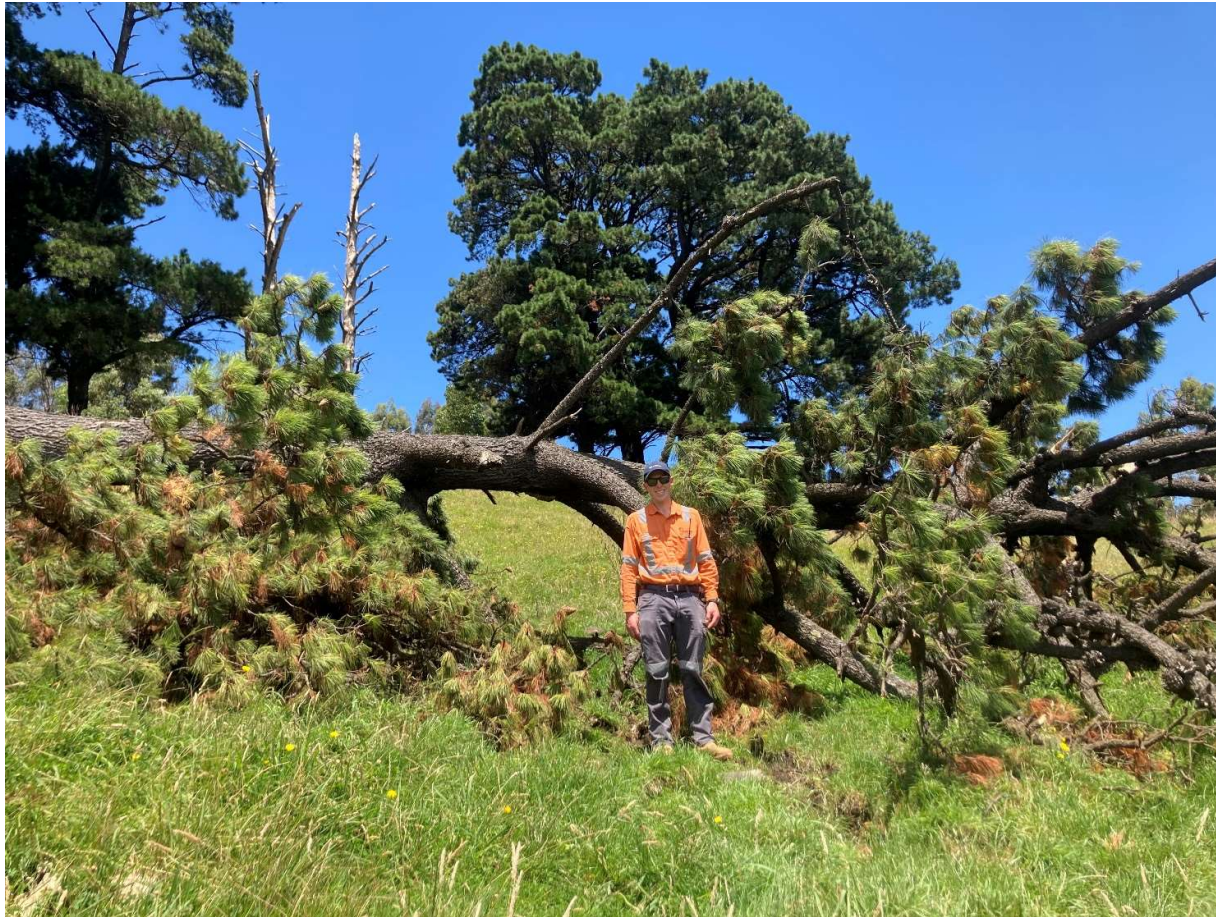
Plate 11 Spring 11  
January 2024

In April 2023, Holcim personnel identified a new, spring (SP11) on the Toomuc Valley (west side of the quarry). It was investigated in January 2024 but there was insufficient outflow present to collect parameters or perform flow assessments.

- A new spring (SP11) was observed over the course of 2023, but insufficient water to collect parameters was present on the day of surveying.
- The spring monitoring in January 2024 does not show any observable influence based on quarry operations. However, if flow data is to be used to determine influence then further metering would be required to increase confidence in the data set.
