# **Mt Shamrock Environmental Management Plan - 3 Monthly Progress Update**

**October 2019 - December 2019**

Prepared by Matt Dodd for Mt Shamrock Quarry Environmental Review Committee

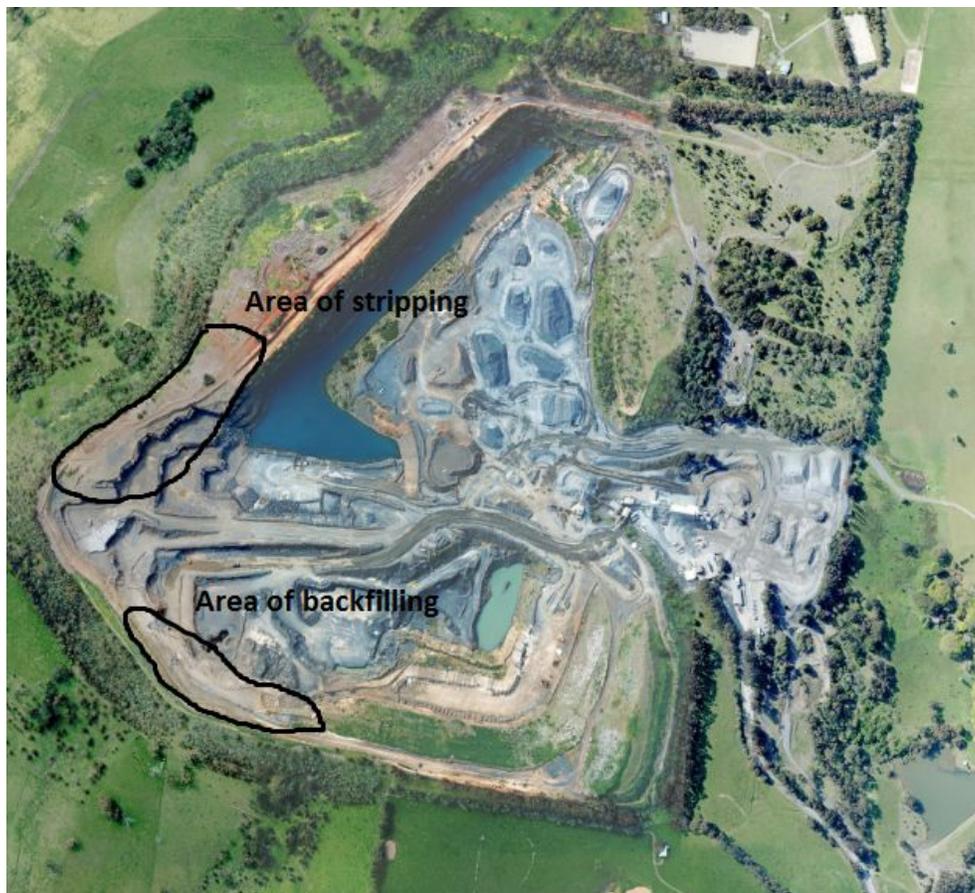
- ERR (Earth Resources Regulators) rehabilitation audit completed - compliant with all requirements
- Stripping program commenced with progressive rehabilitation of terminal southern faces faces began in December

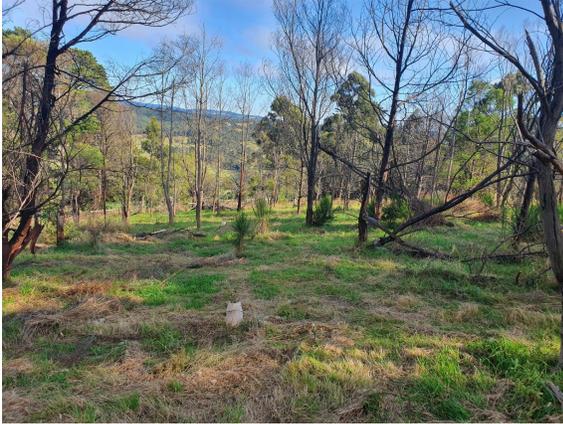
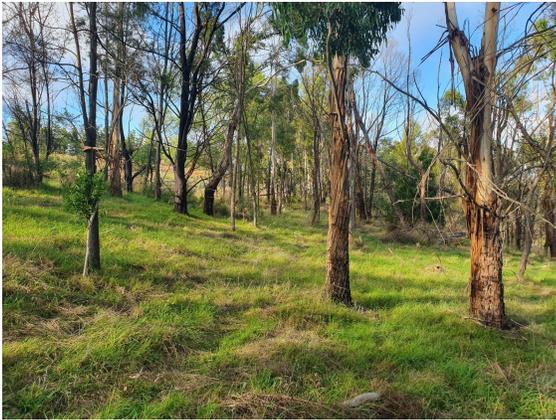
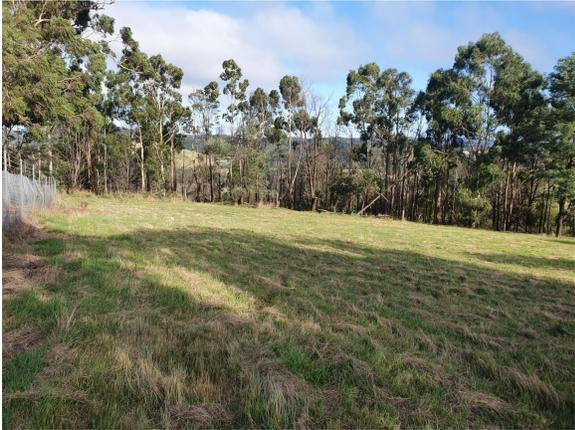
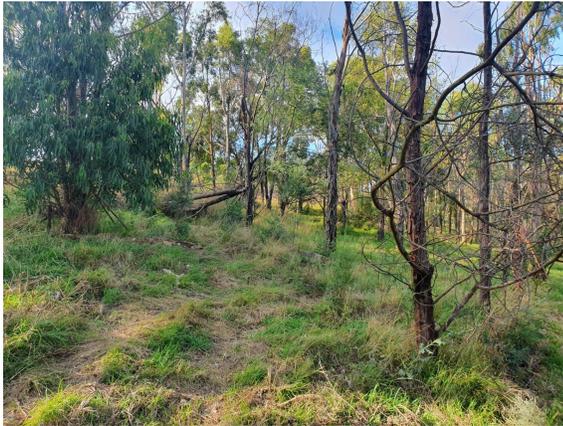
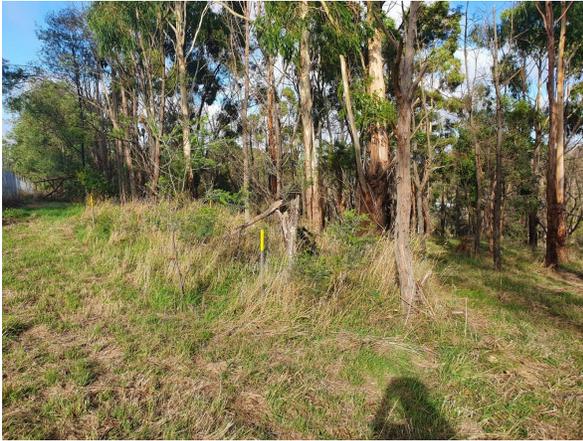
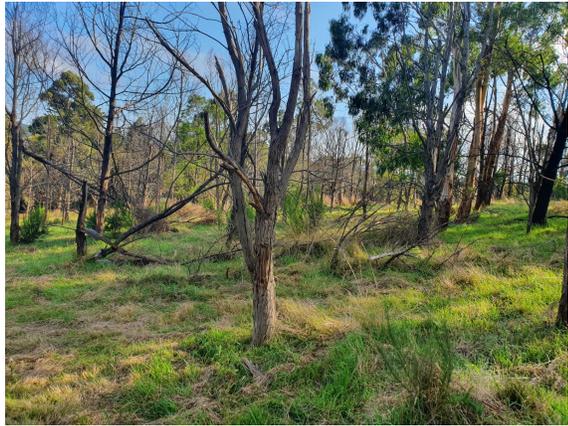
- Weed spraying along the boundary fence including large portion in the north-western section of the quarry
- Installation of watering / irrigation system on South Eastern rehab batters / recent plantations
- Slashing / fire prevention works
- Targeted thistles and brush cutting around natural regrowth and new plantation in Phase A/Phase B
- New plantings and areas of natural regeneration are being staked to monitor health and progress
- Weed spraying in bottom settling pit area and in the paddocks east of the quarry
- Fence repairs around property
- Tidy-up around buffer properties
- Netgain area maintenance annual fire prevention / slashing

Photos of works done around Phase A and B plantings in North East cnr of site

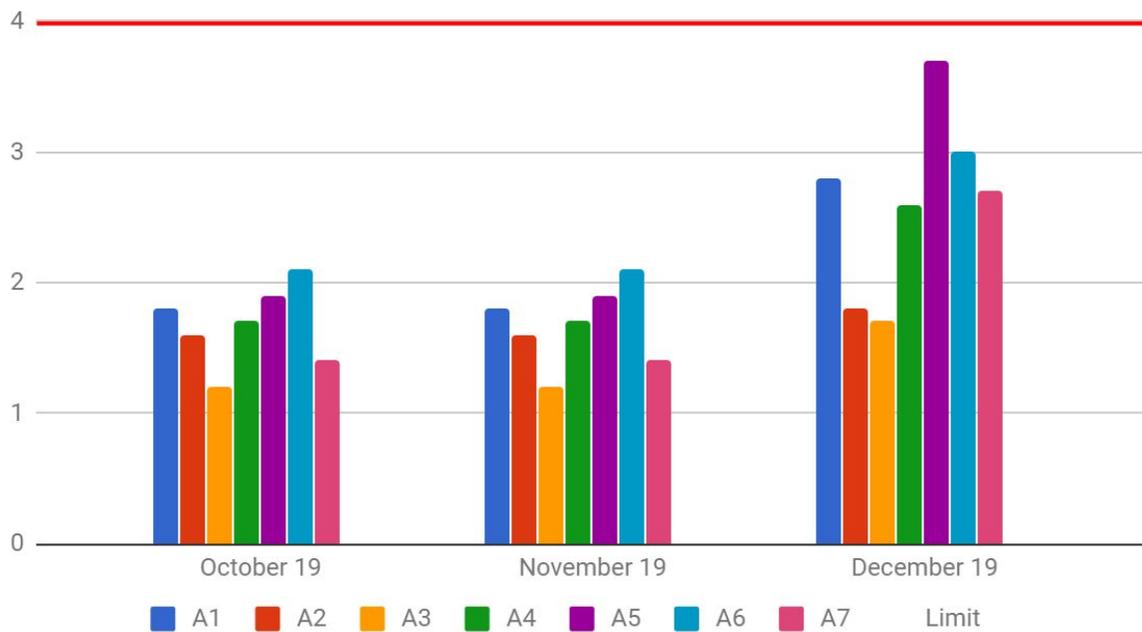
Dust Deposition Q4 2019 (Limit 4.0/m<sup>2</sup>/mth)

DEPOSITIONAL results have indicated the dust emissions tabulated below

**Limit 4.0g/m<sup>2</sup>/mth**

**Note: there were a number of reactive exceedances in December due to bushfire smoke in Gippsland and surrounding areas.**

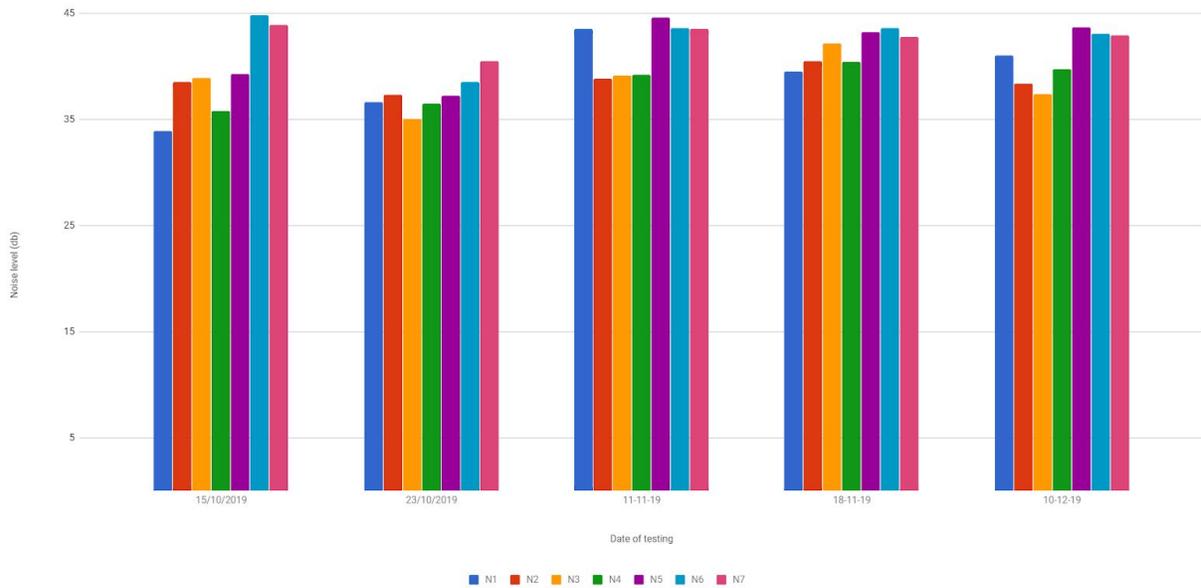
Fortnightly Noise testing results Q4 2019 (Limit 45dB)

Average noise levels for the 2nd quarter are shown below.

**Limit is 45dB under normal operating conditions**

**Graph showing Noise monitoring results by Sensitive Location**

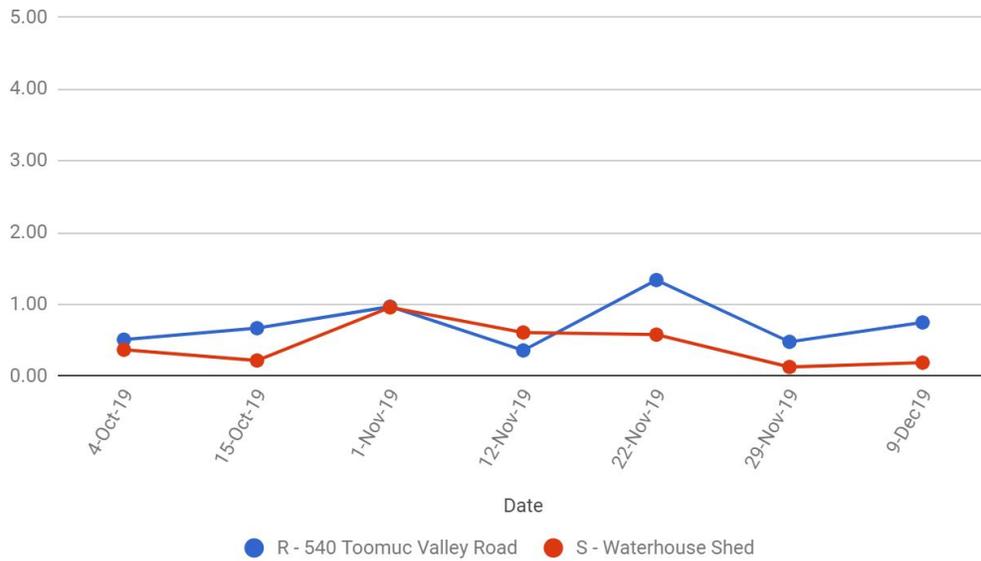
Ground vibration for Q4 2019 (Limit 5 mm/s)

**Limit is 5mm/s for 95% of blasts in a 12 month period.**

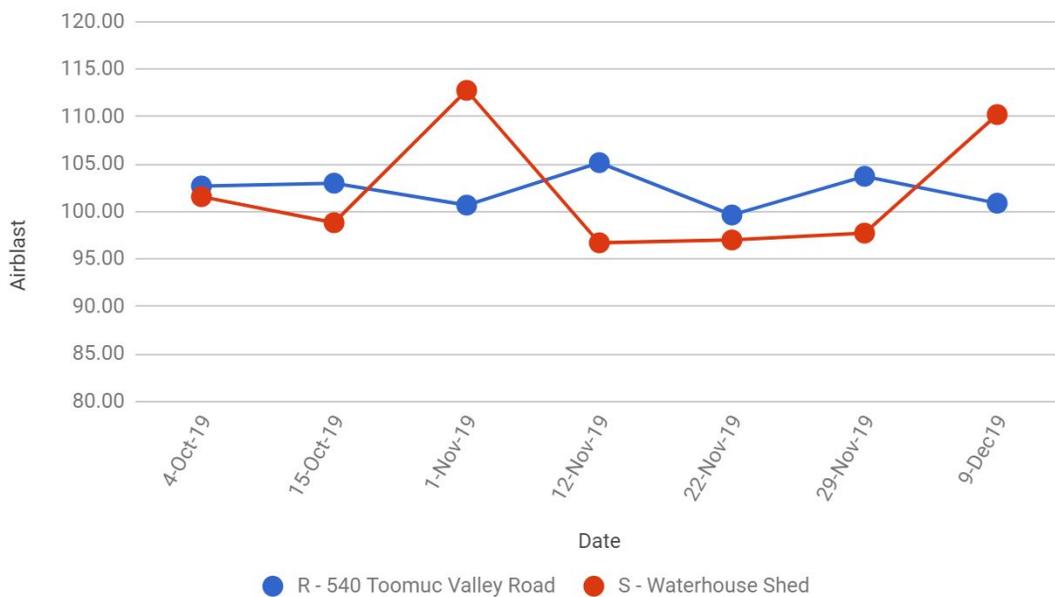
Air blast limit results for Q3 2019 (Limit 115 dBL)

**Limit is 115 dBL for 95% of blasts in a 12 month period.**

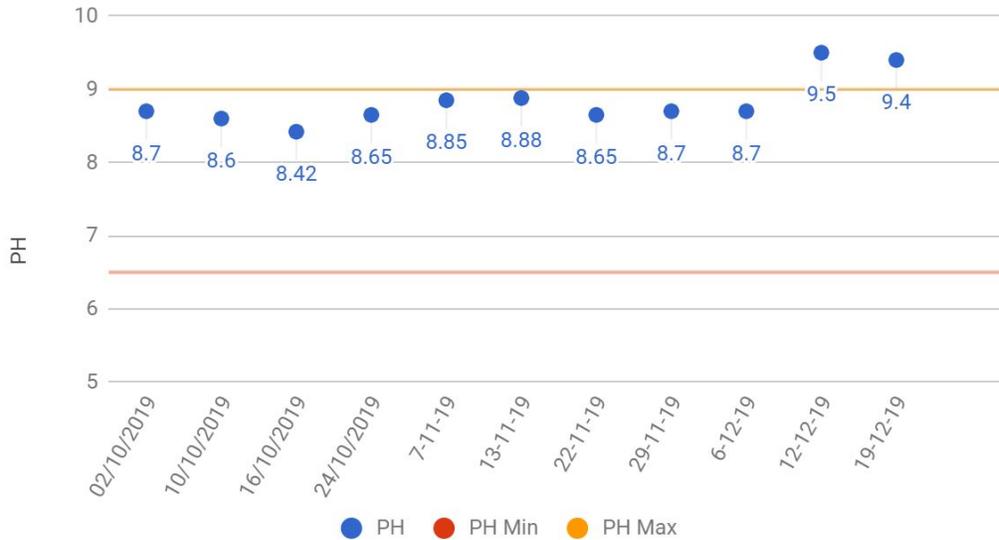
pH Q4 2019

pH – A measure of the Acidity or Alkalinity of the water limit 6.5 to 9.0

**Note - No discharge on days of testing in December (12th & 19th), increase in PH is results of water testing Donnazons dam (low water levels), subsequent testing in early Jan shows PH is under limits for discharge.**

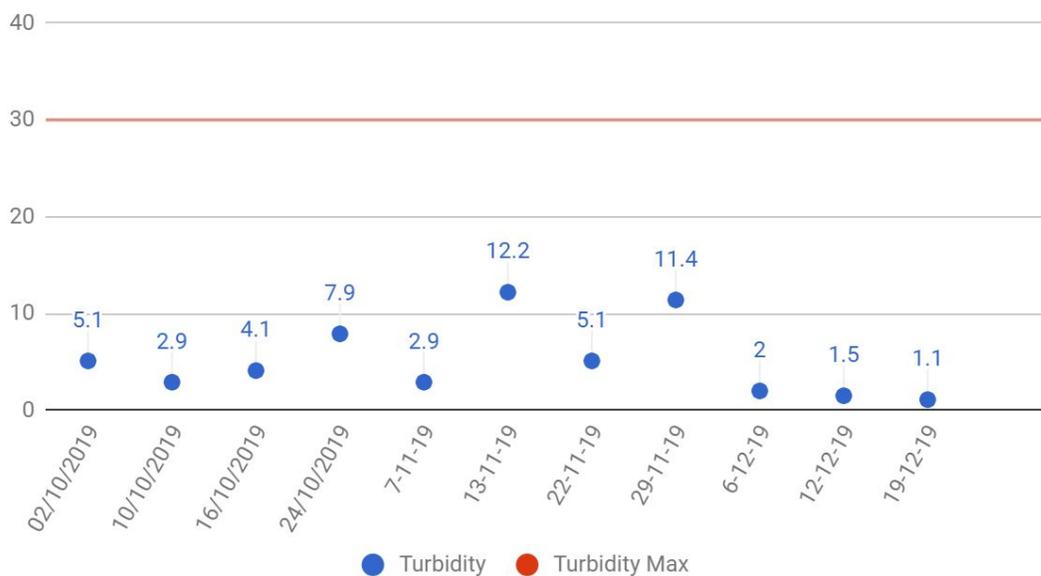
Turbidity Q4 2019

**Turbidity – Clarity of water Maximum 30NTU**

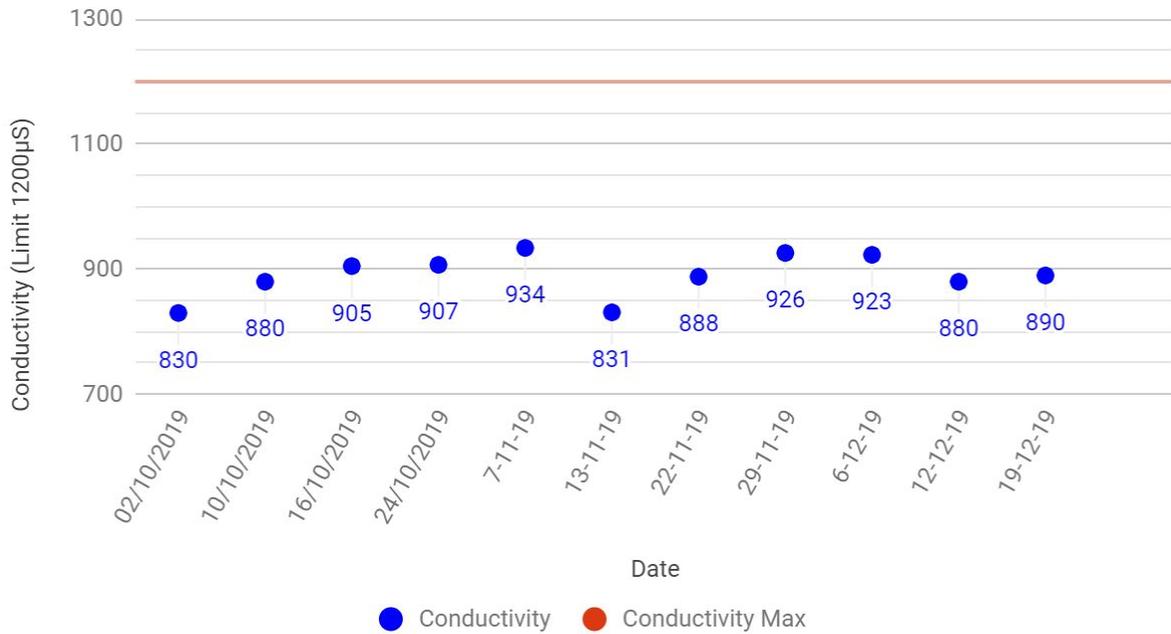
### Conductivity Q4. 2019

**Conductivity** – A measure of the water’s capability to pass electrical current. Limit 1200µS

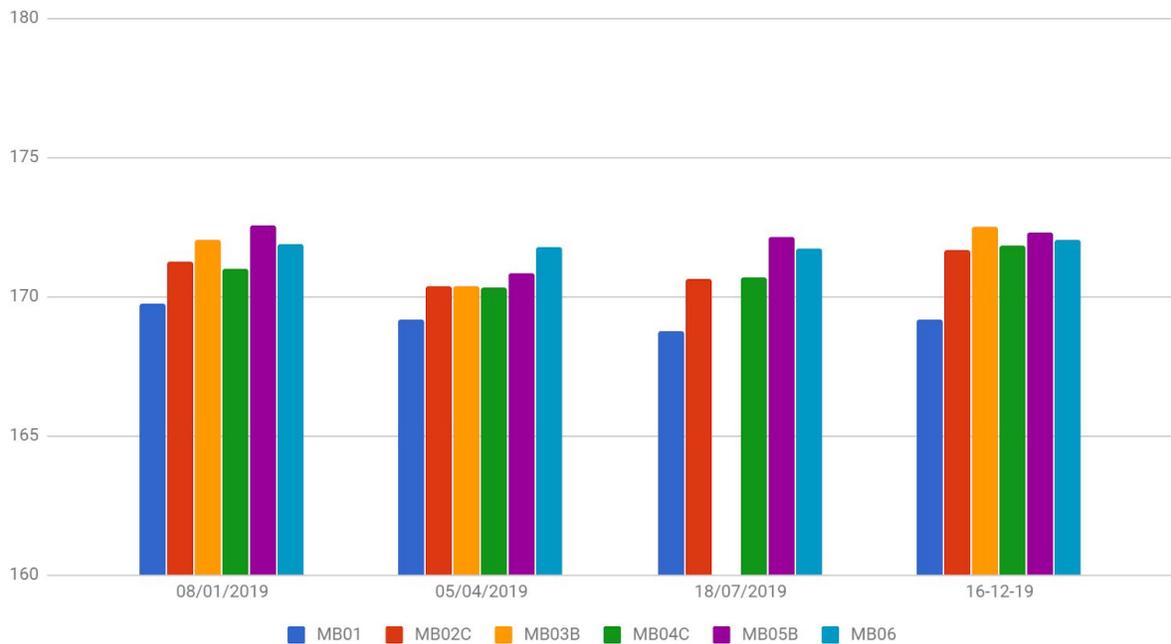
#### RWL of ground monitoring bores 2018-2019

Table showing 2018 - 2019 water table levels in relation to sea level

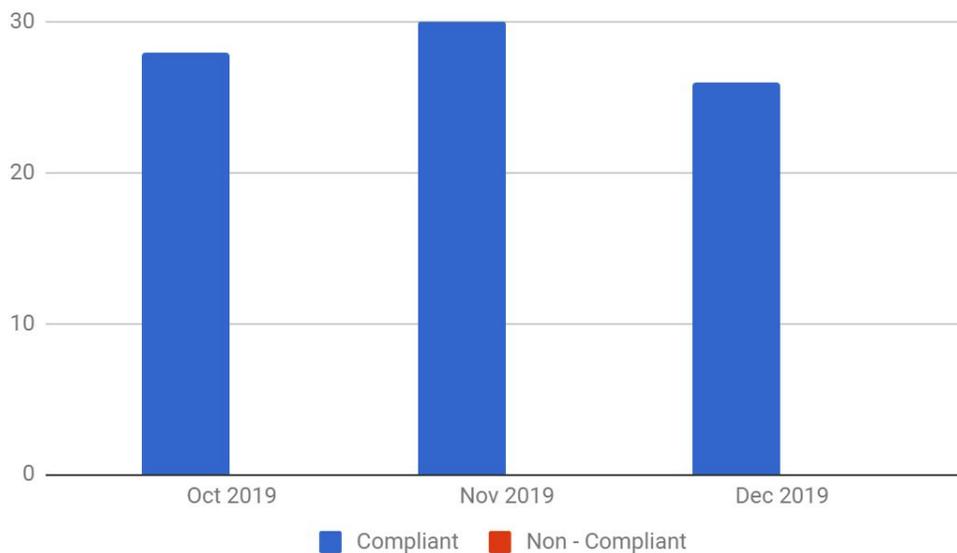
### Tarping compliance Q4 2019

Evaluation of trucks leaving the site concluded that there is minimal material being tracked on to public roadways, representative sampling identified all loads for the Quarter were correctly loaded.

Graph showing Tarping visual checks
