# Mt Shamrock Environmental Management Plan - 3 Monthly Progress Update

January 2020 - March 2020

Prepared by Matt Dodd for Mt Shamrock Quarry Environmental Review Committee

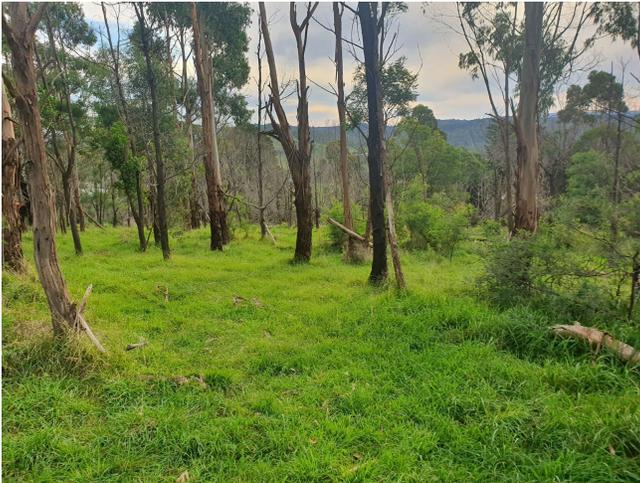
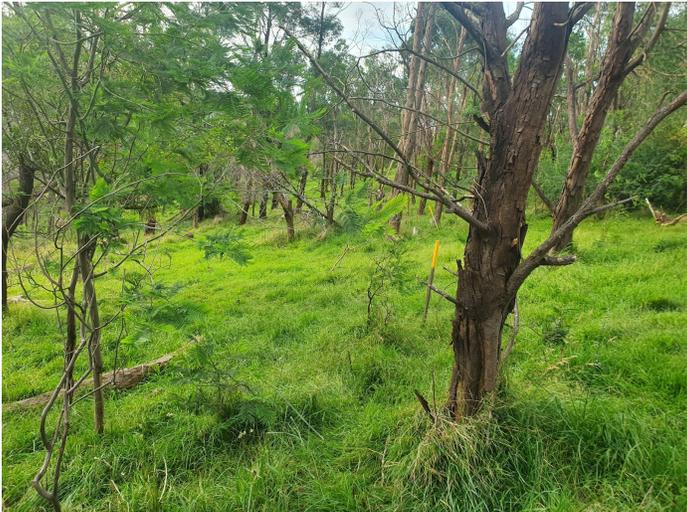
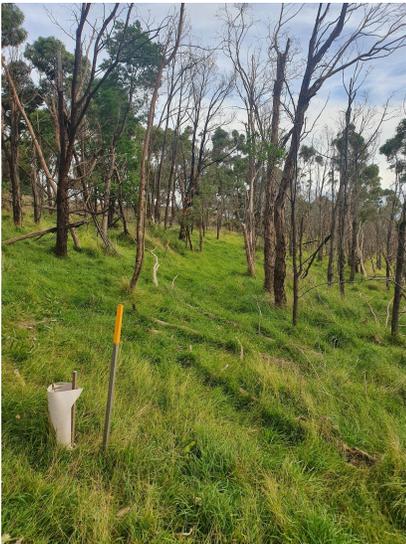
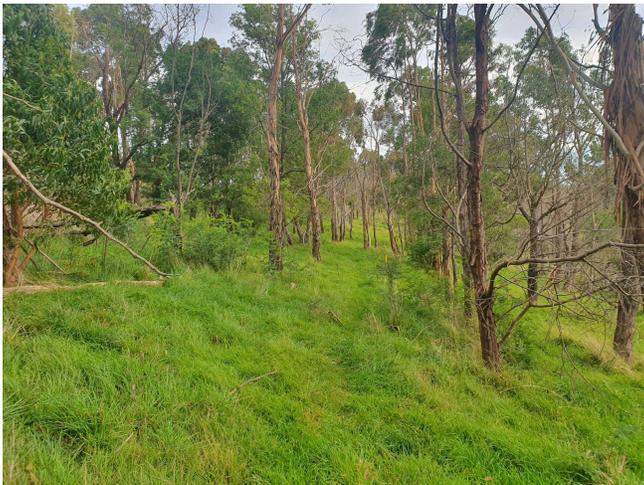
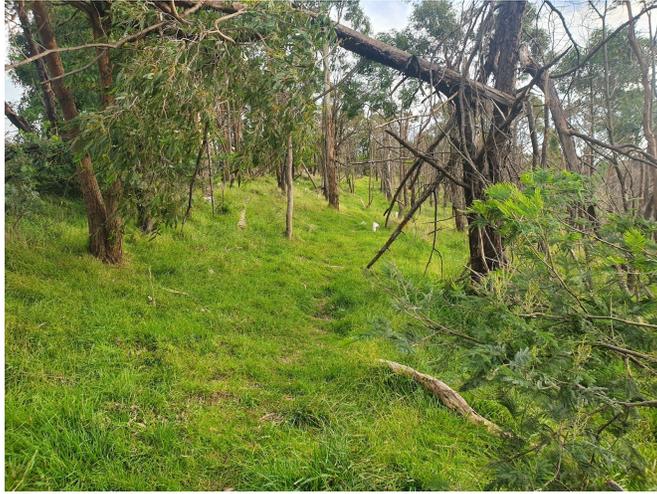
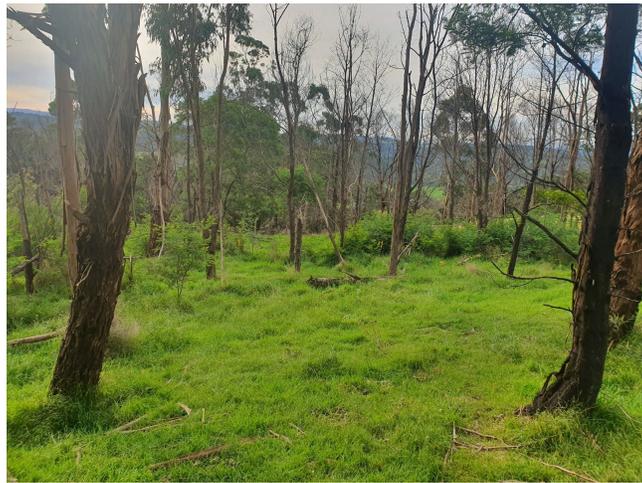
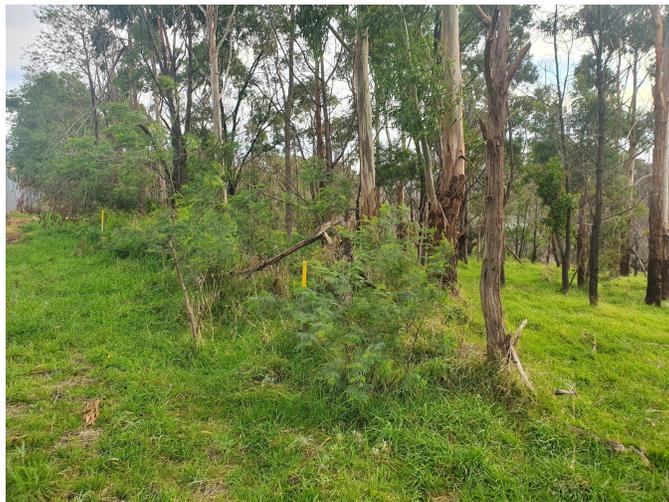
Photos of works done around Phase A and B plantings in North East cnr of site

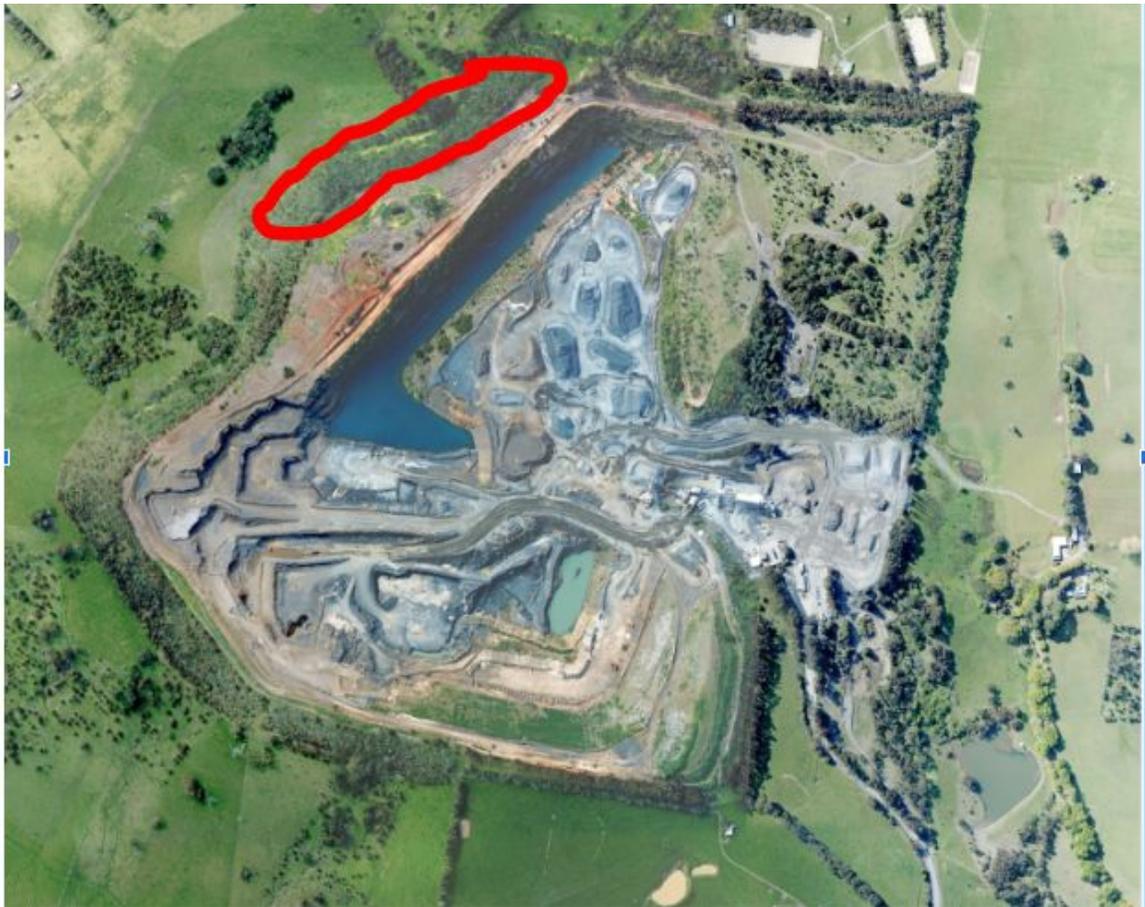
An additional 500 seedlings are being planted in late May 2020. Target Area show below

It is a combination of mid story and Upper story trees. Species list attached for reference.

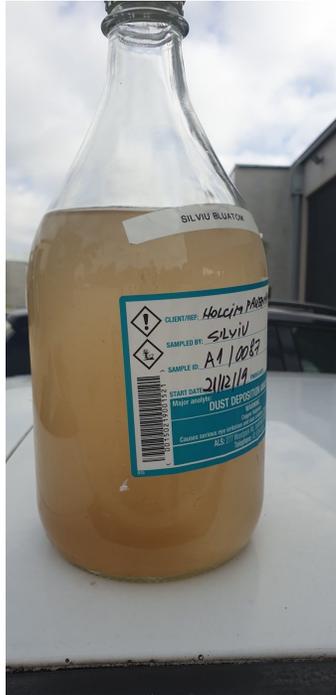
- Exceed landfill target by 400kgs per month
- Dust Deposition exceedance in January - caused by Gippsland Bushfires. Windrows and government air pollution advice verify that it is not dust emitted from the quarry.. Example of contaminated sample bottle attached

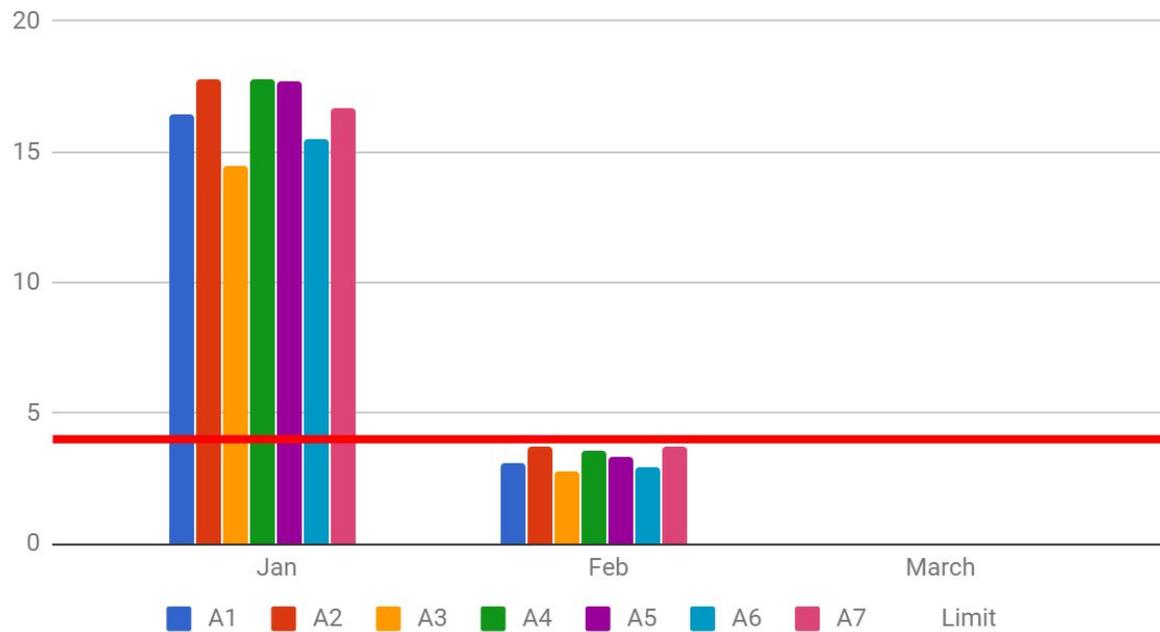
### Dust Deposition Q4 2019 (Limit 4.0/m<sup>2</sup>/mth)

DEPOSITIONAL results have indicated the dust emissions tabulated below

**Limit 4.0g/m<sup>2</sup>/mth**

Note: there were a number of reactive exceedances in Jan and Feb to bushfire smoke in Gippsland and surrounding areas. .

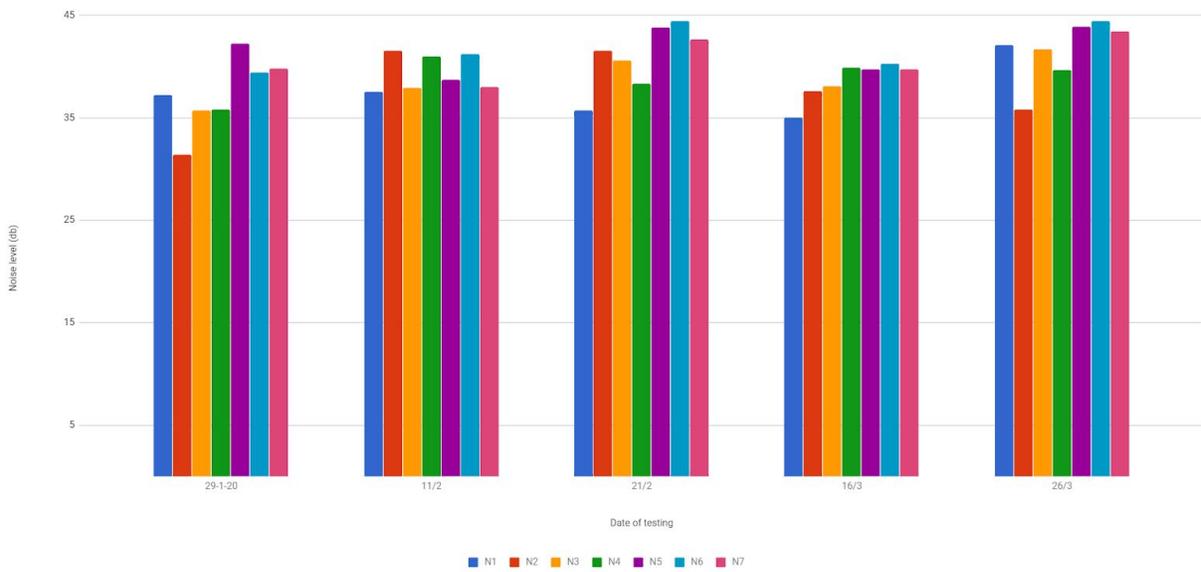
Fortnightly Noise testing results Q1 2020 (Limit 45dB)

Average noise levels for the 1st quarter are shown below.

**Limit is 45dB under normal operating conditions**

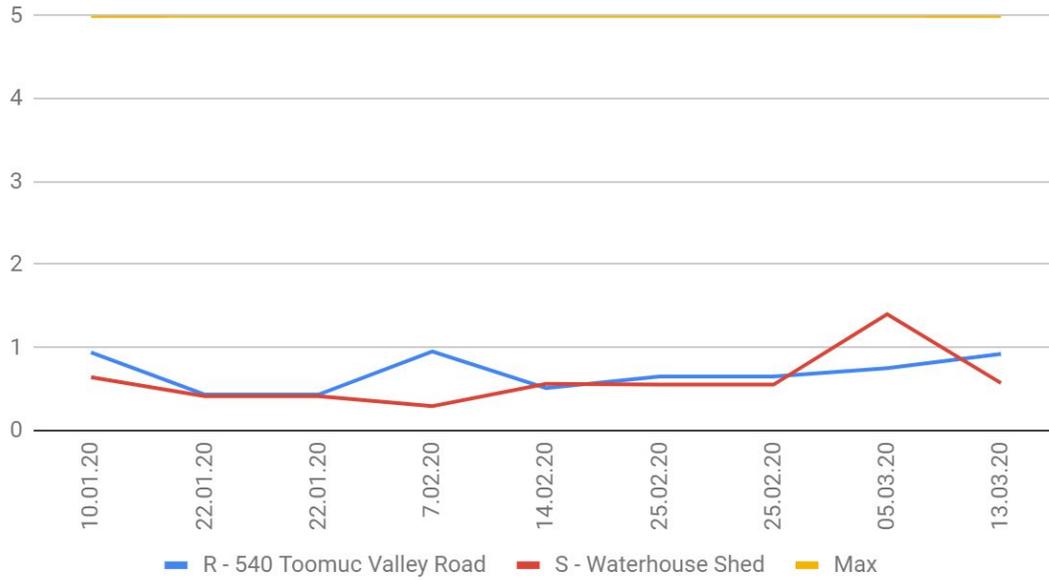
Ground Vibration mm/s Q1 2020

**Limit is 5mm/s for 95% of blasts in a 12 month period.**

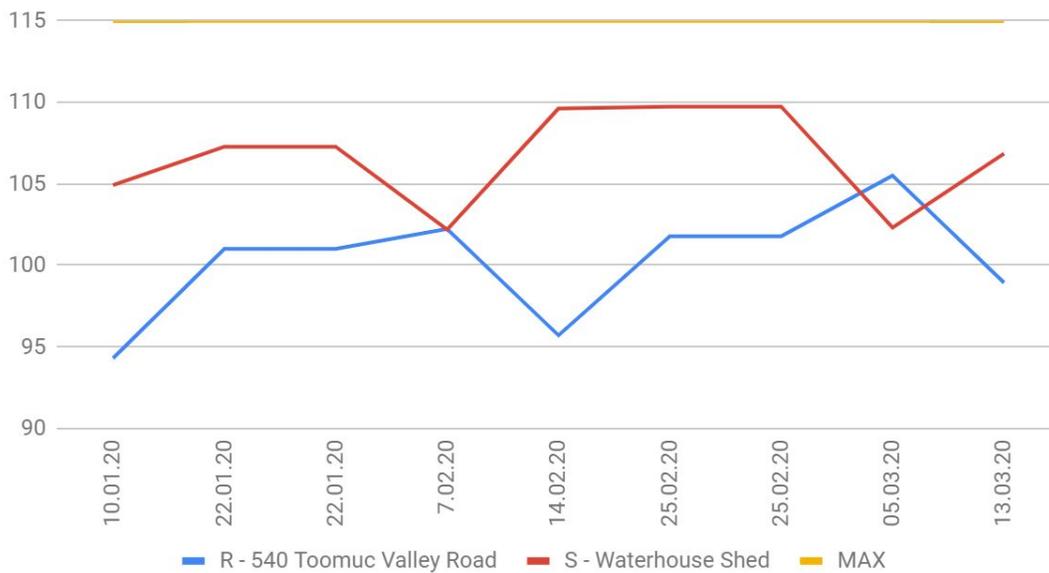
Air Blast dBL Q1 2020

**Limit is 115 dBL for 95% of blasts in a 12 month period.**

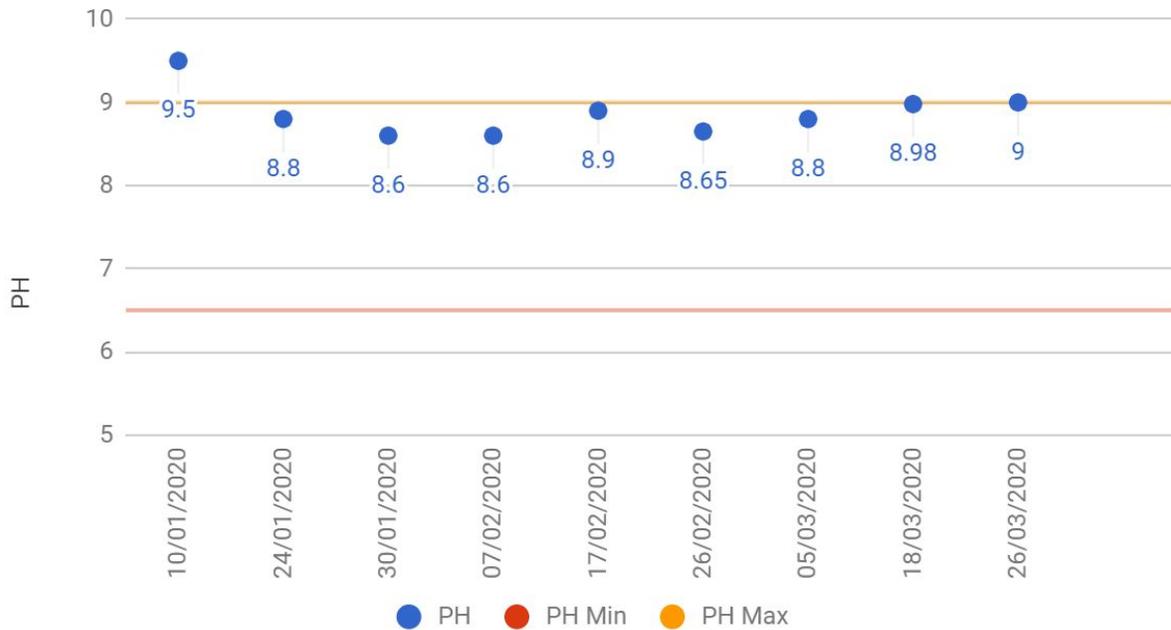
pH Q1 2020

**pH** – A measure of the Acidity or Alkalinity of the water limit 6.5 to 9.0

Note - No discharge on days of testing in Jan 10, increase in PH is results of water testing Donnazons dam (low water levels),

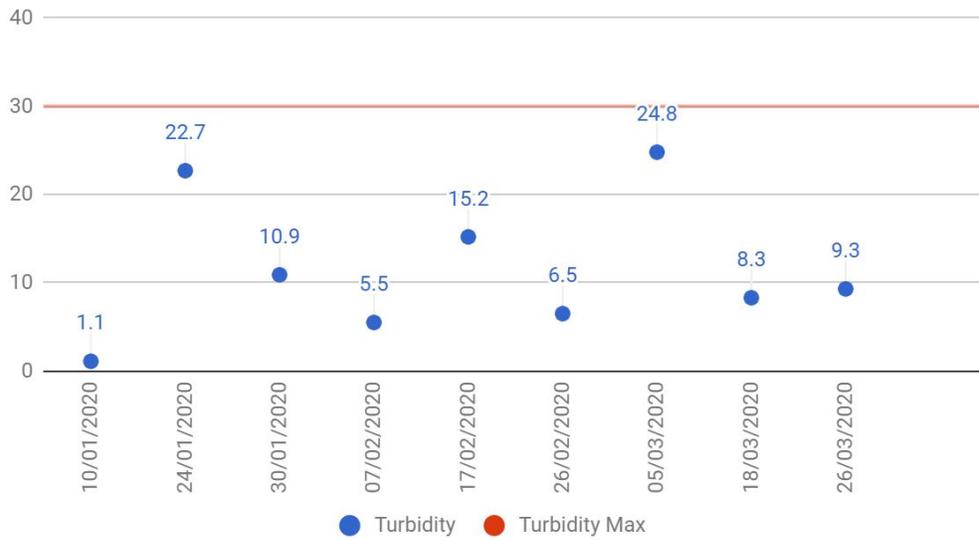
### Turbidity Q1 2020

**Turbidity** – Clarity of water Maximum 30NTU

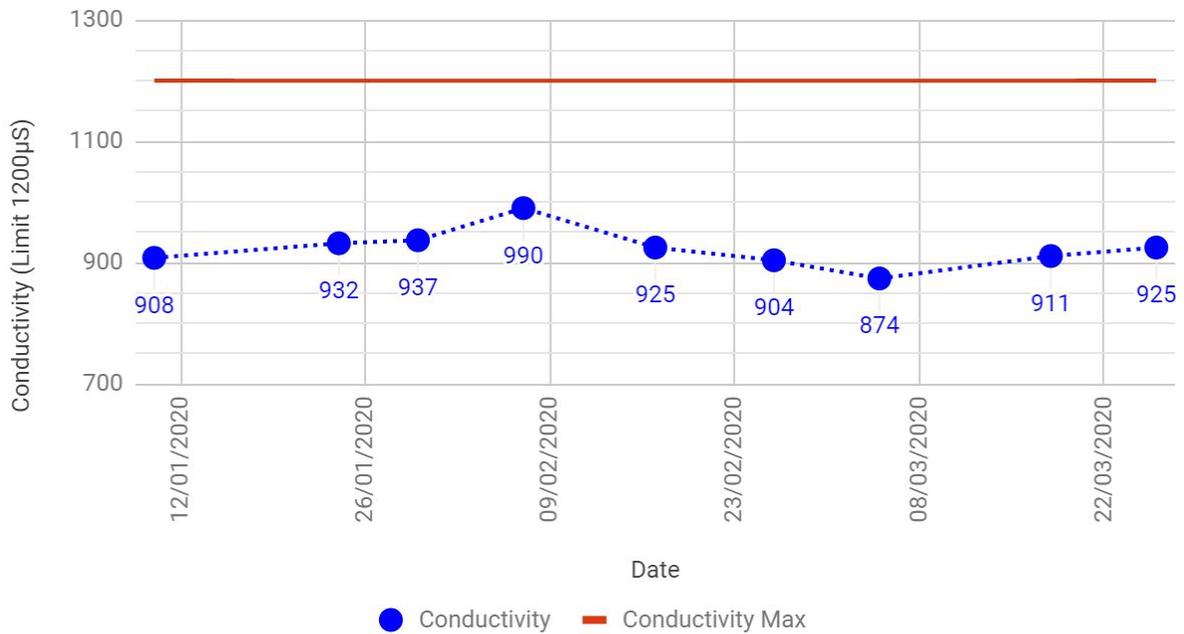
### Conductivity Q1 2020

**Conductivity** – A measure of the water’s capability to pass electrical current. Limit 1200µS

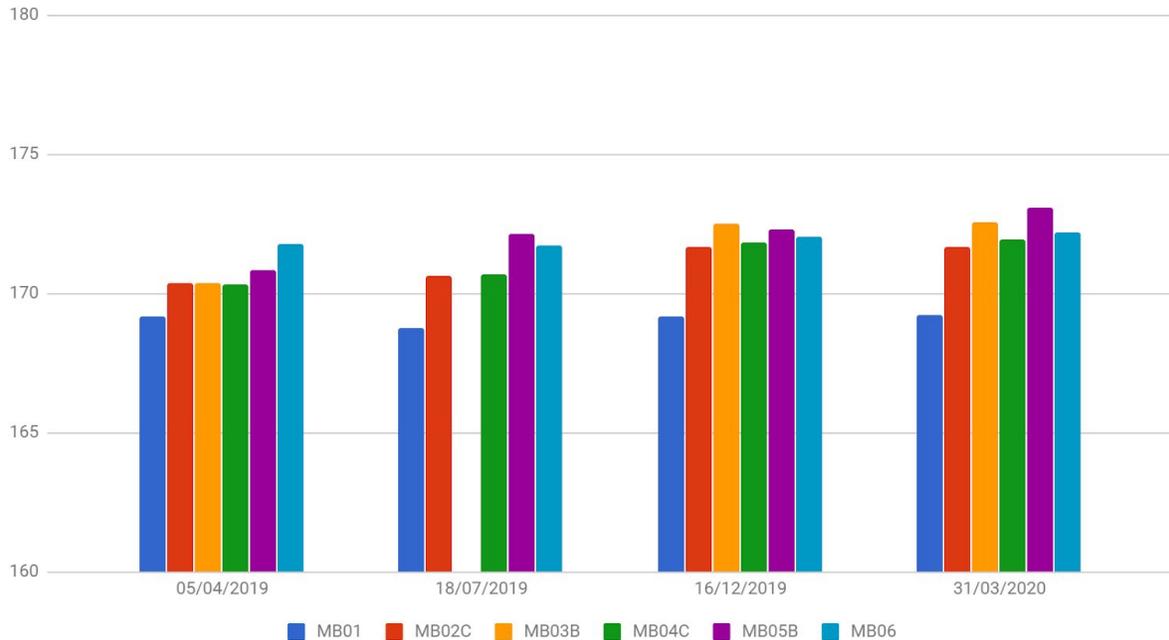
## RWL of ground monitoring bores last 12 months

Table showing 2019/2020 water table levels in relation to sea level

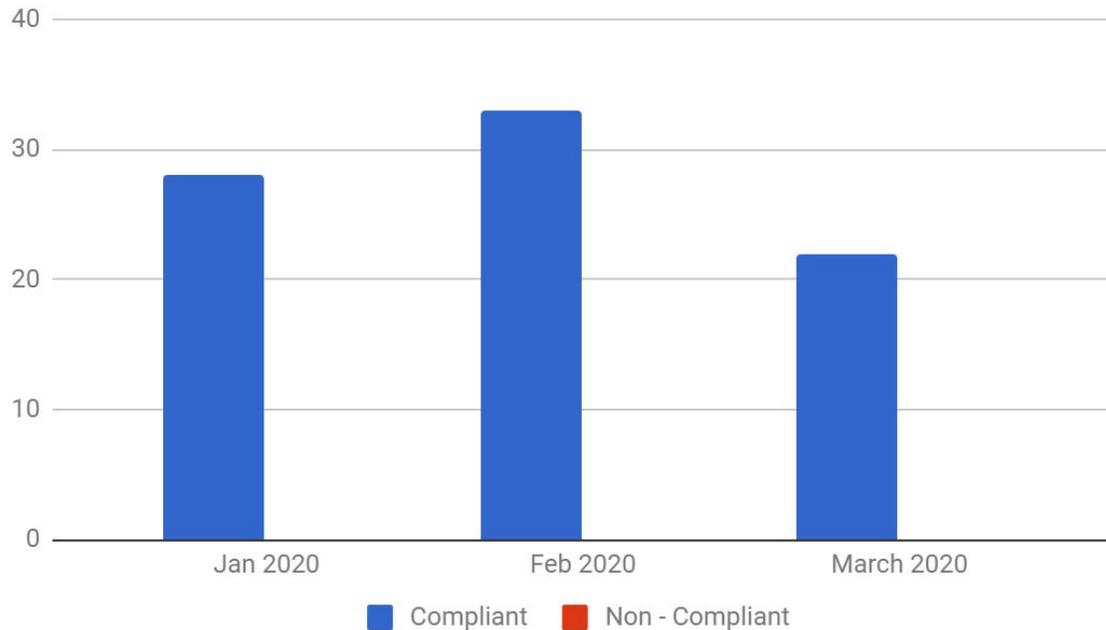
### Tarping compliance Q1 2020

Evaluation of trucks leaving the site concluded that there is minimal material being tracked on to public roadways, representative sampling identified all loads for the Quarter were correctly loaded.
