# Mt Shamrock Environmental Management Plan - 3 Monthly Progress Update

July 20 - Sept 20

Prepared by Matt Dodd for Mt Shamrock Quarry Environmental Review Committee

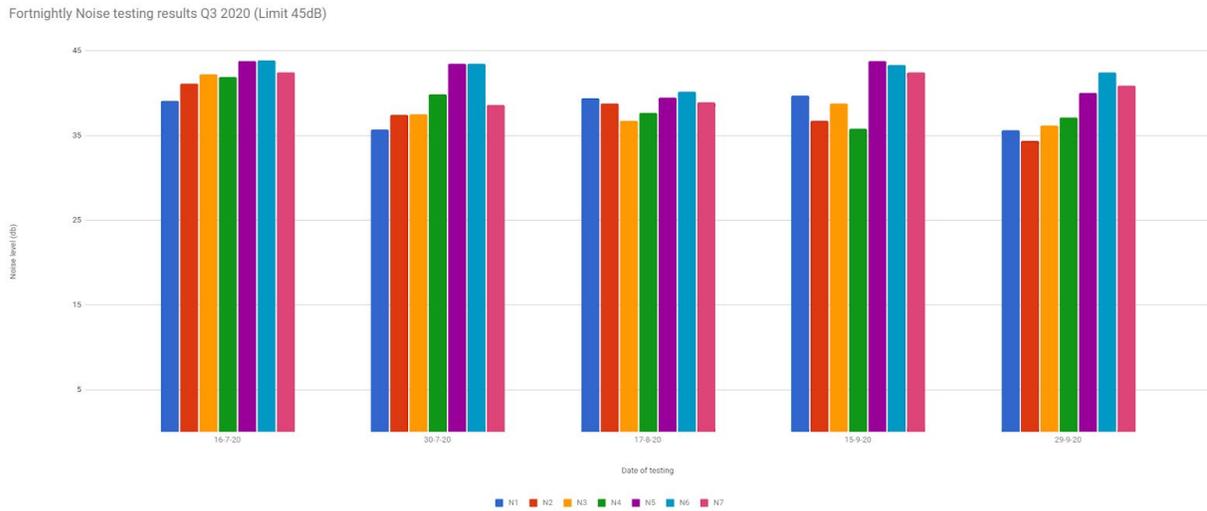
**Graph showing Noise monitoring results by Sensitive Location**

Average noise levels for the 1st quarter are shown below.

**Limit is 45dB under normal operating conditions**

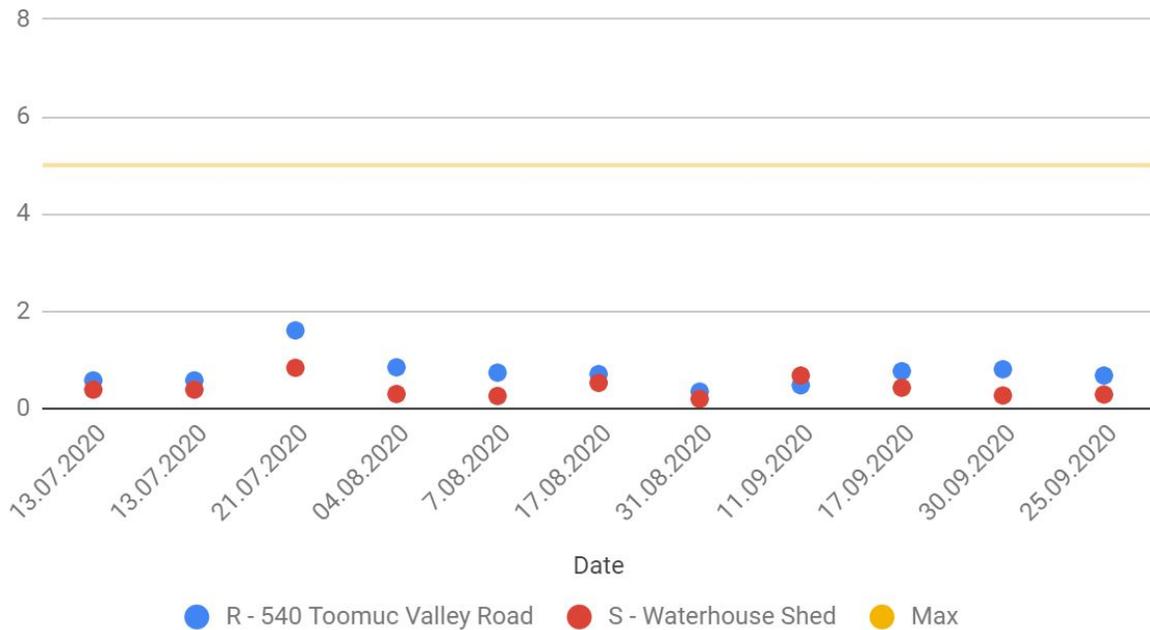
Q3 2020 - Ground vibration (mm/s)

**Limit is 5mm/s for 95% of blasts in a 12 month period.**

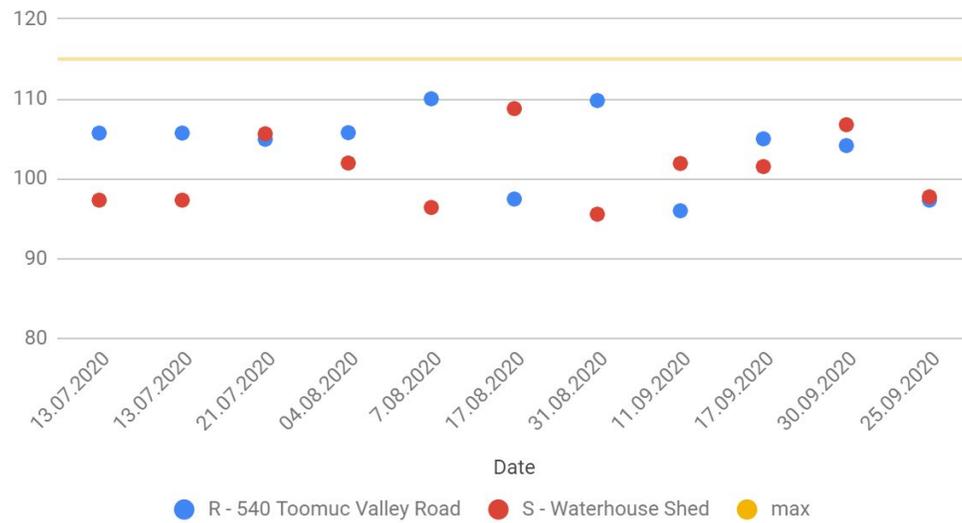
Q3 2020 Air Blast (dbL)

**Limit is 115 dbL for 95% of blasts in a 12 month period.**

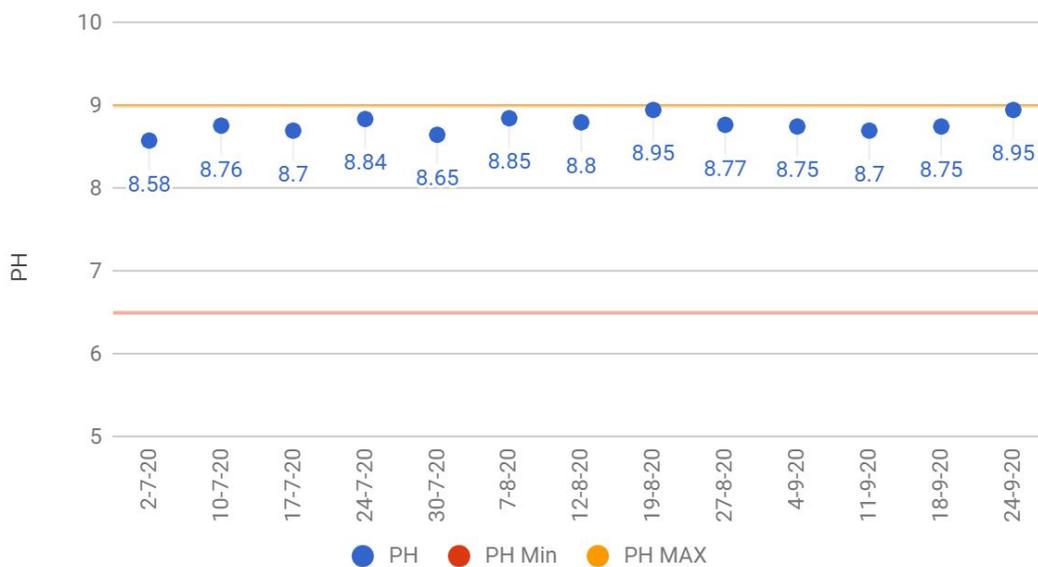
pH Q3 2020

pH – A measure of the Acidity or Alkalinity of the water limit 6.5 to 9.0

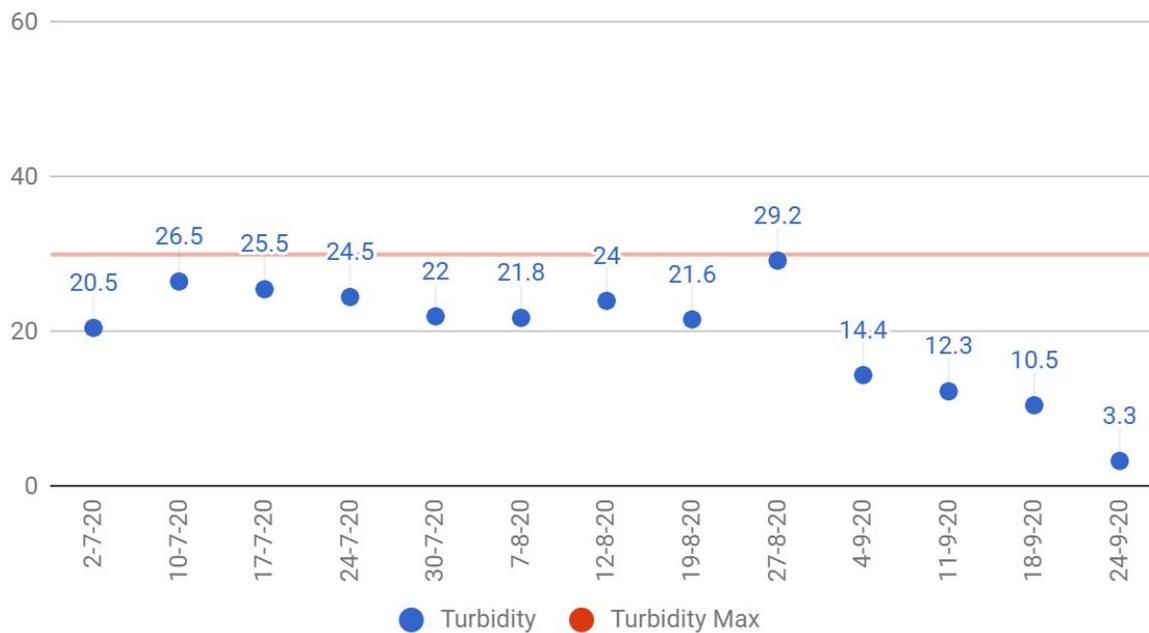
#### Turbidity Q3 2020

### Turbidity – Clarity of water Maximum 30NTU

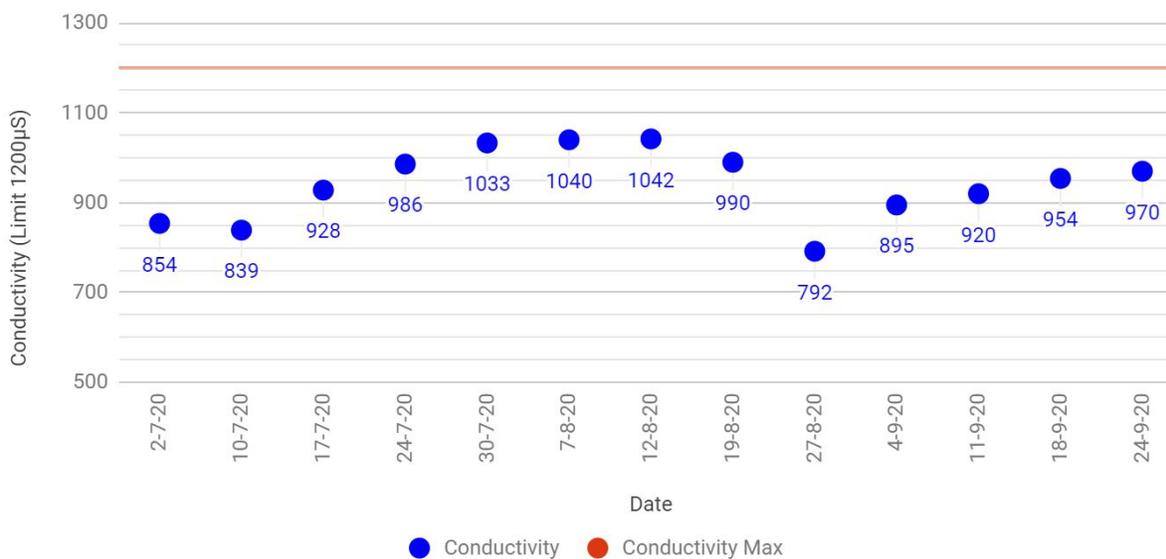
#### Conductivity Q3 2020

### Conductivity – A measure of the water’s capability to pass electrical current. Limit 1200µS

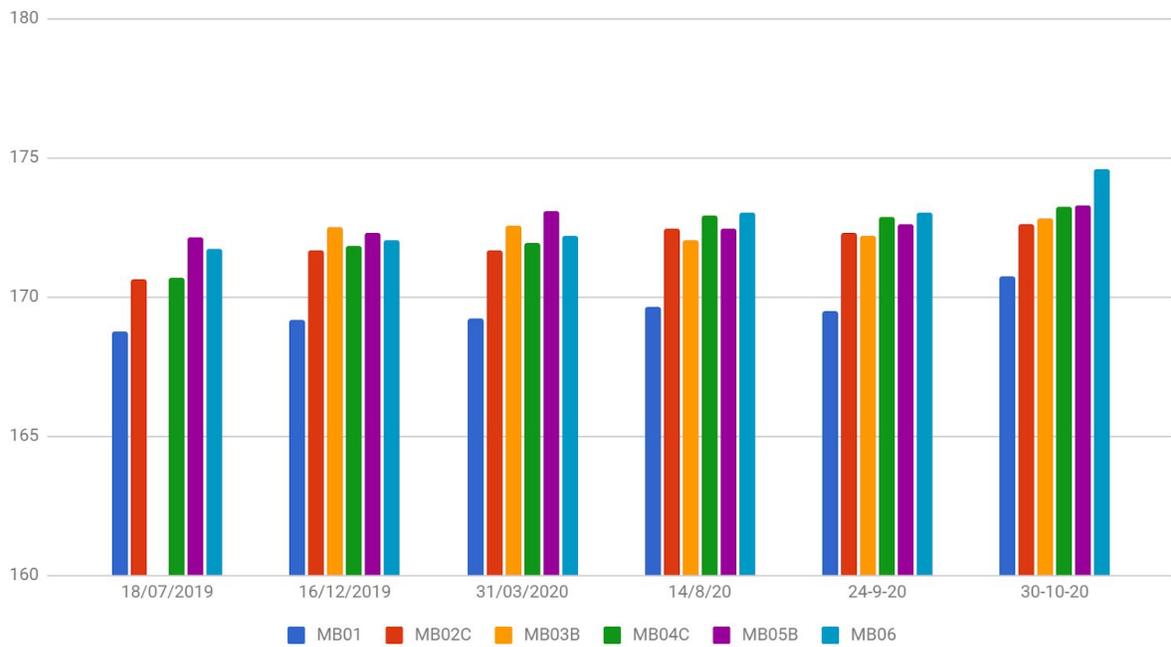
RWL of ground monitoring bores

Table showing 2019/2020 water table levels in relation to sea level

**Note: As part of the most recent discussions, one of the actions Holcim will action is to conduct additional GWL monitoring on a monthly basis, hence the number of monitoring events has increased.**

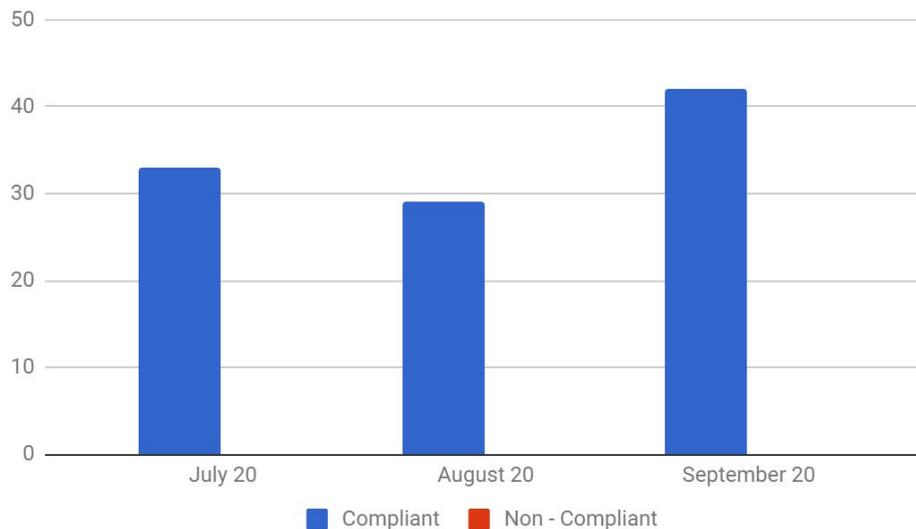
Tarping compliance Q3 2020

Evaluation of trucks leaving the site concluded that there is minimal material being tracked on to public roadways, representative sampling identified all loads for the Quarter were correctly loaded.

Graph showing Tarping visual checks

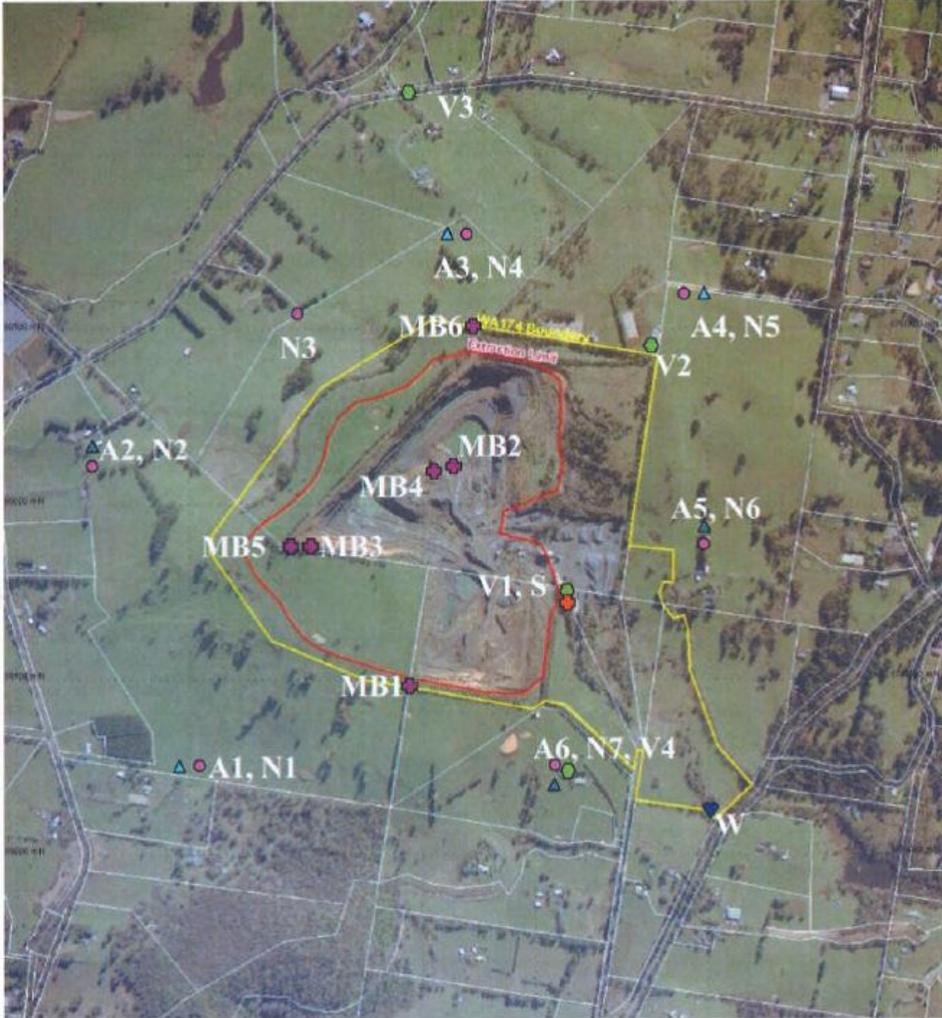
**HOLCIM, MOUNT SHAMROCK QUARRY PAKENHAM**  
**Figure 1: Environmental Monitoring Locations**

This report details information on both monitoring results and management actions by the quarry in the preceding three months. This report will take the form of an exception report that is where there is a deviance from the EMP. This will be highlighted and the reasons for the deviance explained. A summary of quantifiable monitoring outcomes is also included. Figure 1.12 details all monitoring locations.
