# **Mt Shamrock Environmental Management Plan - 3 Monthly Progress Update October 20 - December 20**

Prepared by Matt Dodd for Mt Shamrock Quarry Environmental Review Committee

On 11 March 2008, the Mt Shamrock Quarry Environmental Management Plan Version 1:18 January 2008 (EMP) was formally enacted. This document established a framework to ensure compliance with local council, AAV, DPI, EPA and DSE requirements relating to the extension of extractive limits under Work Authority 174 (WA174). An Environment Review Committee (ERC) was formed to monitor the performance of the quarry against the EMP, the permit and WA174. The ERC consists of delegates from the relevant authorities, members of the Wurundjeri Tribe, and local residents. The ERC is chaired by an independent representative from All Possibilities Pty Ltd to ensure non-partisan administration.

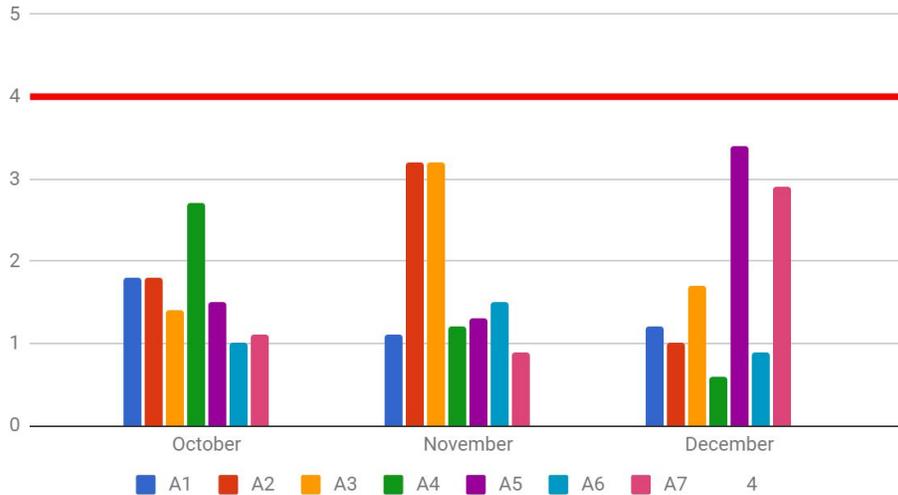
Dust Deposition Q4 2020 (Limit 4.0/m<sup>2</sup>/mth)

DEPOSITIONAL results have indicated the dust emissions tabulated below

**Limit 4.0g/m<sup>2</sup>/mth**

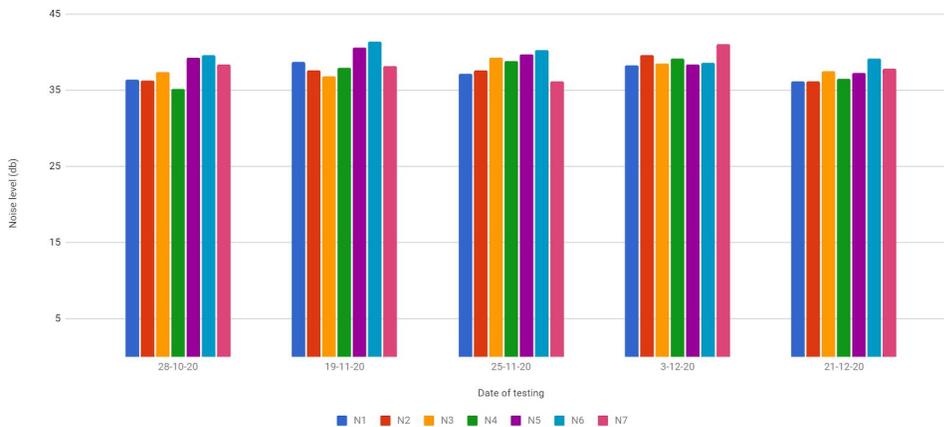
Fortnightly Noise testing results Q4 2020 (Limit 45dB)

Average noise levels for the 1st quarter are shown below.

**Limit is 45dB under normal operating conditions**

**Graph showing Noise monitoring results by Sensitive Location**

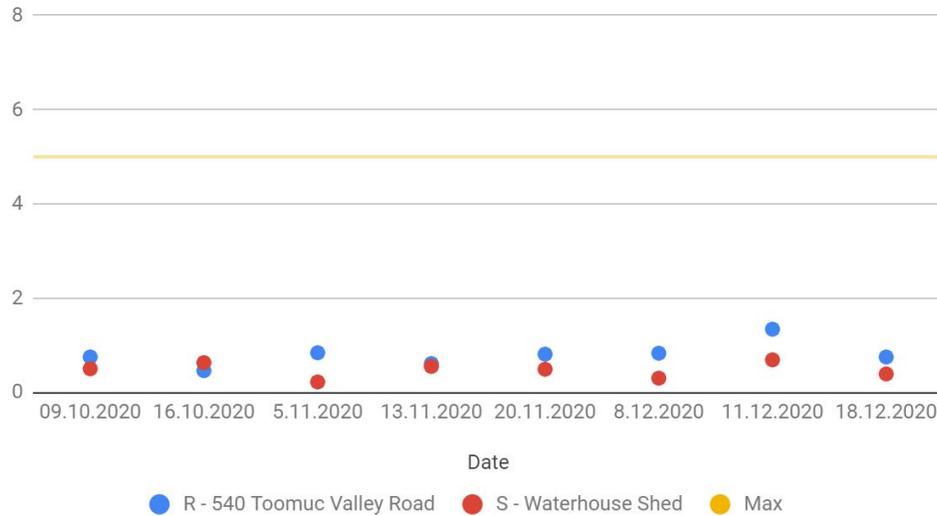
Q4 2020 - Ground vibration (mm/s)

**Limit is 5mm/s for 95% of blasts in a 12 month period.**

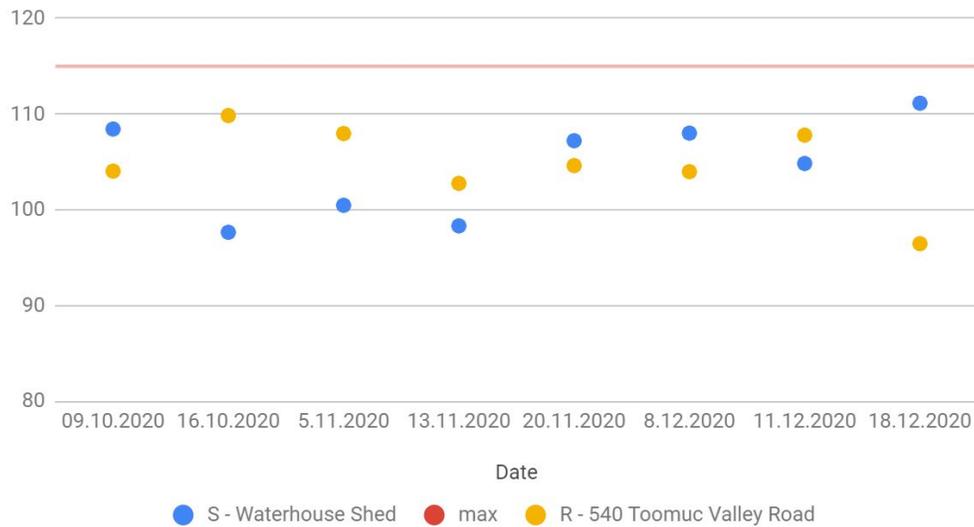
Q4 2020 Air Blast (dbL)

**Limit is 115 dbL for 95% of blasts in a 12 month period.**

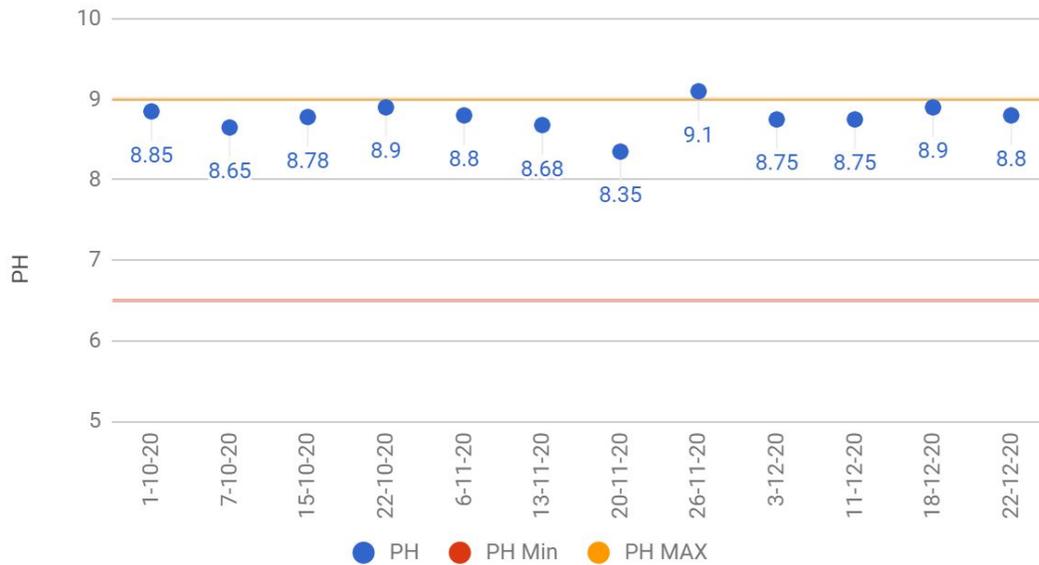
pH Q4 2020

pH – A measure of the Acidity or Alkalinity of the water limit 6.5 to 9.0

Note 26/11/20 high PH, no discharge occurring this water was sampled at Donnazons Dam

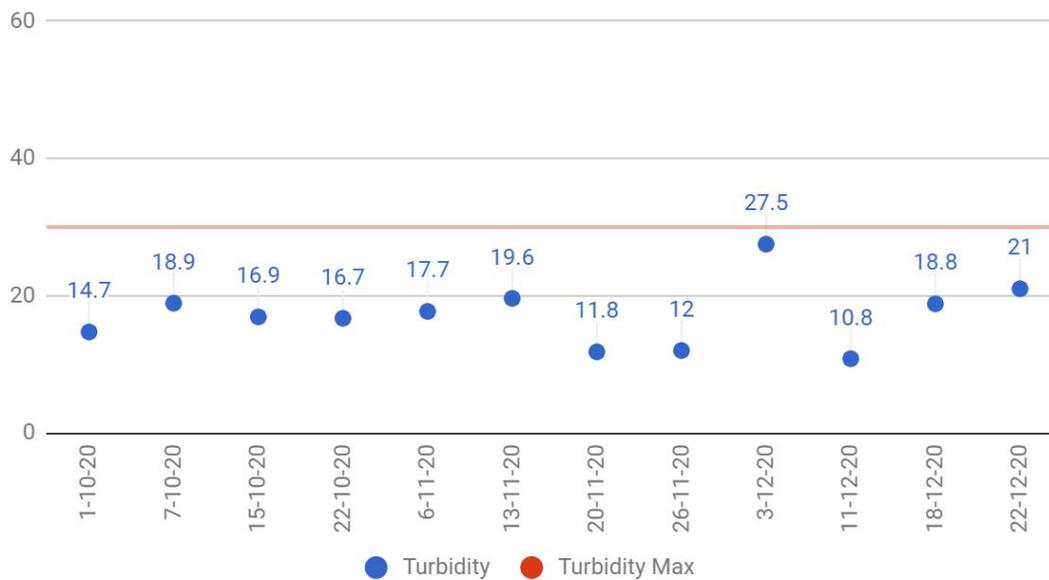
Turbidity Q4 2020

**Turbidity** – Clarity of water Maximum 30NTU

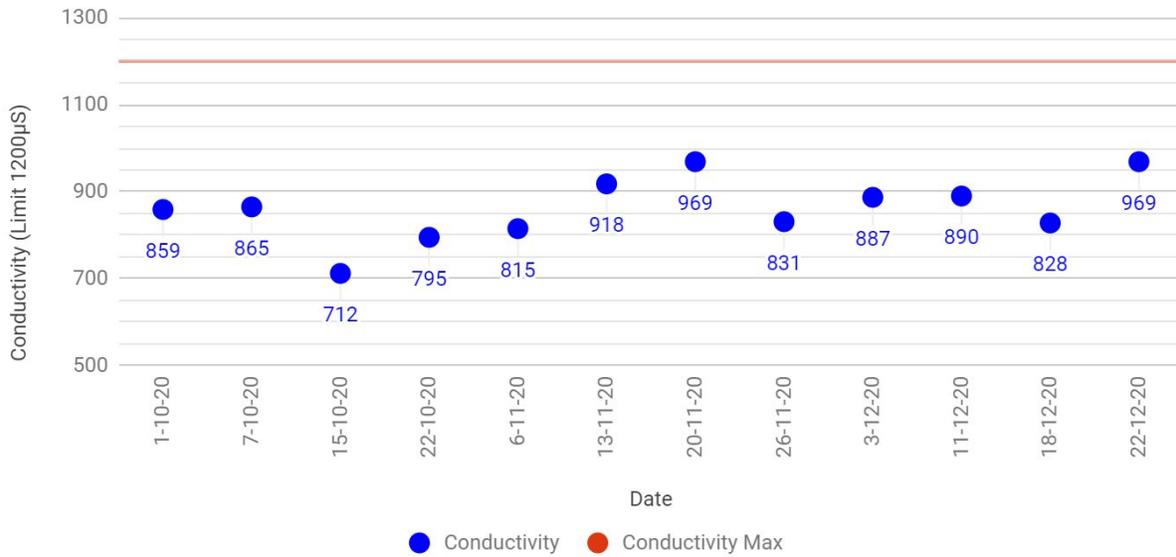
### Conductivity Q4 2020

**Conductivity** – A measure of the water’s capability to pass electrical current. Limit 1200µS

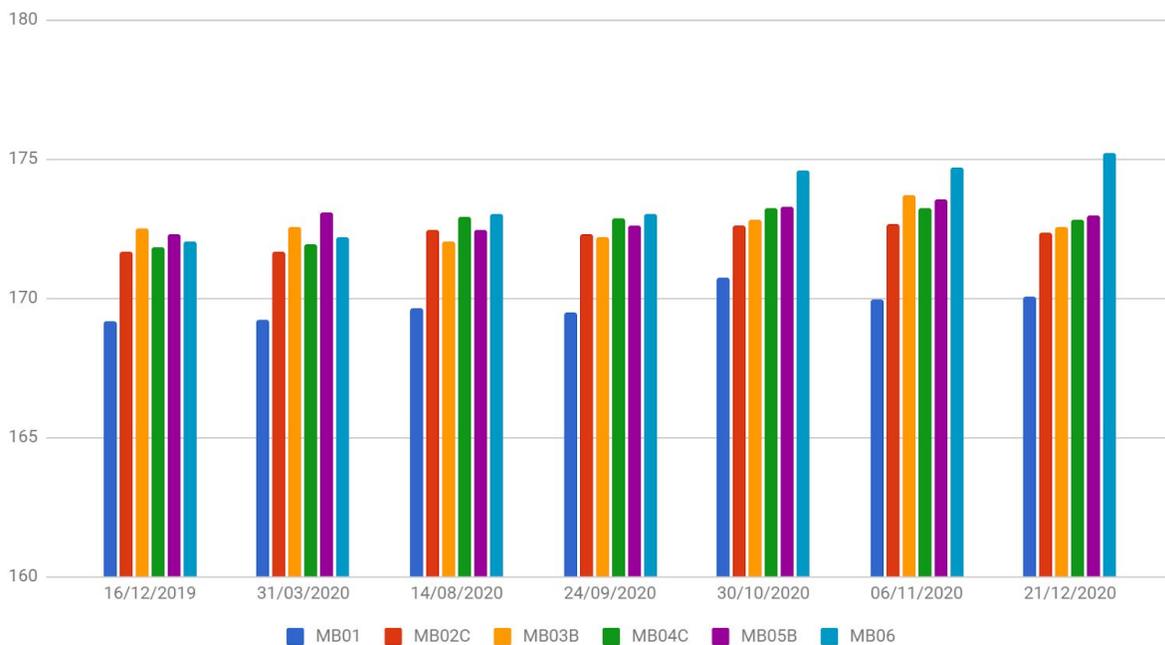
#### RWL of ground monitoring bores 2020

Table showing 2019/2020 water table levels in relation to sea level

**Note: As part of the most recent discussions, one of the actions Holcim will action is to conduct additional GWL monitoring on a monthly basis, hence the number of monitoring events has increased.**

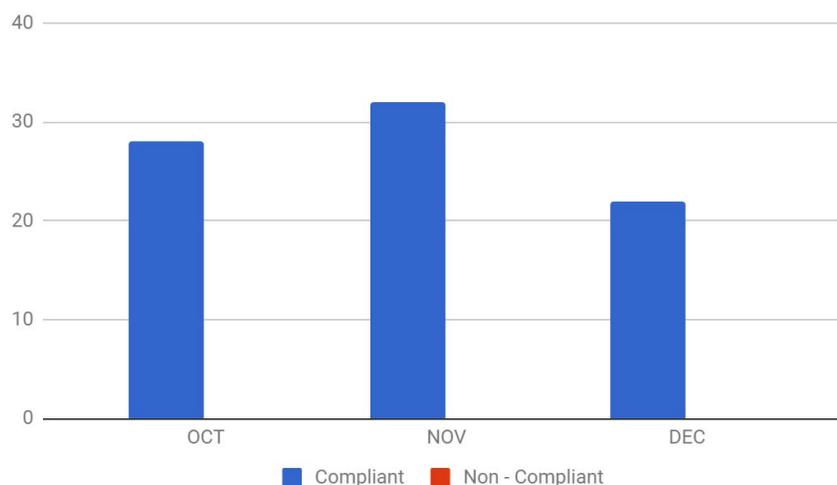
Tarping compliance Q4 2020

Evaluation of trucks leaving the site concluded that there is minimal material being tracked on to public roadways, representative sampling identified all loads for the Quarter were correctly loaded.

**Graph showing Tarping visual checks**

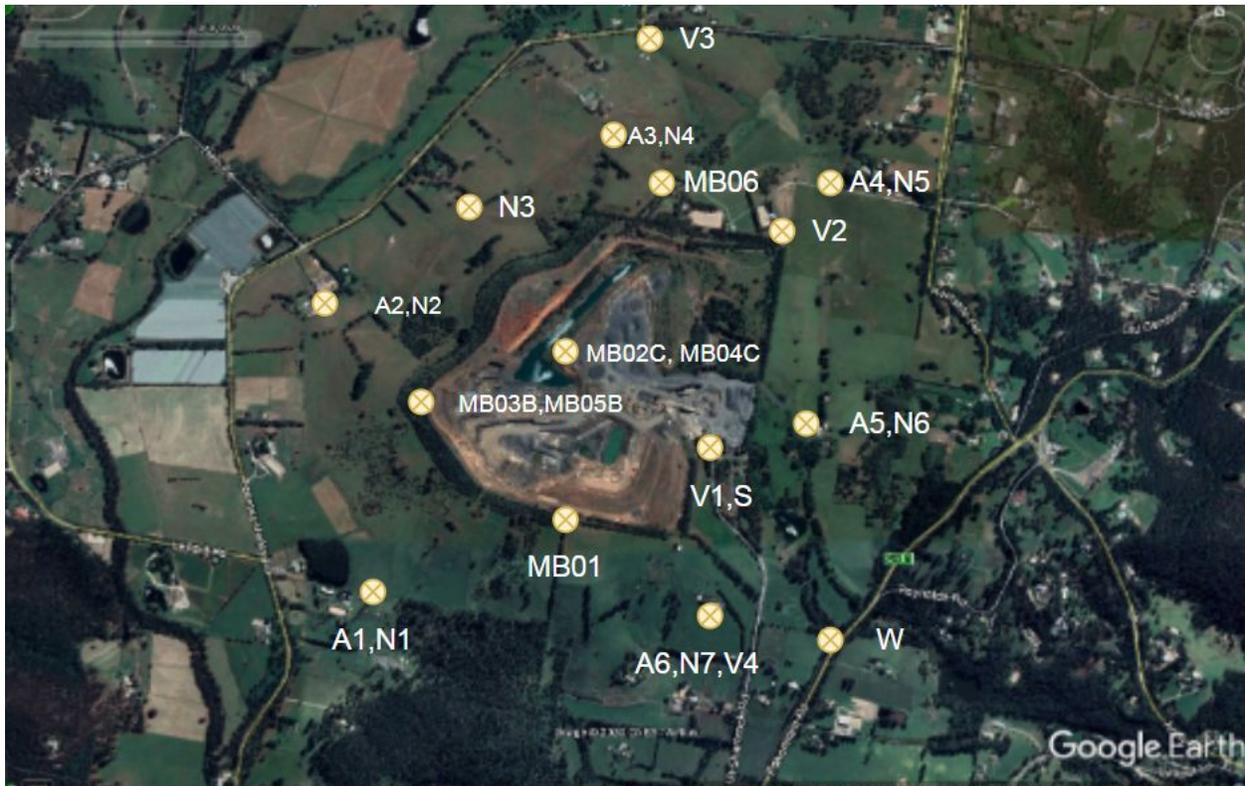
## Appendix 2 – Monitoring Locations

This report details information on both monitoring results and management actions by the quarry in the preceding three months. This report will take the form of an exception report that is where there is a deviance from the EMP. This will be highlighted and the reasons for the deviance explained. A summary of quantifiable monitoring outcomes is also included. Figure 1.12 details all monitoring locations.
