Mt Shamrock Environmental Management Plan - 3

Monthly Progress Update

July 21 - September 2021

Prepared by Matt Dodd for Mt Shamrock Quarry Environmental Review Committee

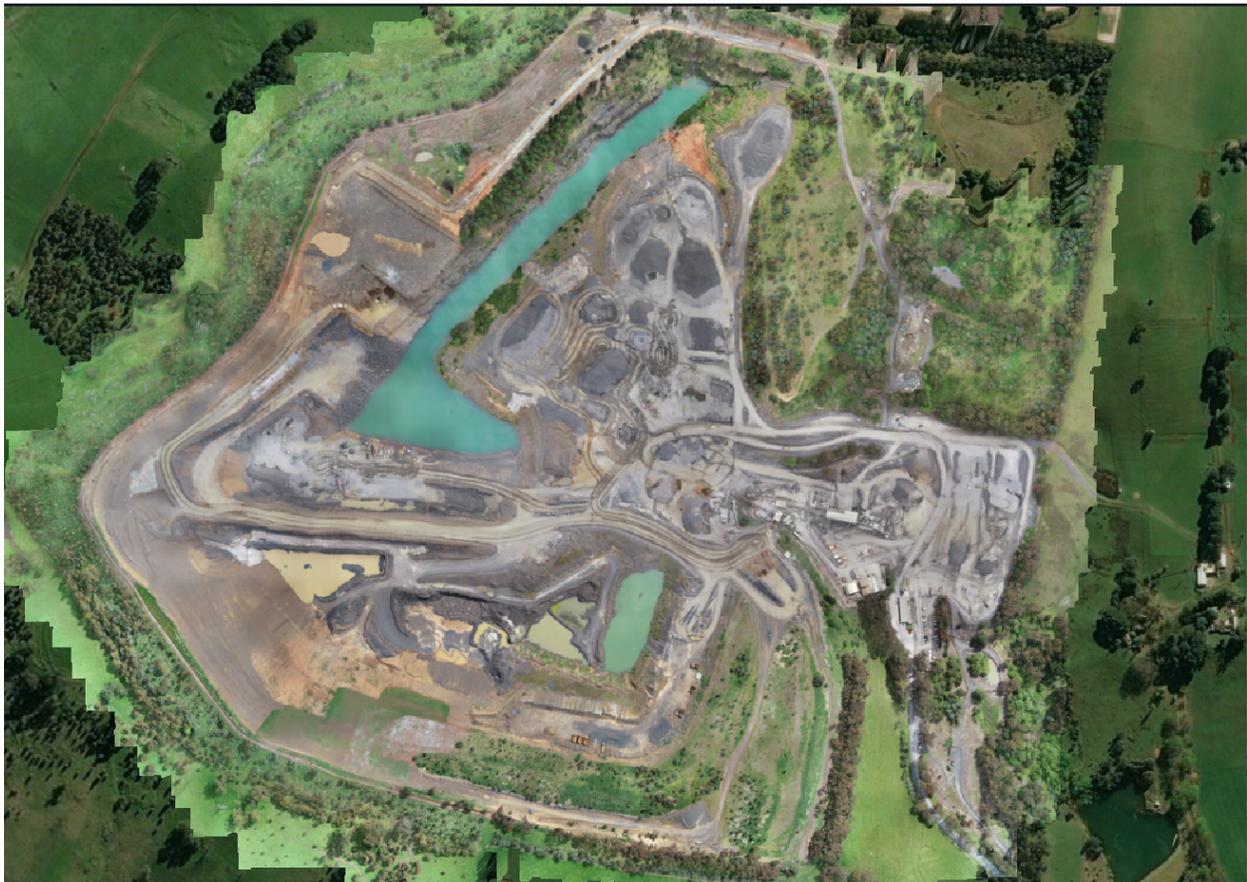
- Operating hours unchanged
- EMP submitted to Cardinia Shire for approval process
- Done survey picture from October 2021 shown below

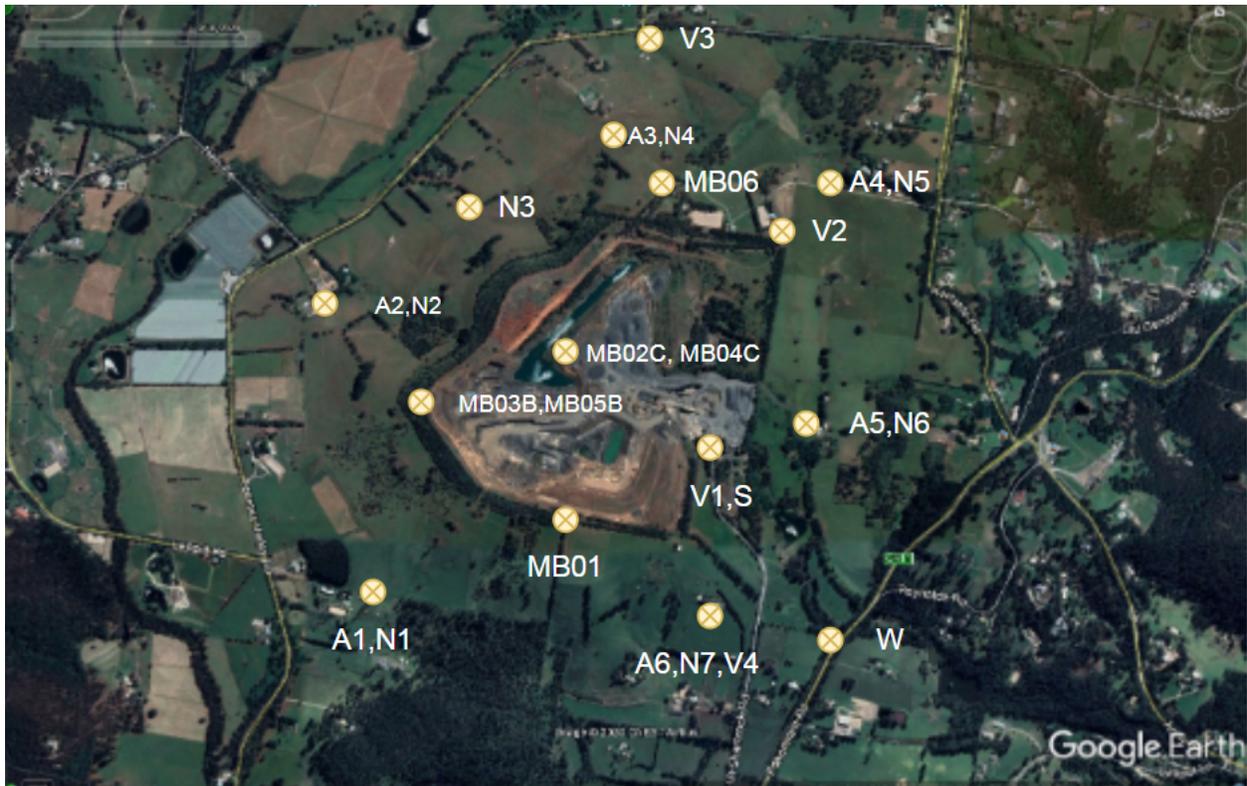
Appendix 2 – Monitoring Locations

This report details information on both monitoring results and management actions by the quarry in the preceding three months. This report will take the form of an exception report that is where there is a deviance from the EMP. This will be highlighted and the reasons for the deviance explained. A summary of quantifiable monitoring outcomes is also included. Figure 1.12 details all monitoring locations.
