Mt Shamrock Environmental Management Plan - 3

Monthly Progress Update

October 2021 - December 2021

Prepared by Leigh Elliott for Mt Shamrock Quarry Environmental Review Committee

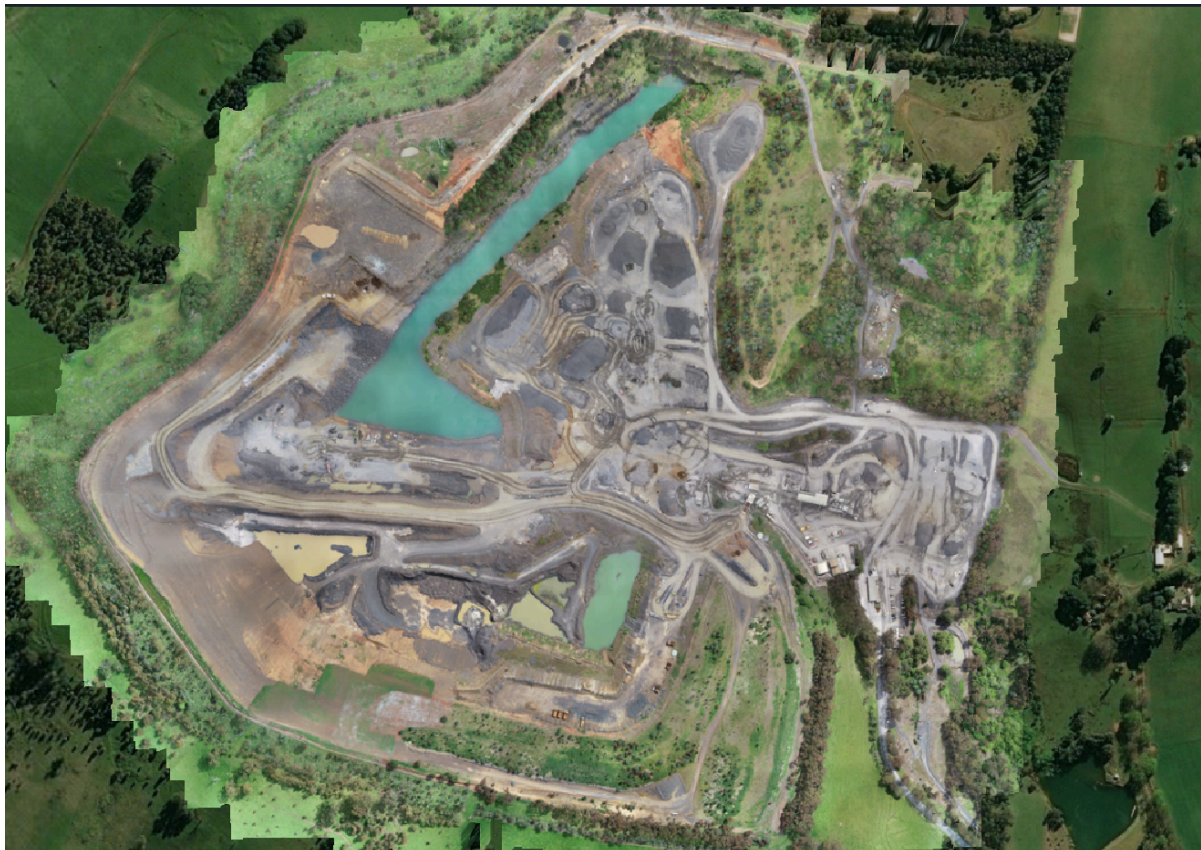
- Operating hours unchanged
- Quarry Manager change from Matt Dodd to Leigh Elliott in early December. Nathan Thomas continues to support in the Operations Manager role. No other staff changes of note.
- 2021 EMP review is still in Cardinia Shire's approvals process.
- Revised Bushfire Management plan issued to CFA and approved in December 2021
- Bushfire preparations underway
- 2021 Annual consultant reports are currently going through Holcim's internal review process
- Done survey picture from October 2021 shown below.

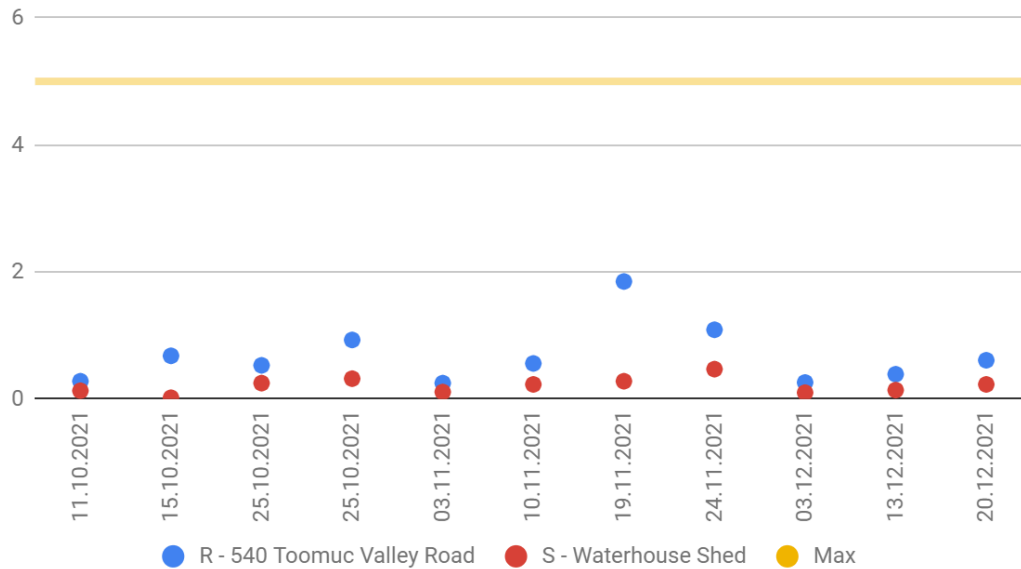
Ground Vibration Q4 2021(max 5mm/s)

All blasting operations have been carried out in accordance with guidelines. No exceedances during the reporting period.

Limit is 5mm/s for 95% of blasts in a 12 month period.

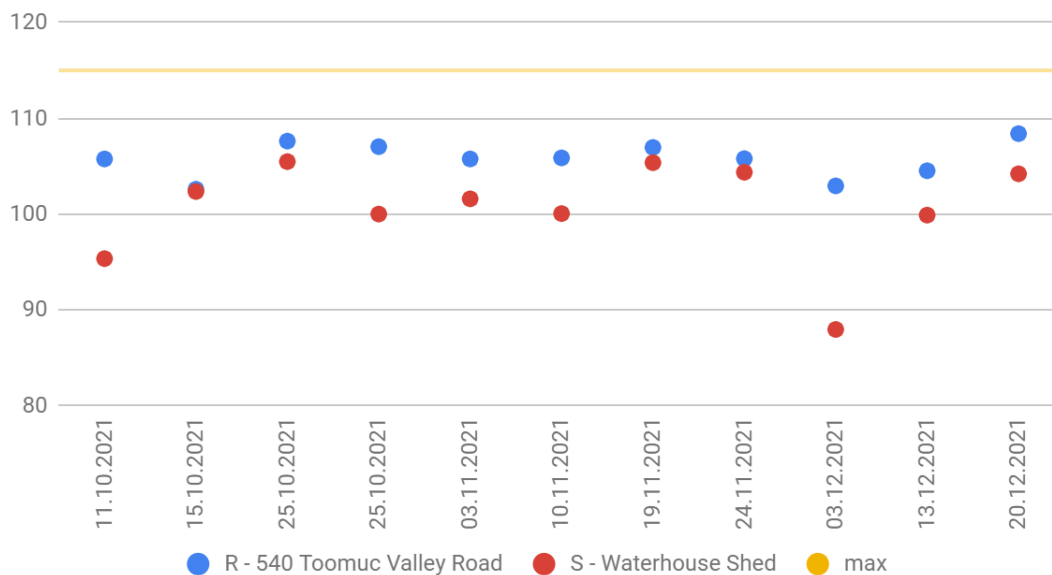
Air Blast Q4 2021 (max 115dBL)

Limit is 115 dBL for 95% of blasts in a 12 month period.

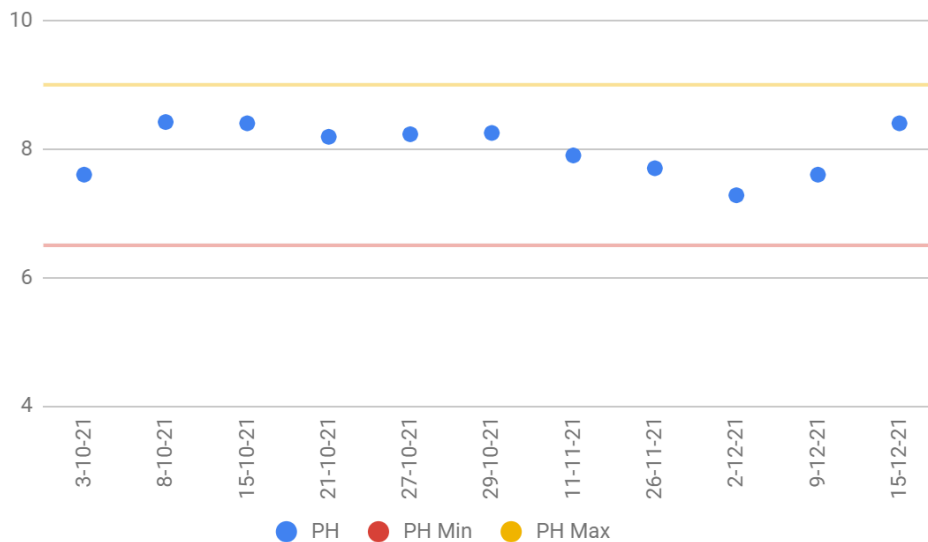
pH Q4 2021

pH – A measure of the Acidity or Alkalinity of the water limit 6.5 to 9.0. No exceedances during the reporting period.

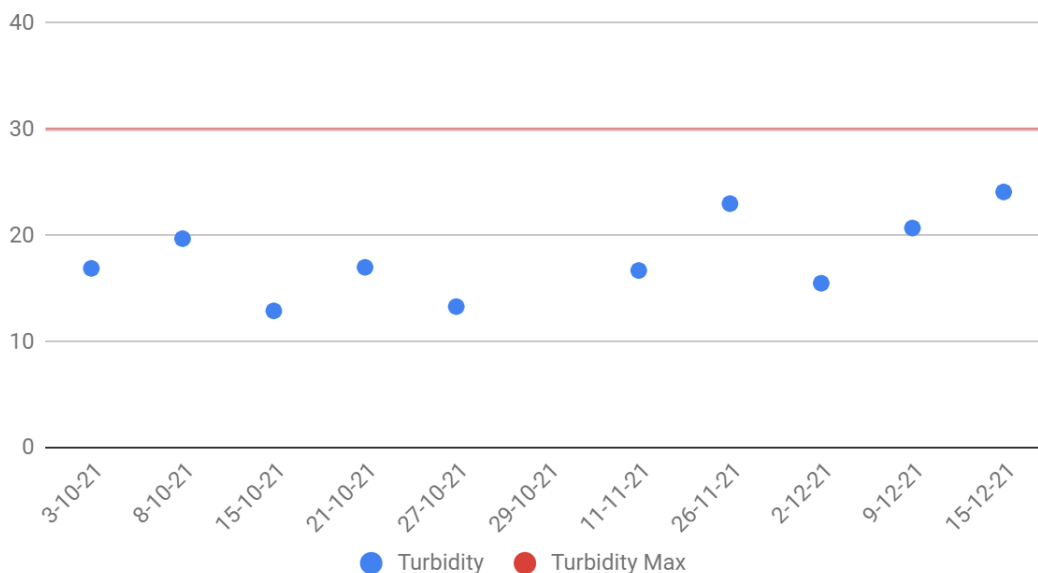
Turbidity Q4 2021

Turbidity – Clarity of water Maximum 30NTU. No exceedances during the reporting period.

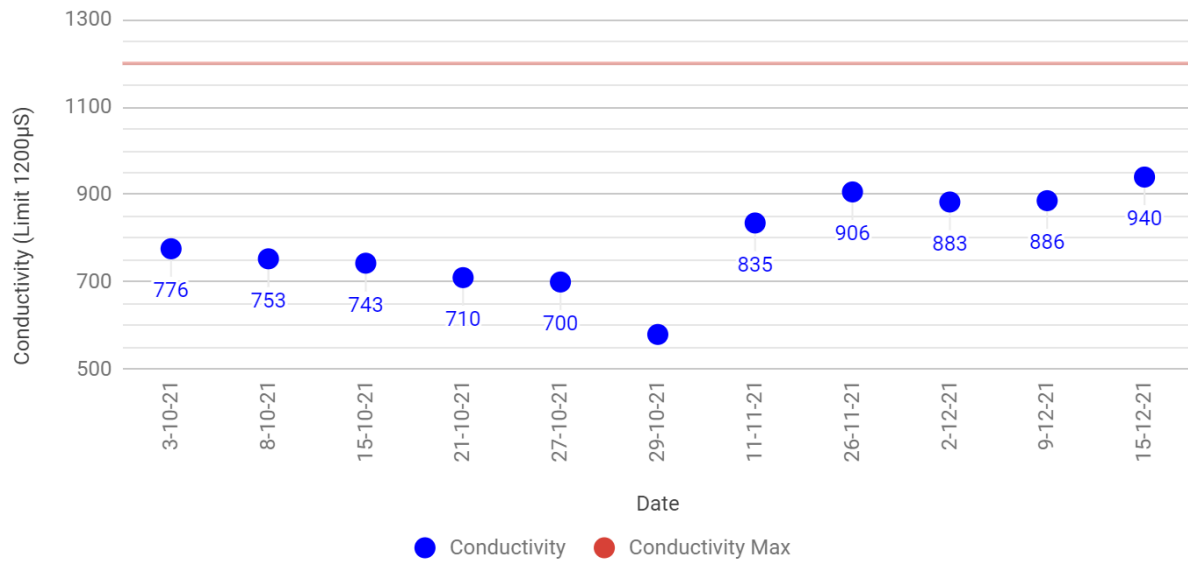
Conductivity Q4 2021

Conductivity – A measure of the water’s capability to pass electrical current. Limit 1200µS. No exceedances during the reporting period.

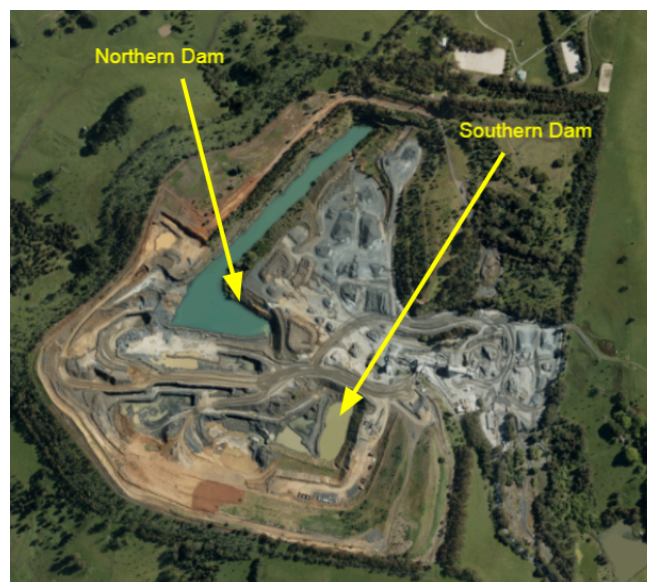
In 2020, Holcim committed to begin and report the in pit water dam levels quarterly, to aid in the annual beneficial use analysis. This was formed as part of the revised EMP submission. Location and naming conventions are shown in the map for reference. All measurements are in RL's (the same unit as ground water levels)

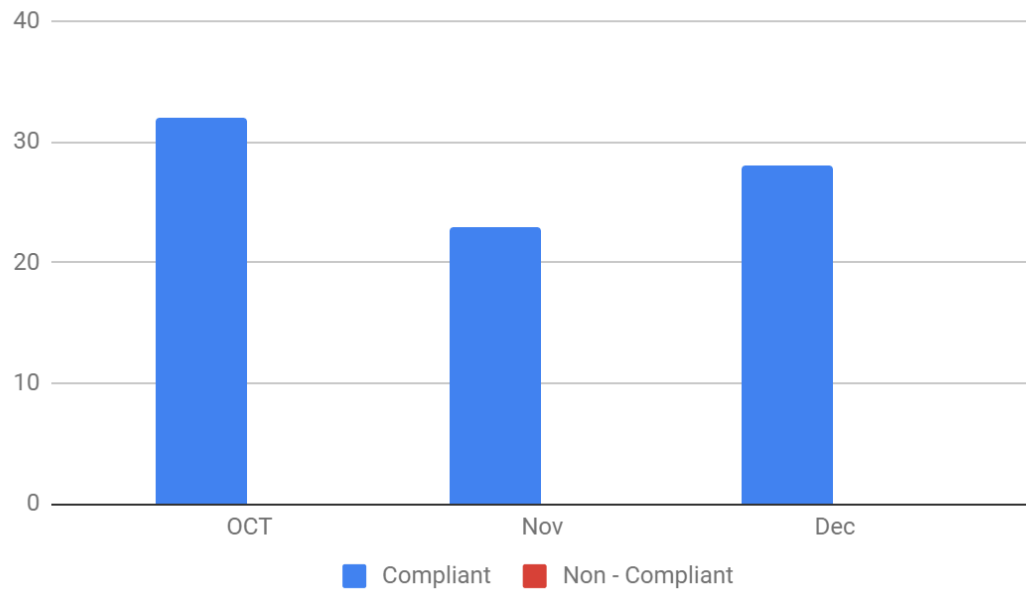
Tarping compliance Q4 2021

Evaluation of trucks leaving the site concluded that there is minimal material being tracked on to public roadways, representative sampling identified all loads for the Quarter were correctly loaded.

Graph showing Tarping visual checks

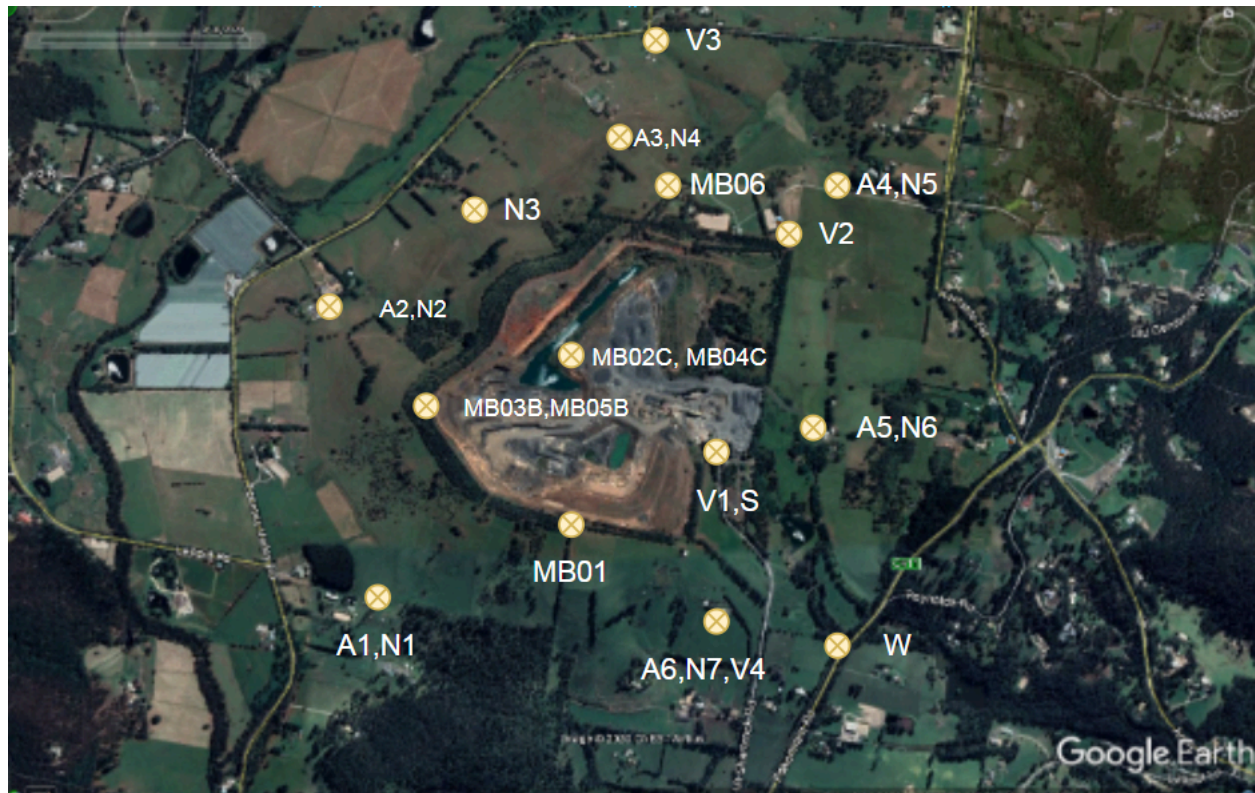
Appendix 2 – Monitoring Locations

This report details information on both monitoring results and management actions by the quarry in the preceding three months. This report will take the form of an exception report that is where there is a deviance from the EMP. This will be highlighted and the reasons for the deviance explained. A summary of quantifiable monitoring outcomes is also included. Figure 1.12 details all monitoring locations.
