Quarterly Report

January - March

**Mt Shamrock
Environmental Management Plan
3 Monthly Progress Update**

Prepared for Mt Shamrock Quarry Environmental Review Committee

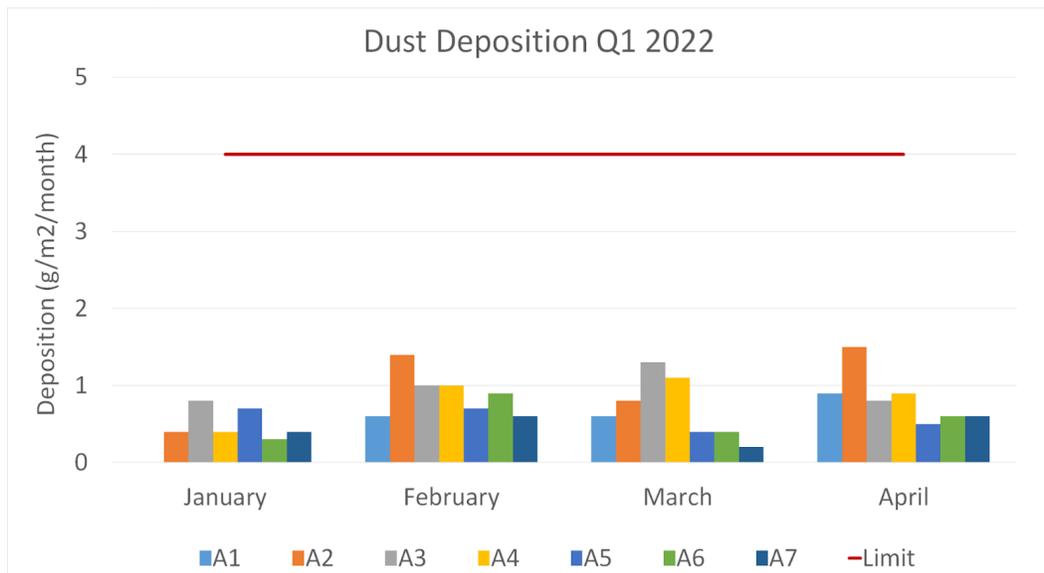
Depositional results have indicated the dust emissions tabulated below. No exceedances during the reporting period.

Figure 2 - Dust Deposition Q1 2022. (Limit 4.0g/m2/mth)

Note that the deposition results presented are Ash analysis test, rather than Total Solids, representing true mineral dust deposition generated by quarry activities.

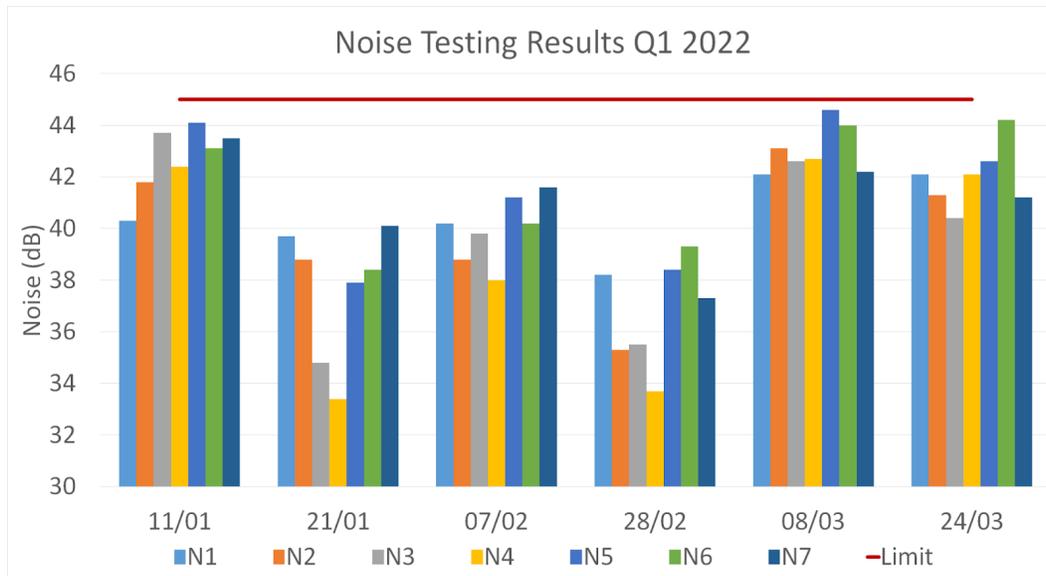
Average noise levels for the 1st Quarter 2022 are shown below. No exceedances during the reporting period.

Figure 3 - Noise Testing Results Q1 2022. (Limit is 45dB under normal operating conditions)

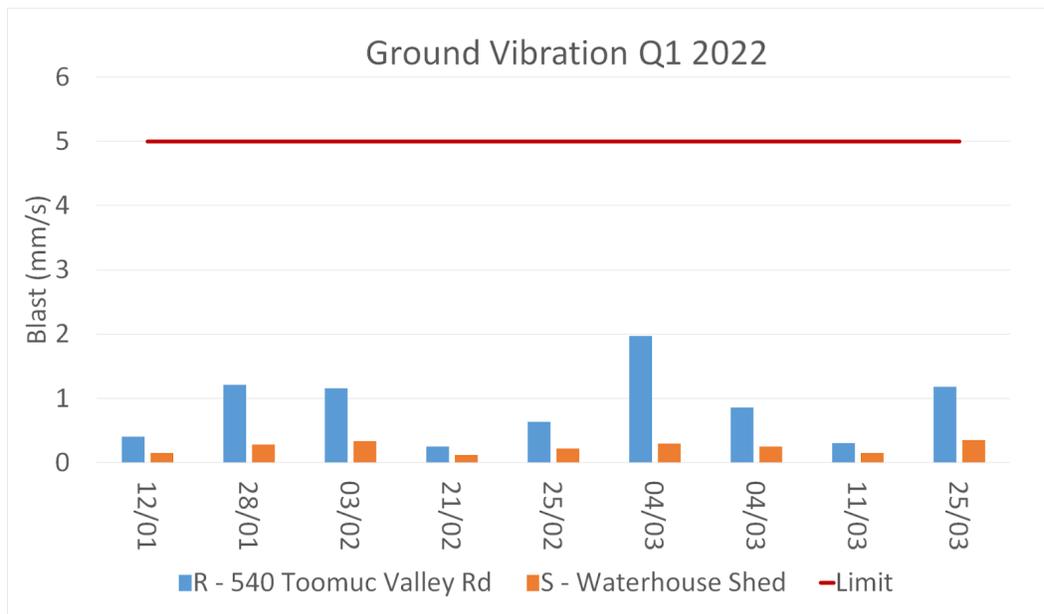
All blasting operations have been carried out in accordance with guidelines. No exceedances during the reporting period.

Figure 4 - Blasting; Ground Vibration Results Q1 2022 (Limit is 5mm/s for 95% of blasts in a 12 month period)

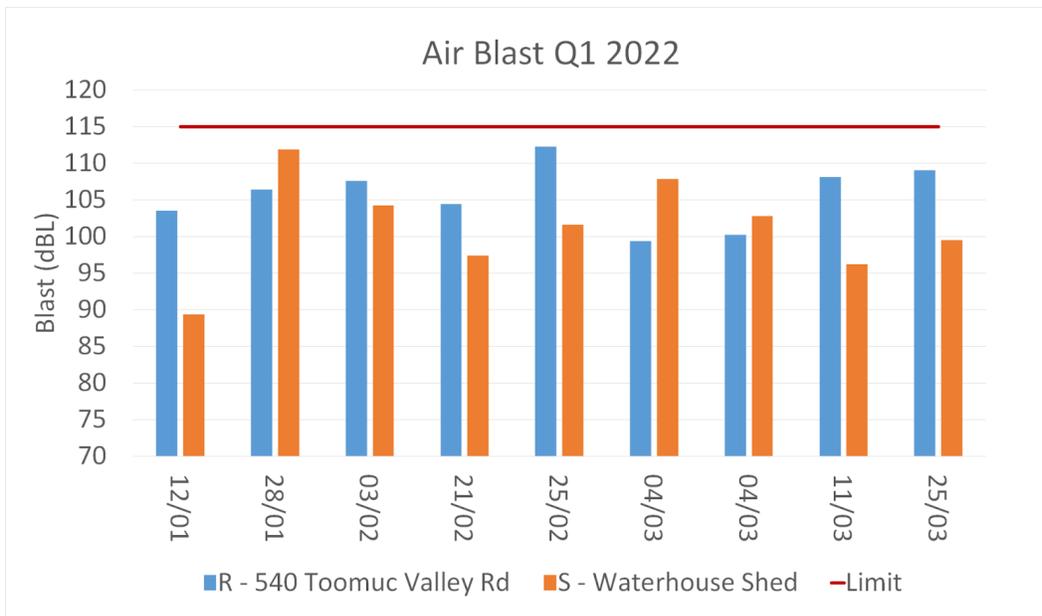
Figure 5 - Blasting; Air Blast Results Q1 2022 (Limit is 115 dBL for 95% of blasts in a 12 month period)

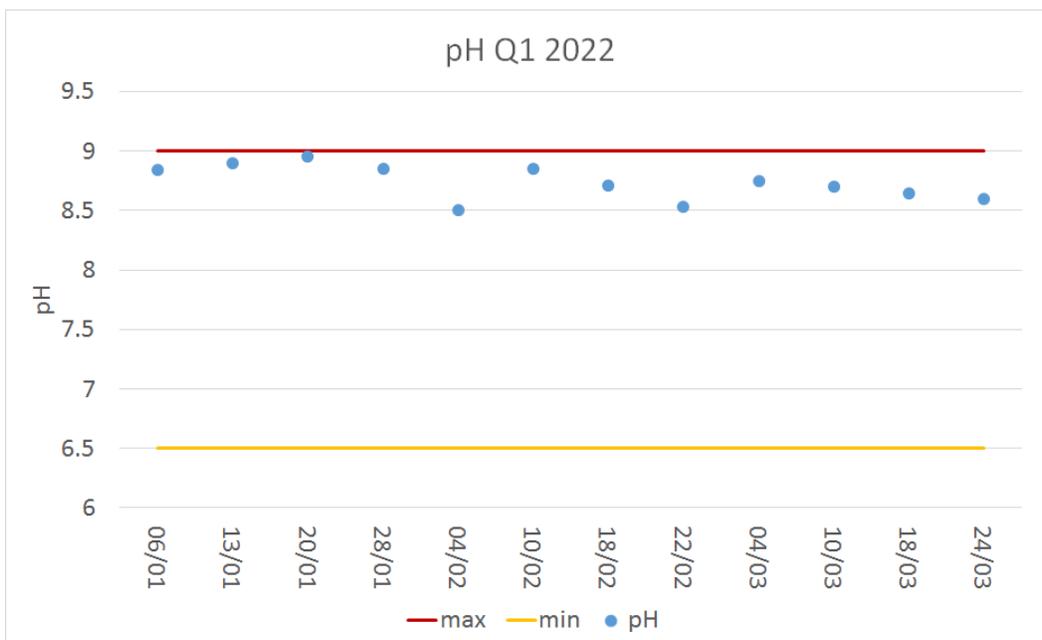
pH – A measure of the Acidity or Alkalinity of the water limit 6.5 to 9.0. No exceedances during the reporting period.

Figure 6 - Discharge Water pH results Q1 2022

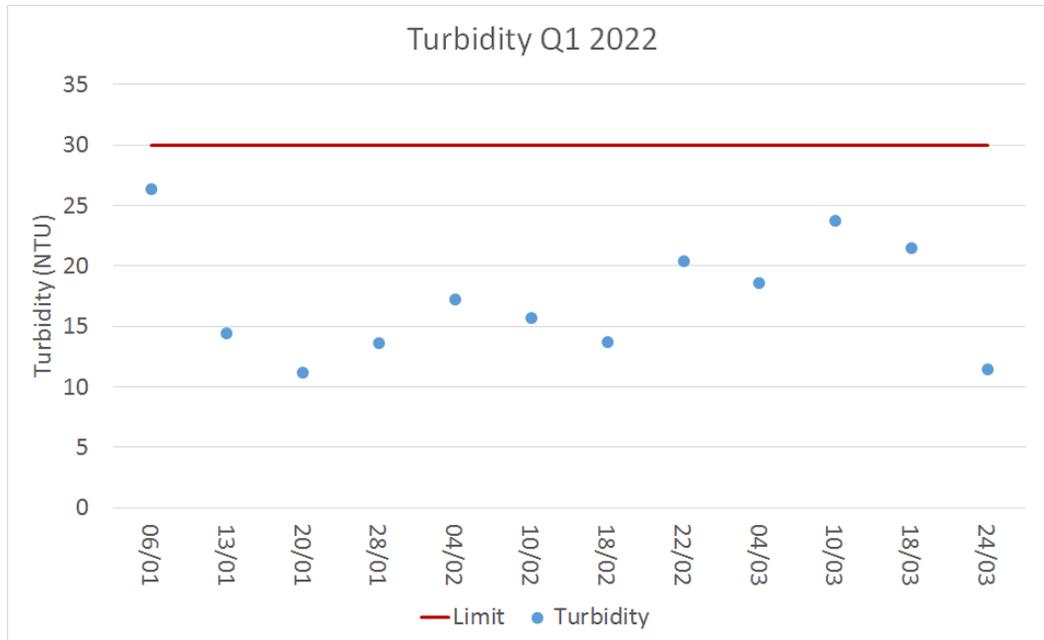
Turbidity – Clarity of water Maximum 30NTU. No exceedances during the reporting period.

Figure 7 - Discharge Water Turbidity results Q1 2022

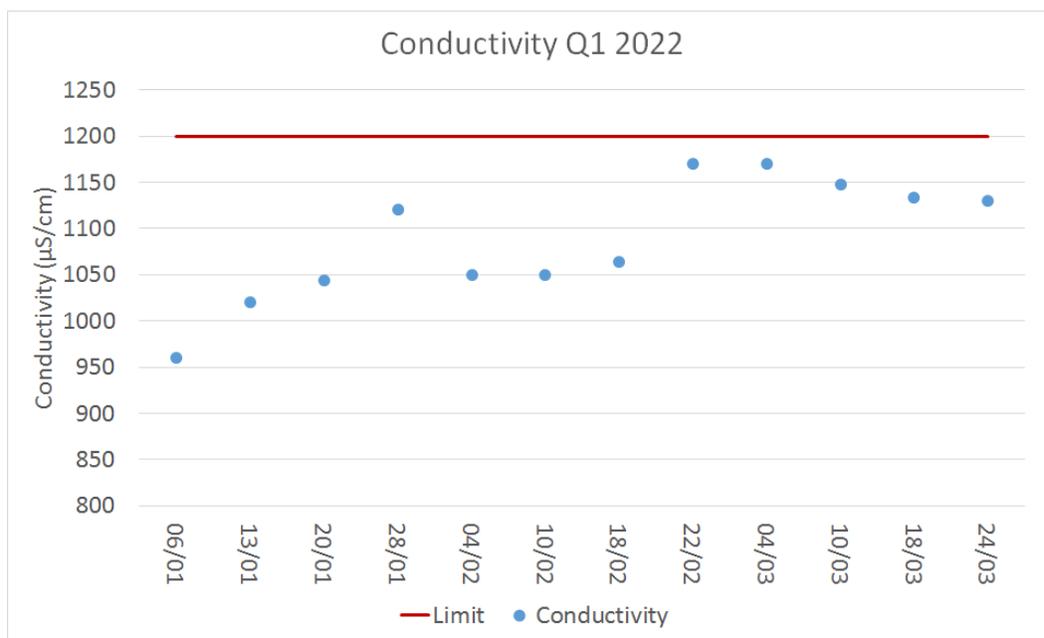
Conductivity – A measure of the water’s capability to pass electrical current. Limit 1200 μ S. No exceedances during the reporting period.

Figure 8 - Discharge Water Conductivity results Q1 2022

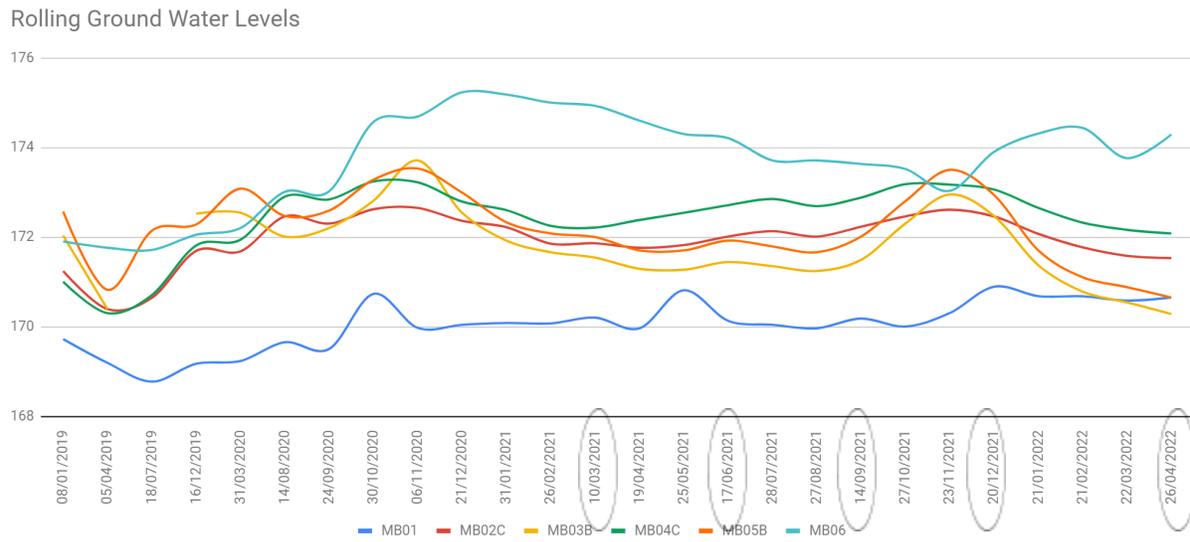
Figure 9 - Groundwater levels 2019 to present (Circled dates indicate from Dec 2020 the readings conducted by AECOM. All readings prior to August 2020 were taken by AECOM)

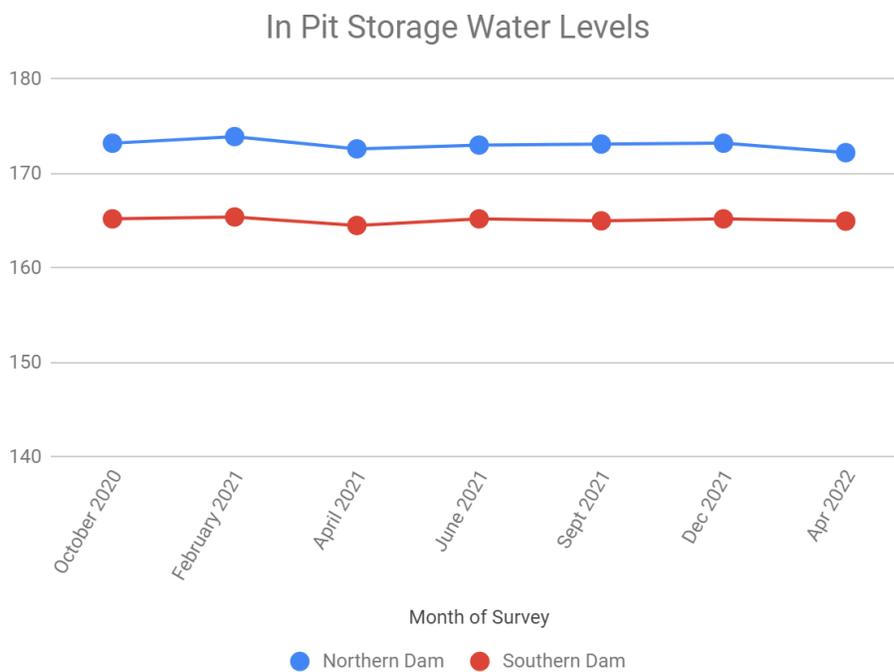
Figure 11 - In Pit Storage Levels October 2020 - Present

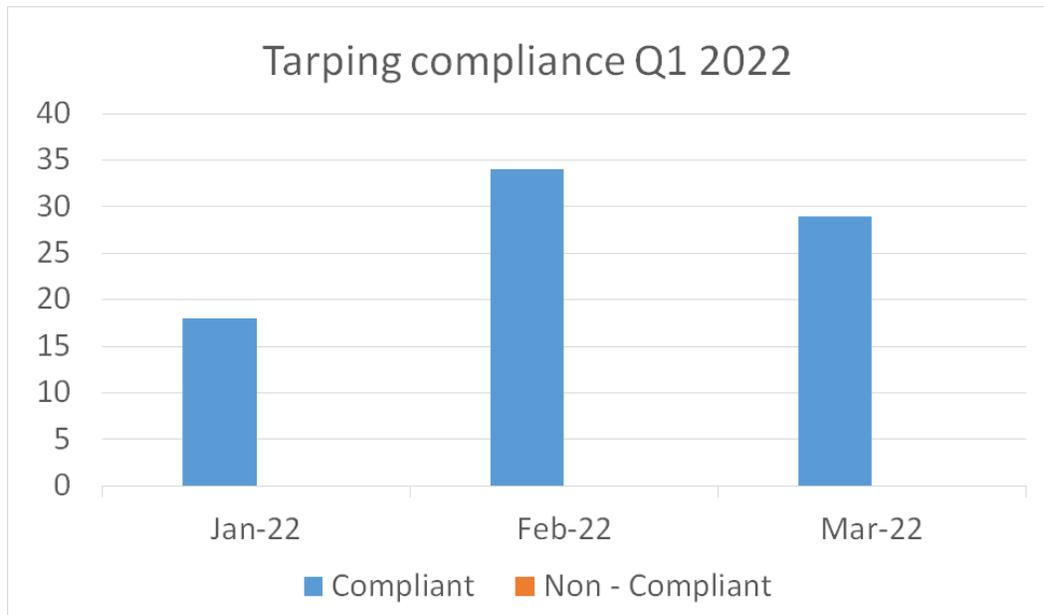
Figure 12 - Tarping visual checks
