2022

Quarterly Report

**Mt Shamrock
Environmental Management Plan
3 Monthly Progress Update**

Prepared for Mt Shamrock Quarry Environmental Review Committee

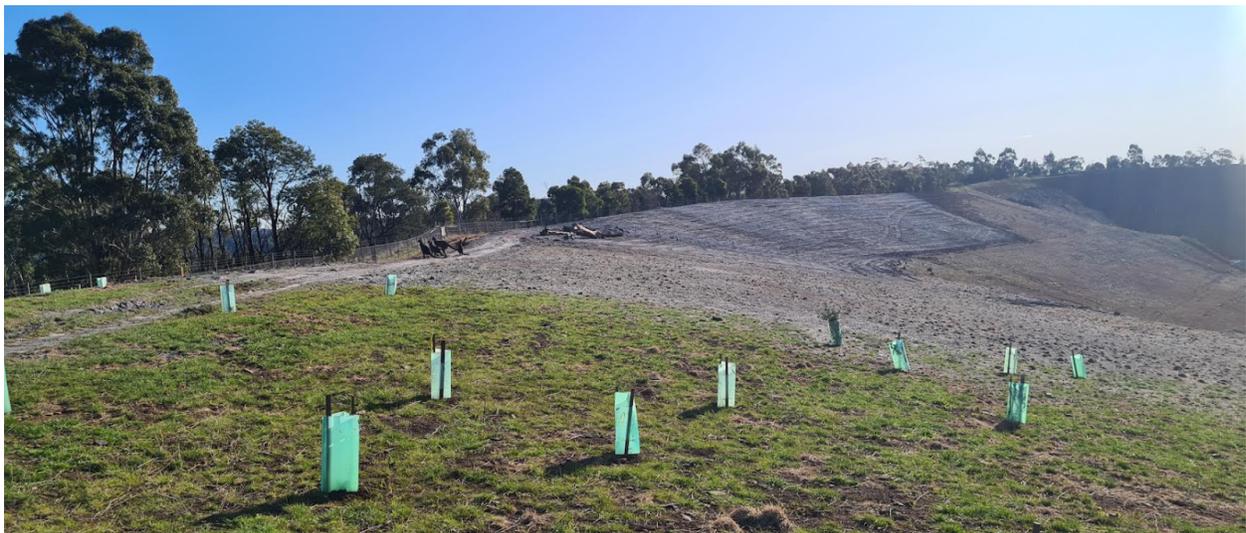
- 1.25Ha of new rehabilitation on the southern terminal face pictured below. Completed topsoil installation and hydro seeded area in July, with Mix of *Rytidospema* sp and *Microleana stipoides*.

Figure 2 - Hydro seeding of 1.25Ha which took place in July

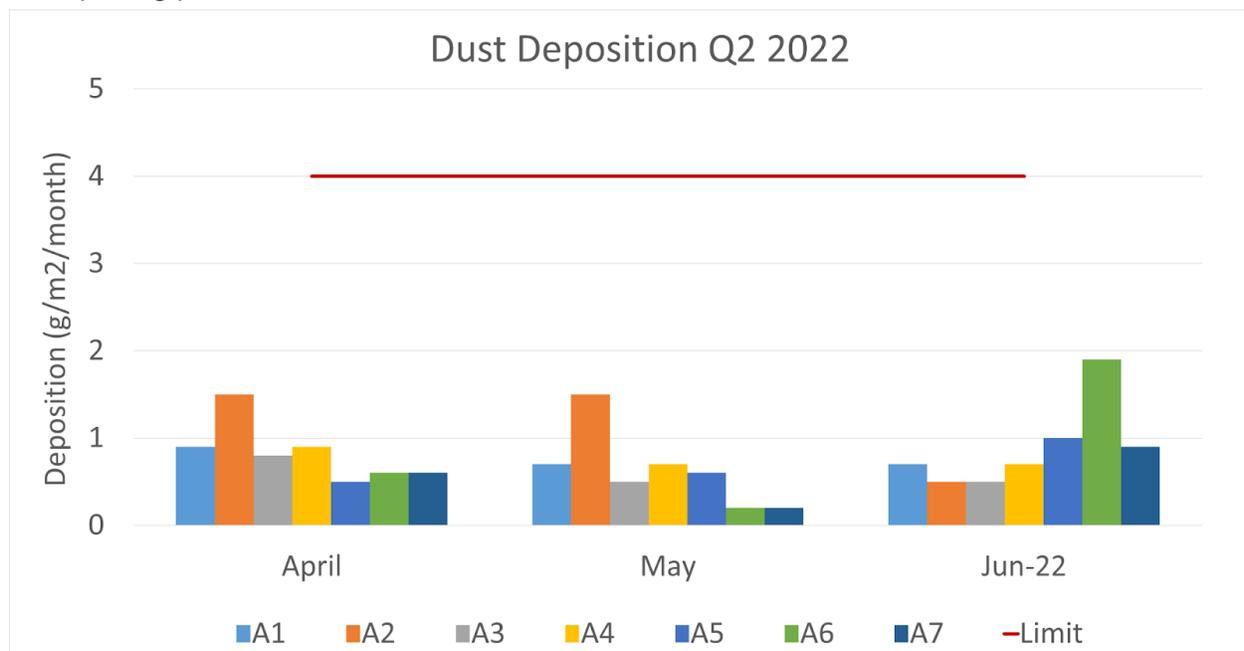
Depositional results have indicated the dust emissions tabulated below. No exceedances during the reporting period.

Figure 3 - Dust Deposition Q2 2022. (Limit 4.0g/m2/mth)

Note that the deposition results presented are Ash analysis test, rather than Total Solids, representing true mineral dust deposition generated by quarry activities.

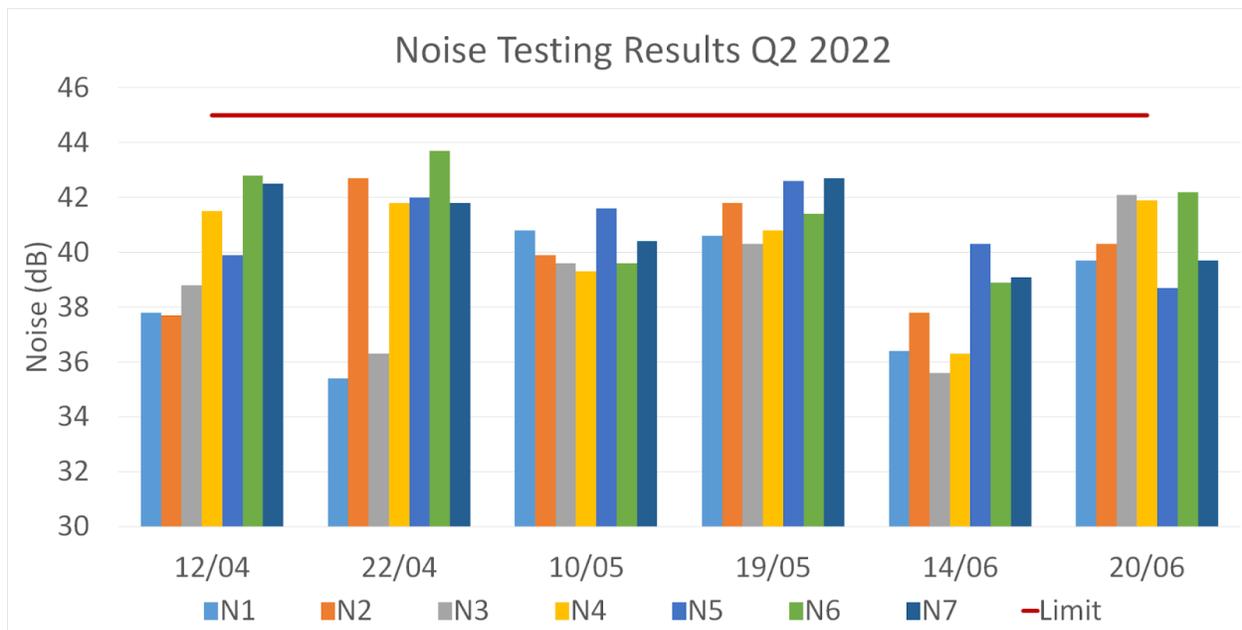
Average noise levels for the 2nd Quarter 2022 are shown below. No exceedances during the reporting period.

Figure 4 - Noise Testing Results Q2 2022. (Limit is 45dB under normal operating conditions)

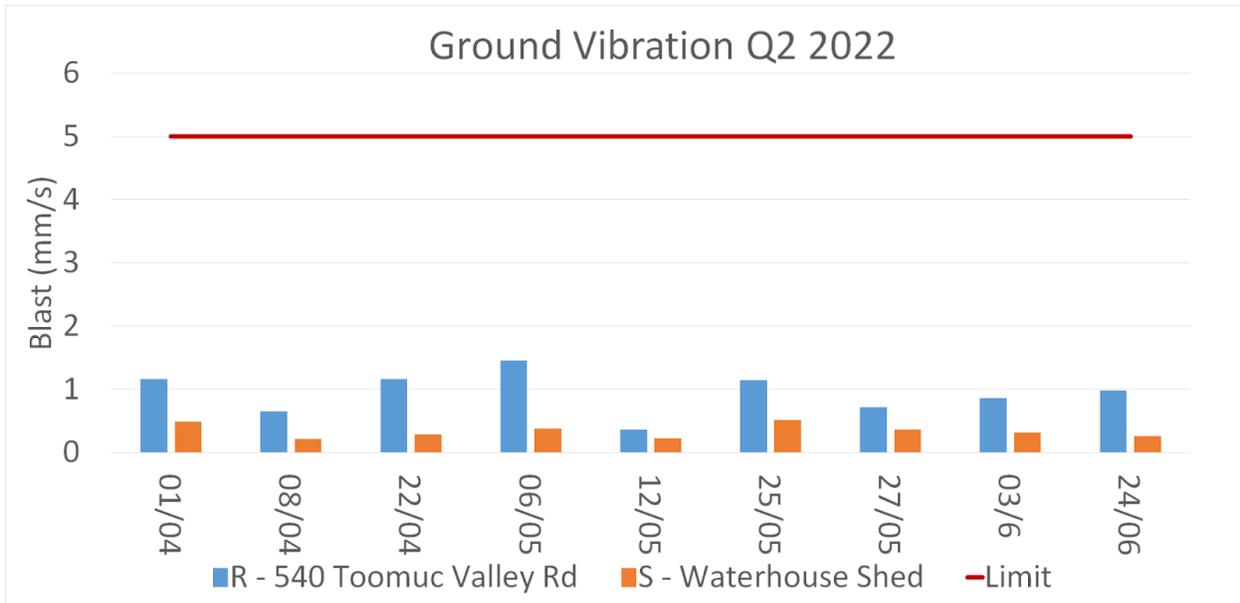
All blasting operations have been carried out in accordance with guidelines. No exceedances during the reporting period.

Figure 5 - Blasting; Ground Vibration Results Q2 2022 (Limit is 5mm/s for 95% of blasts in a 12 month period)

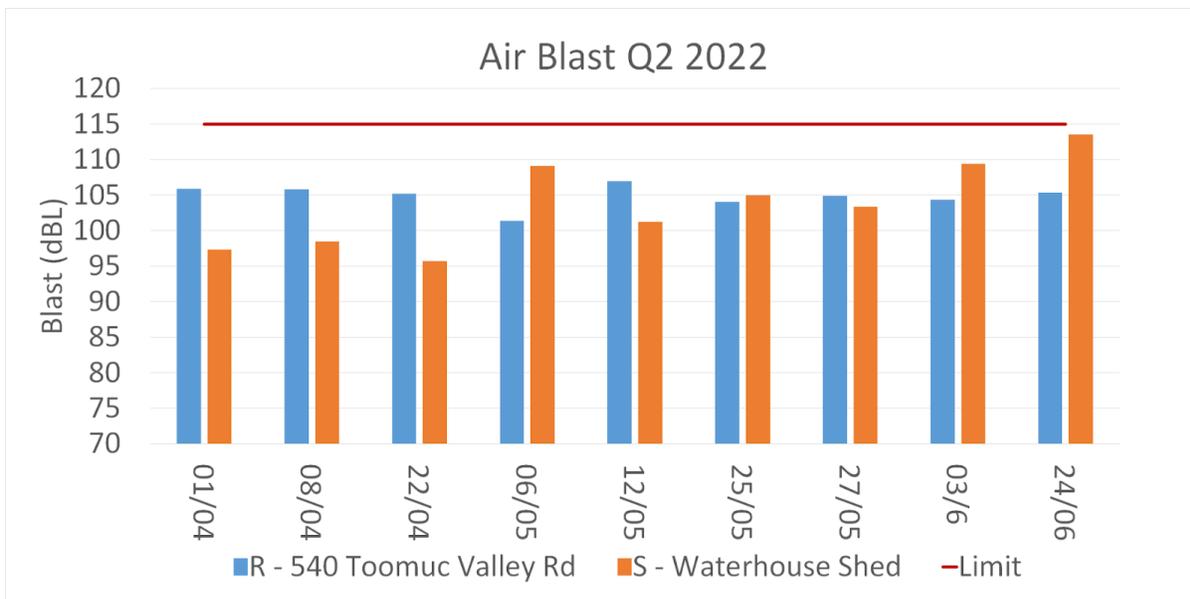
Figure 6 - Blasting; Air Blast Results Q2 2022 (Limit is 115 dB for 95% of blasts in a 12 month period)

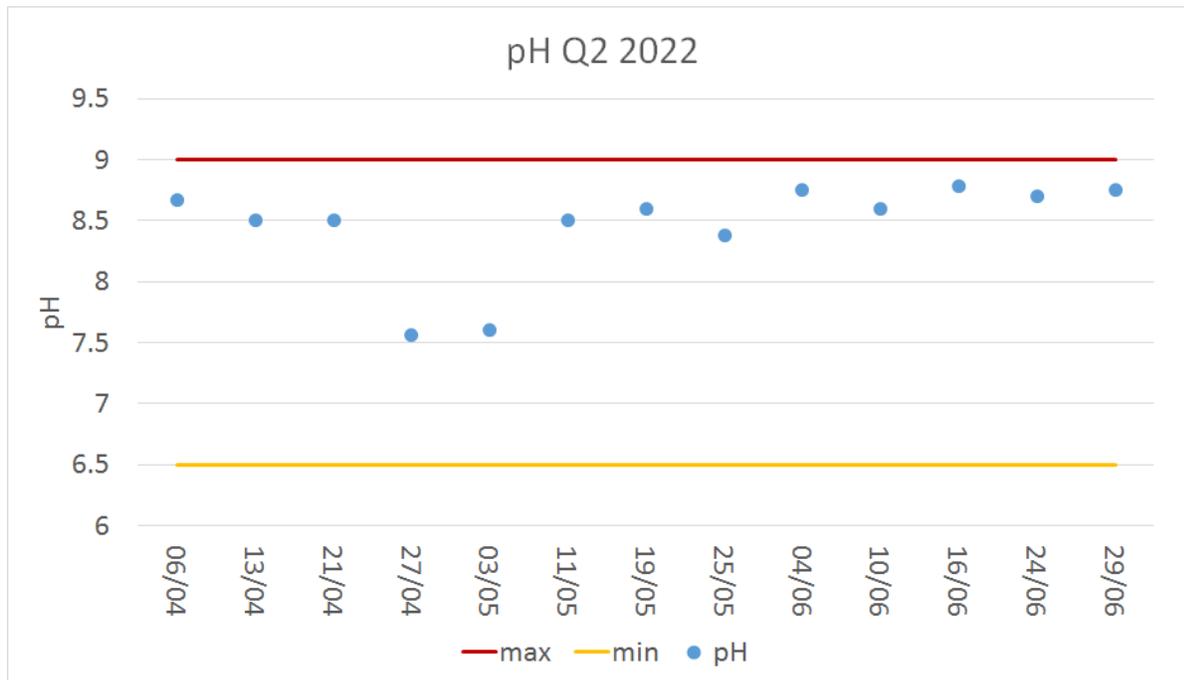
pH – A measure of the Acidity or Alkalinity of the water limit 6.5 to 9.0. No exceedances during the reporting period.

Figure 7 - Discharge Water pH results Q2 2022

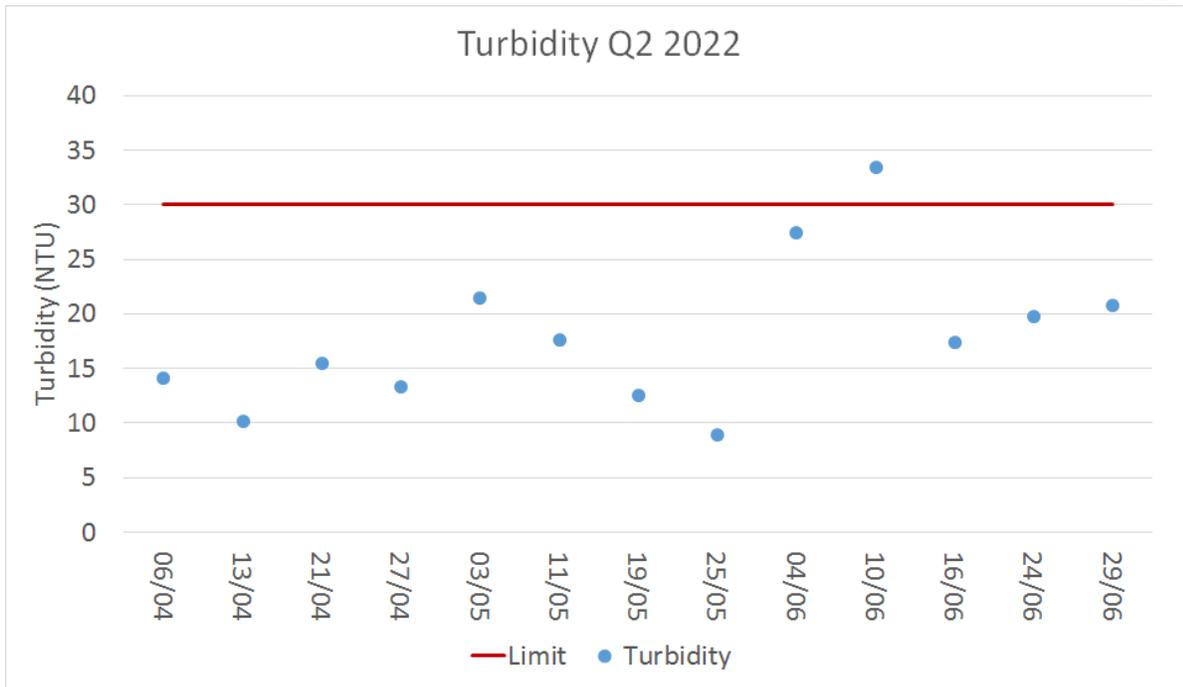
One exceedance during the reporting period on the 10th June. After heavy rainfall a turbidity result of 33.4NTU was obtained at the V-Notch. The compliance limit is 30 NTU. pH and electrical conductivity were both within compliance limits. Donazzan's Dam was tested at 20NTU. Reported to EPA and ICARE event # INC-0211612.

Figure 8 - Discharge Water Turbidity results Q2 2022

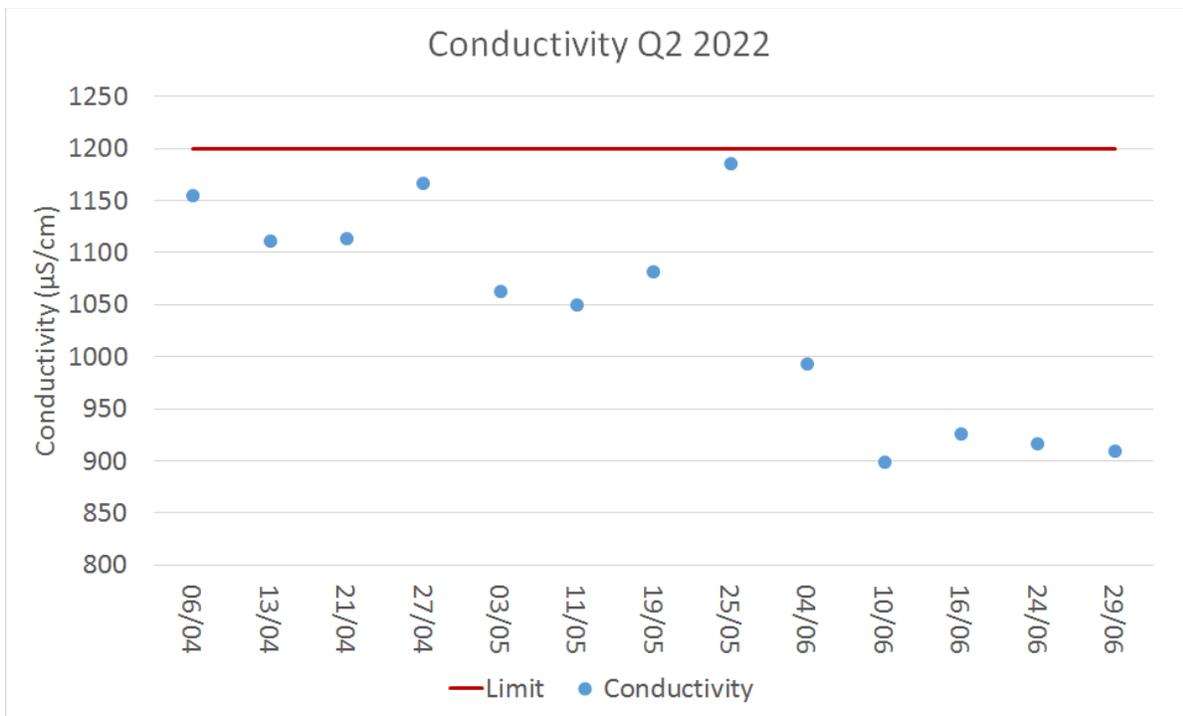
Conductivity – A measure of the water’s capability to pass electrical current. Limit 1200 μ S. No exceedances during the reporting period.

Figure 9 - Discharge Water Conductivity results Q2 2022

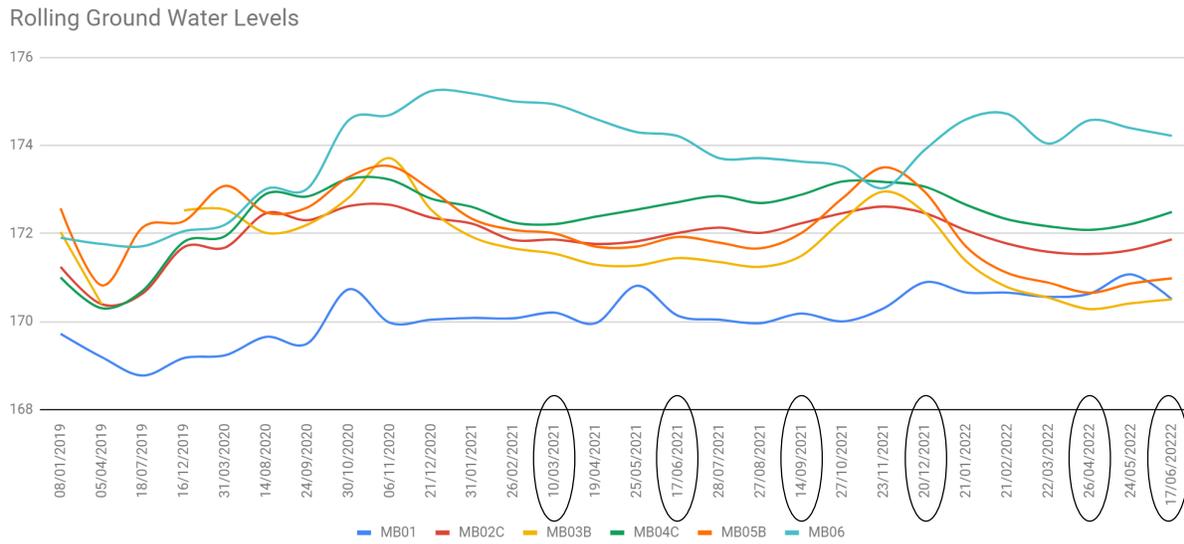
Figure 10 - Groundwater levels 2019 to present (Circled dates indicate from Dec 2020 the readings conducted by AECOM. All readings prior to August 2020 were taken by AECOM)

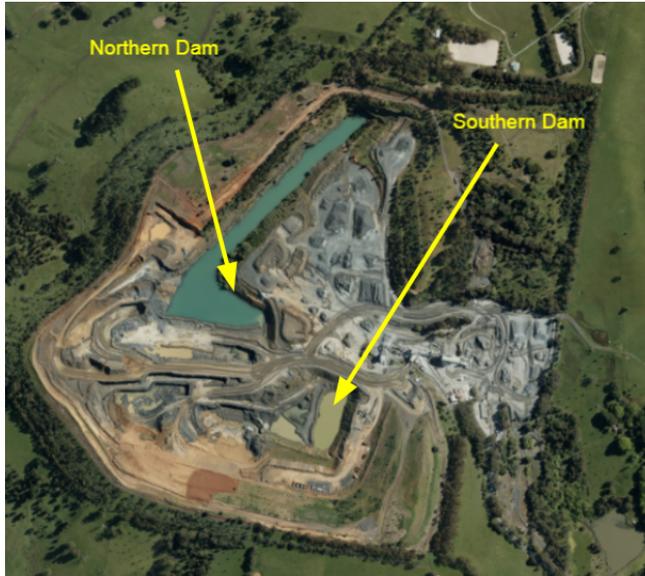
In 2020, Holcim committed to begin and report the in pit water dam levels quarterly, to aid in the annual beneficial use analysis. This was formed as part of the revised EMP submission. Location and naming conventions are shown in the map for reference. All measurements are in RL's (the same unit as ground water levels)

Figure 11 - In Pit Water Identification

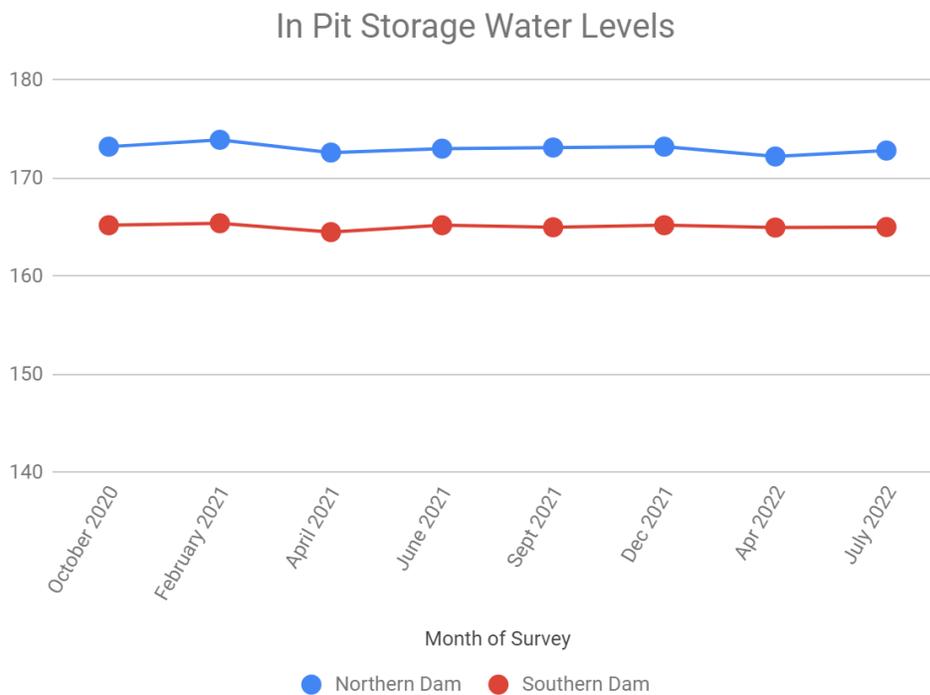
Figure 12 - In Pit Storage Levels October 2020 - Present

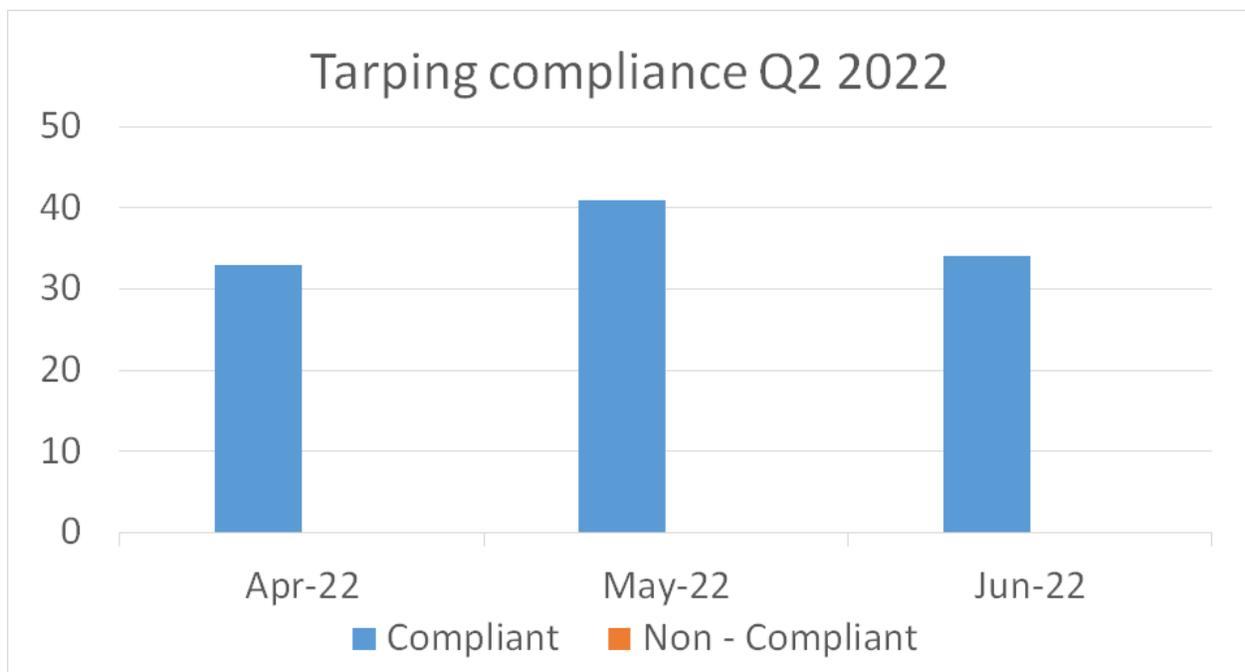
Figure 14 - Tarping visual checks of Q2 2022

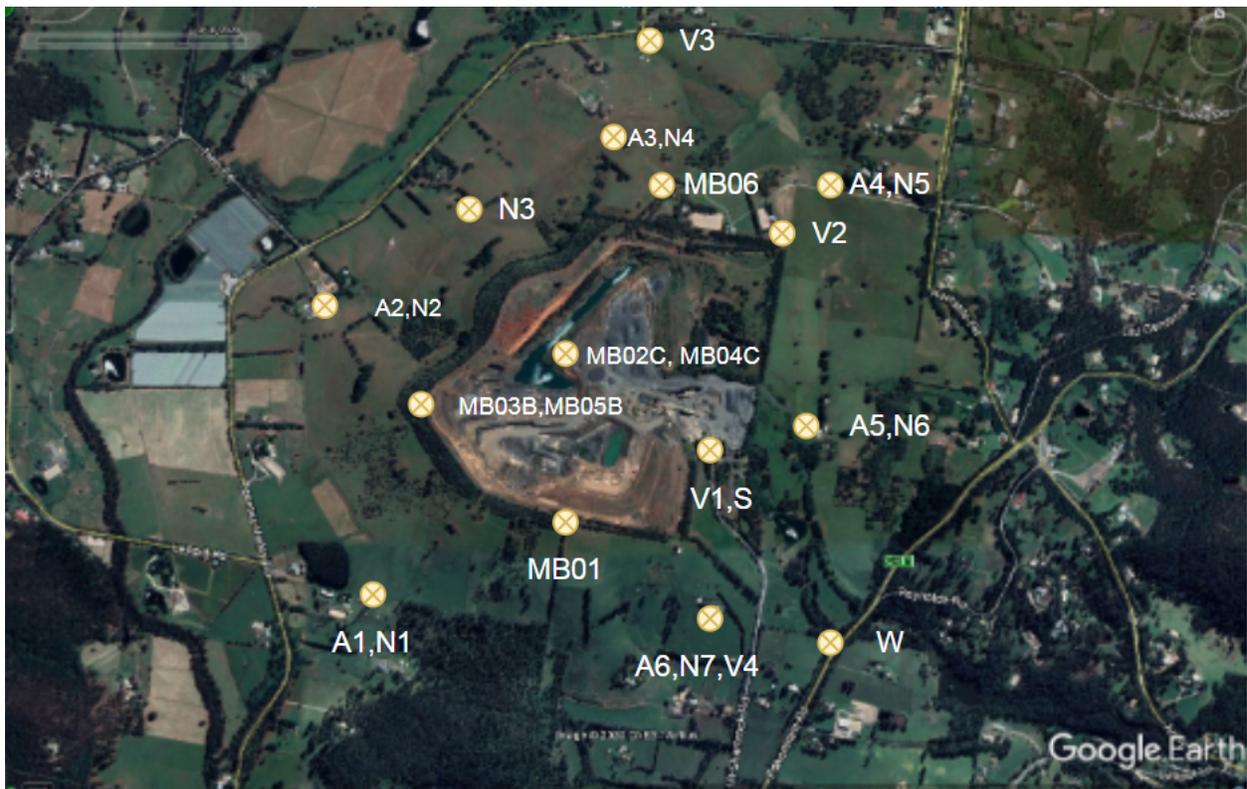
Appendix 2 – Monitoring Locations

Deposition bottles are stationed at 7 locations including a background monitoring location at station A7. Particulate matter sampled by this method is predominantly dust particles which, because of their size rapidly settle from the air. Results can be affected by Ash from burning off, bird droppings and insects.

This report details information on both monitoring results and management actions by the quarry in the preceding three months. This report will take the form of an exception report that is where there is a deviance from the EMP. This will be highlighted and the reasons for the deviance explained. A summary of quantifiable monitoring outcomes is also included. Figure 1.12 details all monitoring locations.
