Quarterly Report

July - September

**Mt Shamrock
Environmental Management Plan
3 Monthly Progress Update**

Prepared for Mt Shamrock Quarry Environmental Review Committee

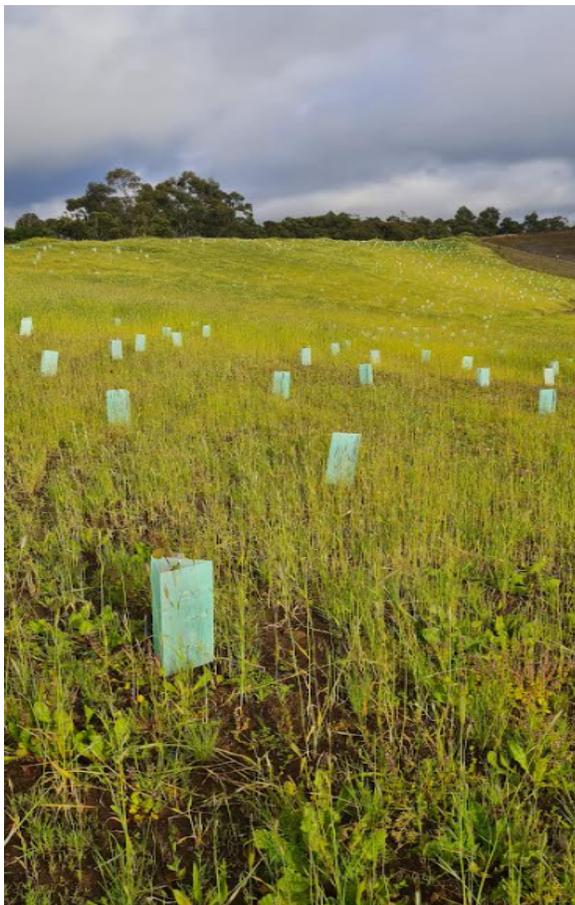
- Netgain Area - Removed fallen branches from fence line both north and southern zone completed. Spray and hand weed north and south.
- 1.25Ha of new rehabilitation on the southern terminal face pictured below. Completed topsoil installation and hydro seeded area in July and the area is doing very well.

Figure 3 - Hydroseeding of 1.25Ha which took place in July as at November

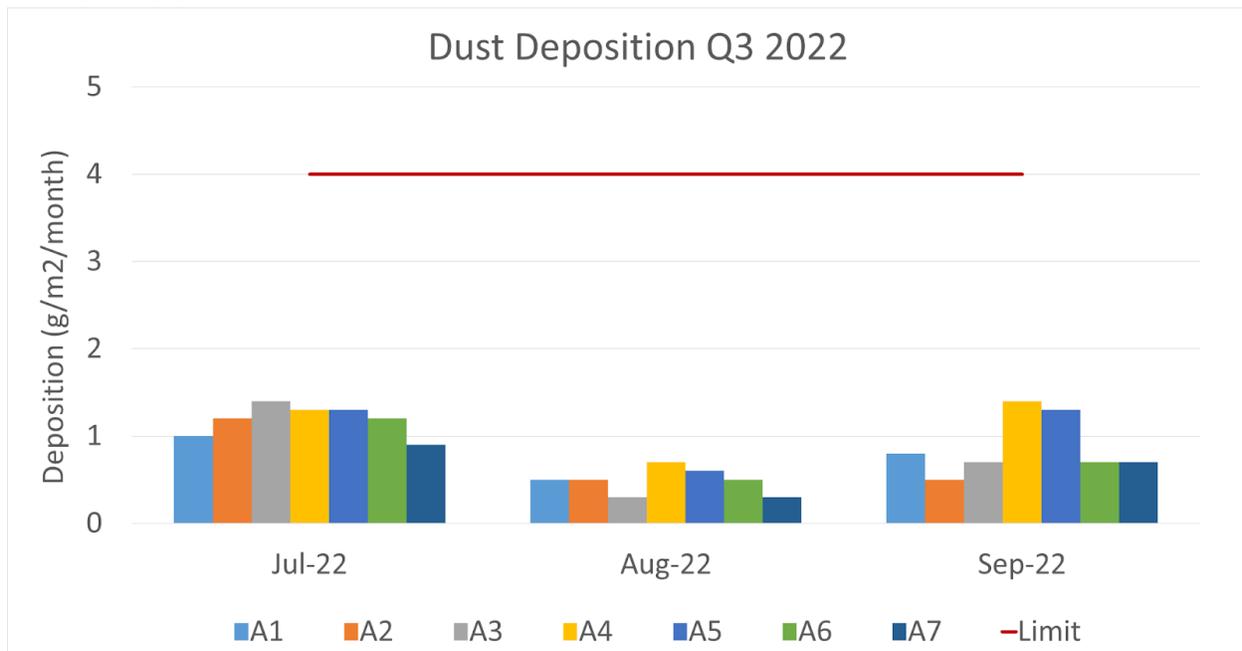
Depositional results have indicated the dust emissions tabulated below. No exceedances during the reporting period.

Figure 3 - Dust Deposition Q3 2022. (Limit 4.0g/m²/mth)

Note that the deposition results presented are Ash analysis test, rather than Total Solids, representing true mineral dust deposition generated by quarry activities.

Deposition bottles are stationed at 7 locations including a background monitoring location at station A7. Particulate matter sampled by this method is predominantly dust particles which, because of their size rapidly settle from the air. Results can be affected by Ash from burning off, bird droppings and insects.

Limit – 4.0gm/m² mth

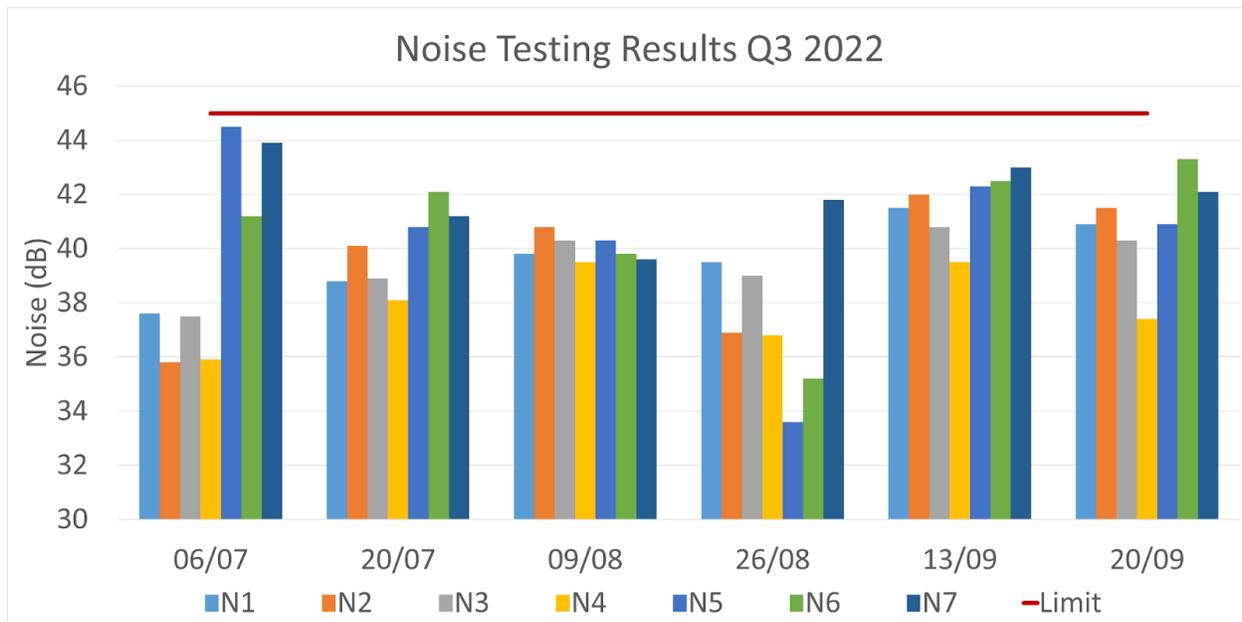
Average noise levels for the 3rd Quarter 2022 are shown below. No exceedances during the reporting period.

Figure 4 - Noise Testing Results Q3 2022. (Limit is 45dB under normal operating conditions)

Noise monitoring locations and limits set in the EMP are monitored through the use of a RION hand held monitor. Employees on site who conduct the monitoring are trained and certified in theoretical and practical assessment of the RION hand held meter and basic acoustics.

Limits – 45dB(A) LAeq 7:00 – 18:00 Normal Operation
68dB(A) LAeq 7:00 – 18:00 Noise Attenuation Mound Construction

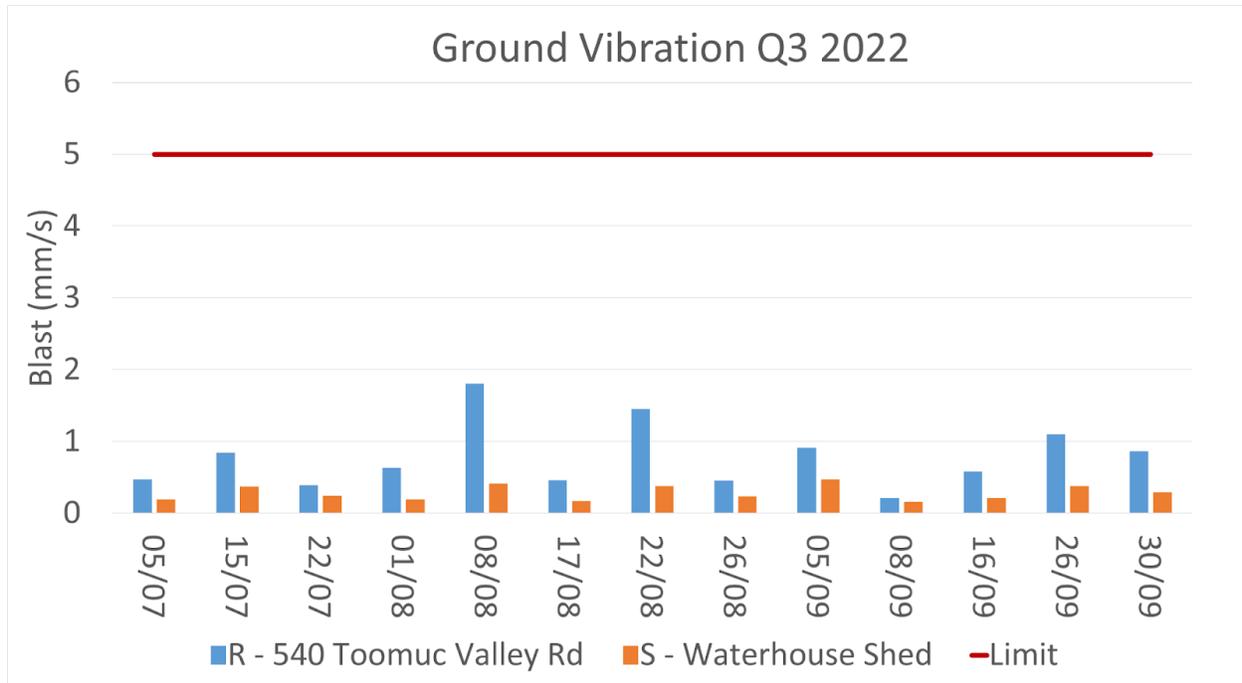
All blasting operations have been carried out in accordance with guidelines. No exceedances during the reporting period.

Figure 5 - Blasting; Ground Vibration Results Q3 2022 (Limit is 5mm/s for 95% of blasts in a 12 month period)

Ground Vibration – a measurement of the shock wave passing through the ground

Ground Vibration Limits – Peak Particle Velocity (PPV) 5mm/sec at sensitive locations for 95% of blasts in a 12 month period

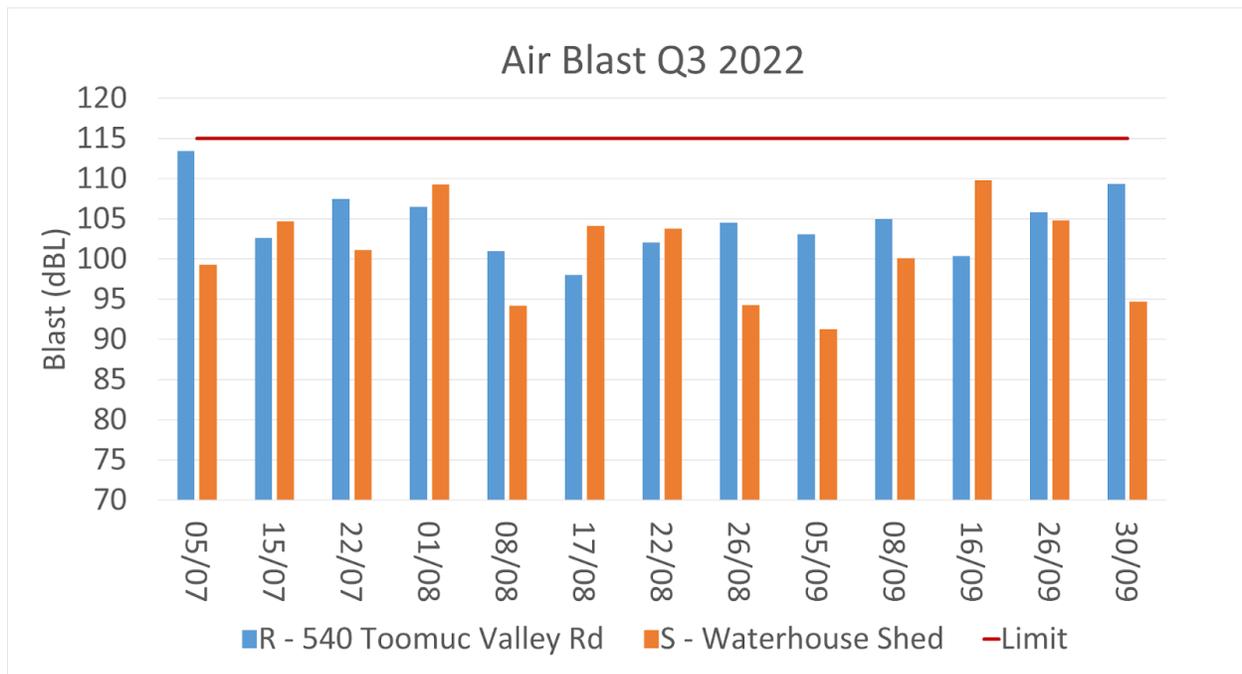
Figure 6 - Blasting; Air Blast Results Q3 2022 (Limit is 115 dB(L) for 95% of blasts in a 12 month period)

Air Blast – a measurement of air pressure pulse travelling through the air.

Air Blast Limits – Peak Air Blast of 115 dBL at sensitive locations for 95% of blasts in a 12 month period

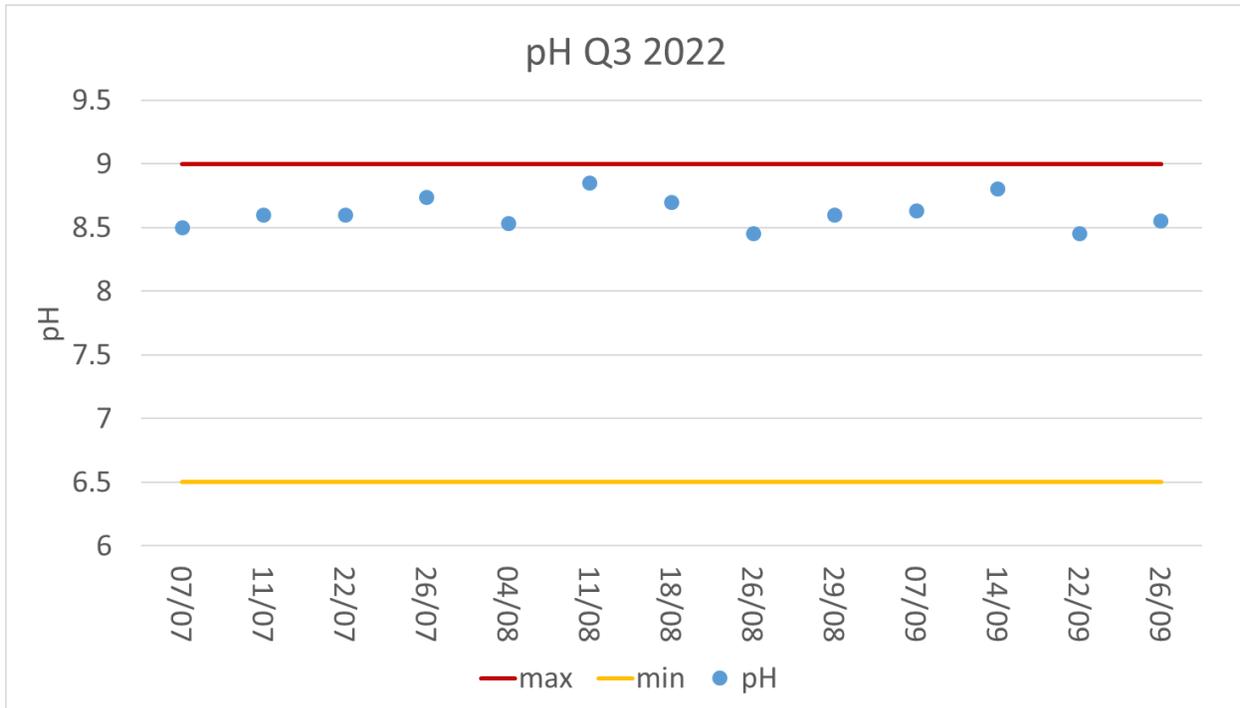
pH – A measure of the Acidity or Alkalinity of the water limit 6.5 to 9.0. No exceedances during the reporting period.

Figure 7 - Discharge Water pH results Q3 2022

pH – A measure of the Acidity or Alkalinity of the water. Limit 6.5-9.0

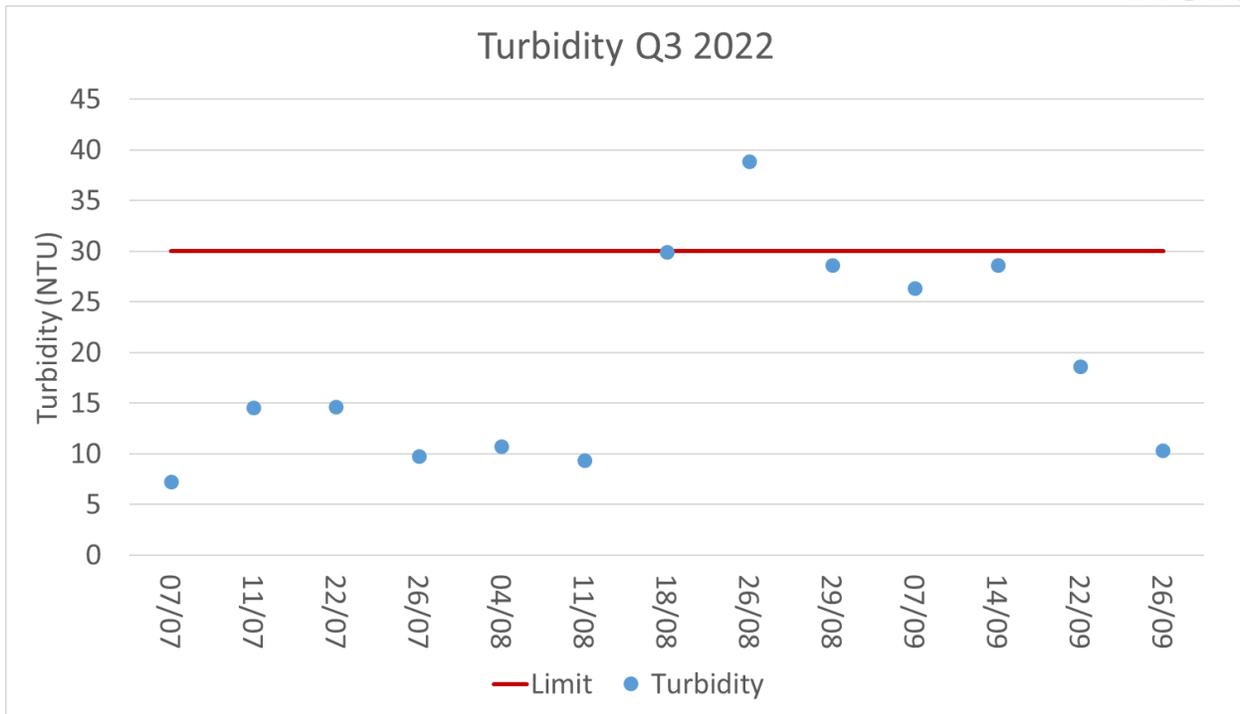
- 26th August - Testing conducted at the licensed discharge point returned a turbidity result of 38.8NTU, the compliance limit is 30NTU. All other results are below the compliance limit. PH8.45, Electrical Conductivity 656. No water had been pumped from the pit since the 24th August and as such the water is surface water run off from heavy rain earlier in the week (51mm).

One exceedance during the reporting period on the 26th August. After heavy rainfall, 51mm for the week, a turbidity result of 38.8NTU was obtained at the V-Notch. The compliance limit is 30NTU. pH and electrical conductivity were both within compliance limits. Reported to EPA and ICARE event # INC-0217808. No water had been pumped from the pit since the 24th August.

Figure 8 - Discharge Water Turbidity results Q3 2022

Turbidity – Clarity of water. Maximum 30NTU

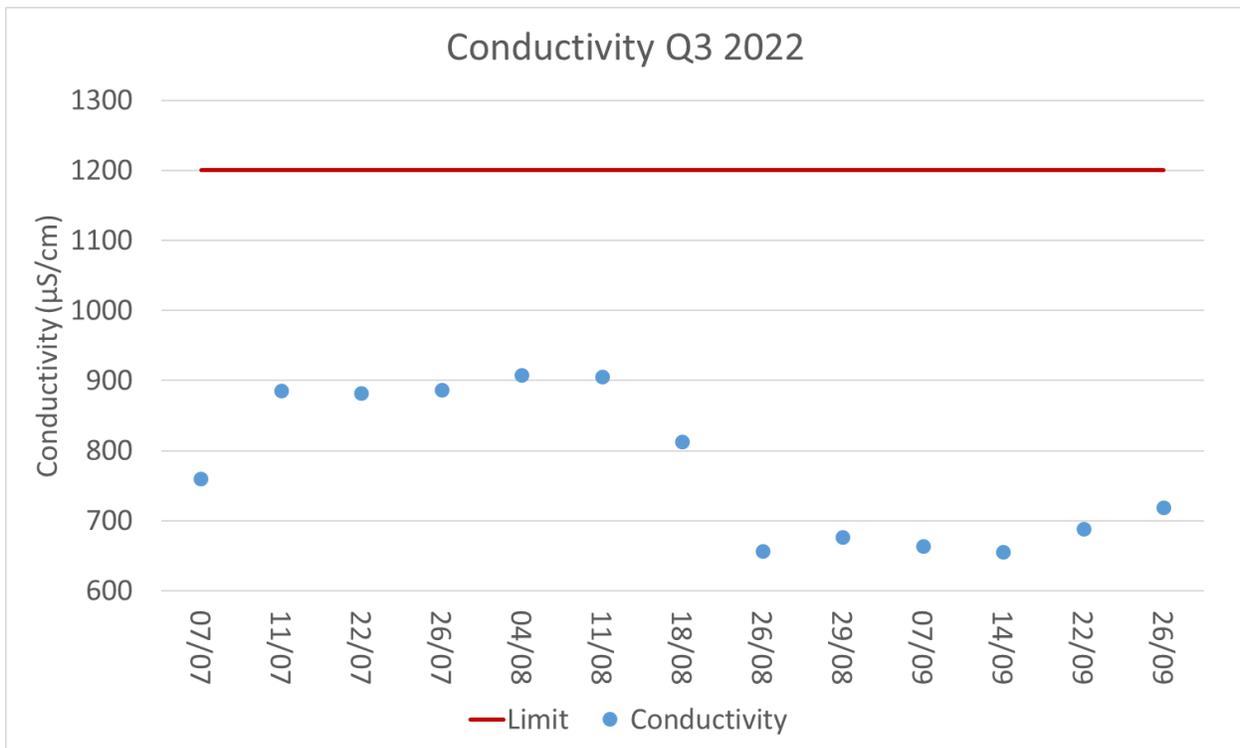
Conductivity – A measure of the water’s capability to pass electrical current. Limit 1200µS. No exceedances during the reporting period.

Figure 9 - Discharge Water Conductivity results Q3 2022

Conductivity – A measure of the water’s capability to pass electrical current. Limit 1200 μ S

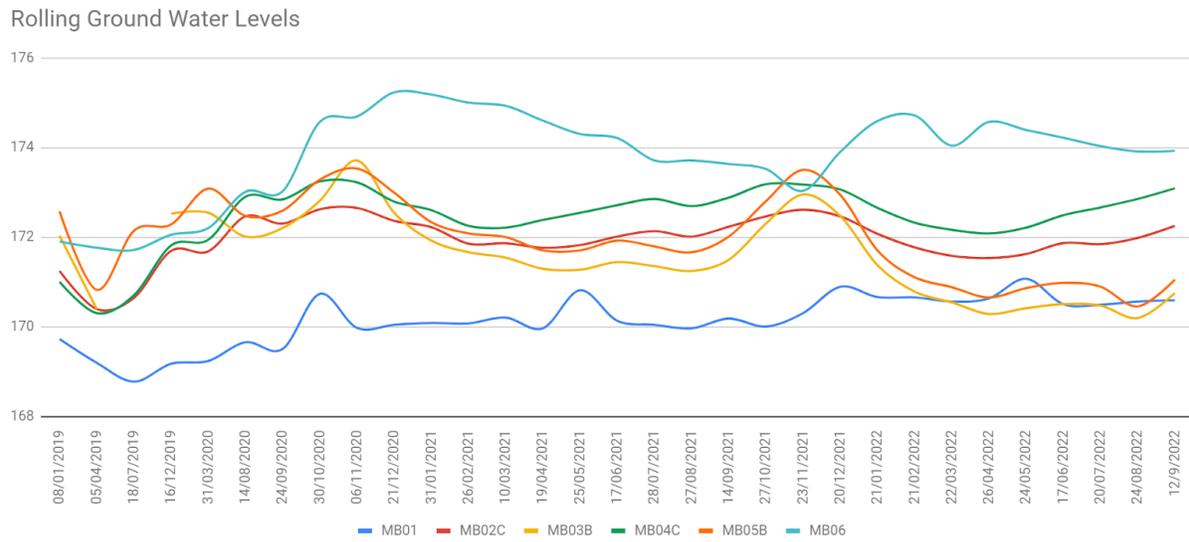
Figure 10 - Groundwater levels 2019 to present.

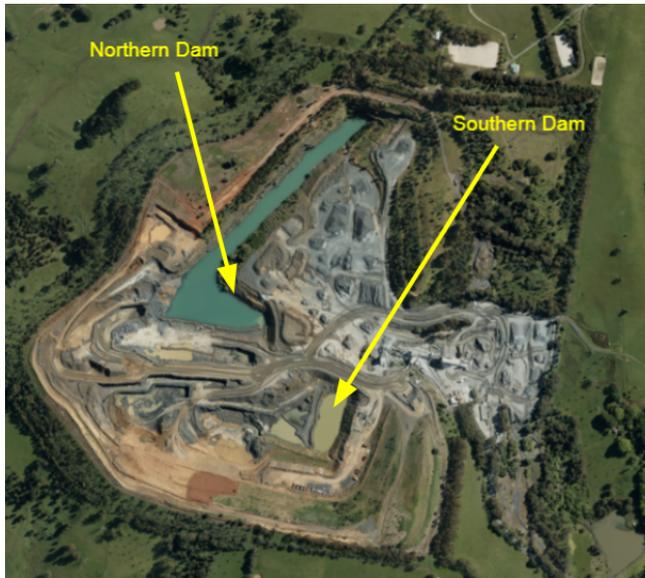
In 2020, Holcim committed to begin and report the in pit water dam levels quarterly, to aid in the annual beneficial use analysis. This was formed as part of the revised EMP submission. Location and naming conventions are shown in the map for reference. All measurements are in RL's (the same unit as ground water levels)

Figure 11 - In Pit Water Identification

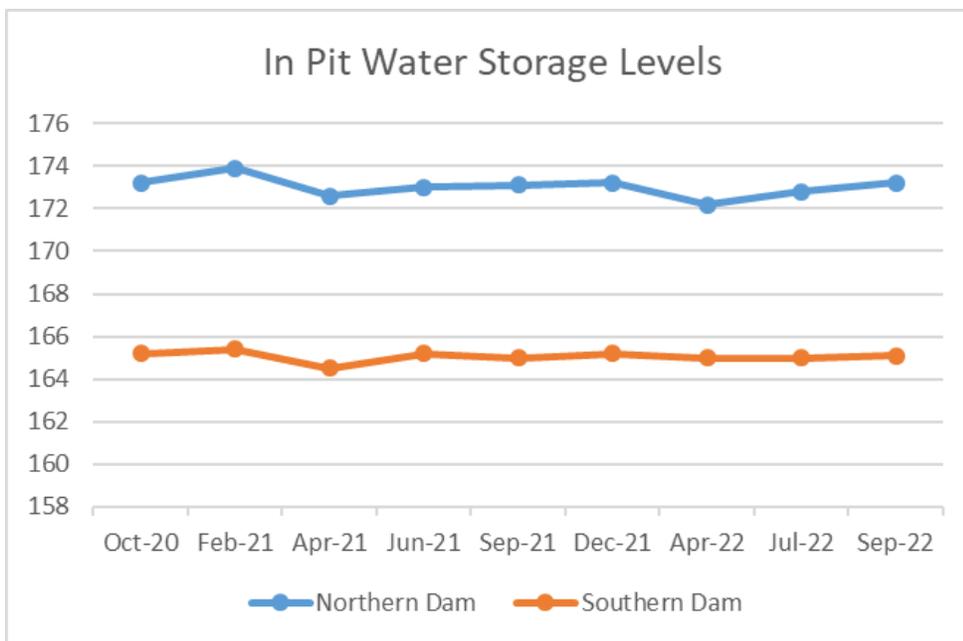
Figure 12 - In Pit Storage Levels October 2020 - Present

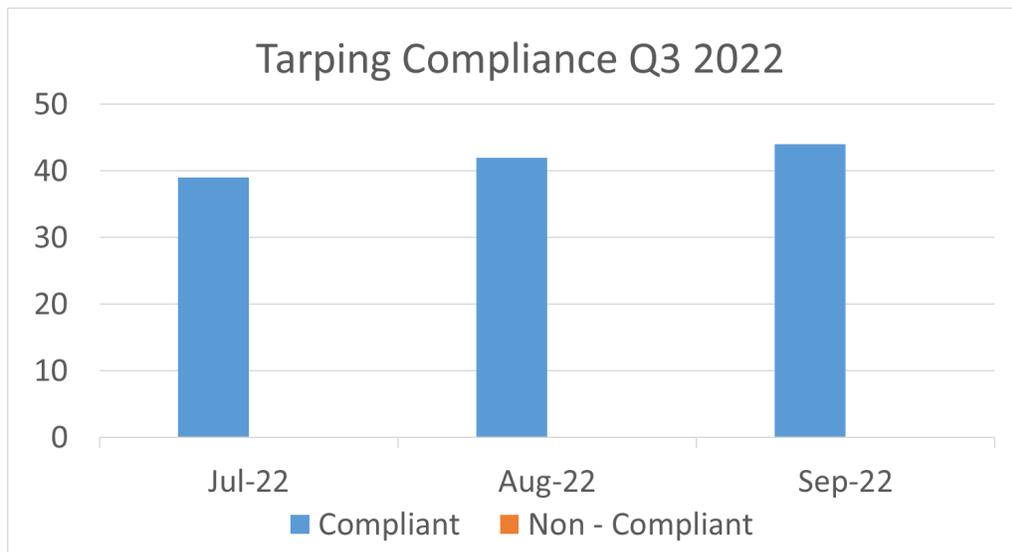
Figure 14 - Tarping visual checks of Q3 2022
