Quarterly Report

April - June

**Mt Shamrock
Environmental Management Plan
3 Monthly Progress Update**

Prepared for Mt Shamrock Quarry Environmental Review Committee

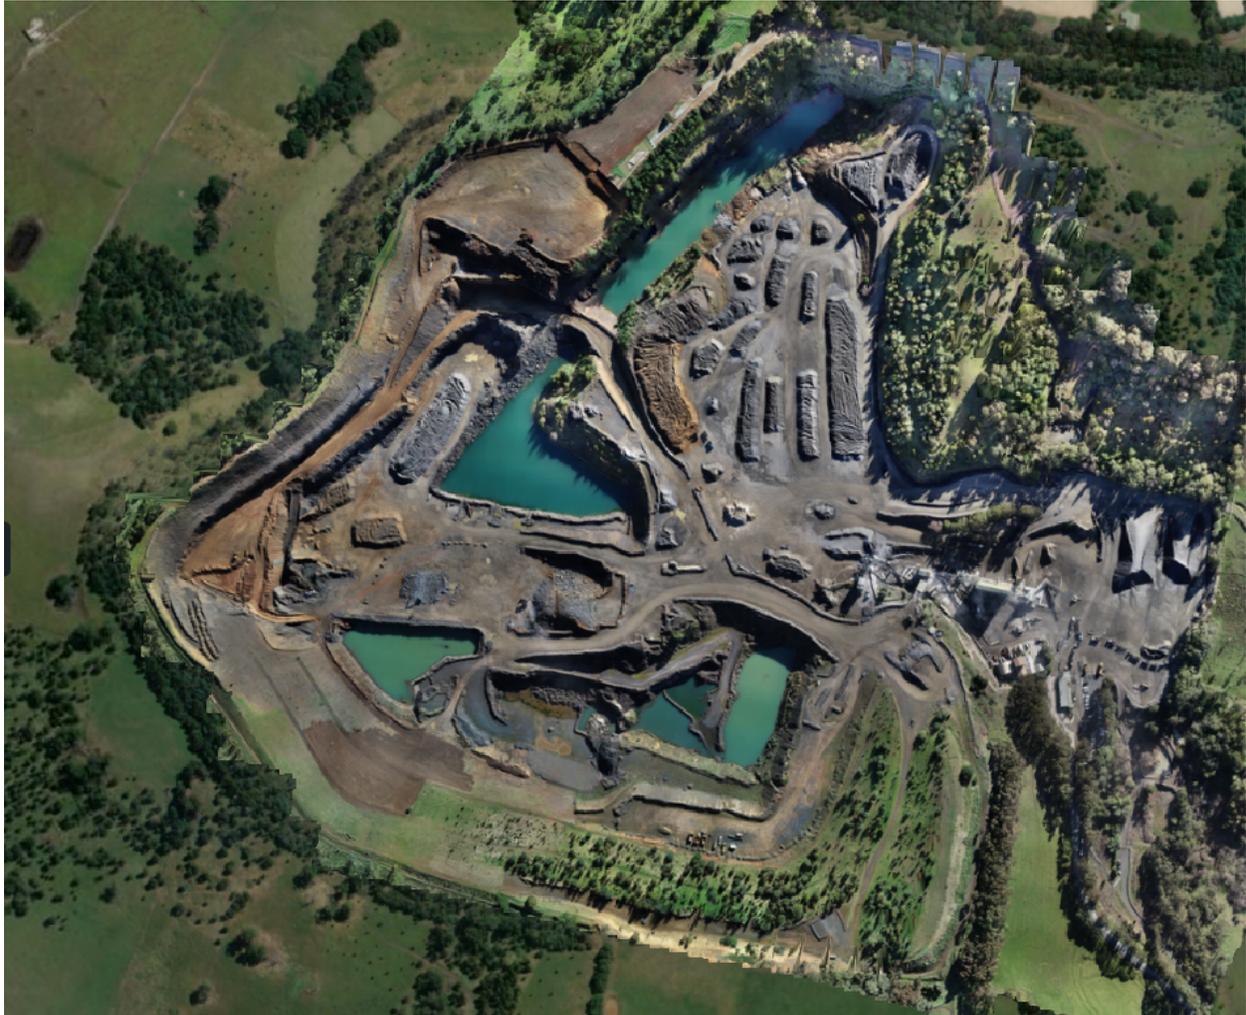
Figure 1 - Site Aerial 17th July 2023

Operational Update

- Operating hours unchanged;
- Management is unchanged with Leigh Elliott continuing as Quarry Manager and Nathan Thomas in the Operations Manager role;
- GHD Hydrogeological review report has been distributed to ERC.
- Mobile crushing took place during June and July
- Stripping and reclamation works have continued throughout Q2.

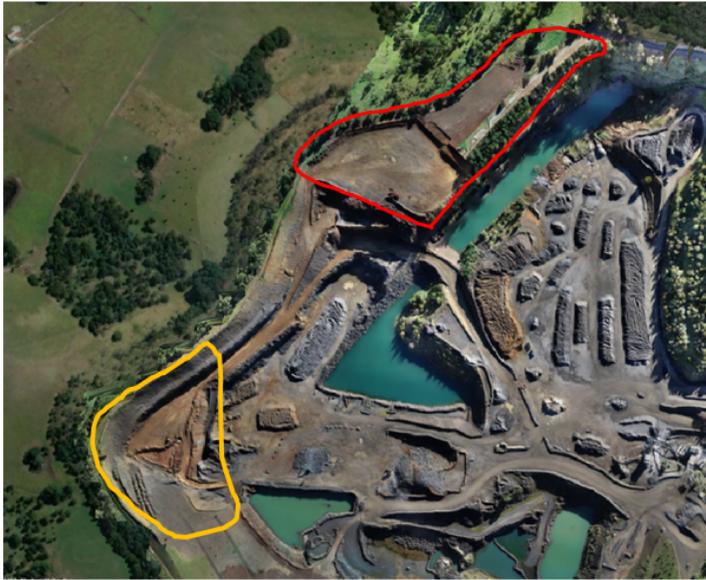
- Overburden removal (stripping) has been conducted during Q2 (red outline) with emplacement of the rocky overburden and clay materials being placed in the western most corner (yellow outline) for reclamation works.
- Topsoil was removed from the stripping area and directly placed on the new 1.1 Hectare (Ha) Revegetation area discussed below.

Figure 2 - 2023 Stripping area (red) and reclamation area (yellow)

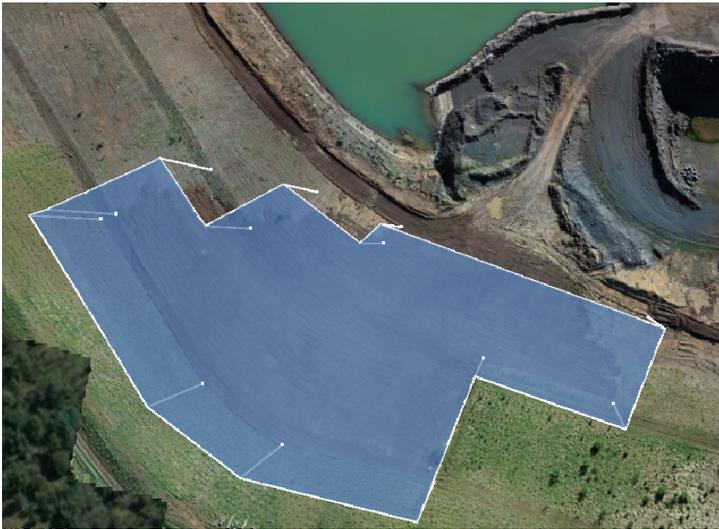
A new 1.1Ha Revegetation area has been established adjacent to the 0.8Ha (est 2021) and 1.2Ha (est 2022) Hectare Revegetation Sites. Topsoil has been spread in preparation for hydroseeding and planting in Q3.

Figure 3 - Identification of the new 1.1Ha Revegetation Site

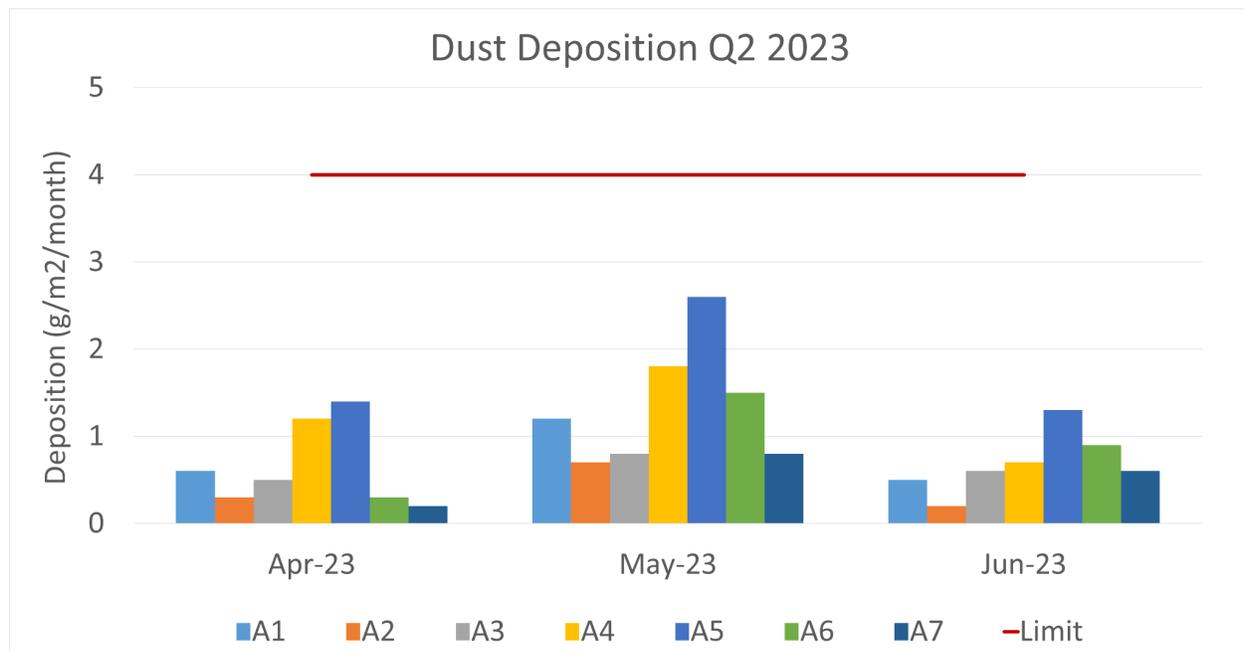
Depositional results have indicated the dust emissions tabulated below. No exceedances during the reporting period.

Figure 4 - Dust Deposition Q2 2023. (Limit 4.0g/m²/mth)

Note that the deposition results presented are Ash analysis test, rather than Total Solids, representing true mineral dust deposition generated by quarry activities.

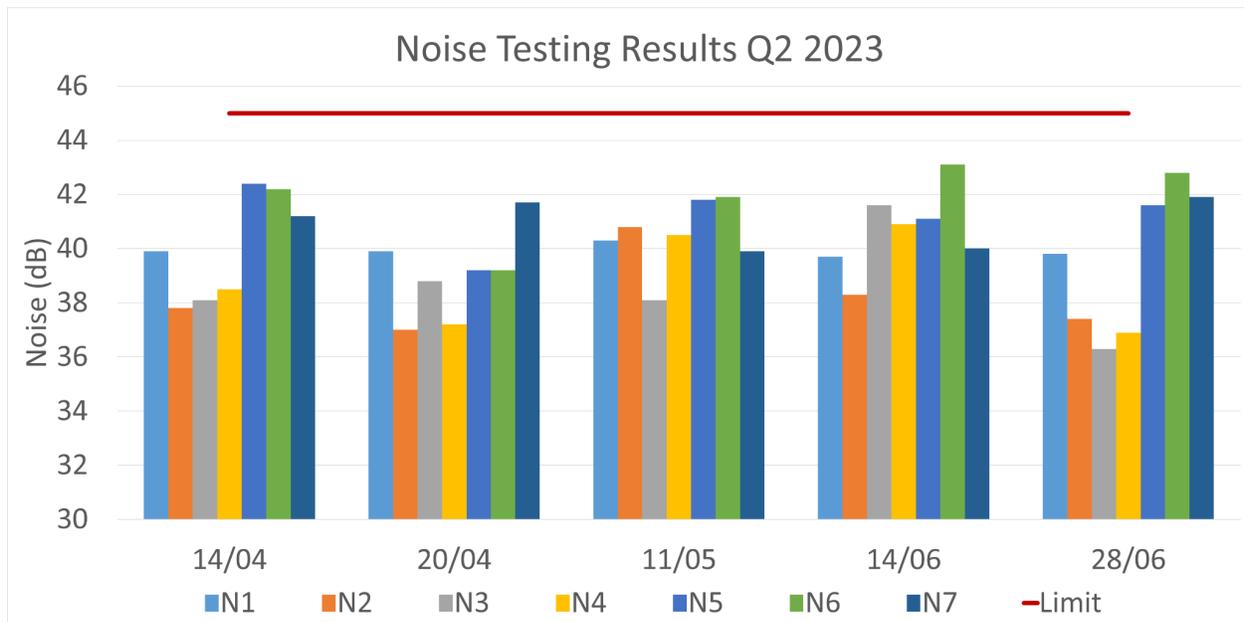
Average noise levels for the 2nd Quarter 2023 are shown below. No exceedances during the reporting period.

Figure 5 - Noise Testing Results Q2 2023. (Limit is 45dB under normal operating conditions)

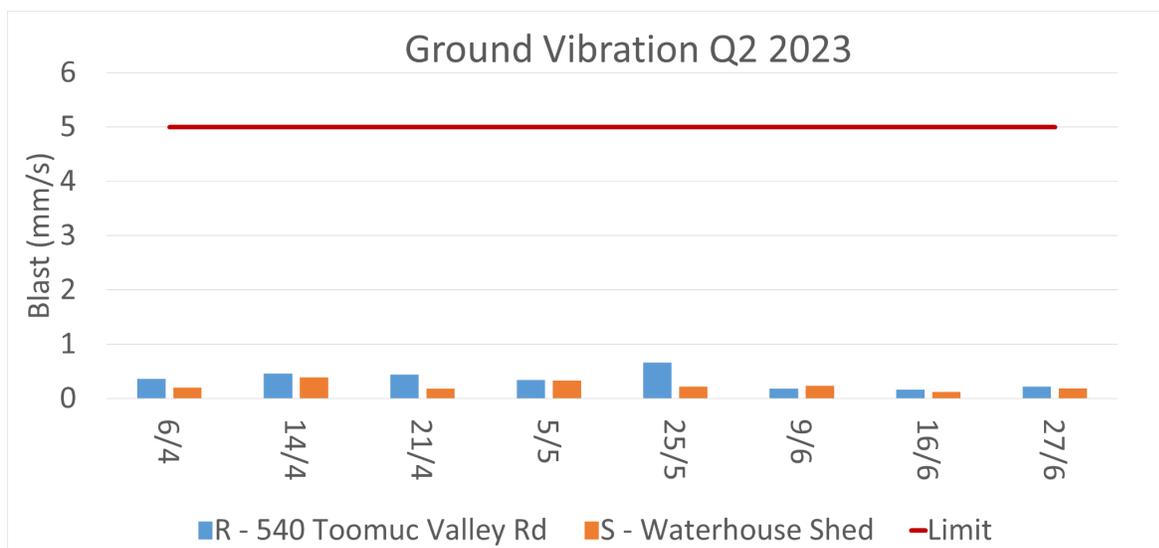
All blasting operations have been carried out in accordance with guidelines. No exceedances during the reporting period.

Figure 6 - Blasting; Ground Vibration Results Q2 2023 (Limit is 5mm/s for 95% of blasts in a 12 month period)

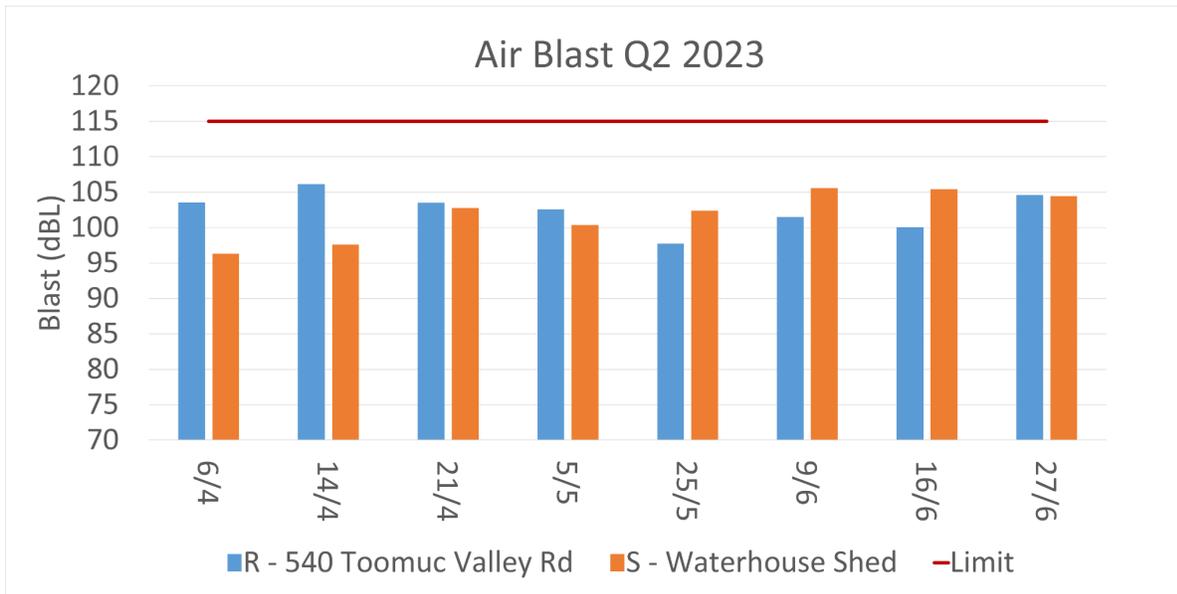
Figure 7 - Blasting; Air Blast Results Q2 2023 (Limit is 115 dBL for 95% of blasts in a 12 month period)

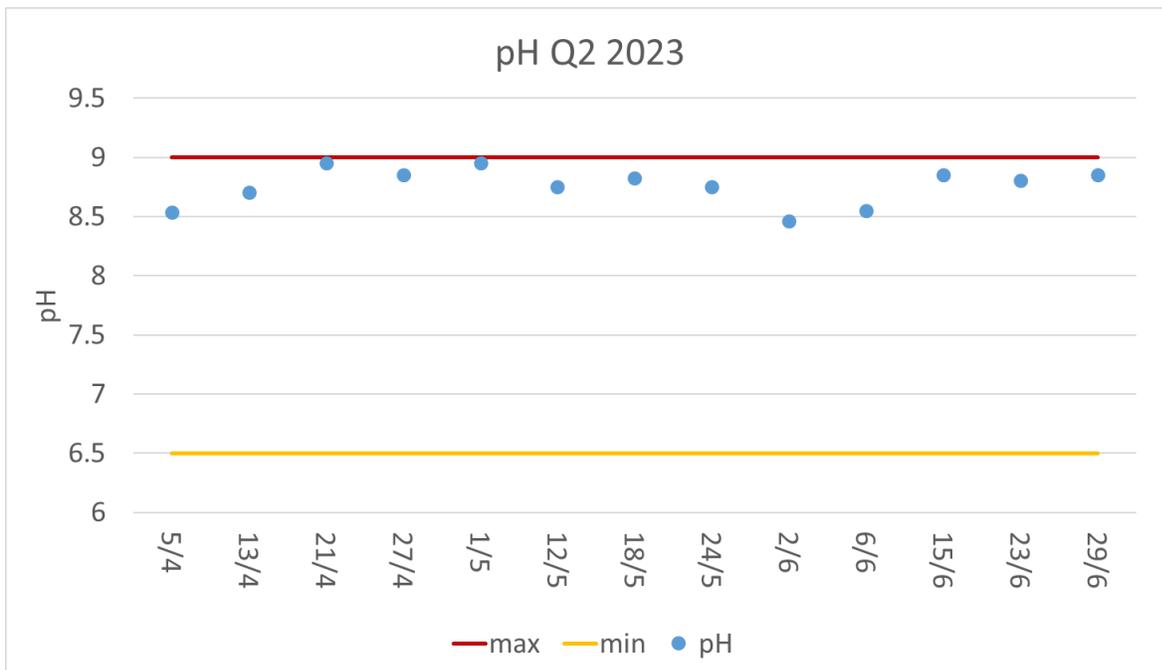
pH – A measure of the Acidity or Alkalinity of the water limit 6.5 to 9.0. No exceedances during the reporting period.

Figure 8 - Discharge Water pH results Q2 2023

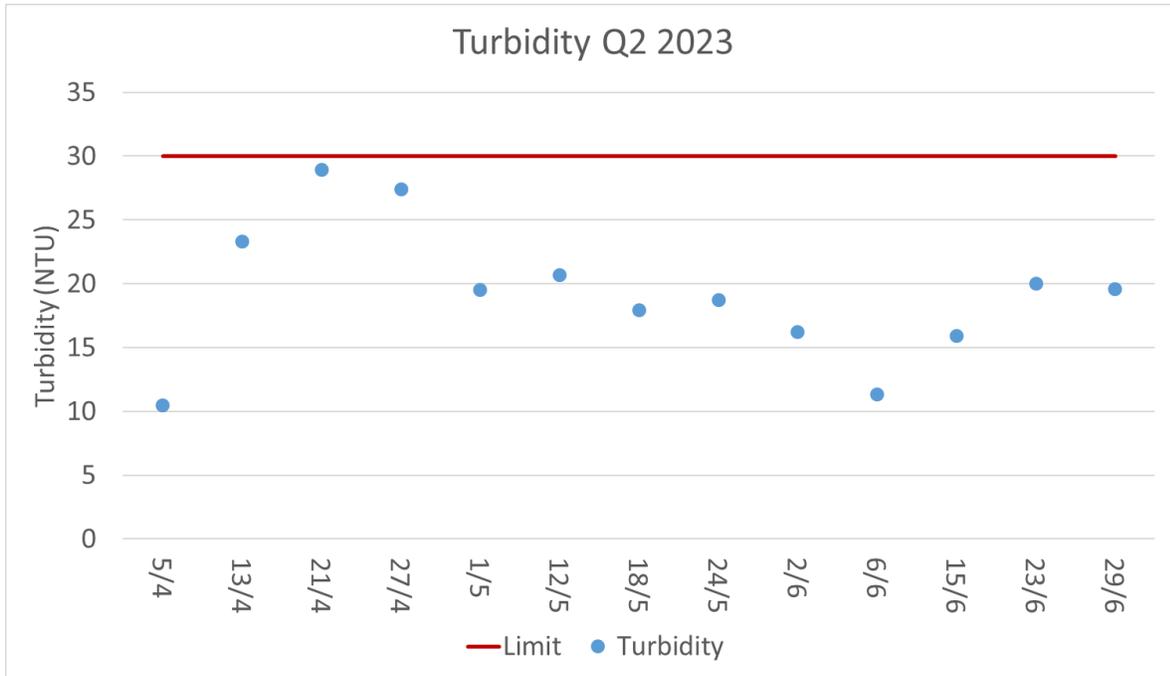
Turbidity – Clarity of water Maximum 30NTU.

Figure 9- Discharge Water Turbidity results Q2 2023

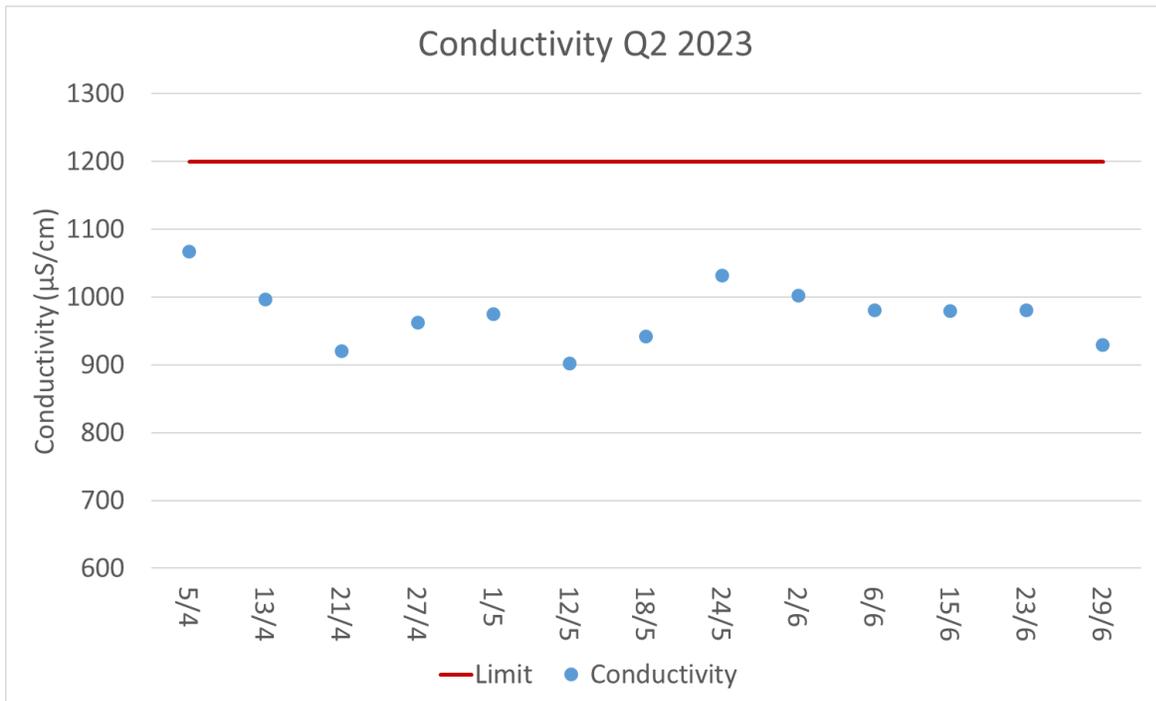
Conductivity – A measure of the water’s capability to pass electrical current. Limit 1200 μ S. No exceedances during the reporting period.

Figure 10 - Discharge Water Conductivity results Q2 2023

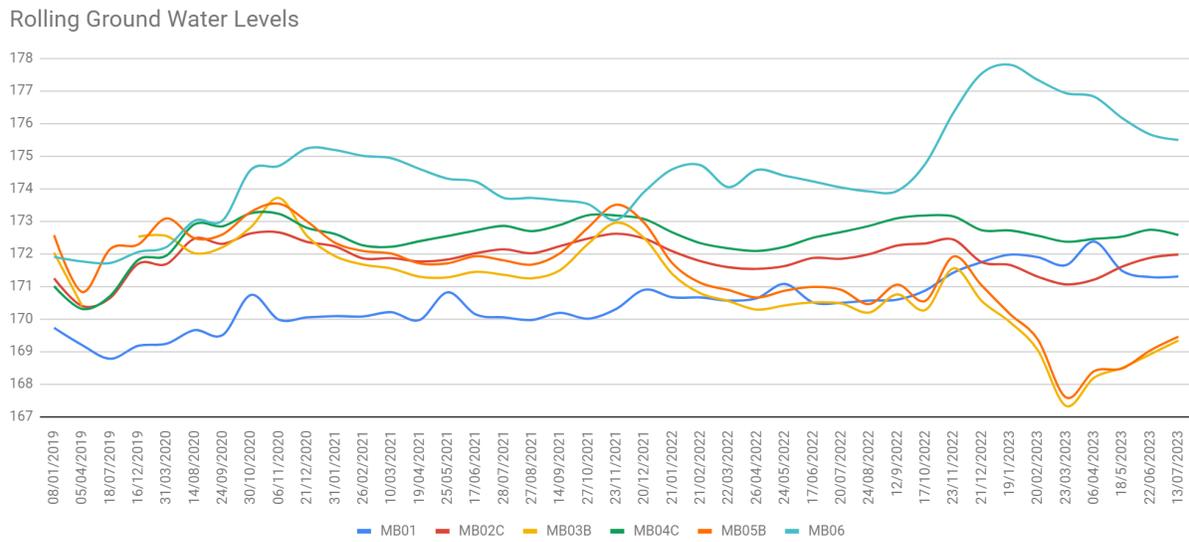
Figure 11 - Groundwater levels 2019 to present.

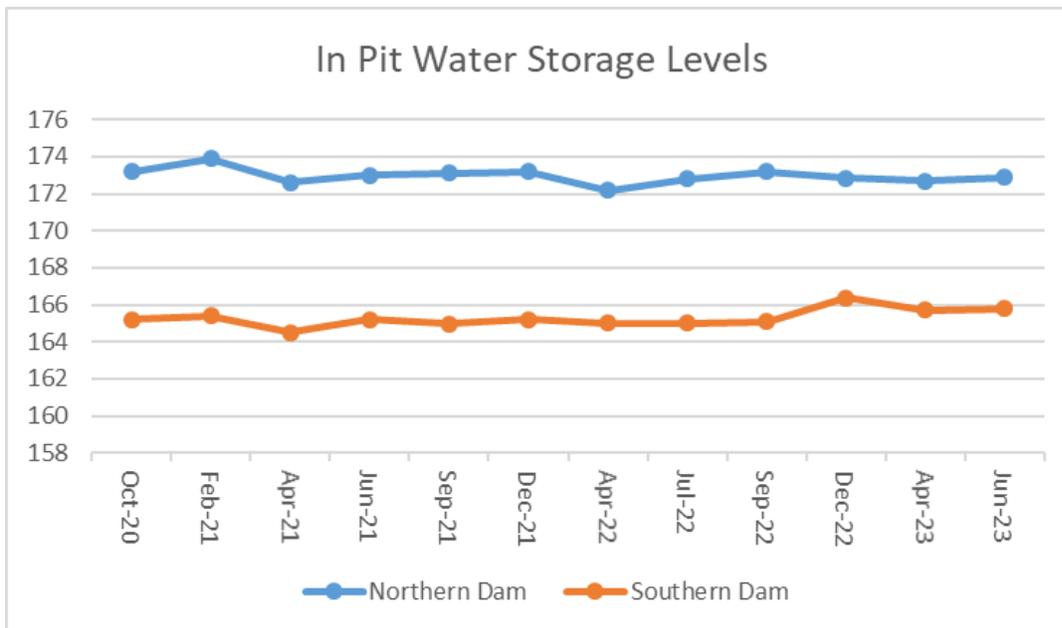
Figure 13 - In Pit Storage Levels October 2020 - Present

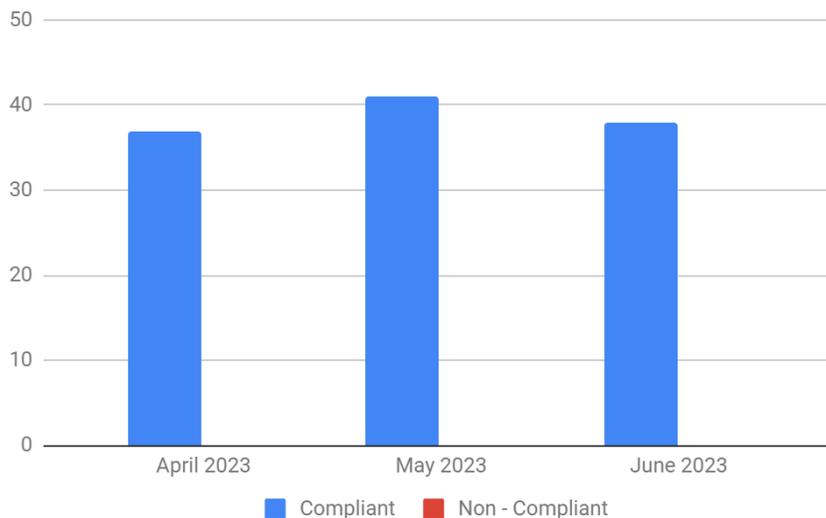
Tarping compliance Q2 2023

Figure 15 - Tarping visual checks of Q2 2023
