# **Quarterly Report**

**October - December**

**Mt Shamrock  
Environmental Management Plan  
3 Monthly Progress Update**

Prepared for Mt Shamrock Quarry Environmental Review Committee

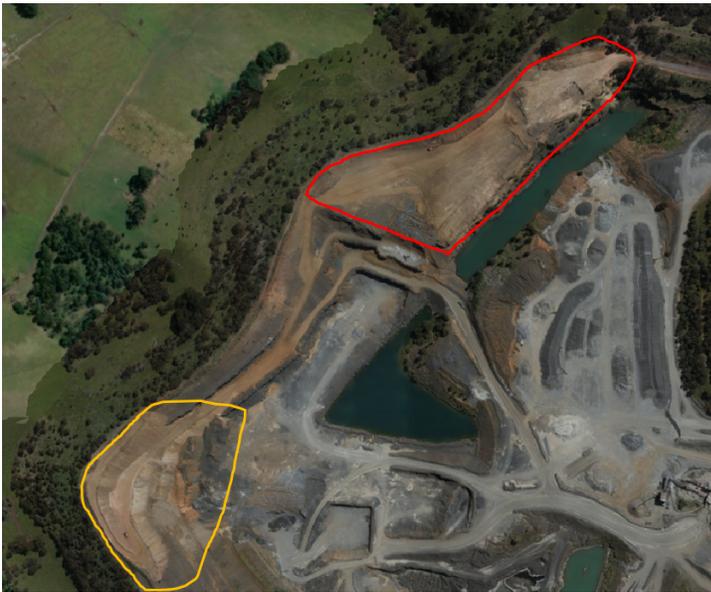
**Figure 2 - 2023 Stripping area (red) and reclamation area (yellow)**

- Overburden removal (stripping) has continued during Q4 (red outline, figure 2) with emplacement of the rocky overburden and clay materials being placed in the western most corner (yellow outline, figure 2) for reclamation works. Stripping works completed in Q4 2023 with some shaping work to continue in Q1 2024.

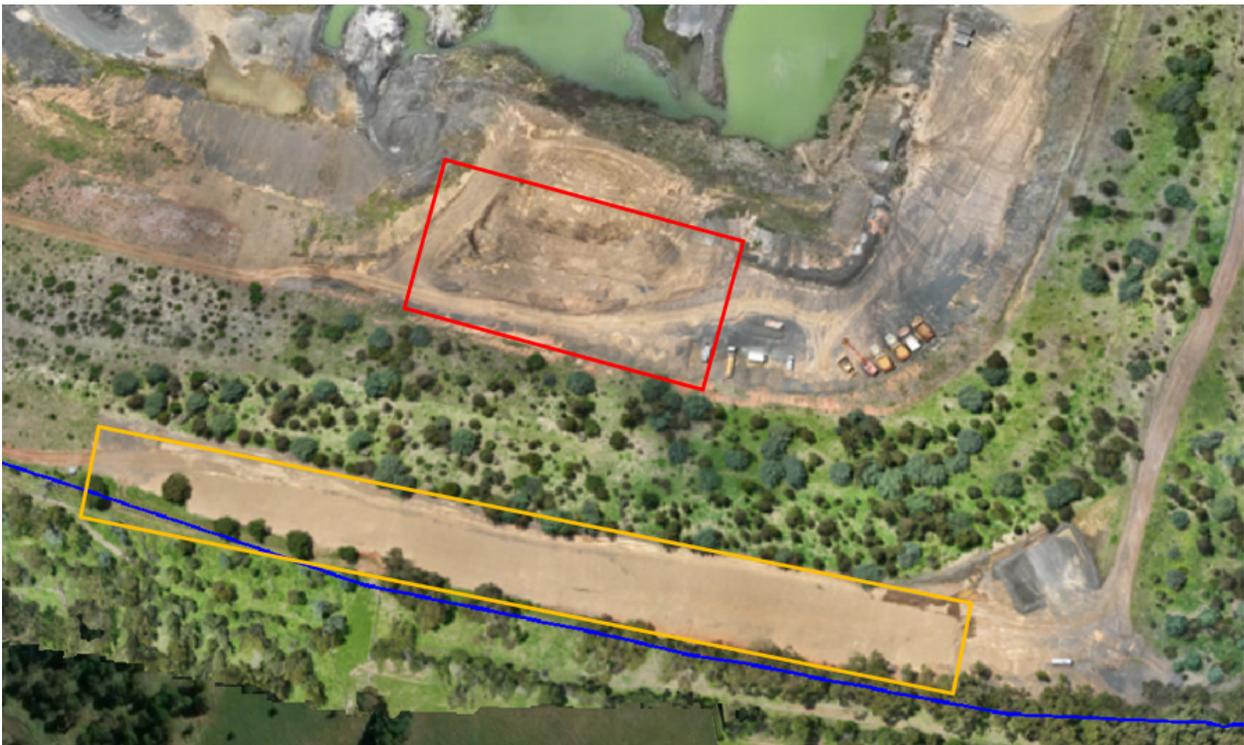
**Figure 3 - Reclamation of top South-South Eastern batter**

- Overburden material has been removed from the temporary emplacement (red outline, figure 3) and materials were placed in top South-South Eastern batter to complete the reclamation in this area (yellow outline, figure 3).

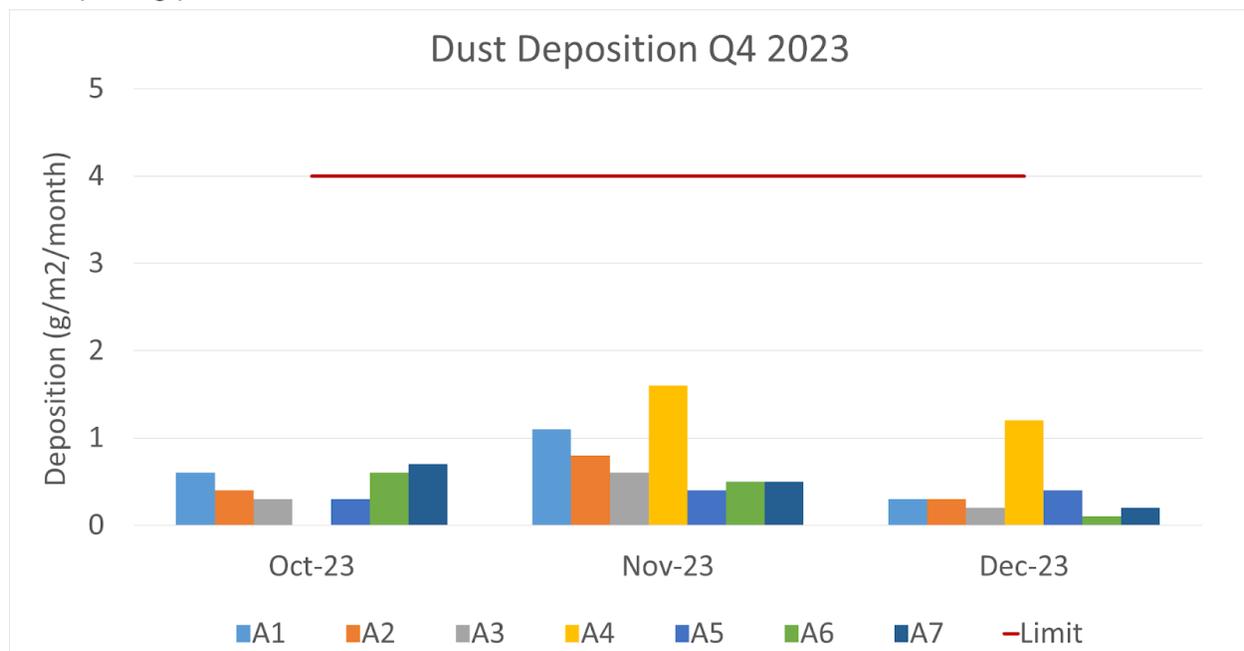
**Figure 4 - Dust Deposition Q4 2023. (Limit 4.0g/m2/mth)**

Depositional results have indicated the dust emissions tabulated below. No exceedances during the reporting period.

October A4 - Deposition Gauge: No result – bottle shattered.

Deposition results presented are Ash analysis test, rather than Total Solids, representing true mineral dust deposition generated by quarry activities.

Deposition bottles are stationed at 7 locations including a background monitoring location at station A7. Particulate matter sampled by this method is predominantly dust particles which, because of their size rapidly settle from the air. Results can be affected by Ash from burning off, bird droppings and insects.

**Limit** – 4.0gm/m<sup>2</sup> mth

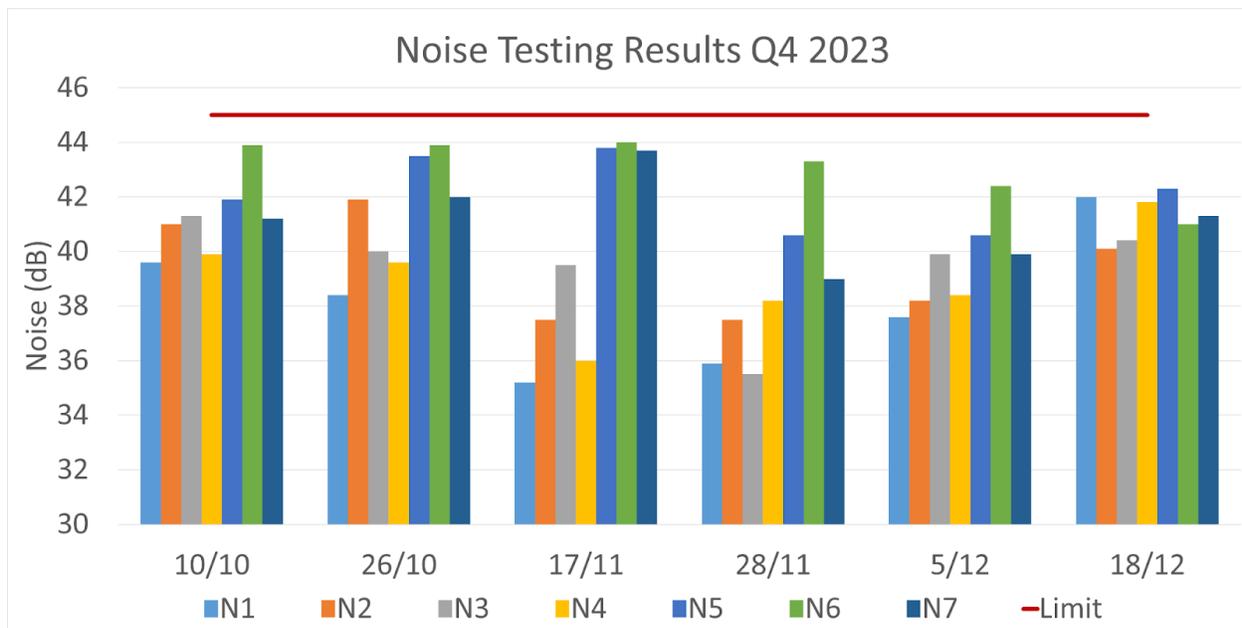
Figure 5 - Noise Testing Results Q4 2023. (Limit is 45dB under normal operating conditions)

Average noise levels for the 4th Quarter 2023 are shown below. No exceedances during the reporting period.

Noise monitoring locations and limits set in the EMP are monitored through the use of a RION hand held monitor. Employees on site who conduct the monitoring are trained and certified in theoretical and practical assessment of the RION hand held meter and basic acoustics.

**Limits** – 45dB(A) LAeq 7:00 – 18:00 Normal Operation  
68dB(A) LAeq 7:00 – 18:00 Noise Attenuation Mound Construction

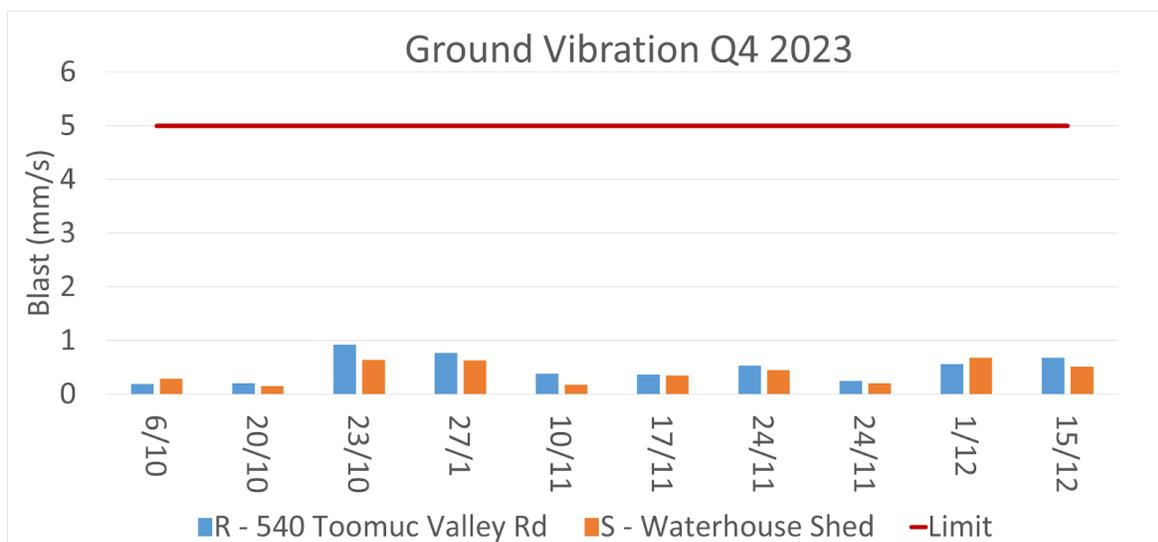
Figure 6 - Blasting; Ground Vibration Results Q4 2023 (Limit is 5mm/s for 95% of blasts in a 12 month period)

All blasting operations have been carried out in accordance with guidelines. No exceedances during the reporting period.

**Ground Vibration** – a measurement of the shock wave passing through the ground

Ground Vibration Limits – Peak Particle Velocity (PPV) 5mm/sec at sensitive locations for 95% of blasts in a 12 month period

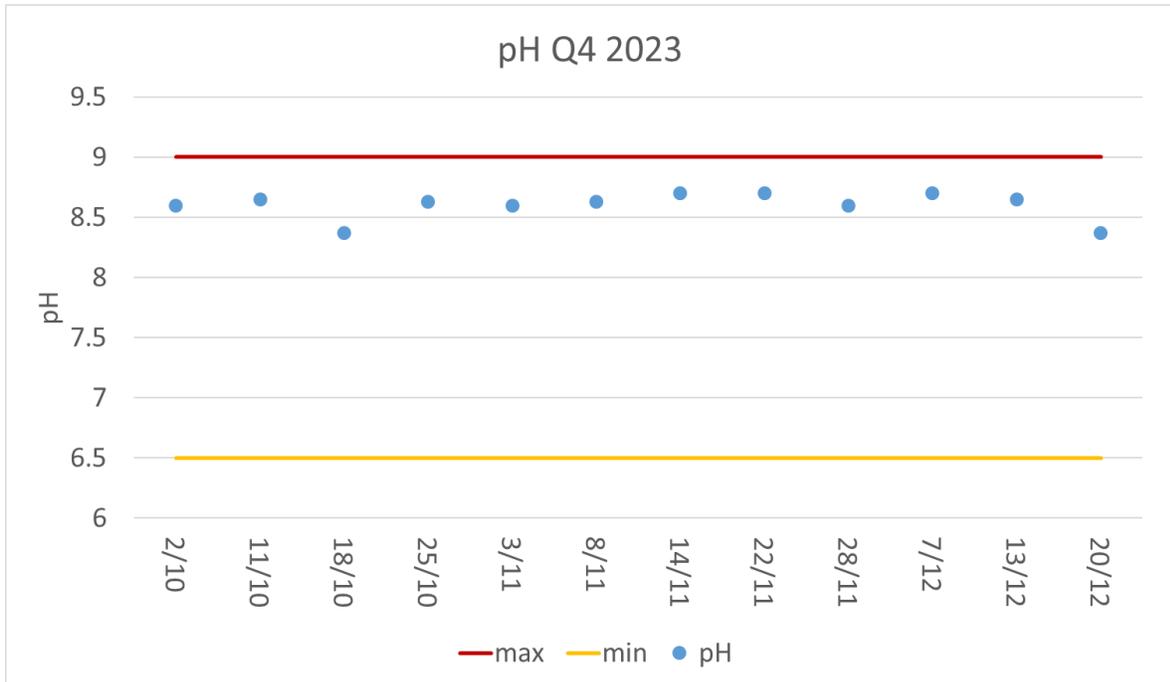
**Figure 8 - Discharge Water pH results Q4 2023**

**pH** – A measure of the Acidity or Alkalinity of the water limit 6.5 to 9.0. No exceedances during the reporting period.

During discharge, water is monitored at the V Notch located at the bottom of the Donnazon property spillway. A solar powered flow meter logs flow data and the water is sampled manually by trained and certified employees. Water is tested for Turbidity, pH and conductivity. Water is monitored at Donnazzons dam regularly prior to discharge to determine if the water is ok to discharge.

**pH** – A measure of the Acidity or Alkalinity of the water. Limit 6.5-9.0

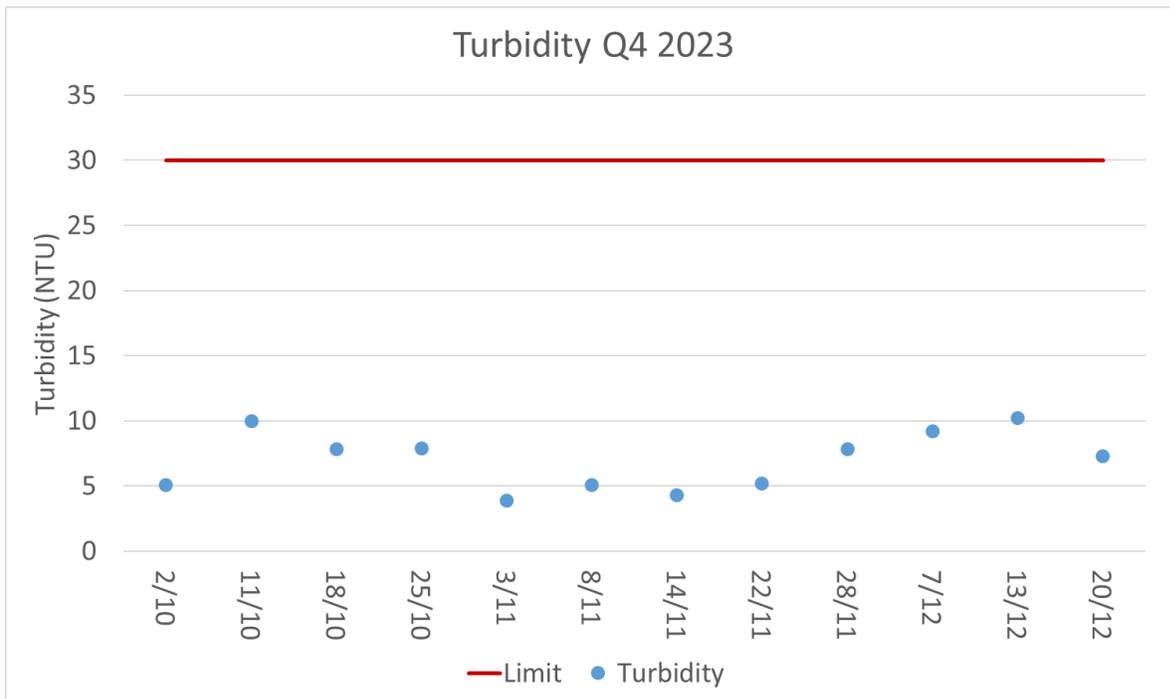
**Figure 9 Discharge Water Turbidity results Q4 2023**

**Turbidity** – Clarity of water Maximum 30NTU.

**Turbidity** – Clarity of water. Maximum 30NTU

| EMP Reference | Rating | Non Conformance | Recommendation | Status |
|---|---|---|--|---|
| 2.4.2 Surface Water | MNC | Three (3) turbidity exceedances were recorded during the audit period, the highest being approx. 80 NTU (Licence Limit 30). | Investigate and then implement effective measures to cease the discharge from the site of sediment and/or colloid-contaminated water that causes exceedance of Licence limits. | In progress |

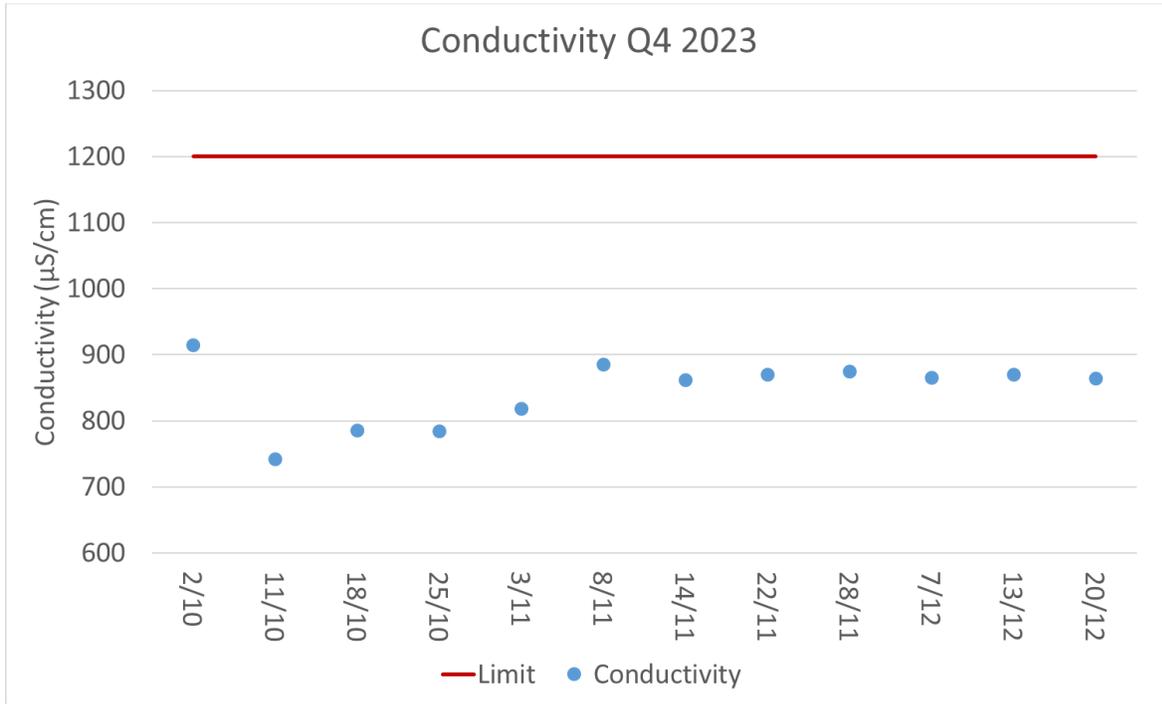
**Figure 10 - Discharge Water Conductivity results Q4 2023**

**Conductivity** – A measure of the water’s capability to pass electrical current. Limit 1200µS. No exceedances during the reporting period.

**Conductivity** – A measure of the water's capability to pass electrical current. Limit 1200 $\mu$ S

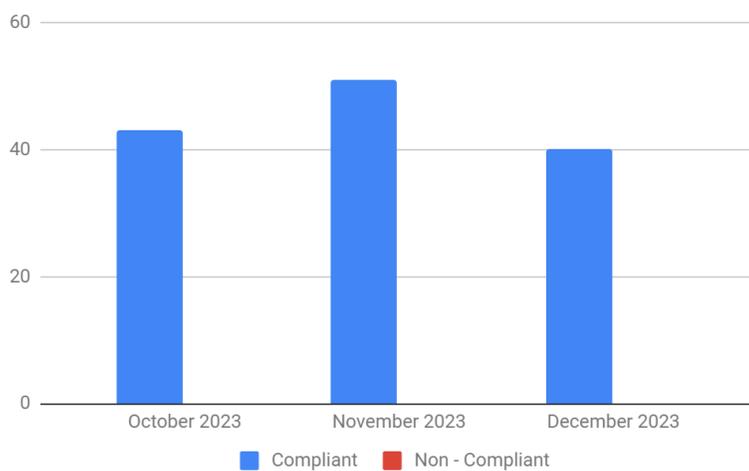
**Figure 15 - Tarping visual checks of Q4 2023**

Tarping compliance Q4 2023

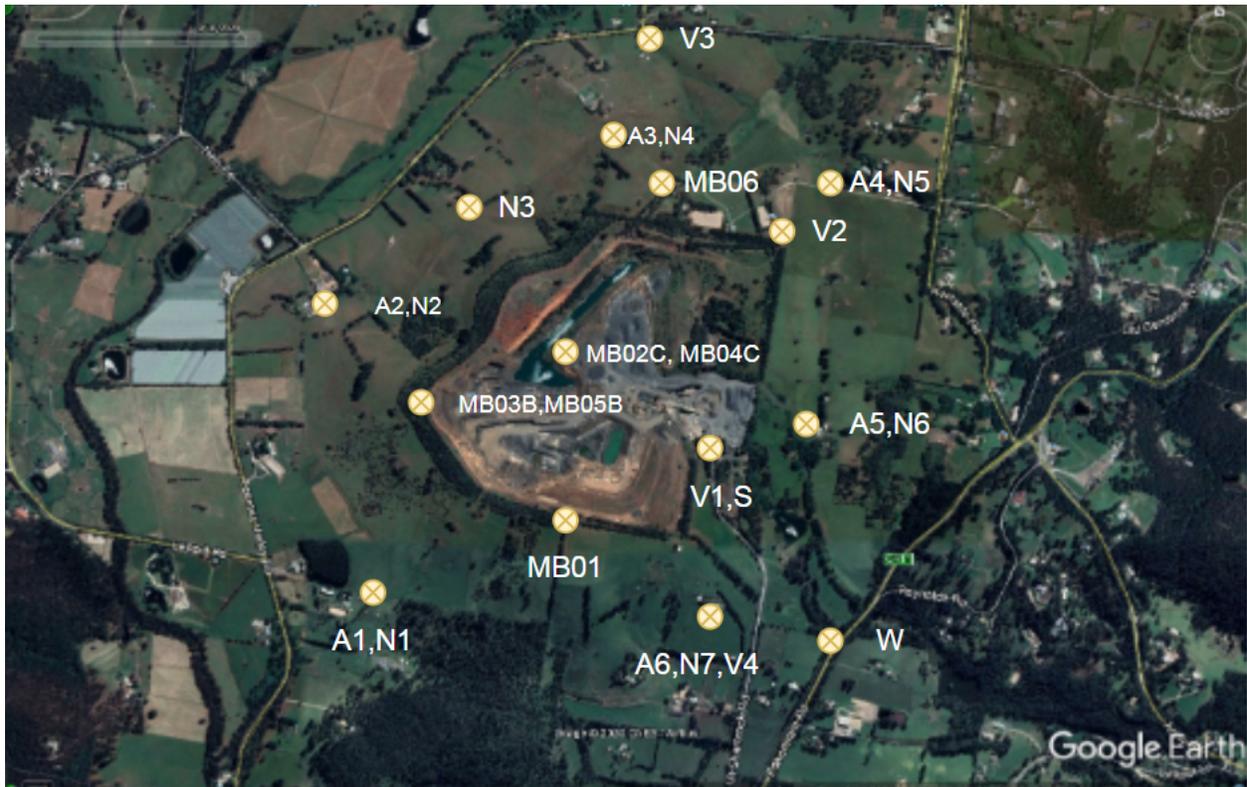
## Appendix 2 – Monitoring Locations

This report details information on both monitoring results and management actions by the quarry in the preceding three months. This report will take the form of an exception report that is where there is a deviance from the EMP. This will be highlighted and the reasons for the deviance explained. A summary of quantifiable monitoring outcomes is also included. Figure 1.12 details all monitoring locations.
