Quarterly Report

July - September

**Mt Shamrock
Environmental Management Plan
3 Monthly Progress Update**

Prepared for Mt Shamrock Quarry Environmental Review Committee

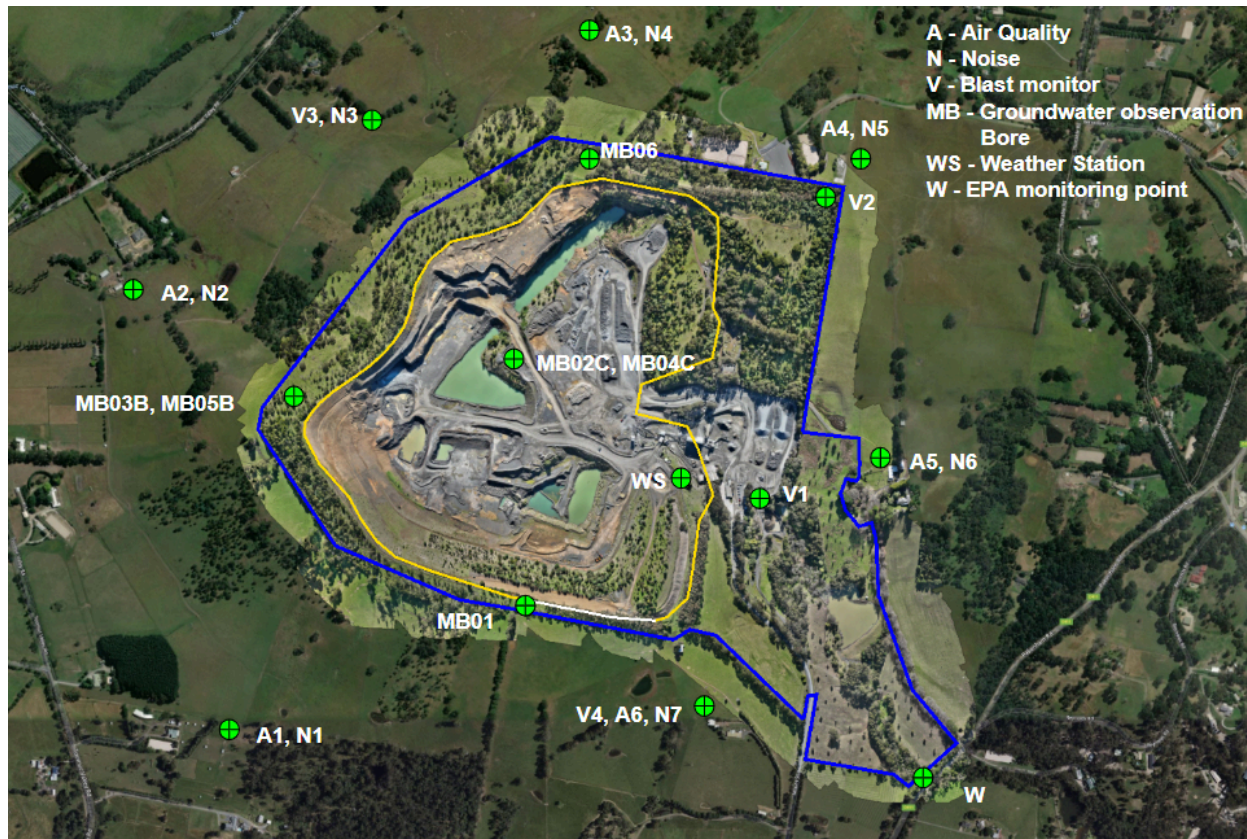
Monitoring Locations

This report details information on both monitoring results and management actions by the quarry in the preceding three months. This report will take the form of an exception report that is where there is a deviance from the EMP. This will be highlighted and the reasons for the deviance explained. A summary of quantifiable monitoring outcomes is also included. Figure 1.12 details all monitoring locations.
