# **Quarterly Report**

**January - March**

**Mt Shamrock  
Environmental Management Plan  
3 Monthly Progress Update**

Prepared for Mt Shamrock Quarry Environmental Review Committee

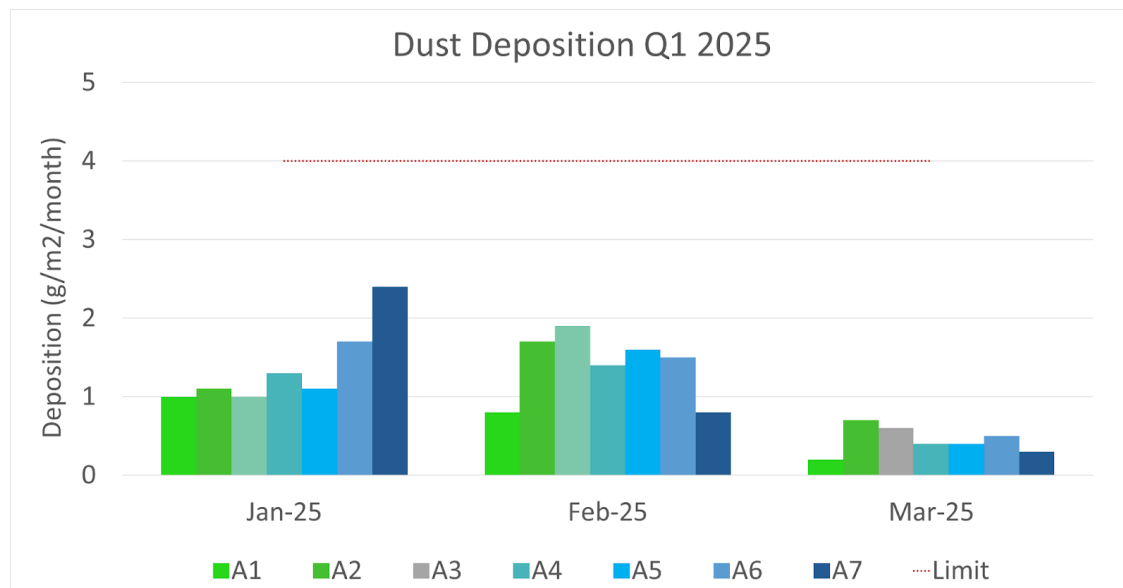
**Figure 2 - Dust Deposition Q1 2025. (Limit 4.0g/m²/mth)**

Dust depositional results have been graphed below for the reporting period. No exceedances during the reporting period.

Deposition results presented are Ash analysis test, rather than Total Solids, representing true mineral dust deposition generated by quarry activities.

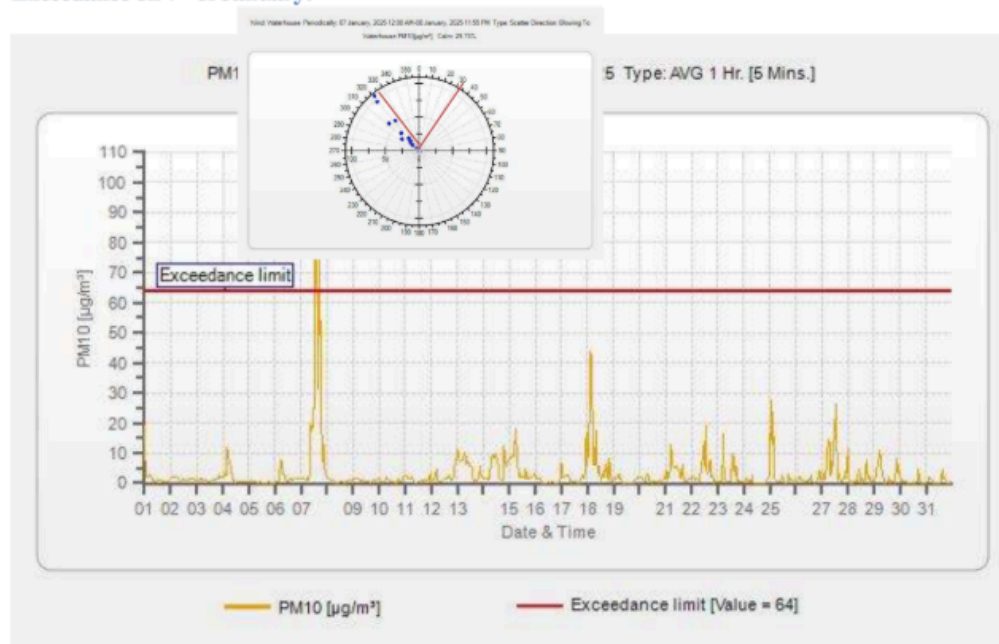
Figure 3 - Waterhouse Property exceedance investigation 7th January (Blue Atmosphere PM 10 Monitoring Report, January 2025)

The scatter plot suggests that the source of high PM10 was from outside the Quarry Operations.

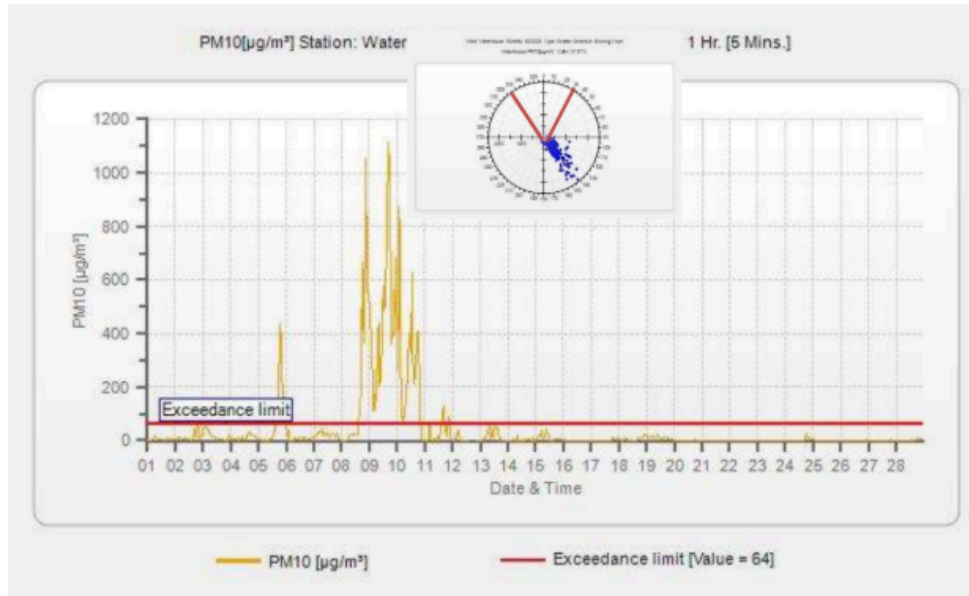
**Figure 4 - Waterhouse Property exceedance investigations February (Blue Atmosphere PM 10 Monitoring Report, February 2025)**

The scatter plot suggests that the source of high PM10 readings was from outside the Quarry Operations.

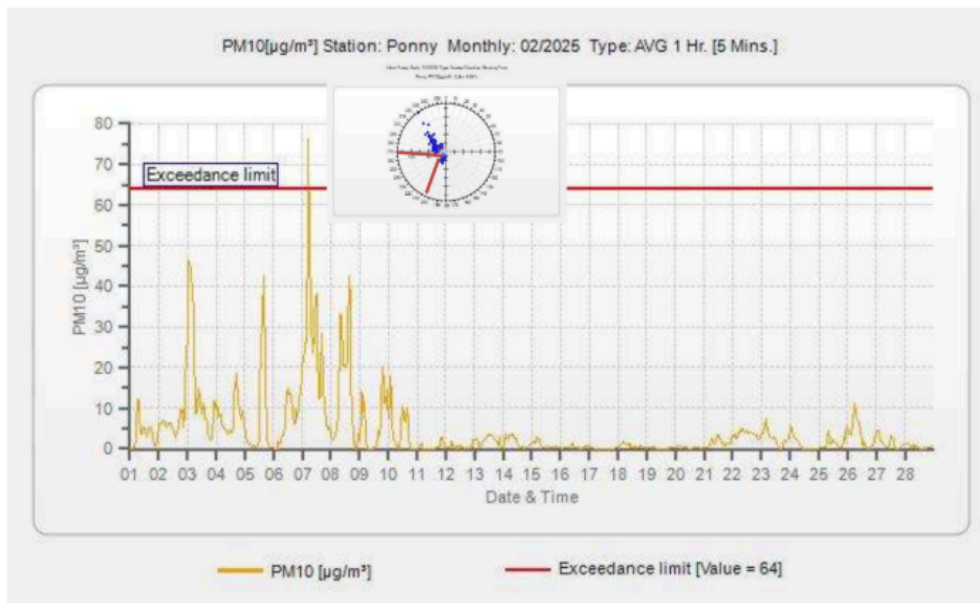
**Figure 5 - Pony Club exceedance investigation 7th February (Blue Atmosphere PM 10 Monitoring Report, February 2025)**

The scatter plot suggests that the source of high readings PM10 on 7<sup>th</sup> of February was from outside the Quarry operations.

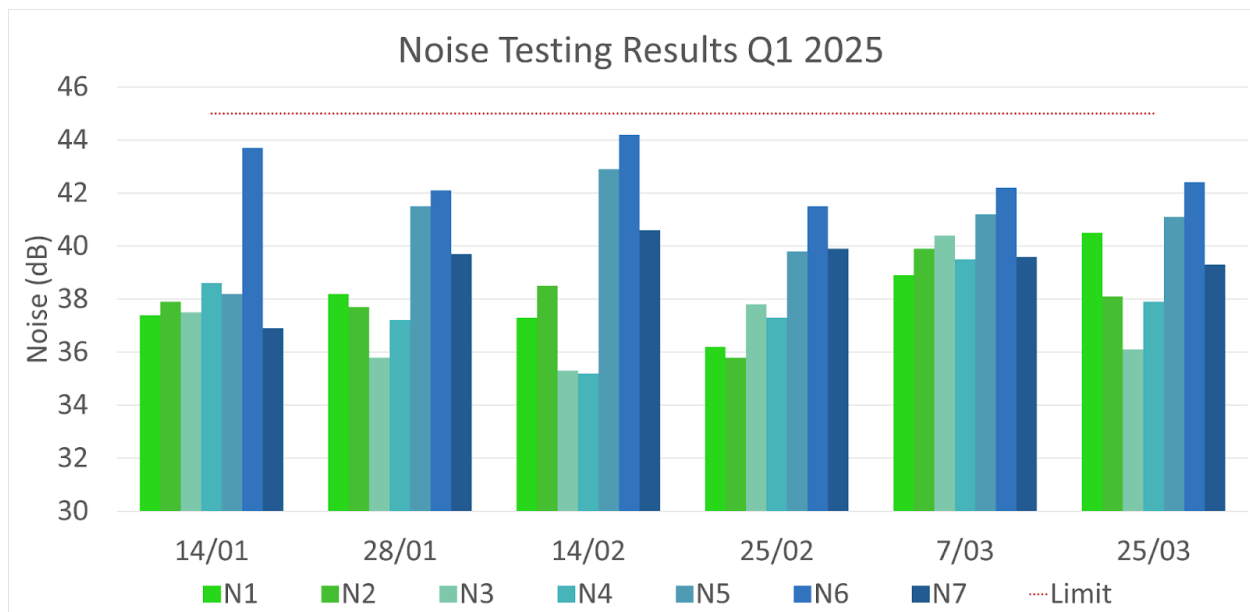
Figure 6 - Noise Testing Results Q1 2025. (Limit is 45dB under normal operating conditions)

Average noise levels for the 1st Quarter 2025 are shown below. No exceedances during the reporting period.

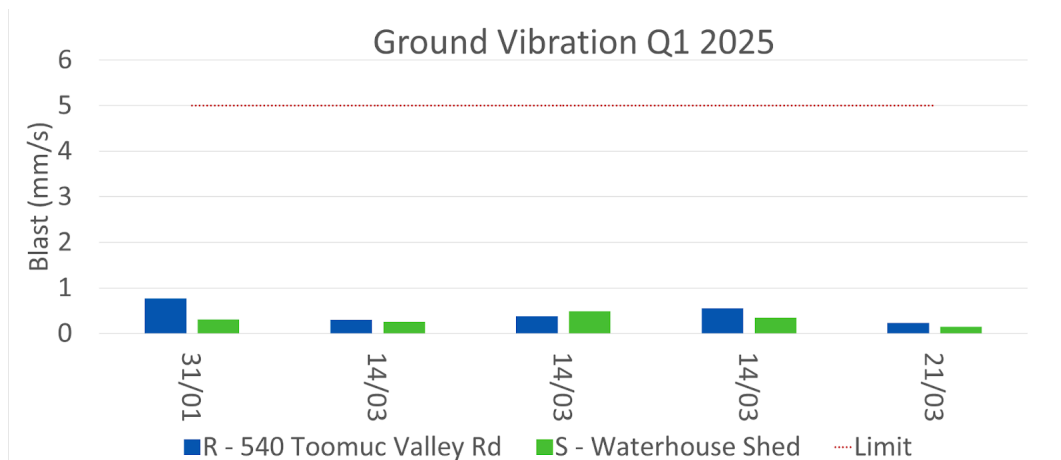
Figure 7 - Blasting; Ground Vibration Results Q1 2025 (Limit is 5mm/s for 95% of blasts in a 12 month period).

No ground vibration exceedances during the reporting period. 3 blasts on the 14th March.

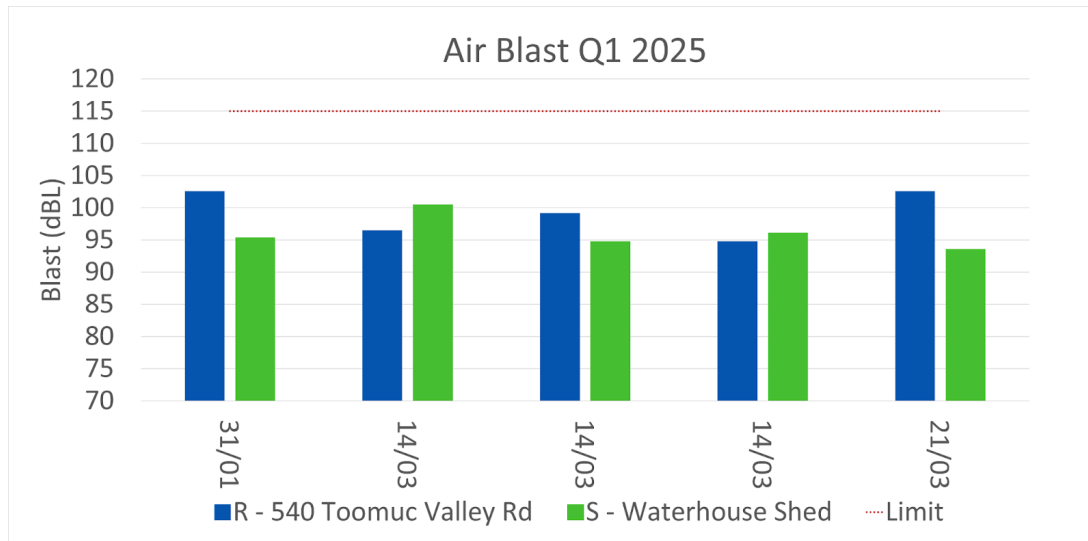
**Figure 8 - Blasting; Air Blast Results Q1 2025 (Limit is 115 dBL for 95% of blasts in a 12 month period)**

No air blast exceedances during the reporting period. 3 blasts on the 14th March.

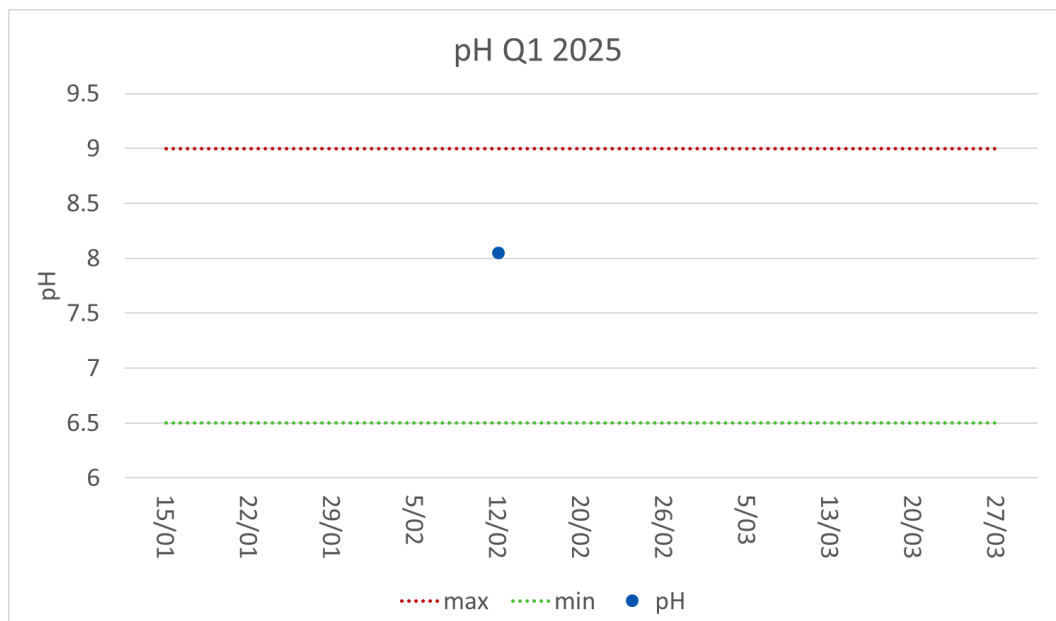
**Figure 9 - Discharge Water pH results Q1 2025**

V-Notch was dry for most of Q1 2025.

**pH** – A measure of the Acidity or Alkalinity of the water limit 6.5 to 9.0.

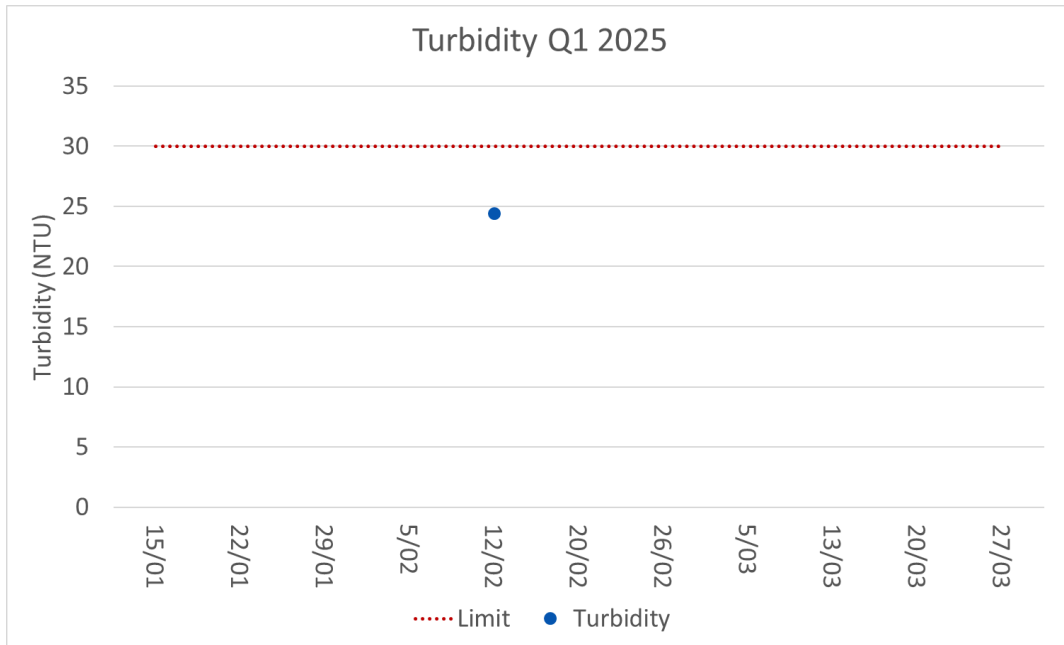
**Figure 10 - Discharge Water Turbidity results Q1 2025**

**Turbidity** – Clarity of water Maximum 30NTU.

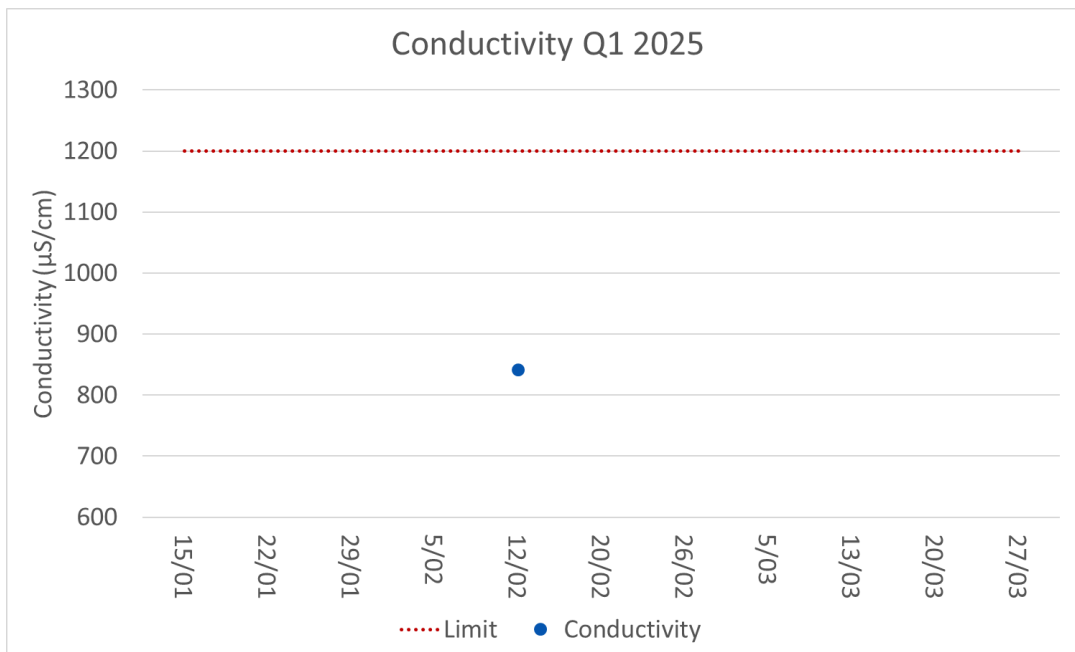
**Figure 11 - Discharge Water Conductivity results Q1 2025**

**Conductivity** – A measure of the water's capability to pass electrical current. Limit 1200 $\mu$ S.

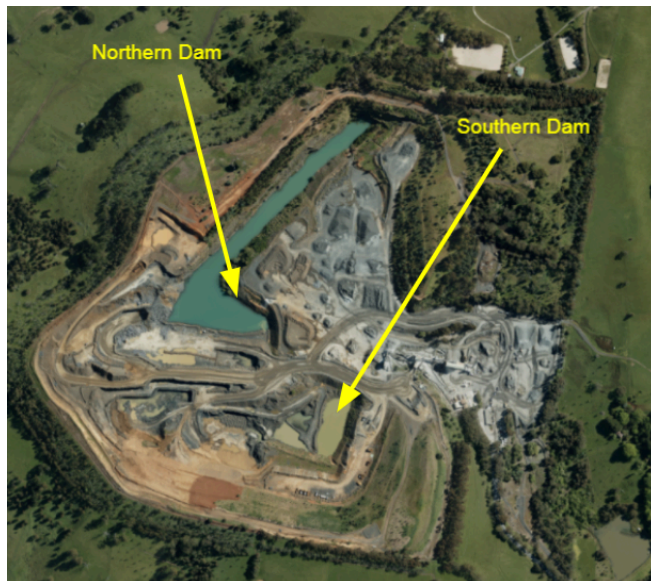
**Figure 13 - In Pit Water Identification**

In 2020, Holcim committed to begin and report the in pit water dam levels quarterly, to aid in the annual beneficial use analysis. This was formed as part of the revised EMP submission. Location and naming conventions are shown in the map for reference. All measurements are in RL's (the same unit as ground water levels)

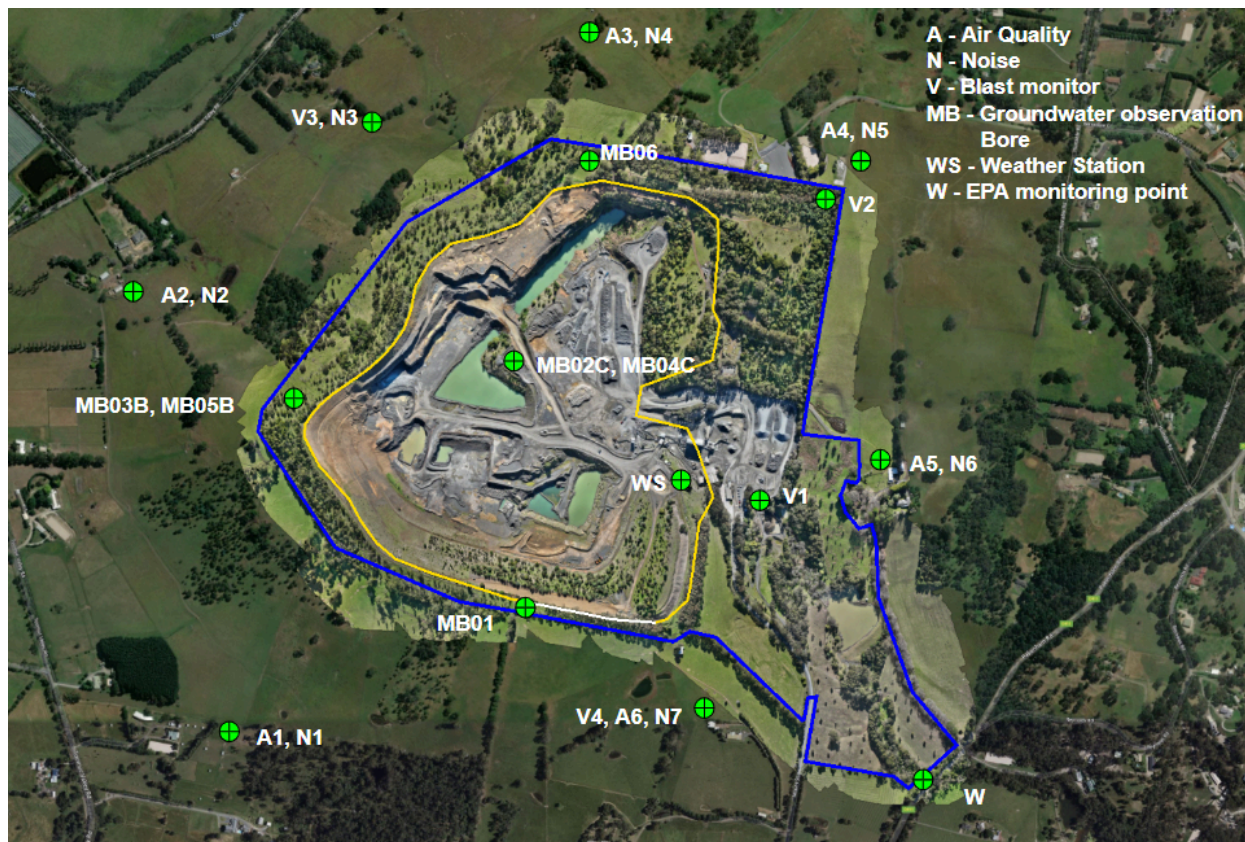
### Monitoring Locations

This report details information on both monitoring results and management actions by the quarry in the preceding three months. This report will take the form of an exception report that is where there is a deviance from the EMP. This will be highlighted and the reasons for the deviance explained. A summary of quantifiable monitoring outcomes is also included. Figure 1.12 details all monitoring locations.
