# **Quarterly Report**

**January - March**

**Mt Shamrock  
Environmental Management Plan  
3 Monthly Progress Update**

Prepared for Mt Shamrock Quarry Environmental Review Committee

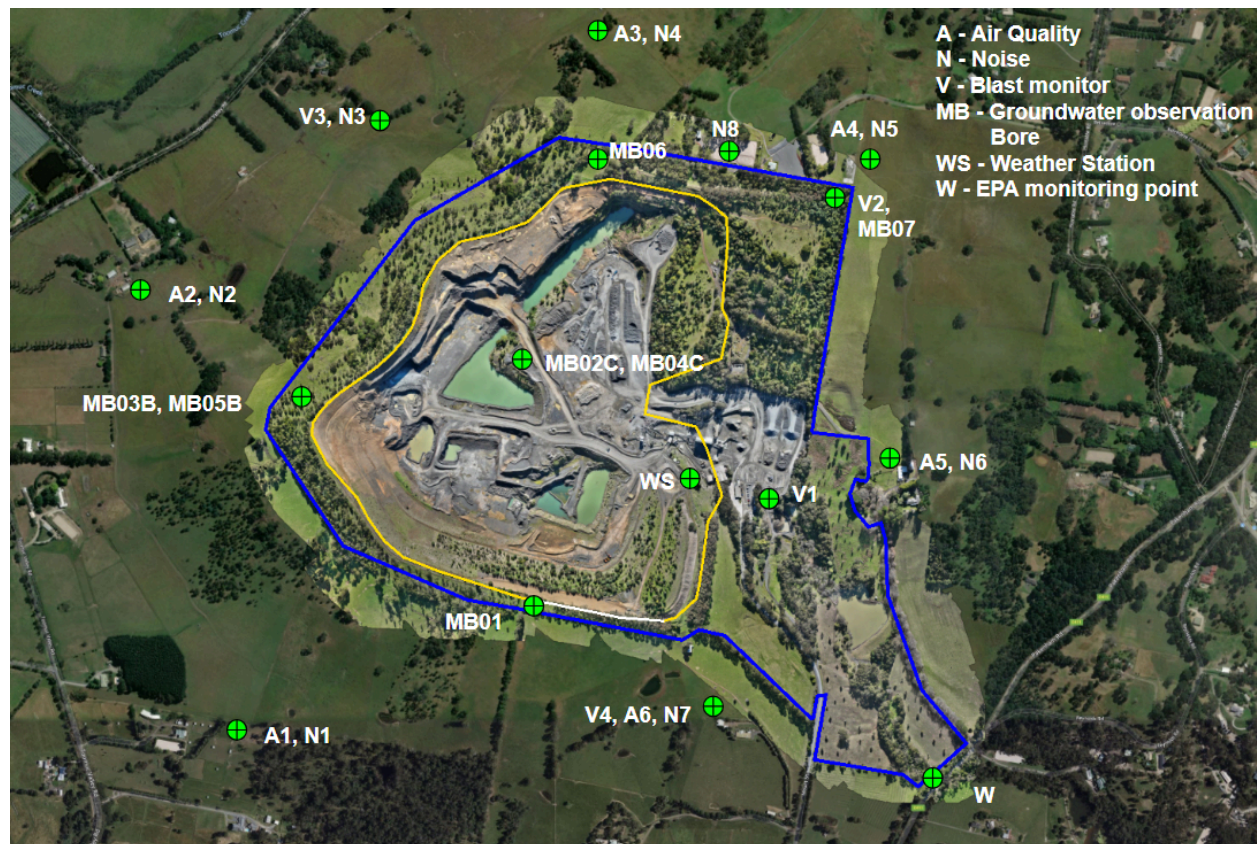
Figure 13 - EMP Monitoring Locations

This report details information on both monitoring results and management actions by the quarry in the preceding three months. This report will take the form of an exception report that is where there is a deviance from the EMP. This will be highlighted and the reasons for the deviance explained. A summary of quantifiable monitoring outcomes is also included and figure 13 details all monitoring locations.
