# Mt Shamrock Quarry Rehabilitation Report

**Site Location:** Holcim Mt Shamrock Quarry Mt Shamrock Rd, Pakenham Upper, Vic,

This report addresses all revegetation and maintenance works carried out by Naturelinks in the area identified as South-East Extraction over the period of 2017- 2019. As part of the Mt Shamrock revegetation works Naturelinks undertook direct seeding and planting works of approximately 3.9 Ha within the SE Extraction area of the quarry. The area rehabilitated is outlined below along with revegetation and management steps undertaken. As well as detailing restoration works, this report outlines issues encountered and management challenges identified throughout the rehabilitation process. Following this a summary list of proposed future management actions is detailed.

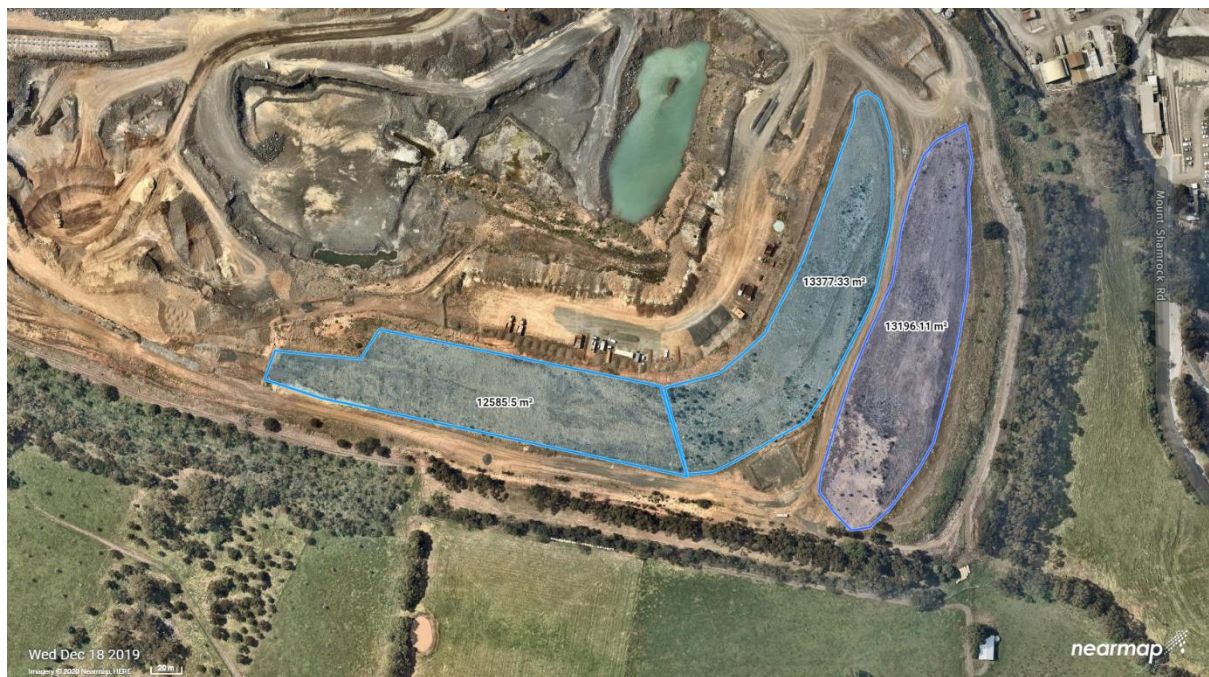
Figure 1: 2017/18 Total Mt Shamrock South-east Extraction Re-vegetation area (3.9Ha).

The area referred to as SE Extraction re-vegetation refers to all revegetation works undertaken from 2017-2019 located in the South-eastern corner of the operational Quarry area. This area is approximately 3.9 hectares in total and is comprised of three separate Areas (see Figure 1). Areas 1 and 2 [Figure 2 (left)] were revegetated in 2017 and together total approximately 2.7Ha, with the 2018 revegetation area totalling approximately 1.2Ha [Figure 2 (right)]. Restoration works were undertaken in all areas and include direct seeding using a sterile cover crop and native seed mix followed by an initial planting of mid and upper story tube-stock. All species selected appear in the EVC 16 List of species for Lowland Forests located within the Gippsland Plains Bioregion as specified in the Holcim Landscape & Rehabilitation Management Plan, Mt Shamrock Quarry, Pakenham (2014).

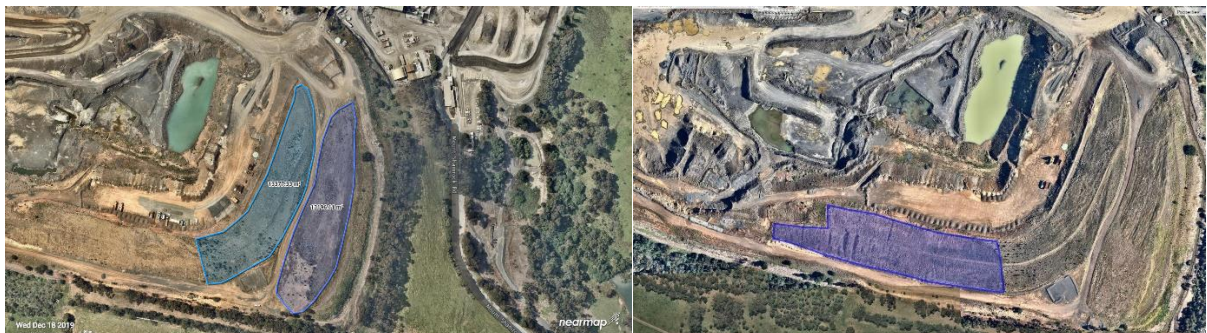
Figure 2: Left – Revegetation Areas 1 & 2 (2017).

Right - Revegetation Area 3 (2018).

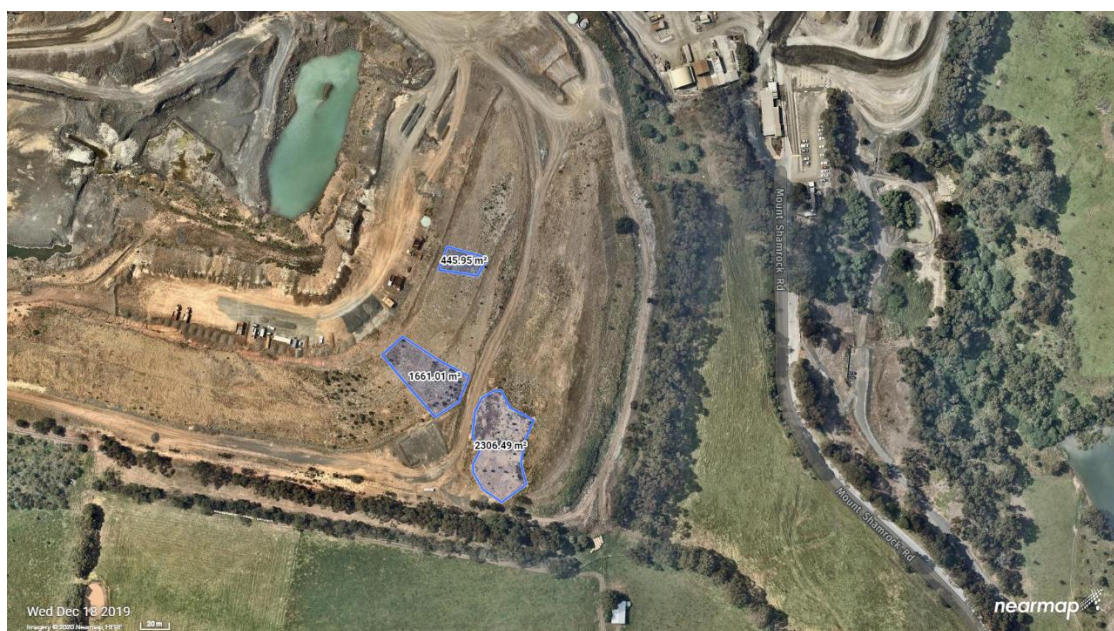
Figure 3: Areas of SE Extraction exhibiting with high cover (>80%) Phalaris.

Significant loss of plantings occurred throughout SE Extraction over the 2017/2018, with some sections seeing isolated losses of up to 90% of species planted. It is likely that multiple factors contributed to these losses, including high temperatures low winter and summer rainfall, shallow soil profile, localised soil compaction and steep slopes in some areas all contributing to low levels of a plant available water in the soil profile through poor water infiltration through the soil. Other factor include inappropriate species selection, High winds and aspect and insufficient subsequent water provided to plantings. From these observations it was determined that areas where high tree mortality occurred were also where high percentages of native understory occurred, predominately Wallaby Grass species. On the other hand, a high percentage cover of exotics was also found where high rates of tree survival were evident. Although a definitive reason as to why this occurred cannot be given without further study, it is possible that this is in direct relationship with water availability and water flow through the site. Where high survival rates and good tree health occur, invasive species that usually appear in wet environment such as *Phalaris aquatica* tend to quickly outcompete and dominate the Wallaby Grass understory.

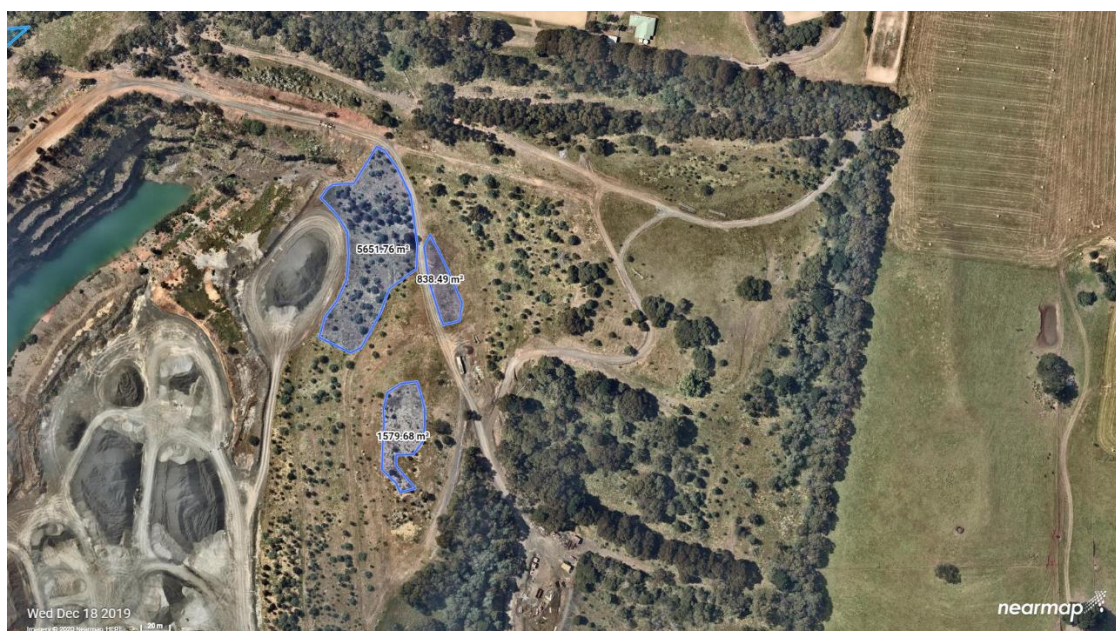
Figure 4: Areas of Extraction exhibiting high (>80%) cover of Perennial grass cover (predominantly Couch and Phalaris)
