2022 Annual Review

1 January 2022 – 31 December 2022

Rooty Hill Distribution Centre

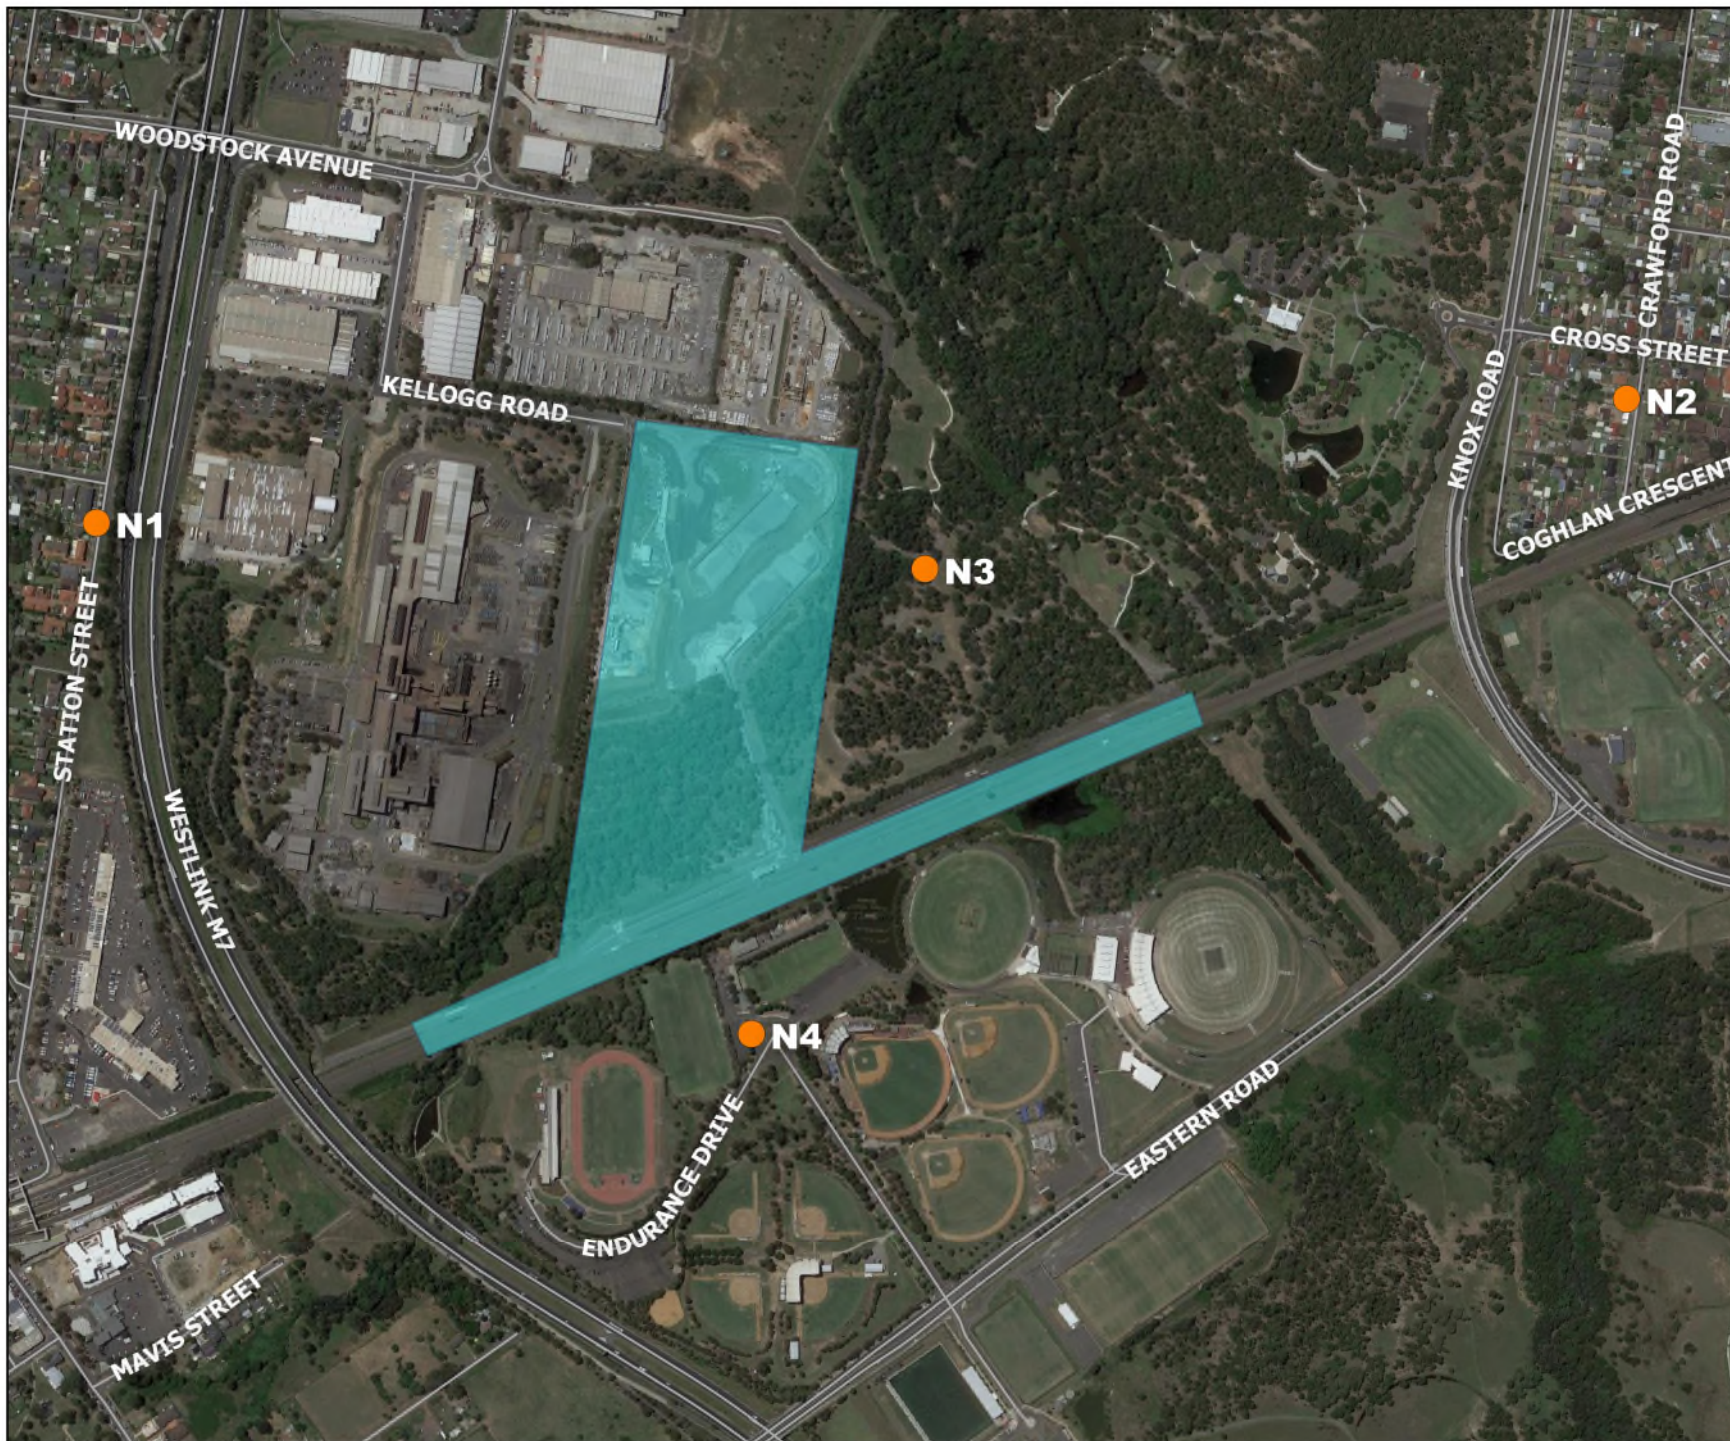
FIGURE 1
Site Locality
MAC180611-01
Holcim Rooty Hill DC

The operational compliance monitoring locations with respect to the RDC are presented in the locality plan shown in **Figure 1** and **Table 1** along with the relevant noise criteria for each location.

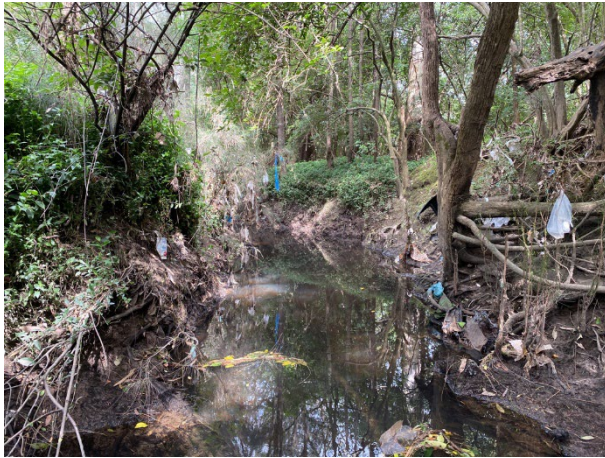
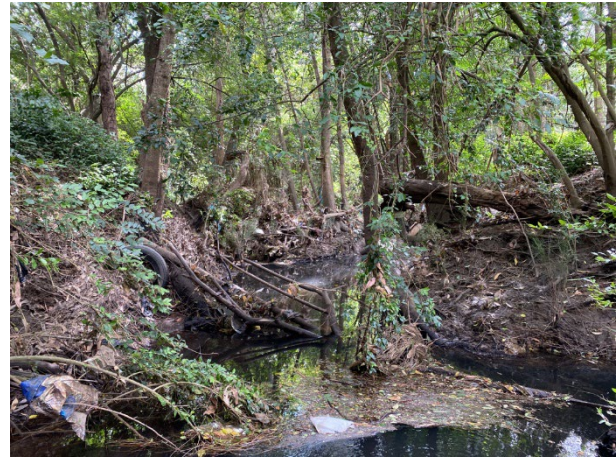
AE1: Angus Creek Upstream

Attribute	AE1 UPSTREAM
Riparian	Vegetation	The dominant tree species comprised Swamp Oak (<i>Casuarina glauca</i>) and Broad-leaf Privet (<i>Ligustrum lucidum</i>). Groundcover was dominated by <i>T. fluminensis</i> .
	Stream shading	Moderate shading
	Exotic vegetation	<i>L. lucidum</i> and <i>T. fluminensis</i>
Stream characteristics	Modal width	3 m
	Bank condition	Slightly vegetated banks and stable. Slight erosion and undercutting of lower bank.
	Substrate	Fine sediment; silt. Hardened clay bottom.
	Flow/depth	Moderate flow/ ~1 m
	Macrophytes/algae	Macrophytes not present.
	Water quality observations	Clear water
Comments		Weeds and rubbish present. Lack of organic material in channel.

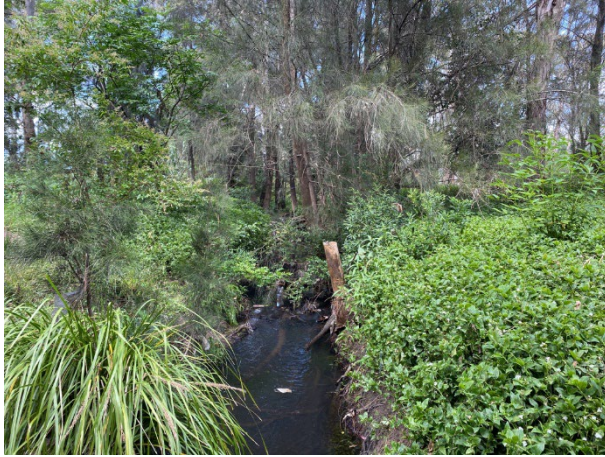
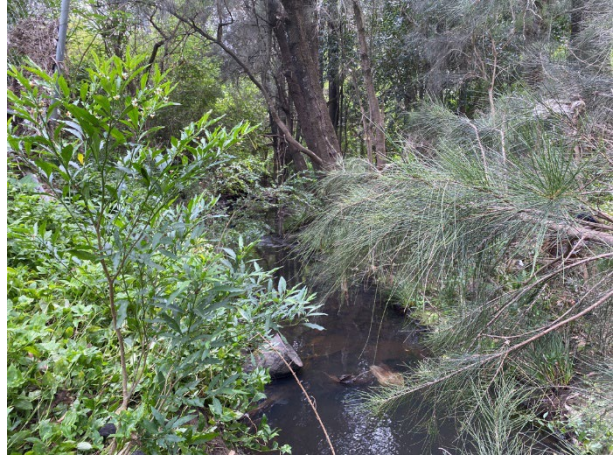
AE2: Angus Creek

Attribute	AE2 DOWNSTREAM
Riparian	Vegetation	Dominant tree species included (<i>C. glauca</i>). Dominant groundcover was <i>T. fluminensis</i> and mixture of exotic and native grasses and herbs.
	Stream shading	Moderate shading
	Exotic vegetation	<i>T. fluminensis</i> and other groundcover species.
Stream characteristics	Modal width	2 m
	Bank Condition	Slightly unstable and heavily vegetated by groundcover
	Substrate	Silt and bedrock / concrete
	Flow/depth	Moderate flow/<1 m
	Macrophytes/algae	Emergent macrophytes present – Bulrush (<i>Typha</i> sp.), <i>Cyprus</i> sp. <i>Potamogeton crispus</i>
	Water quality observations	Clear water
Comments		Weeds and rubbish. Metallic rubbish in system. Concrete rubble in system.

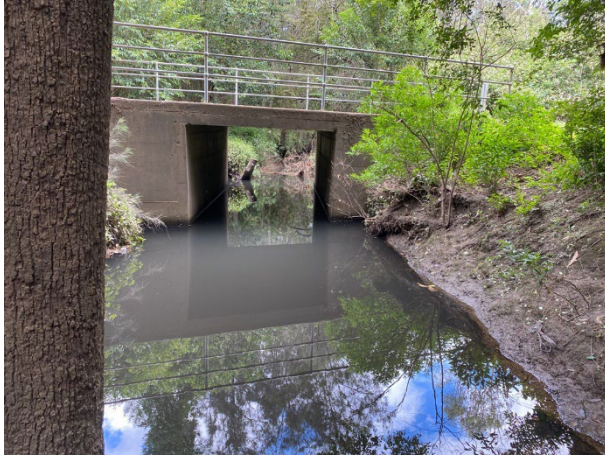
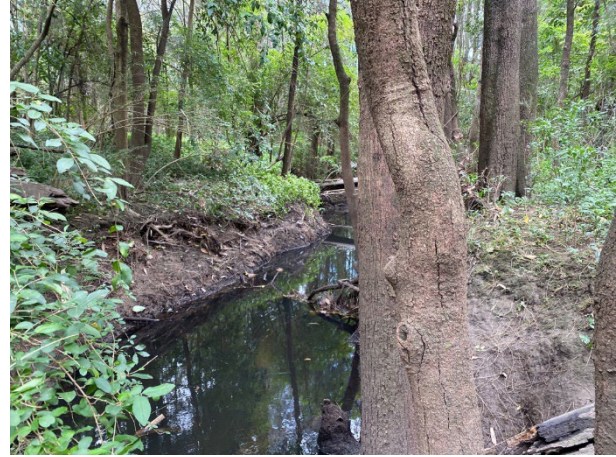
AE3: Angus Creek Downstream

Attribute	AE3 DOWNSTREAM
Riparian	Vegetation	Dominant tree species was <i>C. glauca</i>). Dominant grass/herb species was <i>T. fluminensis</i>
	Stream shading	Moderate shading
	Exotic vegetation	<i>L. Lucidum</i> , <i>T. fluminensis</i>
Stream characteristics	Modal width	4 m
	Bank Condition	Stable, steep, exposed in sections, slight visible erosion.
	Substrate	Fine sediment, organic matter on banks
	Flow/depth	Low flow/~1 metre
	Macrophytes/algae	Ribbon Weed (<i>Vallisneria</i> sp.)
	Water quality observations	Visually water appeared slightly opaque (but within DTVs)
Comments

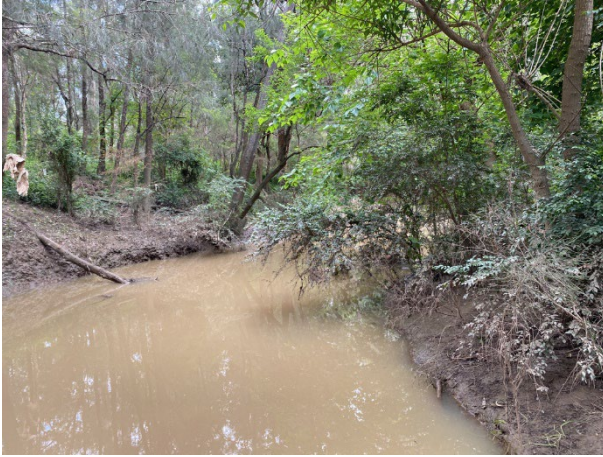
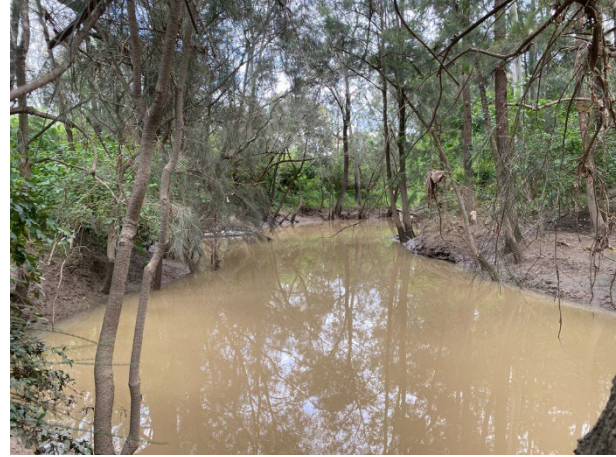
AE4: Eastern Creek Downstream

Attribute	AE4 DOWNSTREAM
Riparian	Vegetation	Dominant canopy species included <i>C. glauca</i>) and Prickly-leaved Tea Tree (<i>Melaleuca styphelioides</i>). Dominant mid-storey species were <i>C. glauca</i> <i>L. lucidum</i>). Dominant groundcover was the exotic <i>T. fluminensis</i>
	Stream shading	Moderate
	Exotic vegetation	<i>L. lucidum</i> and <i>T. fluminensis</i>
Stream characteristics	Modal width	8 m
	Bank condition	Unstable banks
	Substrate	Fine sediment
	Flow/depth	Moderate flow/>1m
	Macrophytes/algae	Macrophytes not present
	Water quality observations	Visually very turbid
Comments

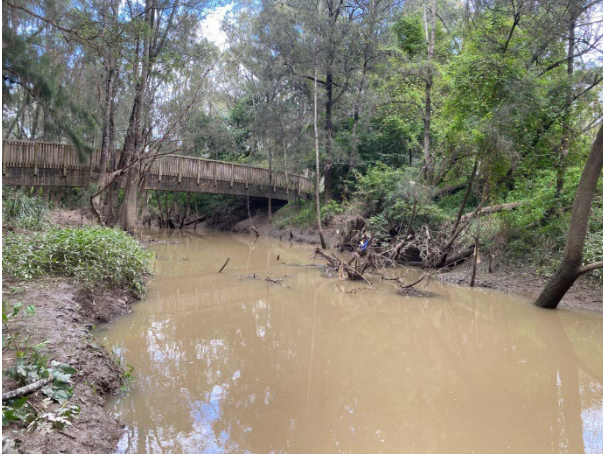
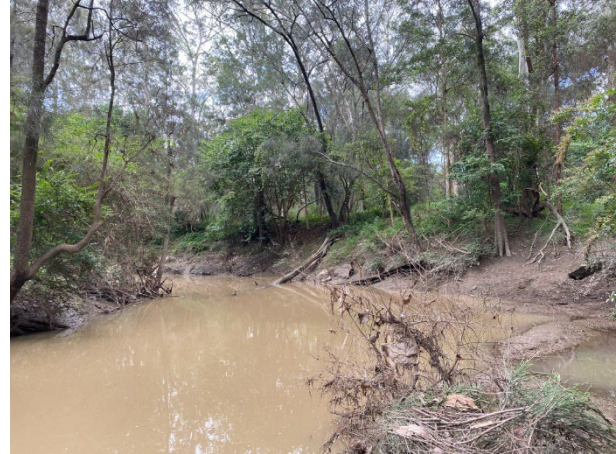
AE 5: Eastern Creek Upstream

Attribute	AE5 UPSTREAM
Riparian	Vegetation	Dominant overstorey species was <i>C. glauca</i> . Dominant grass/herb was <i>Lomandra</i> (<i>Lomandra longifolia</i>) and groundcover <i>T. fluminensis</i> .
	Stream shading	Moderate
	Exotic vegetation	<i>T. fluminensis</i>
Stream characteristics	Modal width	12 m
	Bank condition	Unstable
	Substrate	Fine sediment and large woody debris.
	Flow/depth	Moderate flow/ >1 m
	Macrophytes/algae	Macrophytes not present.
	Water quality observations	Visually very turbid
Comments		Lots of large woody debris and plastic based rubbish

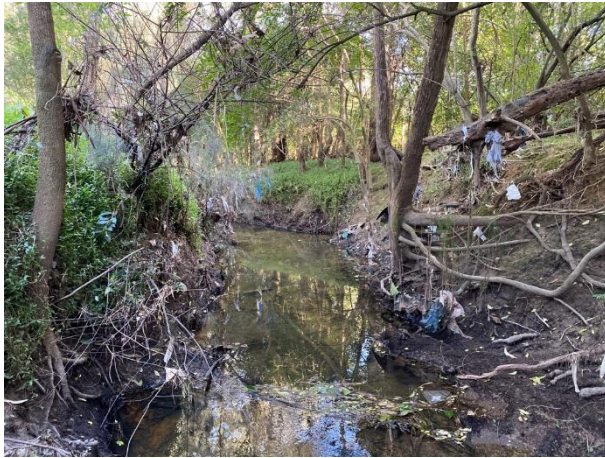
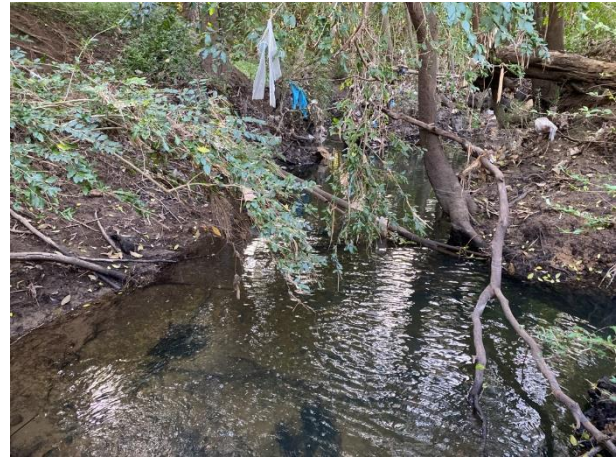
AE1: Angus Creek Upstream

Attribute	AE1 UPSTREAM
Riparian	Vegetation	The dominant tree species comprised Swamp Oak (<i>Casuarina glauca</i>) and Broad-leaf Privet (<i>Ligustrum lucidum</i>). Groundcover was dominated by <i>Tradescantia fluminensis</i> .
	Stream shading	Moderate shading
	Exotic vegetation	<i>L. lucidum</i> and <i>T. fluminensis</i>
Stream characteristics	Modal width	3 m
	Bank condition	Slightly vegetated banks and stable. Slight erosion of lower bank.
	Substrate	Fine sediment; silt. Hardened clay bottom.
	Flow/depth	Moderate flow/ ~1 m
	Macrophytes/algae	Macrophytes not present.
	Water quality observations	Clear water
Comments		Weeds and rubbish present. Lack of organic material in channel.

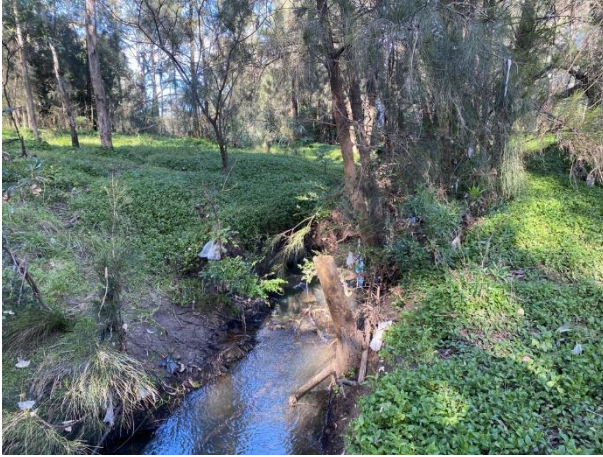
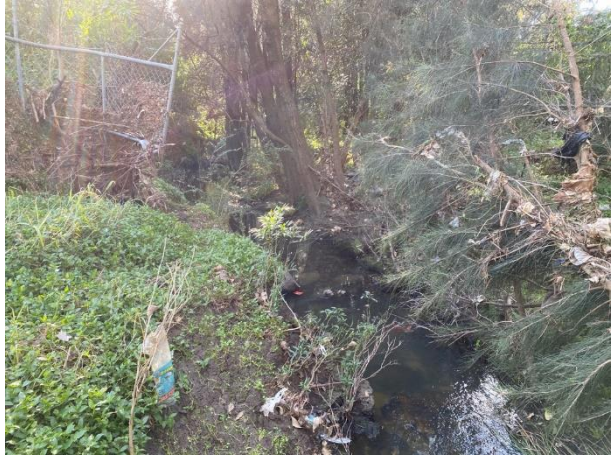
AE2: Angus Creek

Attribute	AE2 DOWNSTREAM
Riparian	Vegetation	Dominant tree species included (<i>C. glauca</i>). Dominant groundcover was <i>T. fluminensis</i> and mixture of exotic and native grasses and herbs.
	Stream shading	Moderate shading
	Exotic vegetation	<i>T. fluminensis</i> and other groundcover species.
Stream characteristics	Modal width	2 m
	Bank Condition	Slightly unstable and heavily vegetated by groundcover
	Substrate	Silt and bedrock
	Flow/depth	Moderate flow/<1 m
	Macrophytes/algae	Emergent macrophytes present – Bulrush (<i>Typha</i> sp.), <i>Cyprus</i> sp. <i>Potamogeton crispus</i>
	Water quality observations	Clear water
Comments		Weeds and rubbish. Metallic rubbish in system. Concrete rubble in system.

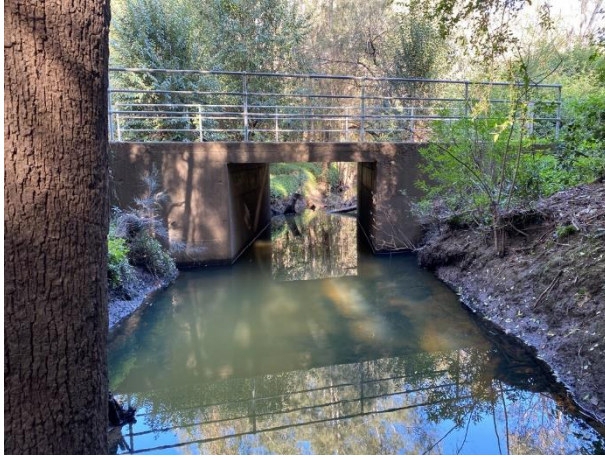
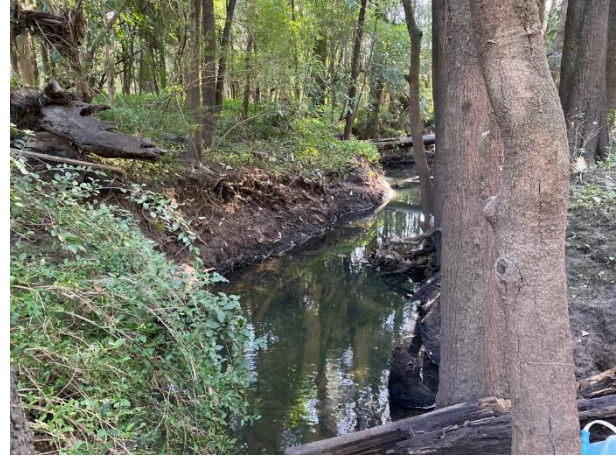
AE3: Angus Creek Downstream

Attribute	AE3 DOWNSTREAM
Riparian	Vegetation	Dominant tree species was <i>C. glauca</i>). Dominant grass/herb species was Wandering Jew (<i>T. fluminensis</i>)
	Stream shading	Moderate shading
	Exotic vegetation	<i>L. Lucidum</i> , <i>T. fluminensis</i>
Stream characteristics	Modal width	4 m
	Bank Condition	Stable, steep, exposed in sections, slight visible erosion.
	Substrate	Fine sediment, organic matter on banks
	Flow/depth	Low flow/~1 metre
	Macrophytes/algae	Ribbon Weed (<i>Vallisneria</i> sp.)
	Water quality observations	Visually water appeared slightly opaque (but within DTVs)
Comments

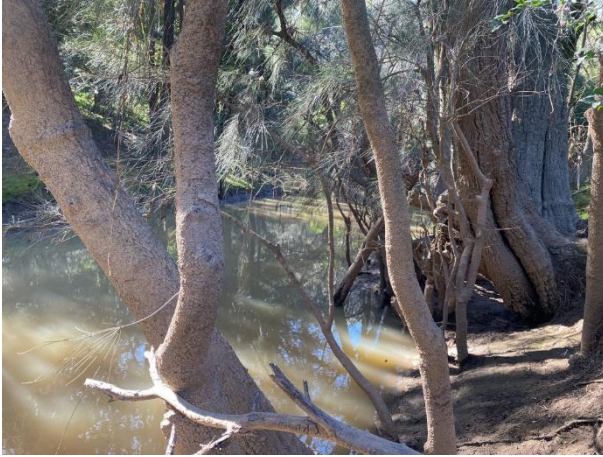
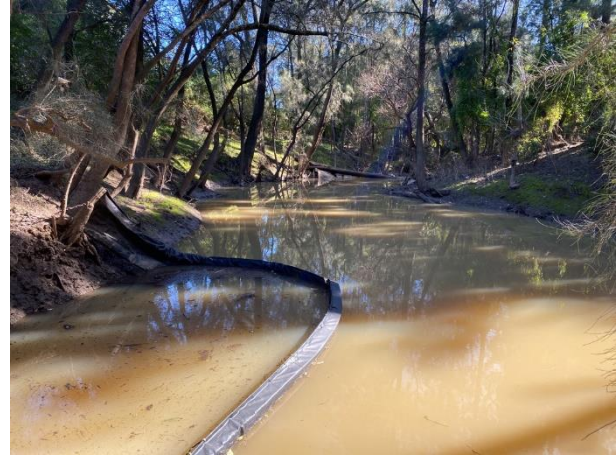
AE4: Eastern Creek Downstream

Attribute	AE4 DOWNSTREAM
Riparian	Vegetation	Dominant canopy species included <i>C. glauca</i>) and Prickly-leaved Tea Tree (<i>Melaleuca styphelioides</i>). Dominant mid-storey species were <i>C. glauca</i> <i>L. lucidum</i>). Dominant groundcover was the exotic <i>T. fluminensis</i>
	Stream shading	Moderate
	Exotic vegetation	<i>L. lucidum</i> and <i>T. fluminensis</i>
Stream characteristics	Modal width	8 m
	Bank condition	Unstable banks
	Substrate	Fine sediment
	Flow/depth	Moderate flow/>1m
	Macrophytes/algae	Macrophytes not present
	Water quality observations	Visually very turbid
Comments

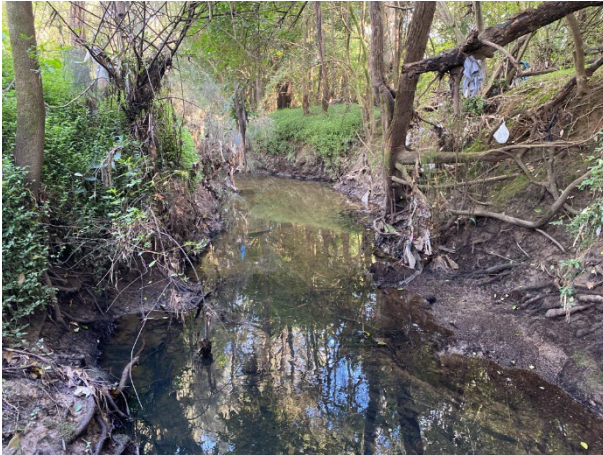
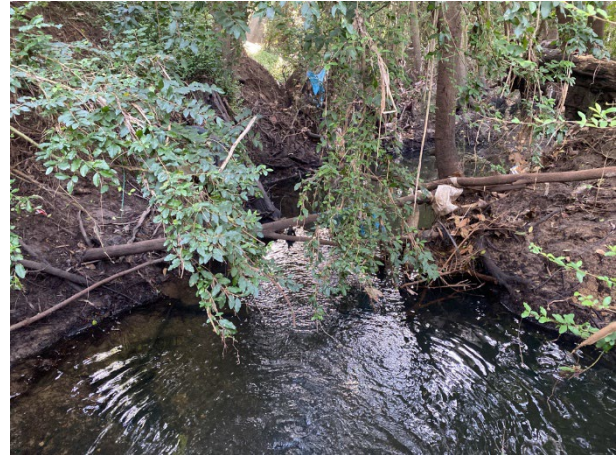
AE1: Angus Creek upstream

Attribute	AE1 UPSTREAM
Riparian	Vegetation	The dominant tree species comprised Swamp Oak (<i>Casuarina glauca</i>) and Broad-leaf Privet (<i>Ligustrum lucidum</i>). Groundcover was dominated by Trad (<i>Tradescantia fluminensis</i>).
	Stream shading	Moderate shading
	Exotic vegetation	<i>L. lucidum</i> and <i>T. fluminensis</i>
Stream characteristics	Modal width	3 metres
	Bank condition	Slightly vegetated banks, slightly unstable. Slight erosion of lower and upper bank.
	Substrate	Fine sediment; Silt. Hardened clay bottom.
	Flow/depth	Moderate Flow/ ~1 metre
	Macrophytes/algae	Macrophytes not present.
	Water quality observations	Clear water
Comments		Weeds and rubbish present.

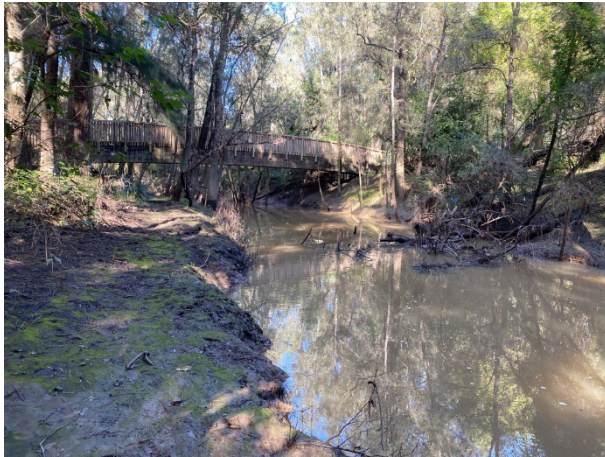
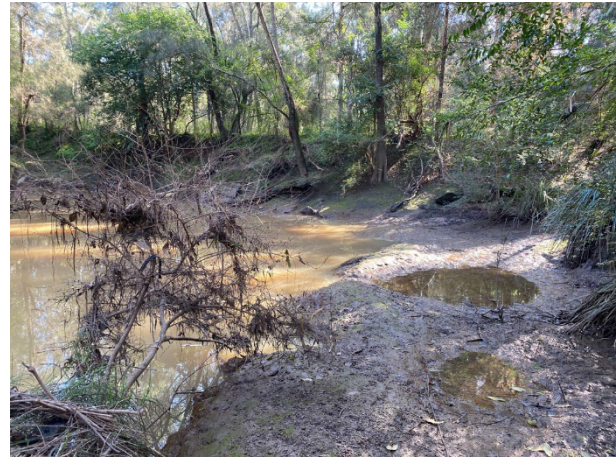
AE4: Eastern Creek downstream

Attribute	AE4 DOWNSTREAM
Riparian	Vegetation	Dominant canopy species included <i>C. glauca</i>) and Prickly-leaved Tea Tree (<i>Melaleuca styphelioides</i>). Dominant mid-storey species were <i>C. glauca</i> <i>L. lucidum</i>). Dominant groundcover was the exotic <i>T. fluminensis</i>
	Stream shading	Moderate
	Exotic vegetation	<i>L. lucidum</i> and <i>T. fluminensis</i>
Stream characteristics	Modal width	7 metres
	Bank condition	Exposed banks, erosion present. Slightly unstable
	Substrate	Fine sediment
	Flow/depth	moderate flow/>1m
	Macrophytes/algae	Macrophytes not present
	Water quality observations	Very turbid
Comments		European Carp present. Inflow from higher drainage lines

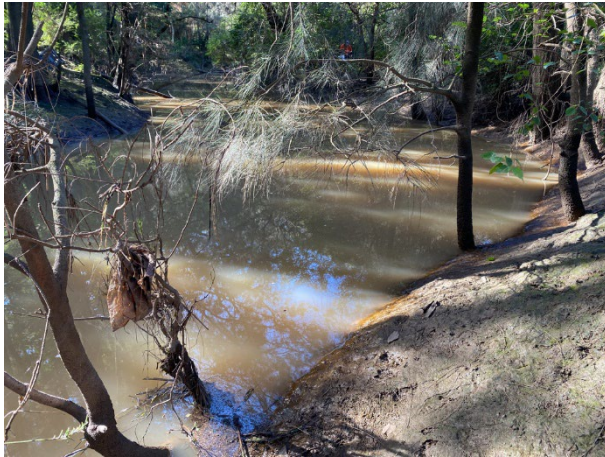
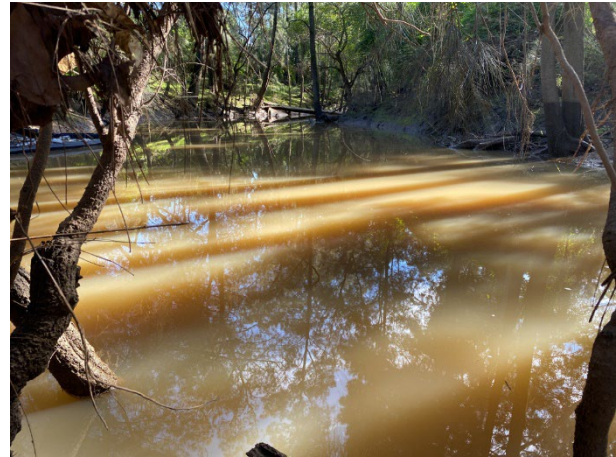
AE 5: Eastern Creek upstream

Attribute	AE5 UPSTREAM
Riparian	Vegetation	Dominant overstorey species was <i>C. glauca</i> . Dominant grass/herb was <i>Lomandra</i> (<i>Lomandra longifolia</i>) and groundcover <i>T. fluminensis</i> .
	Stream shading	Moderate
	Exotic vegetation	<i>T. fluminensis</i>
Stream characteristics	Modal width	5 metres
	Bank condition	Exposed but stable. Slight active erosion present. Flood scouring present
	Substrate	Fine sediment and large woody debris.
	Flow/depth	Moderate flow/ >1 metre
	Macrophytes/algae	Macrophytes not present.
	Water quality observations	Very turbid
Comments		Lots of large woody debris and plastic based rubbish. European Carp present.

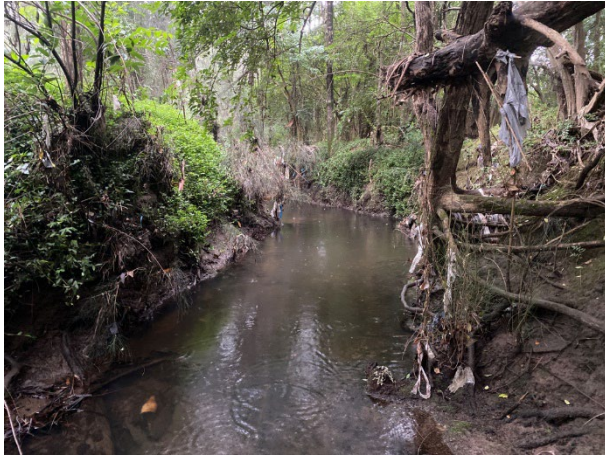
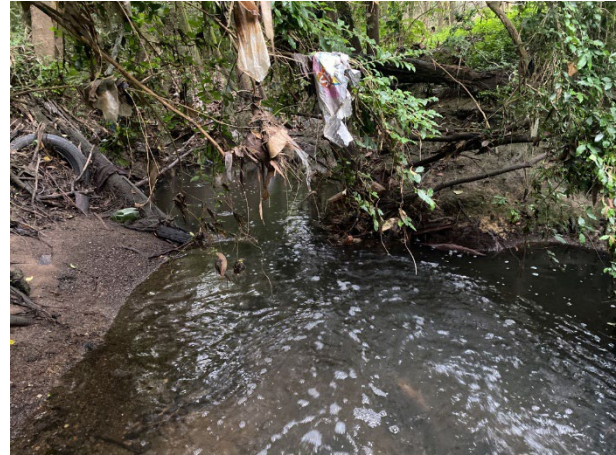
AE1: Angus Creek upstream

Attribute	AE1 UPSTREAM
Riparian	Vegetation	The dominant tree species comprised Swamp Oak (<i>Casuarina glauca</i>) and Broad-leaf Privet (<i>Ligustrum lucidum</i>). Groundcover was dominated by Wandering Jew (<i>Tradescantia fluminensis</i>).
	Stream shading	Moderate shading
	Exotic vegetation	<i>L. lucidum</i> and <i>T. fluminensis</i>
Stream characteristics	Modal width	3 m
	Bank condition	Slightly vegetated banks and stable. Slight erosion of lower bank.
	Substrate	Fine sediment; silt. Hardened clay bottom.
	Flow/depth	Moderate flow/ ~1 m
	Macrophytes/algae	Macrophytes not present.
	Water quality observations	Clear water
Comments		Weeds and rubbish present. Lack of organic material in channel.

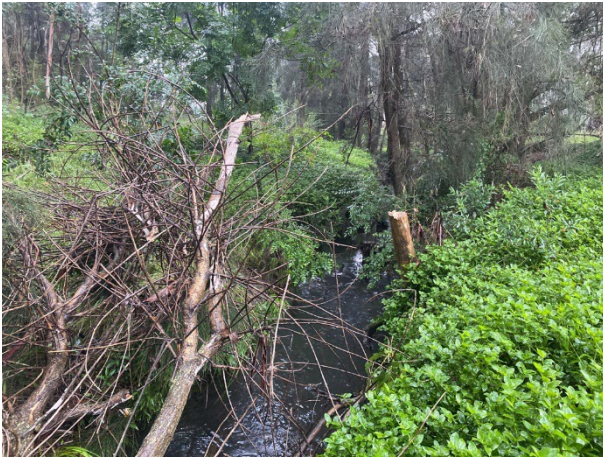
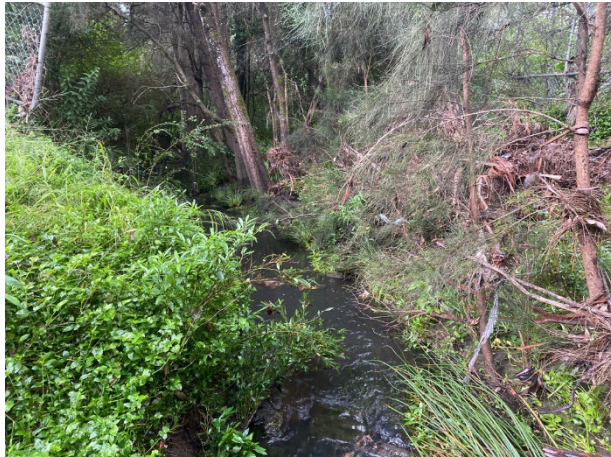
AE2: Angus Creek

Attribute	AE2 DOWNSTREAM
Riparian	Vegetation	Dominant tree species included (<i>C. glauca</i>). Dominant groundcover was (<i>T. fluminensis</i>) and mixture of exotic and native grasses and herbs.
	Stream shading	Moderate shading
	Exotic vegetation	<i>T. fluminensis</i> and other groundcover species.
Stream characteristics	Modal width	2 m
	Bank Condition	Slightly unstable and heavily vegetated by groundcover
	Substrate	Silt and bedrock
	Flow/depth	Moderate flow/<1 m
	Macrophytes/algae	Emergent macrophytes present – Bulrush (<i>Typha</i> sp.), <i>Cyprus</i> sp. <i>Potamogeton crispus</i>
	Water quality observations	Clear water
Comments		Weeds and rubbish. Metallic rubbish in system. Concrete rubble in system.

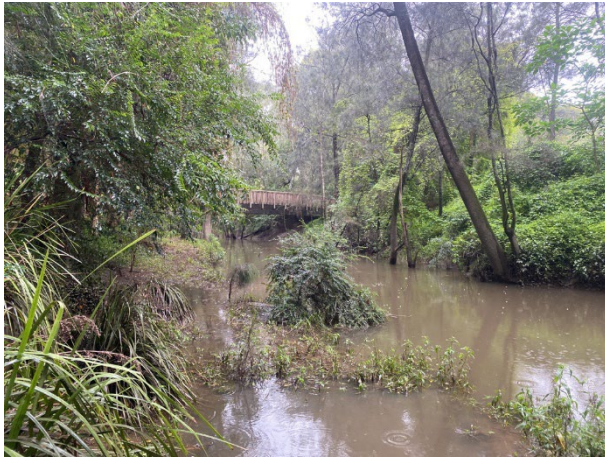
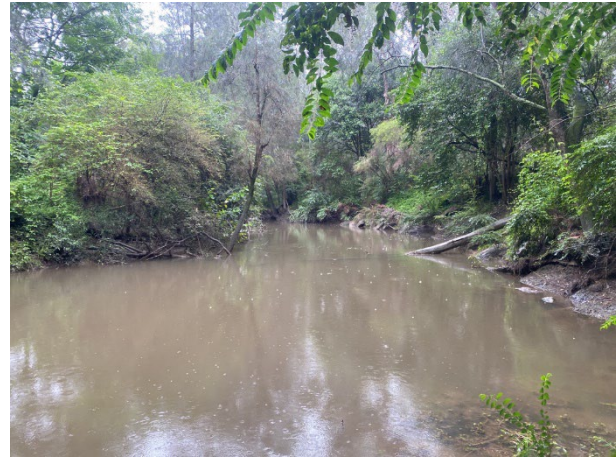
AE4: Eastern Creek downstream

Attribute	AE4 DOWNSTREAM
Riparian	Vegetation	Dominant canopy species included <i>C. glauca</i>) and Prickly-leaved Tea Tree (<i>Melaleuca styphelioides</i>). Dominant mid-storey species were <i>C. glauca</i> <i>L. lucidum</i>). Dominant groundcover was the exotic <i>T. fluminensis</i>
	Stream shading	Moderate
	Exotic vegetation	<i>L. lucidum</i> and <i>T. fluminensis</i>
Stream characteristics	Modal width	8 m
	Bank condition	Inundated banks, unstable banks
	Substrate	Fine sediment
	Flow/depth	Moderate flow/>1m
	Macrophytes/algae	Macrophytes not present
	Water quality observations	Very turbid/in flood
Comments		European Carp present.
