# **2023 Annual Review**

**1 January 2023 – 31 December 2023**

**Rooty Hill Distribution Centre**

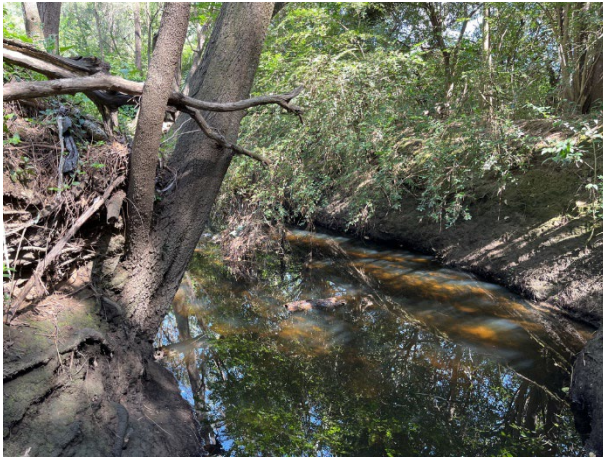
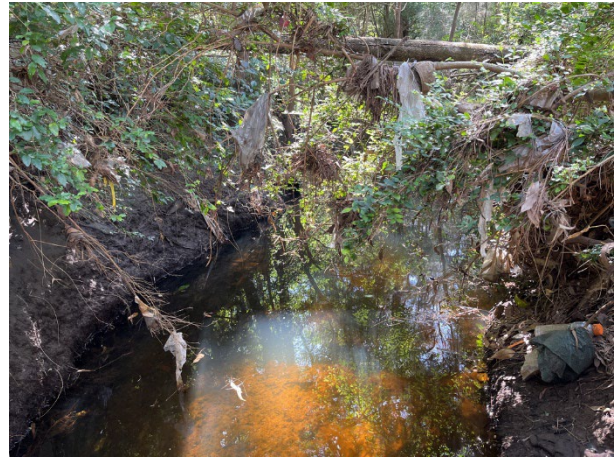
### AE1: Angus Creek Upstream

Attribute	AE1 UPSTREAM
Riparian	Vegetation	The dominant tree species comprised Swamp Oak ( <i>Casuarina glauca</i> ) and Broad-leaf Privet ( <i>Ligustrum lucidum</i> ). Groundcover was dominated by <i>Tradescantia fluminensis</i> .
	Stream shading	Moderate shading
	Exotic vegetation	<i>L. lucidum</i> and <i>T. fluminensis</i>
Stream characteristics	Modal width	3 m
	Bank condition	Slightly vegetated banks and stable. Slight erosion of lower bank.
	Substrate	Fine sediment; silt. Hardened clay bottom.
	Flow/depth	Moderate flow/ ~1 m
	Macrophytes/algae	Macrophytes not present.
	Water quality observations	Clear water
Comments		Weeds and rubbish present. Lack of organic material in channel.

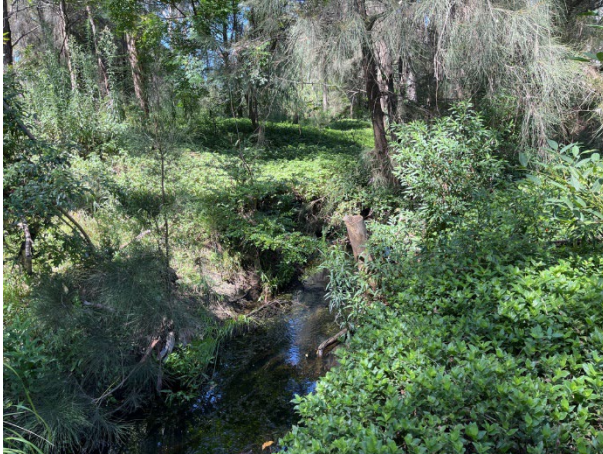
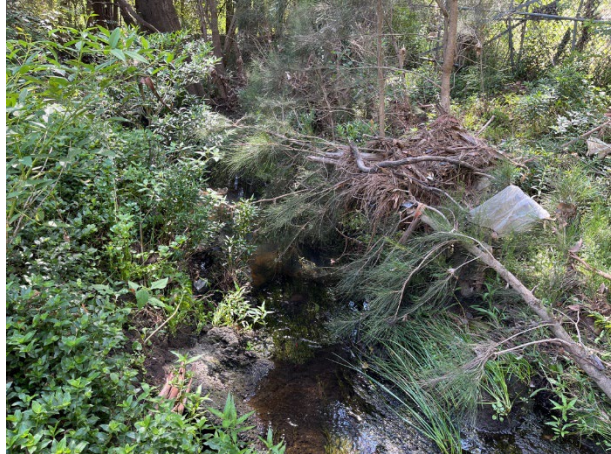
## AE2: Angus Creek

Attribute	AE2 DOWNSTREAM
Riparian	Vegetation	Dominant tree species included ( <i>C. glauca</i> ). Dominant groundcover was <i>T. fluminensis</i> and mixture of exotic and native grasses and herbs.
	Stream shading	Moderate shading
	Exotic vegetation	<i>T. fluminensis</i> and other groundcover species.
Stream characteristics	Modal width	2 m
	Bank Condition	Slightly unstable and heavily vegetated by groundcover
	Substrate	Silt and bedrock
	Flow/depth	Moderate flow/<1 m
	Macrophytes/algae	Emergent macrophytes present – Bulrush ( <i>Typha</i> sp.), <i>Cyprus</i> sp. <i>Potamogeton crispus</i>
	Water quality observations	Clear water
Comments		Weeds and rubbish. Metallic rubbish in system. Concrete rubble in system.

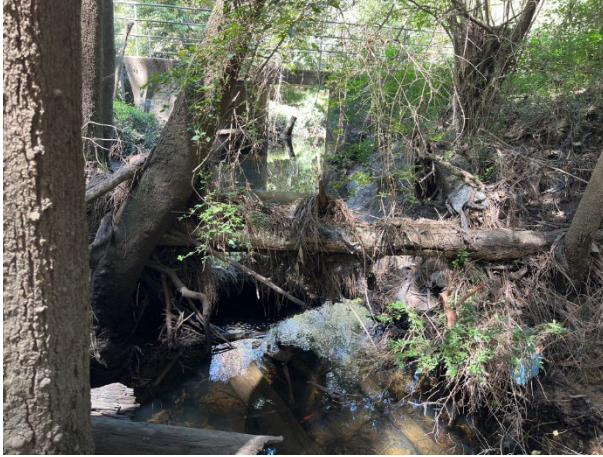
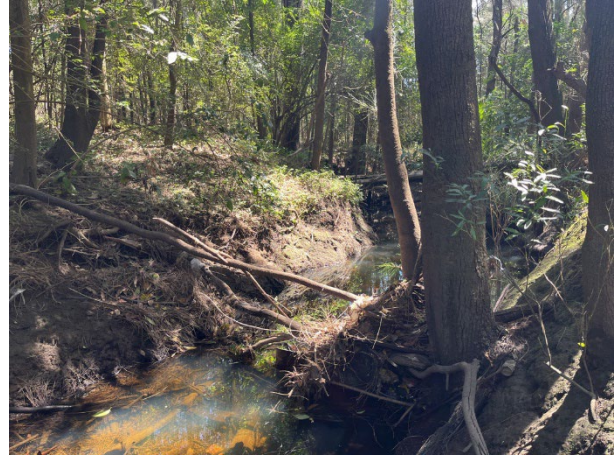
## AE3: Angus Creek Downstream

Attribute	AE3 DOWNSTREAM
Riparian	Vegetation	Dominant tree species was <i>C. glauca</i> ). Dominant grass/herb species was Wandering Jew ( <i>T. fluminensis</i> )
	Stream shading	Moderate shading
	Exotic vegetation	<i>L. Lucidum</i> , <i>T. fluminensis</i>
Stream characteristics	Modal width	4 m
	Bank Condition	Stable, steep, exposed in sections, slight visible erosion.
	Substrate	Fine sediment, organic matter on banks
	Flow/depth	Low flow/~1 metre
	Macrophytes/algae	Ribbon Weed ( <i>Vallisneria</i> sp.)
	Water quality observations	Visually water appeared slightly opaque (but within DTVs)
Comments		Significant amount of plastic based rubbish in stream

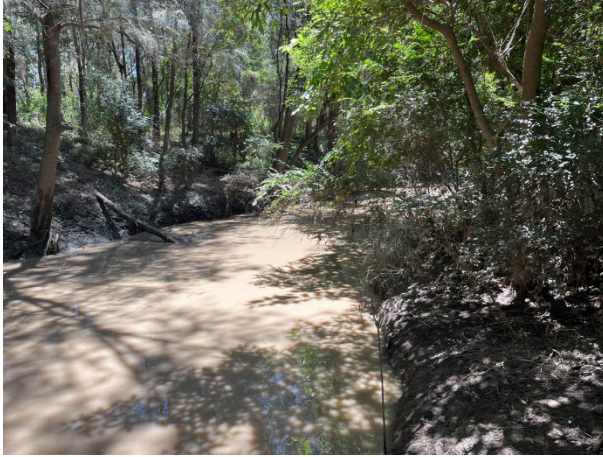
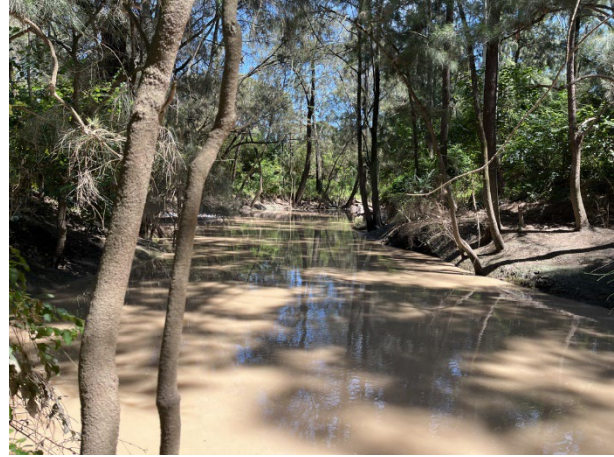
## AE4: Eastern Creek Downstream

Attribute	AE4 DOWNSTREAM
Riparian	Vegetation	Dominant canopy species included <i>C. glauca</i> ) and Prickly-leaved Tea Tree ( <i>Melaleuca styphelioides</i> ). Dominant mid-storey species were <i>C. glauca</i> <i>L. lucidum</i> ). Dominant groundcover was the exotic <i>T. fluminensis</i>
	Stream shading	Moderate
	Exotic vegetation	<i>L. lucidum</i> and <i>T. fluminensis</i>
Stream characteristics	Modal width	8 m
	Bank condition	Unstable banks
	Substrate	Fine sediment
	Flow/depth	Moderate flow/>1m
	Macrophytes/algae	Macrophytes not present
	Water quality observations	Visually very turbid (above DTVs)
Comments

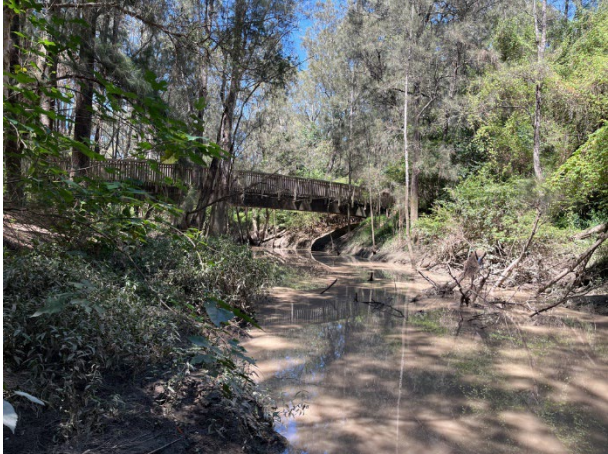
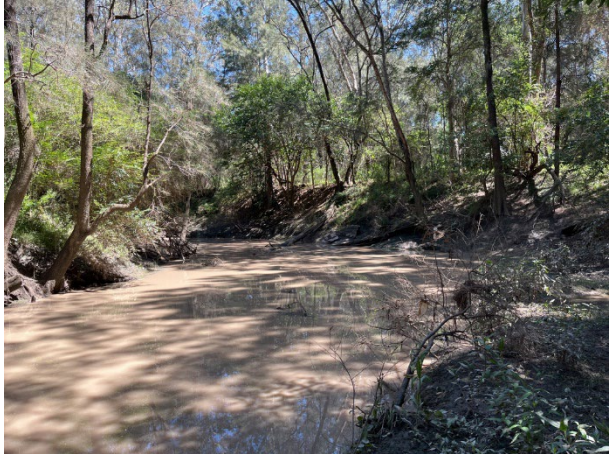
AE 5: Eastern Creek Upstream

Attribute	AE5 UPSTREAM
Riparian	Vegetation	Dominant overstorey species was <i>C. glauca</i> . Dominant grass/herb was Lomandra ( <i>Lomandra longifolia</i> ) and groundcover <i>T. fluminensis</i> .
	Stream shading	Moderate
	Exotic vegetation	<i>T. fluminensis</i>
Stream characteristics	Modal width	12 m
	Bank condition	Unstable
	Substrate	Fine sediment and large woody debris.
	Flow/depth	Moderate flow/ >1 m
	Macrophytes/algae	Macrophytes not present.
	Water quality observations	Visually very turbid (Above DTVs)
Comments		Lots of large woody debris and plastic based rubbish

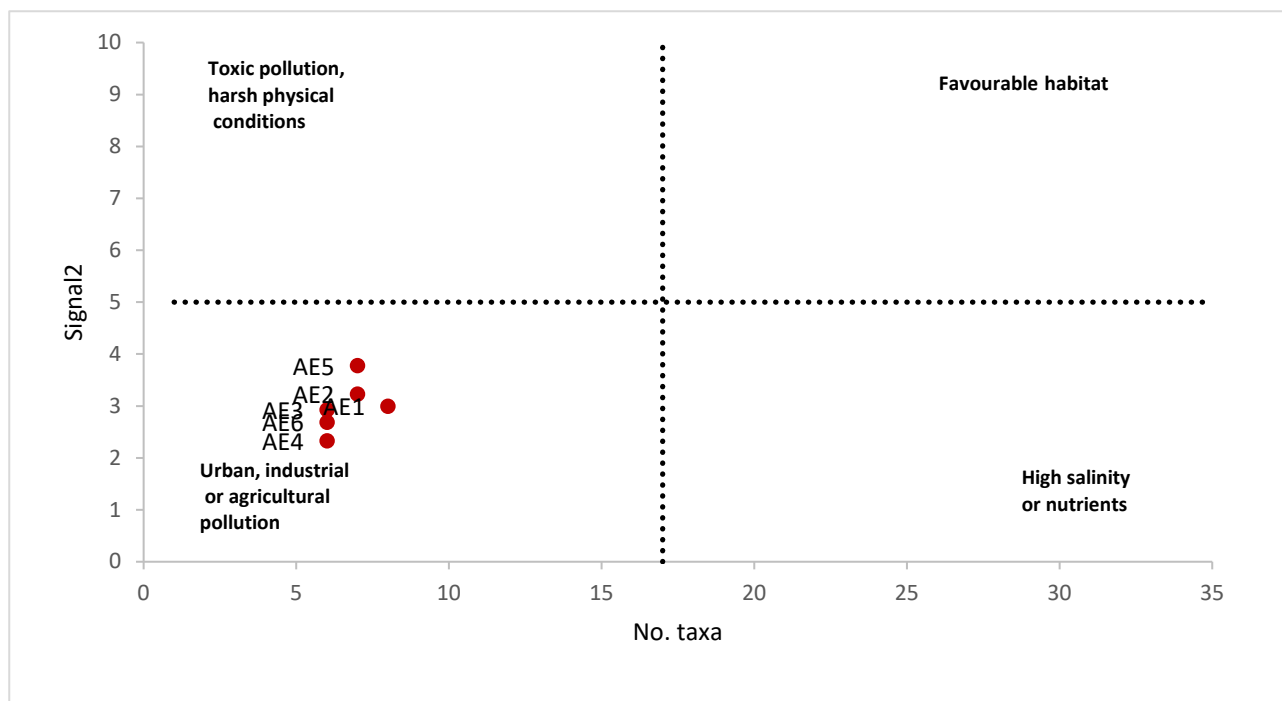
**Figure 3: SIGNAL2 score and number of taxa bi-plot.**

Site	Number of taxa	SIGNAL2 weighted scores
AE1	8	3.00
AE2	7	3.23
AE3	6	2.93
AE4	6	2.33
AE5	7	3.78
AE6	6	2.69

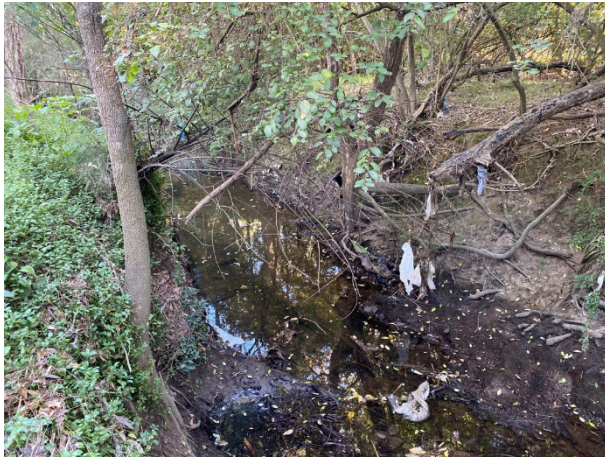
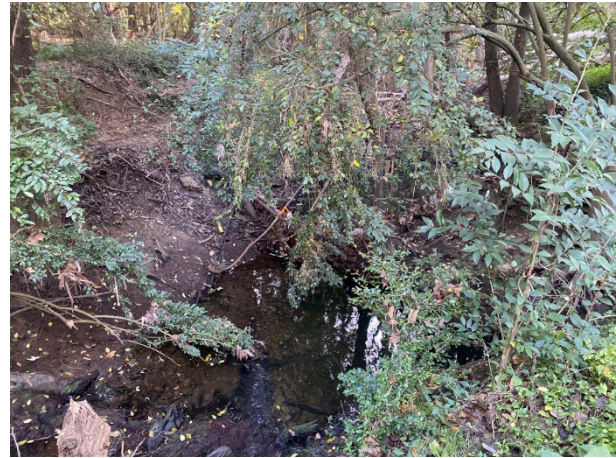
### AE1: Angus Creek Upstream

Attribute	AE1 UPSTREAM
Riparian	Vegetation	The dominant tree species comprised Swamp Oak ( <i>Casuarina glauca</i> ) and Broad-leaf Privet ( <i>Ligustrum lucidum</i> ). Groundcover was dominated by <i>T. fluminensis</i> .
	Stream shading	Moderate shading
	Exotic vegetation	<i>L. lucidum</i> and <i>T. fluminensis</i>
Stream characteristics	Modal width	3 m
	Bank condition	Slightly vegetated banks and stable. Slight erosion and undercutting of lower bank.
	Substrate	Fine sediment; silt. Hardened clay bottom.
	Flow/depth	Moderate flow/ <1 m
	Macrophytes/algae	Macrophytes not present.
	Water quality observations	Clear water
Comments		Weeds and rubbish present. Lack of organic material in channel.

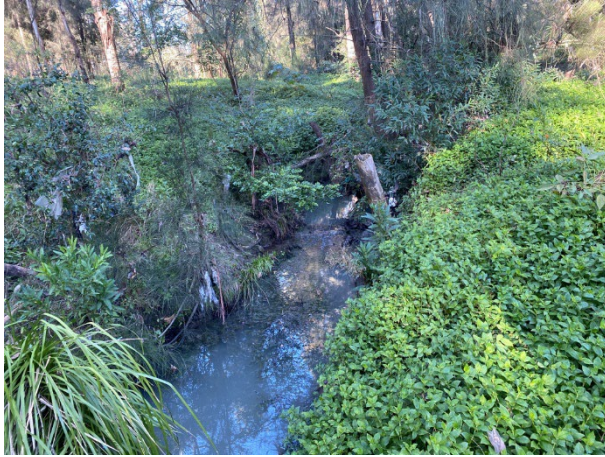
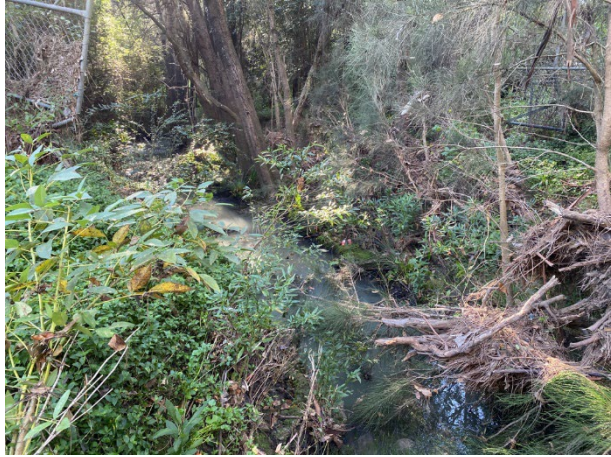
## AE2: Angus Creek

Attribute	AE2 DOWNSTREAM
<b>Riparian</b>	Vegetation	Dominant tree species included ( <i>C. glauca</i> ). Dominant groundcover was <i>T. fluminensis</i> and mixture of exotic and native grasses and herbs.
	Stream shading	Moderate shading
	Exotic vegetation	<i>T. fluminensis</i> and other groundcover species.
<b>Stream characteristics</b>	Modal width	2 m
	Bank Condition	Slightly unstable and heavily vegetated by groundcover
	Substrate	Silt and bedrock / concrete
	Flow/depth	Moderate flow/<1 m
	Macrophytes/algae	Emergent macrophytes present – Bulrush ( <i>Typha</i> sp.), <i>Cyprus</i> sp. <i>Potamogeton crispus</i>
	Water quality observations	Water was cloudy and opaque
<b>Comments</b>		Weeds and rubbish. Metallic rubbish in system. Concrete rubble in system.

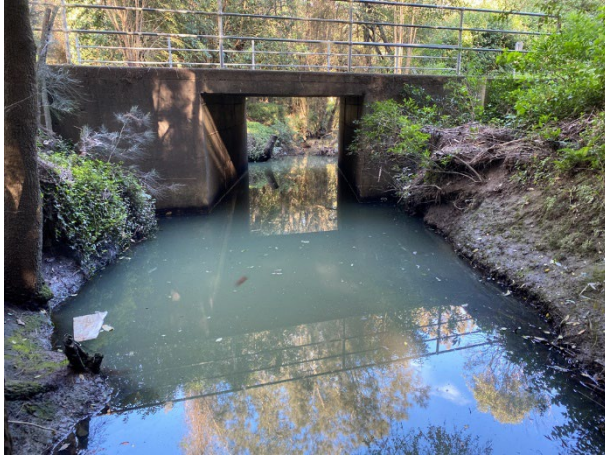
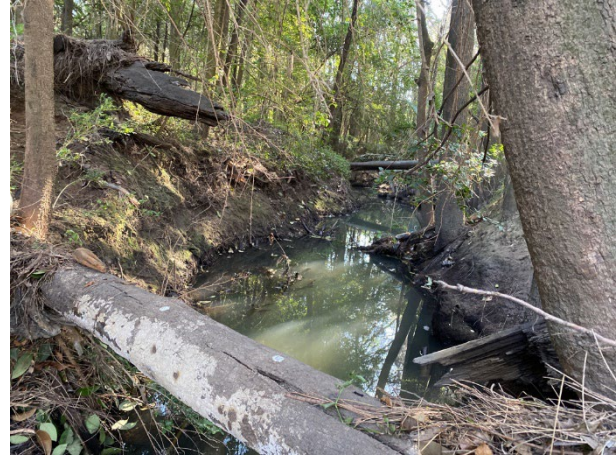
## AE3: Angus Creek Downstream

Attribute	AE3 DOWNSTREAM
<b>Riparian</b>	Vegetation	Dominant tree species was <i>C. glauca</i> ). Dominant grass/herb species was <i>T. fluminensis</i>
	Stream shading	Moderate shading
	Exotic vegetation	<i>L. Lucidum</i> , <i>T. fluminensis</i>
<b>Stream characteristics</b>	Modal width	4 m
	Bank Condition	Stable, steep, exposed in sections, slight visible erosion.
	Substrate	Fine sediment, organic matter on banks
	Flow/depth	Low flow/<1 metre
	Macrophytes/algae	Ribbon Weed ( <i>Vallisneria</i> sp.)
	Water quality observations	Visually water appeared slightly opaque (but within DTVs)
<b>Comments</b>		Dense organic matter in middle of pool.

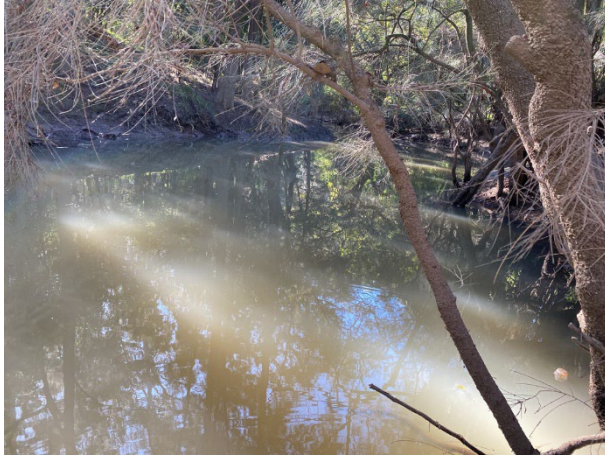
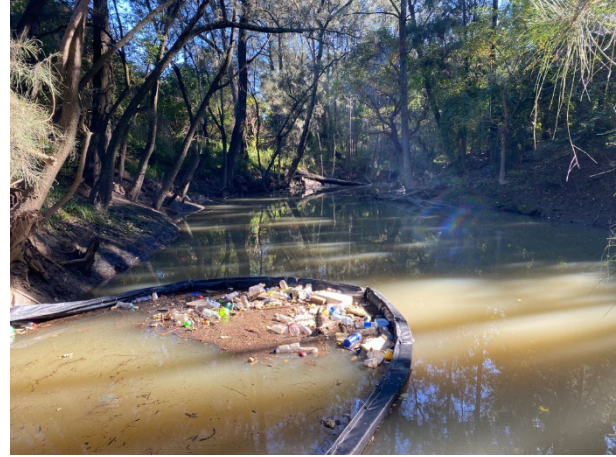
## AE4: Eastern Creek Downstream

Attribute	AE4 DOWNSTREAM
Riparian	Vegetation	Dominant canopy species included <i>C. glauca</i> ) and Prickly-leaved Tea Tree ( <i>Melaleuca styphelioides</i> ). Dominant mid-storey species were <i>C. glauca</i> <i>L. lucidum</i> ). Dominant groundcover was the exotic <i>T. fluminensis</i>
	Stream shading	Moderate
	Exotic vegetation	<i>L. lucidum</i> and <i>T. fluminensis</i>
Stream characteristics	Modal width	8 m
	Bank condition	Unstable banks
	Substrate	Fine sediment
	Flow/depth	Moderate flow/<1m
	Macrophytes/algae	Macrophytes not present
	Water quality observations	Visually very turbid
Comments

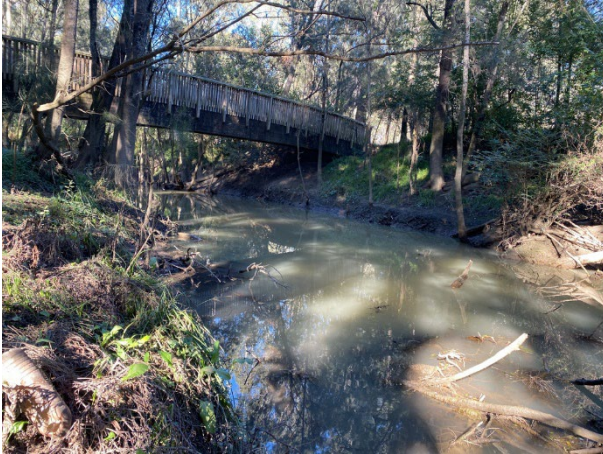
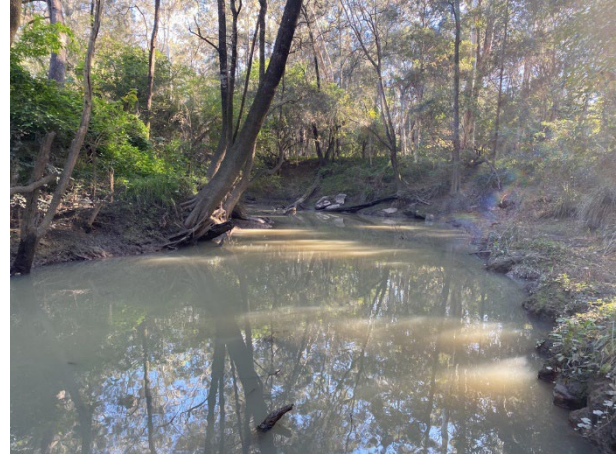
## AE 5: Eastern Creek Upstream

Attribute	AE5 UPSTREAM
Riparian	Vegetation	Dominant overstorey species was <i>C. glauca</i> . Dominant grass/herb was <i>Lomandra</i> ( <i>Lomandra longifolia</i> ) and groundcover <i>T. fluminensis</i> .
	Stream shading	Moderate
	Exotic vegetation	<i>T. fluminensis</i>
Stream characteristics	Modal width	12 m
	Bank condition	Unstable
	Substrate	Fine sediment and large woody debris.
	Flow/depth	Moderate flow/ <1 m
	Macrophytes/algae	Macrophytes not present.
	Water quality observations	Visually very turbid
Comments		Lots of large woody debris and plastic based rubbish

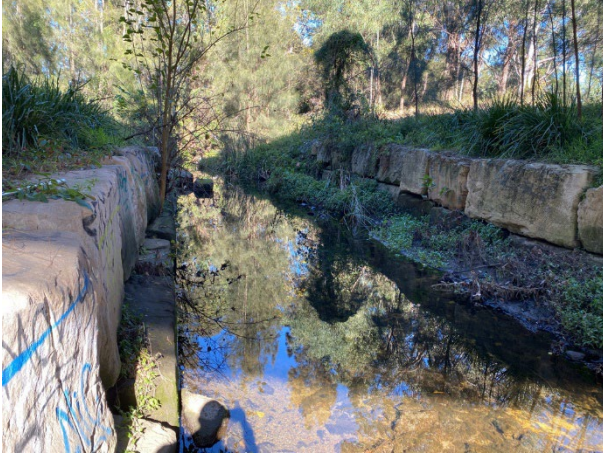
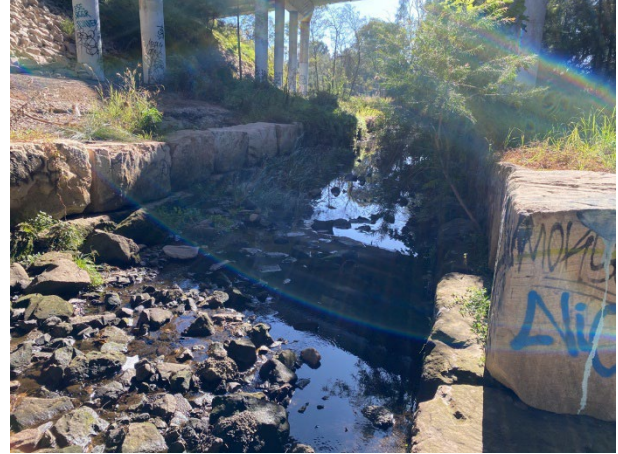
## AE 6: Angus Creek Upstream

Attribute	AE5 UPSTREAM
Riparian	Vegetation	Dominant overstorey species was <i>C. glauca</i> . Dominant grass/herb was <i>Lomandra</i> ( <i>Lomandra longifolia</i> ) and groundcover <i>T. fluminensis</i> .
	Stream shading	Moderate
	Exotic vegetation	<i>T. fluminensis</i>
Stream characteristics	Modal width	4 m
	Bank condition	Stable (Artificial)
	Substrate	Fine sediment and cobble
	Flow/depth	Moderate flow/ <1 m
	Macrophytes/algae	Macrophytes and algae
	Water quality observations	Clear
Comments

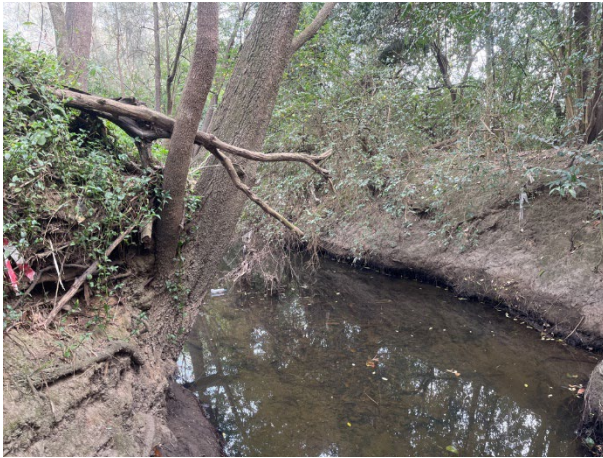
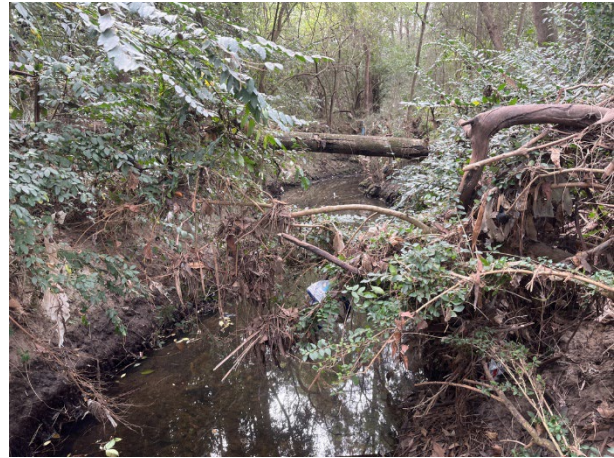
### AE1: Angus Creek Upstream

Attribute	AE1 UPSTREAM
Riparian	Vegetation	The dominant tree species comprised Swamp Oak ( <i>Casuarina glauca</i> ) and Broad-leaf Privet ( <i>Ligustrum lucidum</i> ). Groundcover was dominated by <i>Tradescantia fluminensis</i> .
	Stream shading	Moderate shading
	Exotic vegetation	<i>L. lucidum</i> and <i>T. fluminensis</i>
Stream characteristics	Modal width	3 m
	Bank condition	Slightly vegetated banks and stable. Slight erosion of lower bank.
	Substrate	Fine sediment; silt. Hardened clay bottom.
	Flow/depth	Moderate flow/ ~1 m
	Macrophytes/algae	Macrophytes not present.
	Water quality observations	Clear water
Comments		Weeds and rubbish present. Lack of organic material in channel.

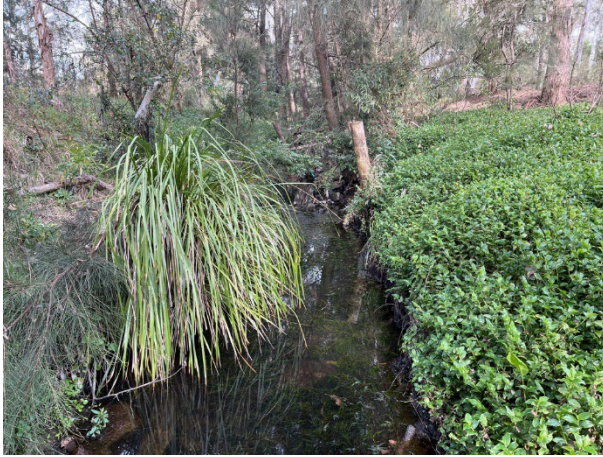
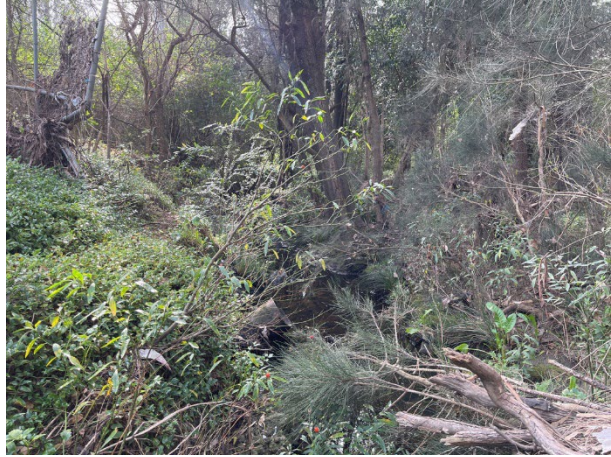
## AE2: Angus Creek

Attribute	AE2 DOWNSTREAM
Riparian	Vegetation	Dominant tree species included ( <i>C. glauca</i> ). Dominant groundcover was <i>T. fluminensis</i> and mixture of exotic and native grasses and herbs.
	Stream shading	Moderate shading
	Exotic vegetation	<i>T. fluminensis</i> and other groundcover species.
Stream characteristics	Modal width	2 m
	Bank Condition	Slightly unstable and heavily vegetated by groundcover
	Substrate	Silt and bedrock
	Flow/depth	Moderate flow/<1 m
	Macrophytes/algae	Emergent macrophytes present – Bulrush ( <i>Typha</i> sp.), <i>Cyprus</i> sp. <i>Potamogeton crispus</i>
	Water quality observations	Clear water
Comments		Weeds and rubbish. Metallic rubbish in system. Concrete rubble in system.

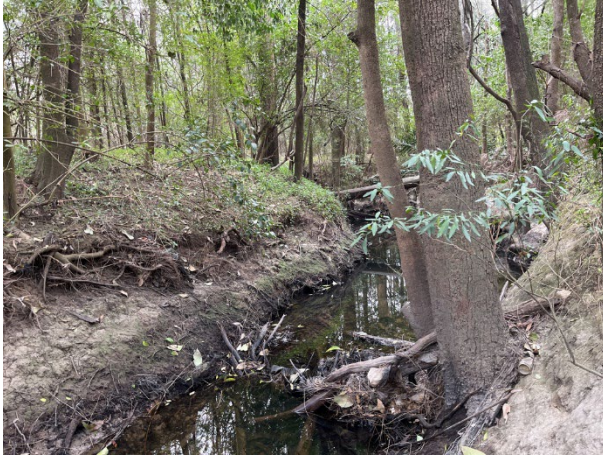
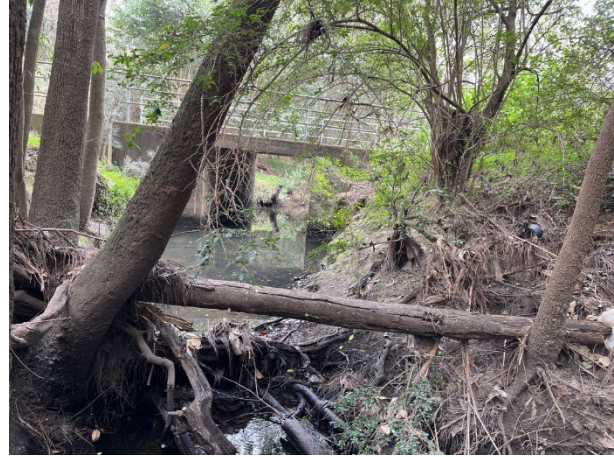
## AE3: Angus Creek Downstream

Attribute	AE3 DOWNSTREAM
Riparian	Vegetation	Dominant tree species was <i>C. glauca</i> ). Dominant grass/herb species was Wandering Jew ( <i>T. fluminensis</i> )
	Stream shading	Moderate shading
	Exotic vegetation	<i>L. Lucidum</i> , <i>T. fluminensis</i>
Stream characteristics	Modal width	4 m
	Bank Condition	Stable, steep, exposed in sections, slight visible erosion.
	Substrate	Fine sediment, organic matter on banks
	Flow/depth	Low flow/~1 metre
	Macrophytes/algae	Ribbon Weed ( <i>Vallisneria</i> sp.)
	Water quality observations	Visually water appeared slightly opaque (but within DTVs)
Comments		Significant amount of plastic based rubbish in stream

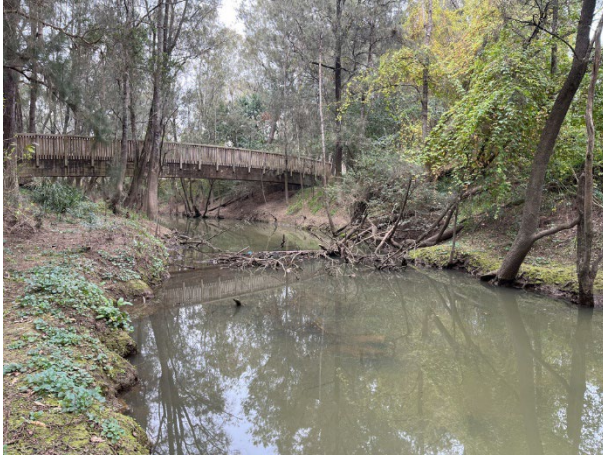
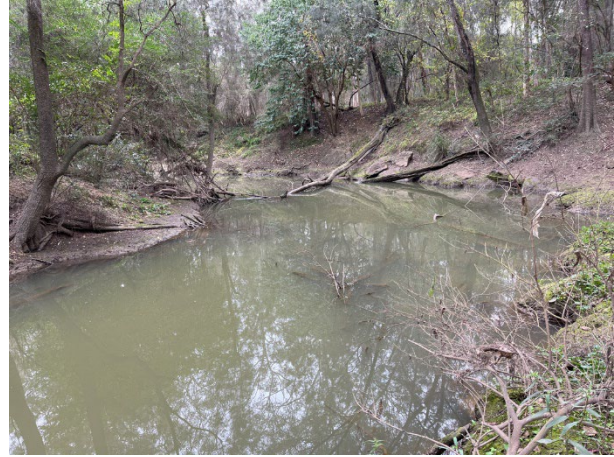
## AE4: Eastern Creek Downstream

Attribute	AE4 DOWNSTREAM
Riparian	Vegetation	Dominant canopy species included <i>C. glauca</i> ) and Prickly-leaved Tea Tree ( <i>Melaleuca styphelioides</i> ). Dominant mid-storey species were <i>C. glauca</i> <i>L. lucidum</i> ). Dominant groundcover was the exotic <i>T. fluminensis</i>
	Stream shading	Moderate
	Exotic vegetation	<i>L. lucidum</i> and <i>T. fluminensis</i>
Stream characteristics	Modal width	8 m
	Bank condition	Unstable banks
	Substrate	Fine sediment
	Flow/depth	Moderate flow/>1m
	Macrophytes/algae	Macrophytes not present
	Water quality observations	Visually Turbid (Although within DTV's)
Comments

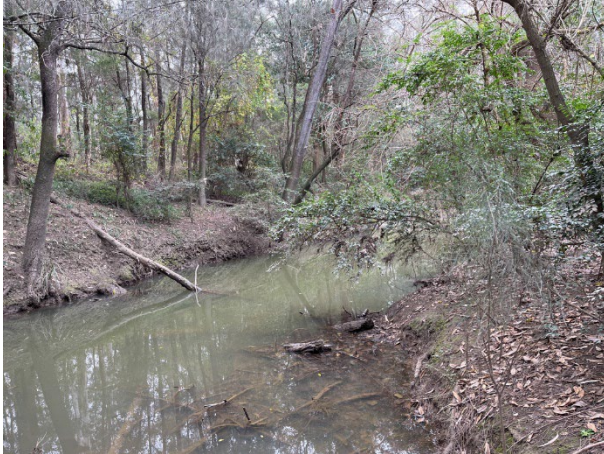
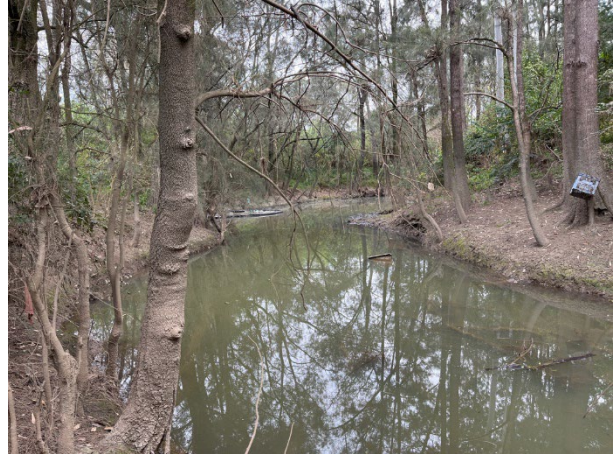
## AE 5: Eastern Creek Upstream

Attribute	AE5 UPSTREAM
Riparian	Vegetation	Dominant overstorey species was <i>C. glauca</i> . Dominant grass/herb was <i>Lomandra</i> ( <i>Lomandra longifolia</i> ) and groundcover <i>T. fluminensis</i> .
	Stream shading	Moderate
	Exotic vegetation	<i>T. fluminensis</i>
Stream characteristics	Modal width	12 m
	Bank condition	Unstable
	Substrate	Fine sediment and large woody debris.
	Flow/depth	Moderate flow/ >1 m
	Macrophytes/algae	Macrophytes not present.
	Water quality observations	Visually turbid (although with DTV's)
Comments		Lots of large woody debris and plastic based rubbish

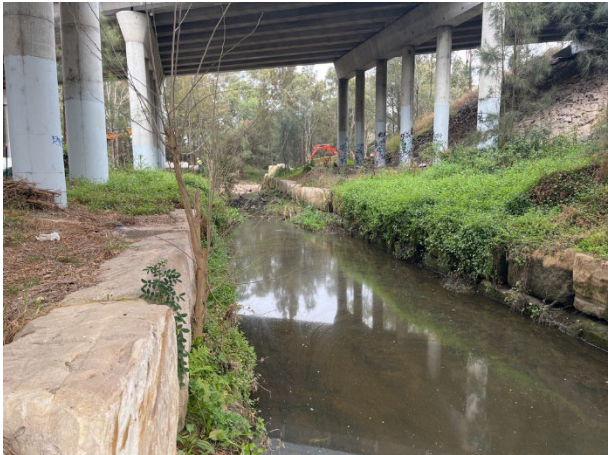
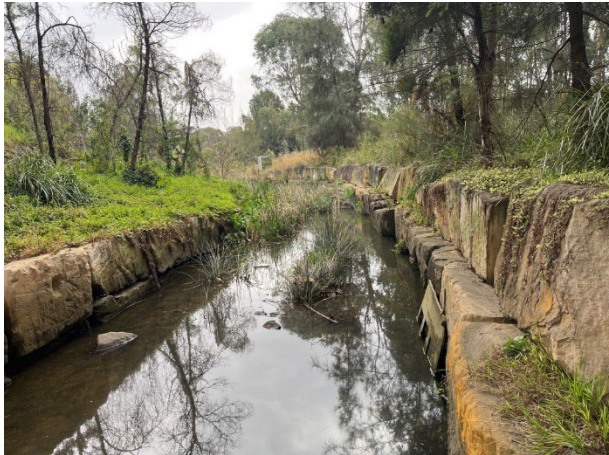
AE 6: Angus creek Upstream

Attribute	AE5 UPSTREAM
Riparian	Vegetation	Dominant overstorey species was <i>C. glauca</i> . Dominant grass/herb was Lomandra ( <i>Lomandra longifolia</i> ) and groundcover <i>T. fluminensis</i> .
	Stream shading	Moderate
	Exotic vegetation	<i>T. fluminensis</i>
Stream characteristics	Modal width	12 m
	Bank condition	Unstable
	Substrate	Fine sediment and large woody debris.
	Flow/depth	Moderate flow/ >1 m
	Macrophytes/algae	Macrophytes not present.
	Water quality observations	Clear
Comments		Lots of large woody debris and plastic based rubbish

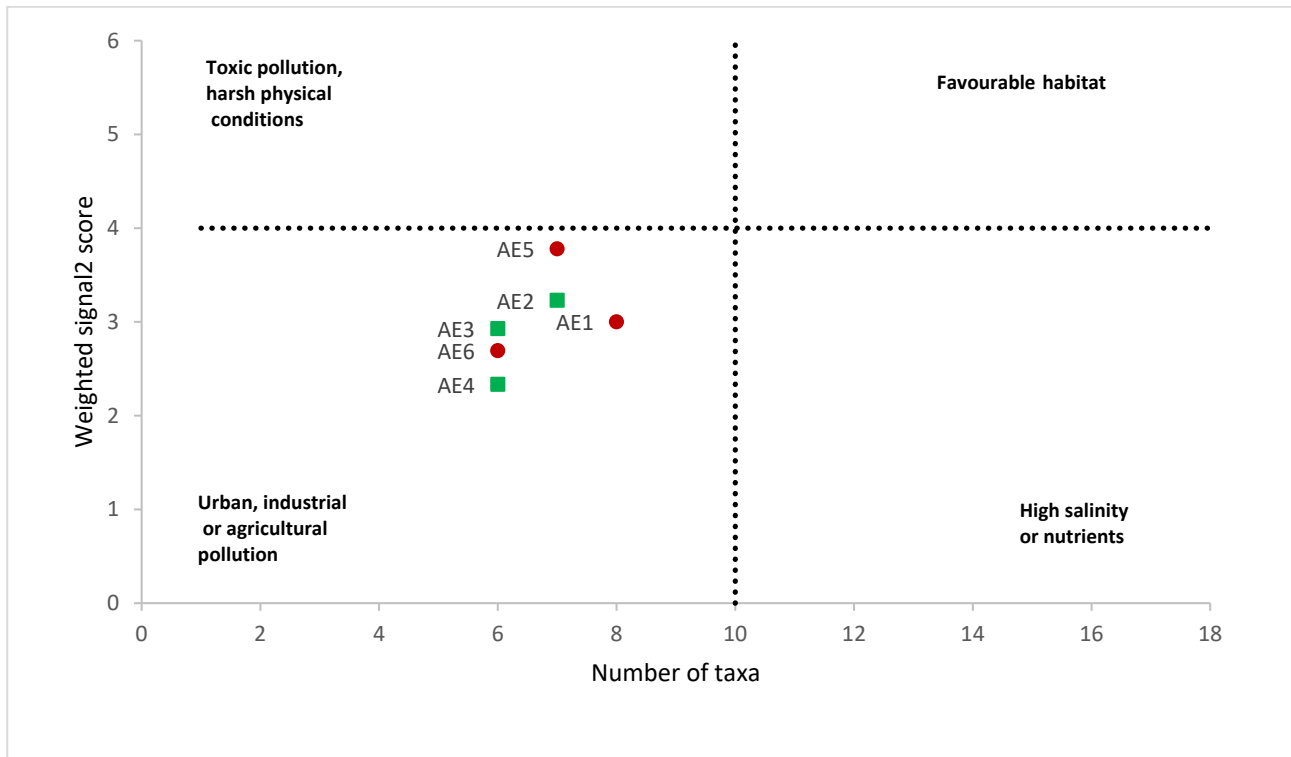
Figure 3: SIGNAL2 score and number of taxa bi-plot.

The SIGNAL2 bi-plot (Figure 3), indicates that no sites have favourable habitat and all locations are exhibiting some form of pollution or natural stress. Control site AE1 (Angus Creek) recorded the highest SIGNAL2 score of any site from both creeks, but is still considered a low score. (Table 6). The results are observed to cluster together, suggesting relatively consistent conditions across the sites.

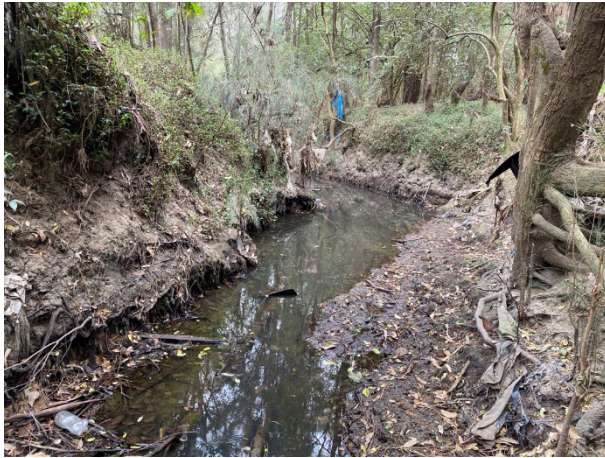
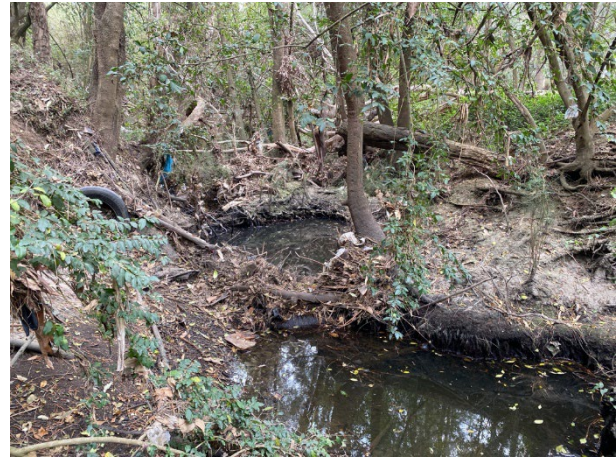
### AE1: Angus Creek Upstream

Attribute	AE1 UPSTREAM
Riparian	Vegetation	The dominant tree species comprised Swamp Oak ( <i>Casuarina glauca</i> ) and Broad-leaf Privet ( <i>Ligustrum lucidum</i> ). Groundcover was dominated by <i>T. fluminensis</i> .
	Stream shading	Moderate shading
	Exotic vegetation	<i>L. lucidum</i> and <i>T. fluminensis</i>
Stream characteristics	Modal width	3 m
	Bank condition	Slightly vegetated banks and stable. Slight erosion and undercutting of lower bank.
	Substrate	Fine sediment; silt. Hardened clay bottom.
	Flow/depth	Moderate flow/ <1 m
	Macrophytes/algae	Macrophytes not present.
	Water quality observations	Clear water
Comments		Weeds and rubbish present.

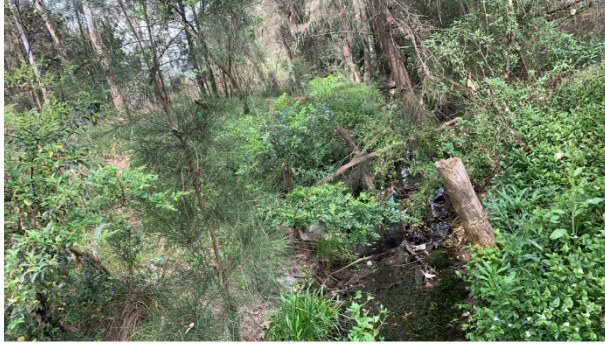
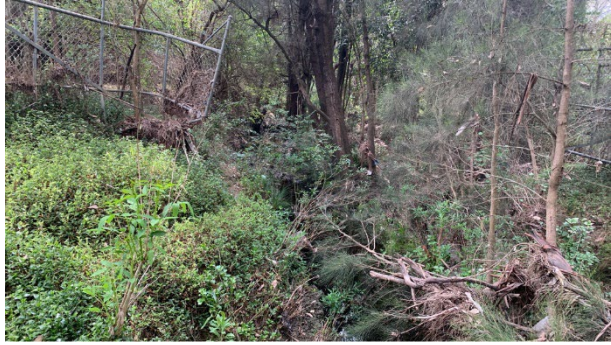
## AE2: Angus Creek

Attribute	AE2 DOWNSTREAM
Riparian	Vegetation	Dominant tree species included ( <i>C. glauca</i> ). Dominant groundcover was <i>T. fluminensis</i> and mixture of exotic and native grasses and herbs.
	Stream shading	Moderate shading
	Exotic vegetation	<i>T. fluminensis</i> and other groundcover species.
Stream characteristics	Modal width	2 m
	Bank Condition	Slightly unstable and heavily vegetated by groundcover
	Substrate	Silt and bedrock / concrete
	Flow/depth	Moderate flow/<1 m
	Macrophytes/algae	Emergent macrophytes present – Bulrush ( <i>Typha</i> sp.), <i>Cyprus</i> sp. <i>Potamogeton crispus</i>
	Water quality observations	Water was cloudy and opaque
Comments		Weeds and rubbish. Metallic rubbish in system. Concrete rubble in system.

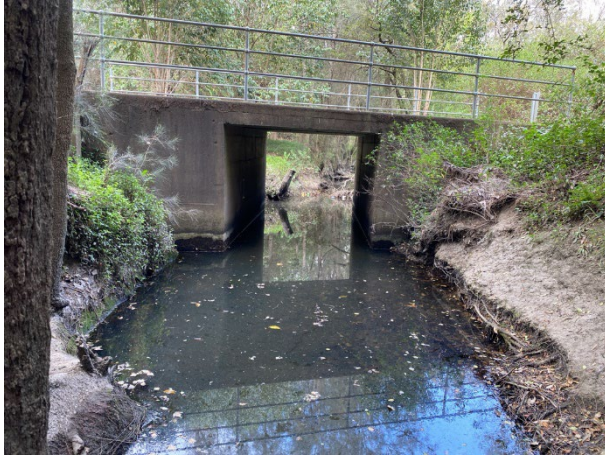
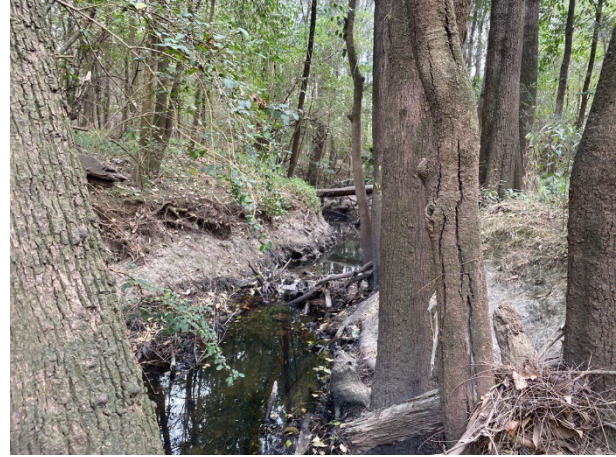
## AE3: Angus Creek Downstream

Attribute	AE3 DOWNSTREAM
Riparian	Vegetation	Dominant tree species was <i>C. glauca</i> ). Dominant grass/herb species was <i>T. fluminensis</i>
	Stream shading	Moderate shading
	Exotic vegetation	<i>L. Lucidum</i> , <i>T. fluminensis</i>
Stream characteristics	Modal width	4 m
	Bank Condition	Stable, steep, exposed in sections, slight visible erosion.
	Substrate	Fine sediment, organic matter on banks
	Flow/depth	Low flow/<1 metre
	Macrophytes/algae	Ribbon Weed ( <i>Vallisneria</i> sp.)
	Water quality observations	
Comments		Dense organic matter in middle of pool.

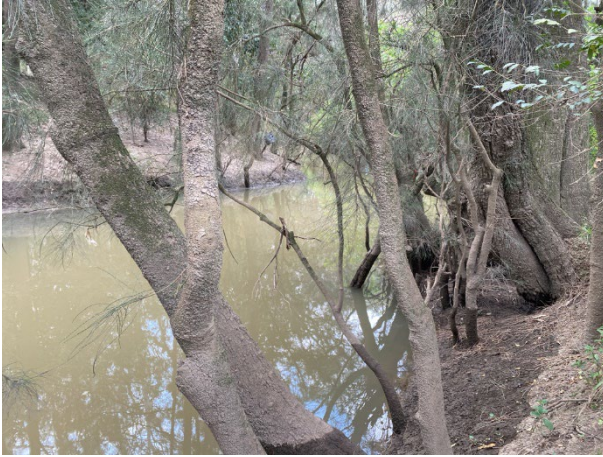
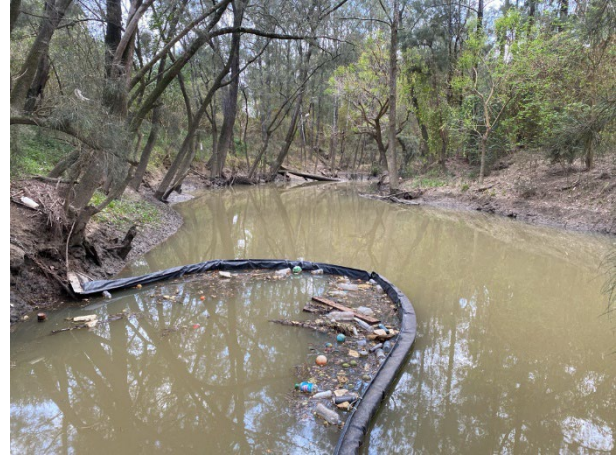
## AE4: Eastern Creek Downstream

Attribute	AE4 DOWNSTREAM
Riparian	Vegetation	Dominant canopy species included <i>C. glauca</i> ) and Prickly-leaved Tea Tree ( <i>Melaleuca styphelioides</i> ). Dominant mid-storey species were <i>C. glauca</i> <i>L. lucidum</i> ). Dominant groundcover was the exotic <i>T. fluminensis</i>
	Stream shading	Moderate
	Exotic vegetation	<i>L. lucidum</i> and <i>T. fluminensis</i>
Stream characteristics	Modal width	8 m
	Bank condition	Unstable banks
	Substrate	Fine sediment
	Flow/depth	Moderate flow/<1m
	Macrophytes/algae	Macrophytes not present
	Water quality observations	Visually very turbid
Comments

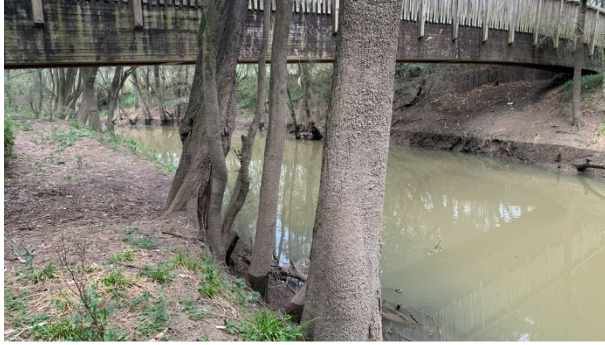
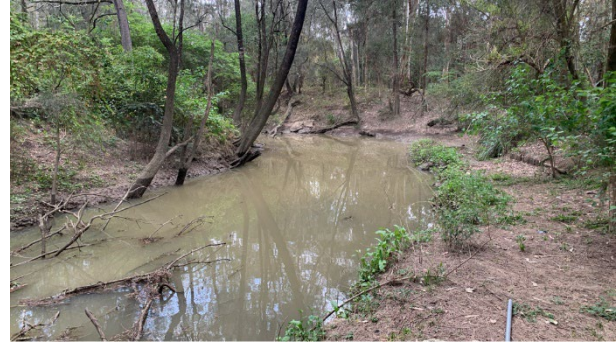
## AE 5: Eastern Creek Upstream

A: Upstream

B: Downstream

Attribute	AE5 UPSTREAM
Riparian	Vegetation	Dominant overstorey species was <i>C. glauca</i> . Dominant grass/herb was <i>Lomandra</i> ( <i>Lomandra longifolia</i> ) and groundcover <i>T. fluminensis</i> .
	Stream shading	Moderate
	Exotic vegetation	<i>T. fluminensis</i>
Stream characteristics	Modal width	12 m
	Bank condition	Unstable
	Substrate	Fine sediment and large woody debris.
	Flow/depth	Moderate flow/ <1 m
	Macrophytes/algae	Macrophytes not present.
	Water quality observations	Visually very turbid
Comments		Lots of large woody debris and plastic based rubbish

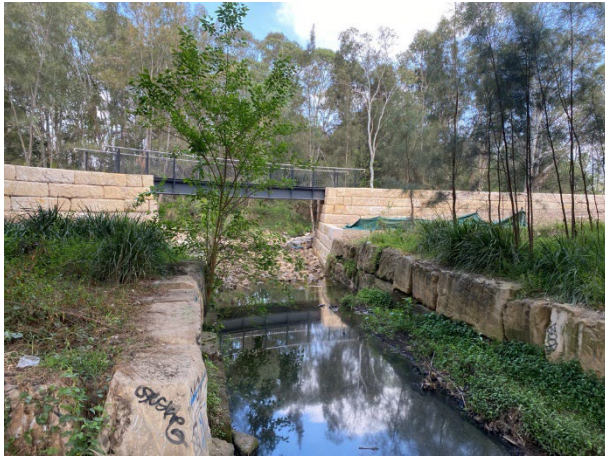
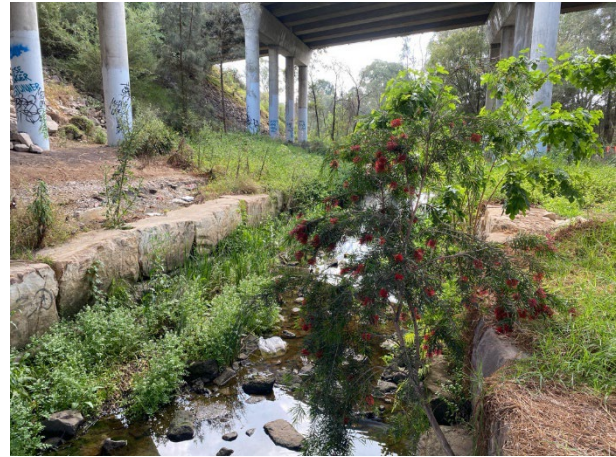
## AE 6: Angus Creek Upstream

A: Upstream

B: Downstream

Attribute	AE5 UPSTREAM
Riparian	Vegetation	Dominant overstorey species was <i>C. glauca</i> . Dominant grass/herb was <i>Lomandra</i> ( <i>Lomandra longifolia</i> ) and groundcover <i>T. fluminensis</i> .
	Stream shading	Moderate
	Exotic vegetation	<i>T. fluminensis</i>
Stream characteristics	Modal width	4 m
	Bank condition	Stable (Artificial)
	Substrate	Fine sediment and cobble
	Flow/depth	Moderate flow/ <1 m
	Macrophytes/algae	Macrophytes and algae
	Water quality observations	Clear
Comments		Major earthworks have been conducted at the upstream section of AE6. With large amounts of rock and a new footbridge having been built.
