ROOTY HILL DISTRIBUTION CENTRE

2025 Annual Review

Organisation	Holcim (Australia) Pty Ltd
Project	Rooty Hill Distribution Centre
Developmental Consent / Project Approval #	PA 05_0051
Document Title	Annual Review 2025
Document Revision	A
Author	IEMA
Project Identifier	HOL06-006
Annual review start date	1 January 2025
Annual review end date	31 December 2025
<p>I, Michael Ensor, certify that this audit report is a true and accurate record of the compliance status of the ROOTY HILL DISTRIBUTION CENTRE for the period of 1 JANUARY 2025 – 31 DECEMBER 2025 and that I am authorised to make this statement on behalf of HOLCIM (AUSTRALIA) PTY LTD.</p> <p>Note.</p> <p>a) <i>The Annual Review is an 'environmental audit' for the purposes of section 122B(2) of the Environmental Planning and Assessment Act 1979. Section 122E provides that a person must not include false or misleading information (or provide information for inclusion in) an audit report produced to the Minister in connection with an environmental audit if the person knows that the information is false or misleading in a material respect. The maximum penalty is, in the case of a corporation, \$1 million and for an individual, \$250

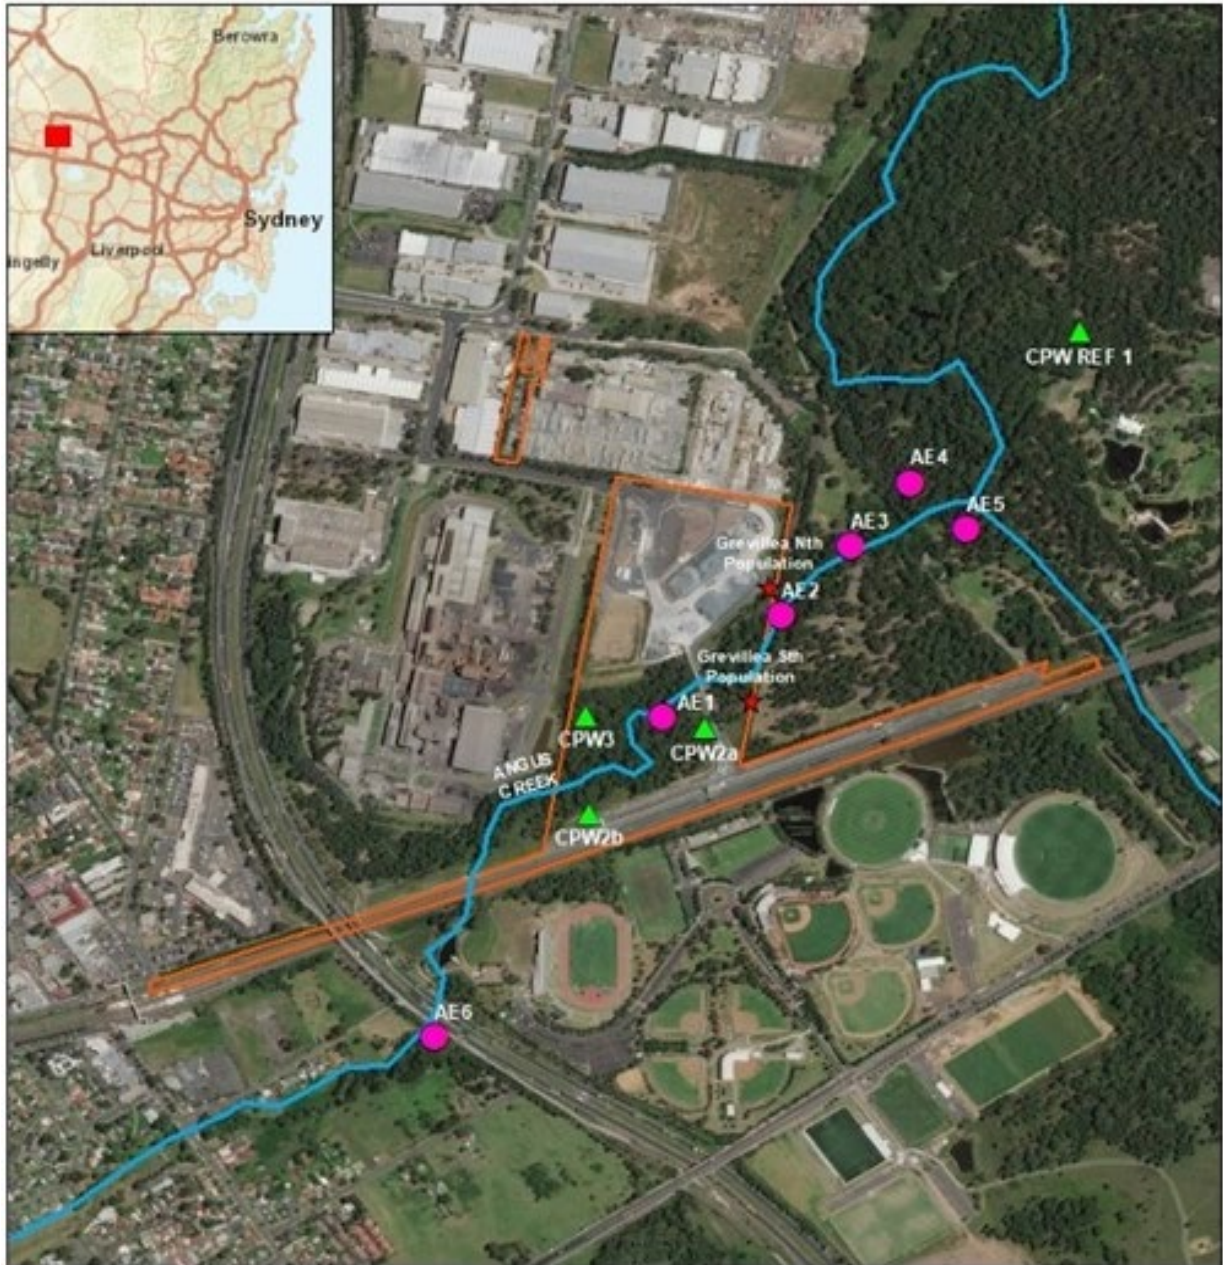
Aquatic monitoring is undertaken at the locations shown in **Figure 2**.

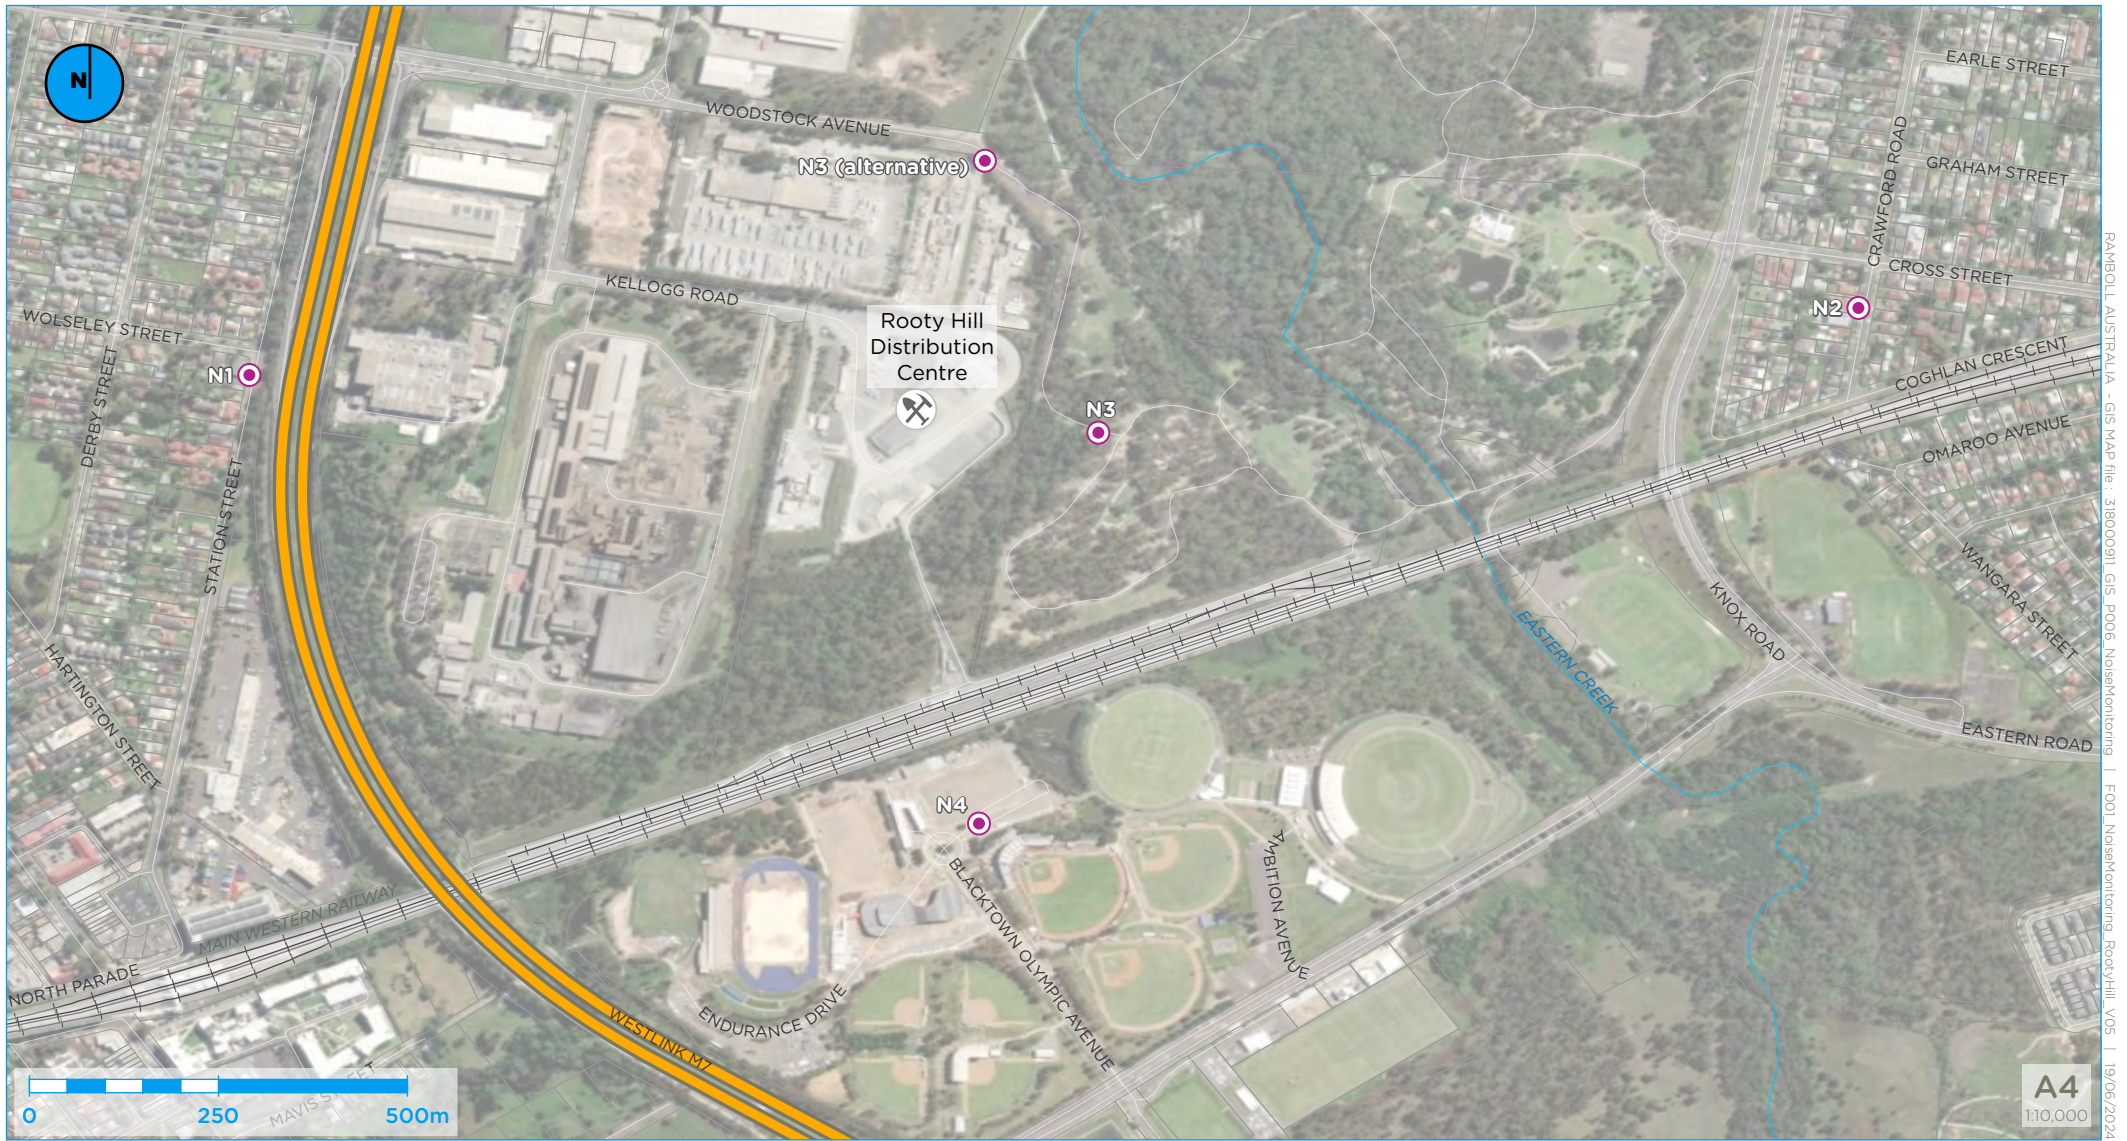
Figure 1: Noise monitoring locations at Rooty Hill Distribution Centre

Monitoring locations were selected in accordance with the NMP and are representative of the nearest noise sensitive receivers to the RHDC. The monitoring locations with respect to the RHDC and assessed receivers are presented in the locality plan in **Figure 1**.

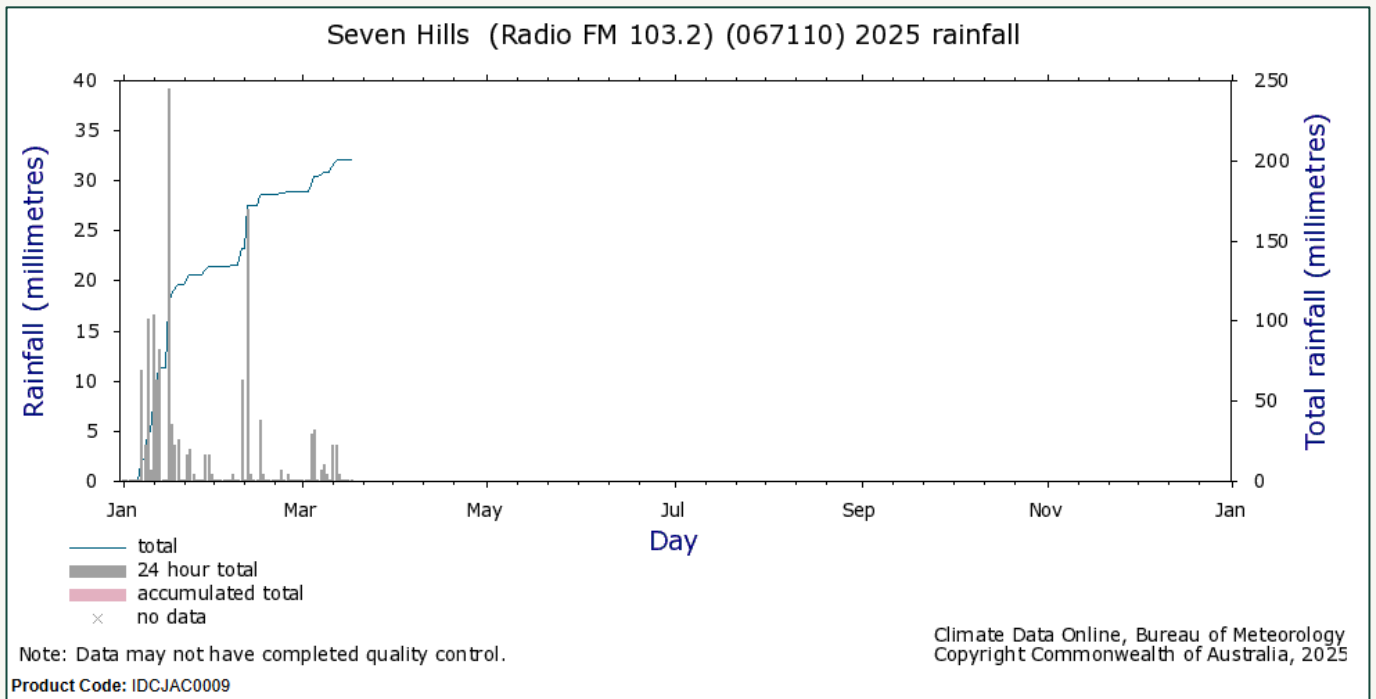
Antecedent rainfall from the month preceding the summer monitoring totalled 50.5 millimetres (mm) (Figure 2). 4.5 mm of rain was recorded in the week leading up to the sampling. The water level at the time of sampling was low to moderate.

Figure 2: Rainfall January to March 2025

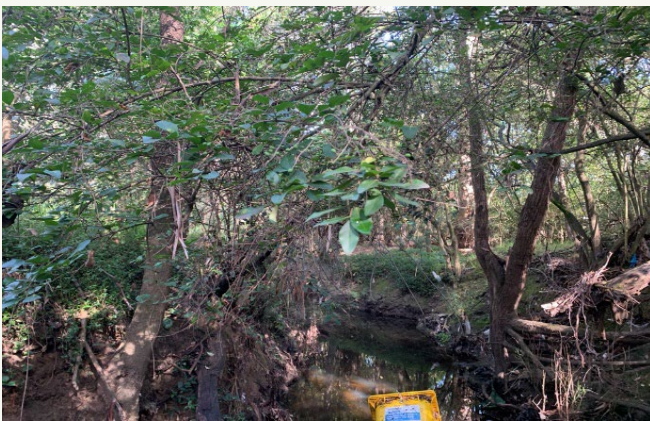
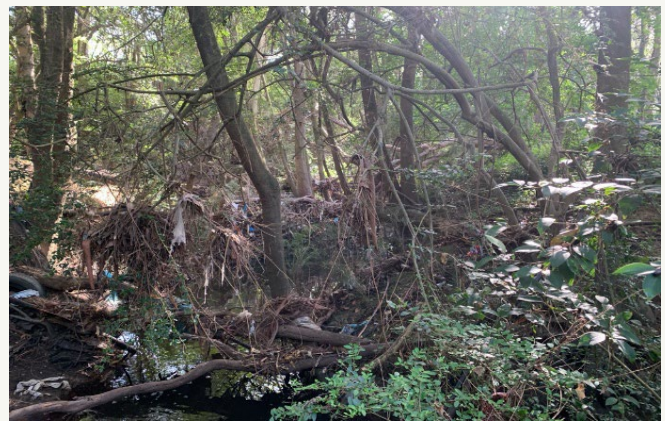
AE1: Angus Creek Upstream

Category	Attribute	AE1 Upstream
Riparian	Vegetation	The dominant tree species comprised Swamp Oak (<i>Casuarina glauca</i>) and Broad-leaf Privet (<i>Ligustrum lucidum</i>). Groundcover was dominated by <i>Tradescantia fluminensis</i> .
	Stream shading	Moderate shading
	Exotic vegetation	<i>L. lucidum</i> and <i>T. fluminensis</i>
Stream characteristics	Modal width	3 m
	Bank condition	Slightly vegetated banks and stable. Slight erosion of lower bank.
	Substrate	Fine sediment; silt. Hardened clay bottom.
	Flow/depth	Moderate flow/ ~1 m
	Macrophytes/algae	Macrophytes not present.

Category	Attribute	AE1 Upstream
	Water quality observations	Water visually turbid
Comments	Weeds and rubbish present. Lack of organic material in channel.

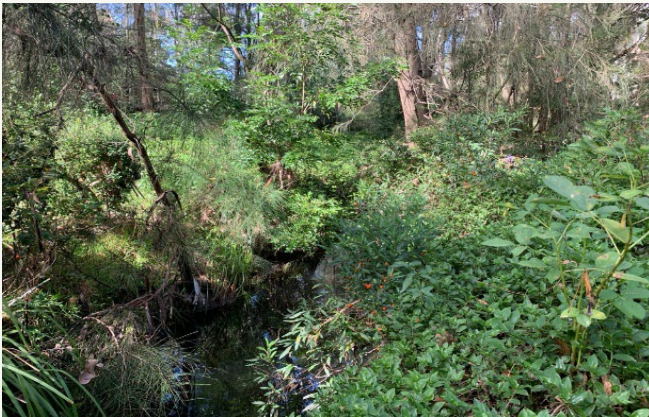
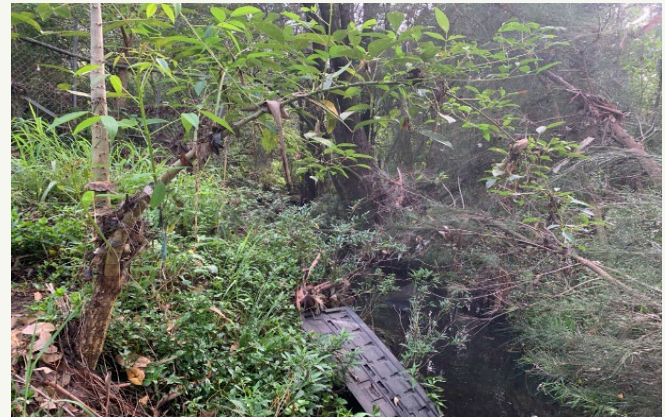
AE2: Angus Creek

Category	Attribute	AE2 downstream
Riparian	Vegetation	Dominant tree species included (<i>C. glauca</i>). Dominant groundcover was <i>T. fluminensis</i> and mixture of exotic and native grasses and herbs.
	Stream shading	Moderate shading
	Exotic vegetation	<i>T. fluminensis</i> and other groundcover species.
Stream characteristics	Modal width	2 m
	Bank Condition	Slightly unstable and heavily vegetated by groundcover
	Substrate	Silt and bedrock
	Flow/depth	Moderate flow/<1 m

Category	Attribute	AE2 downstream
	Macrophytes/algae	Emergent macrophytes present - Bulrush (<i>Typha</i> sp.), <i>Cyprus</i> sp. <i>Potamogeton crispus</i>
	Water quality observations	Clear water
Comments	Weeds and rubbish. Metal debris and litter in system. Concrete rubble in system.

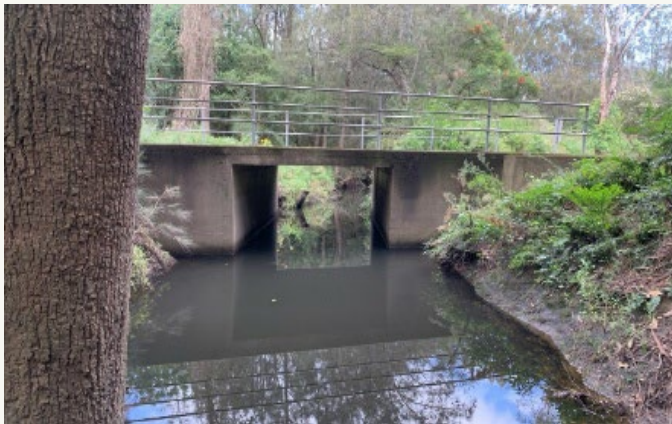
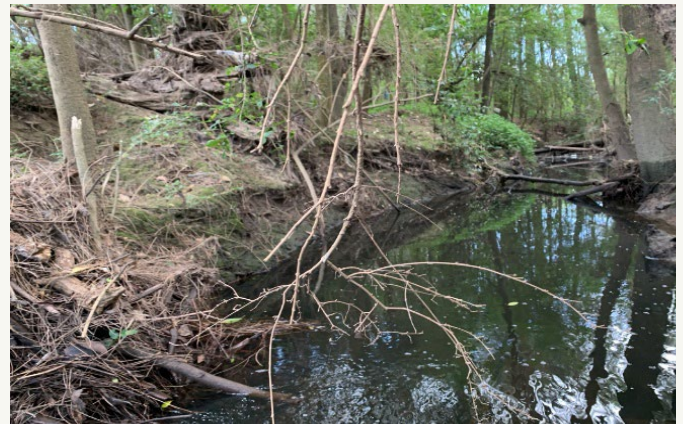
AE3: Angus Creek Downstream

Category	Attribute	AE3 Downstream
Riparian	Vegetation	Dominant tree species was <i>C. glauca</i> . Dominant grass/herb species was <i>T. fluminensis</i>
	Stream shading	Moderate shading
	Exotic vegetation	<i>L. Lucidum</i> , <i>T. fluminensis</i>
Stream characteristics	Modal width	4 m
	Bank Condition	Stable, steep, exposed in sections, slight visible erosion.
	Substrate	Fine sediment, organic matter on banks

Category	Attribute	AE3 Downstream
	Flow/depth	Low flow/~1 metre
	Macrophytes/algae	Ribbon Weed (<i>Vallisneria</i> sp.)
	Water quality observations	Visually water appeared slightly opaque
Comments	Significant amount of plastic based rubbish in stream

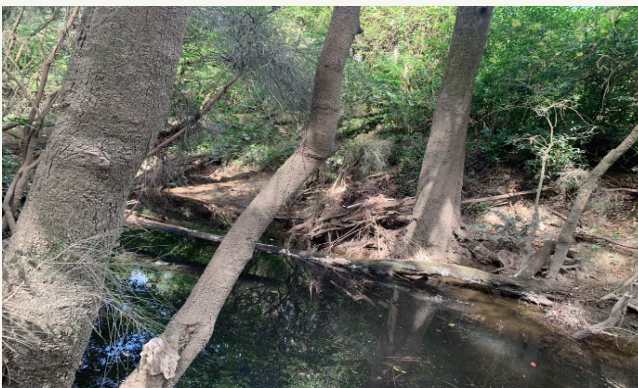
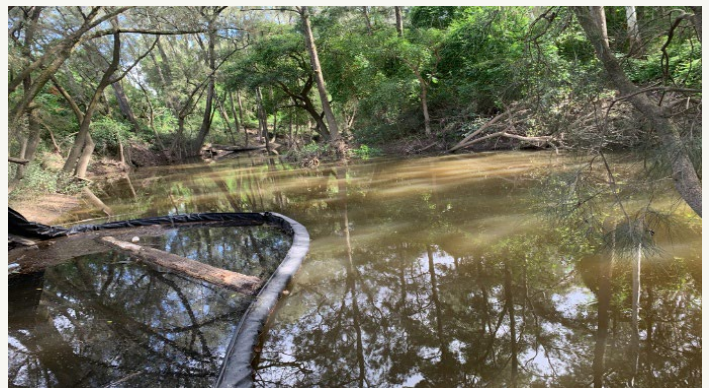
AE4: Eastern Creek Downstream

Category	Attribute	AE4 Downstream
Riparian	Vegetation	Dominant canopy species included <i>C. glauca</i> and Prickly-leaved Tea Tree (<i>Melaleuca styphelioides</i>). Dominant mid-storey species were <i>C. glauca</i> <i>L. lucidum</i> . Dominant groundcover was the exotic <i>T. fluminensis</i>
	Stream shading	Moderate
	Exotic vegetation	<i>L. lucidum</i> and <i>T. fluminensis</i>
Stream characteristics	Modal width	8 m
	Bank condition	Unstable banks
	Substrate	Fine sediment

Category	Attribute	AE4 Downstream
	Flow/depth	Moderate flow/>1m
	Macrophytes/algae	Macrophytes not present
	Water quality observations	Visually Turbid
Comments	Rubbish from floating gross pollutant trap has been cleared out. Some smaller plastic rubbish still in stream.

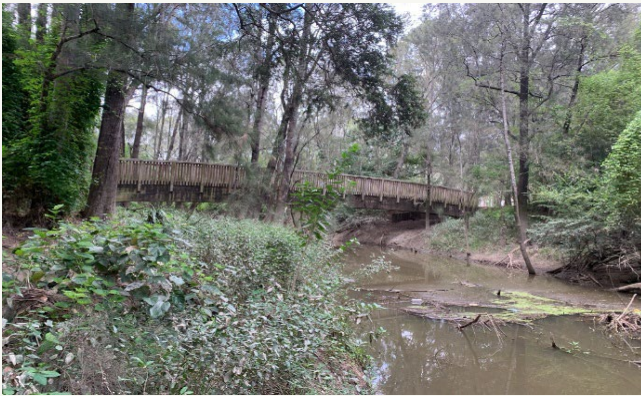
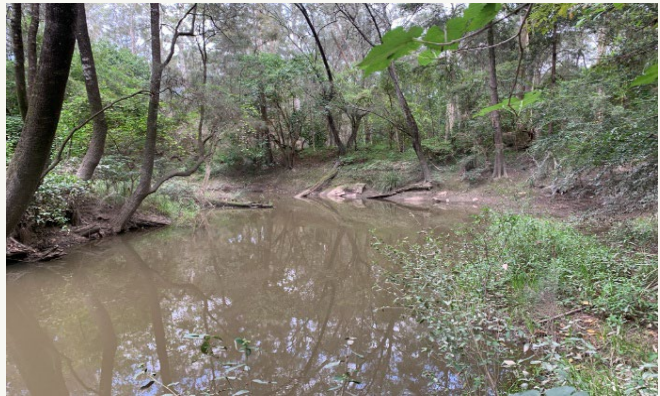
AE5: Eastern Creek Upstream

Category	Attribute	AE5 Upstream
Riparian	Vegetation	Dominant overstorey species was <i>C. glauca</i> . Dominant grass/herb was <i>Lomandra (Lomandra longifolia)</i> and groundcover <i>T. fluminensis</i> .
	Stream shading	Moderate
	Exotic vegetation	<i>T. fluminensis</i>
Stream characteristics	Modal width	12 m
	Bank condition	Unstable
	Substrate	Fine sediment and large woody debris.

Category	Attribute	AE5 Upstream
	Flow/depth	Moderate flow/ >1 m
	Macrophytes/algae	Macrophytes not present.
	Water quality observations	Visually turbid
Comments	Lots of large woody debris and plastic based rubbish

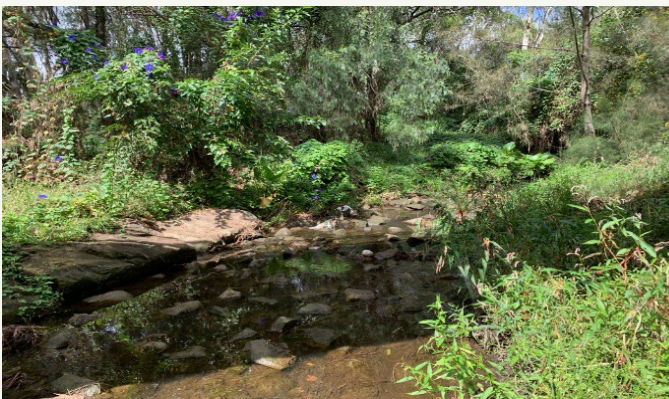
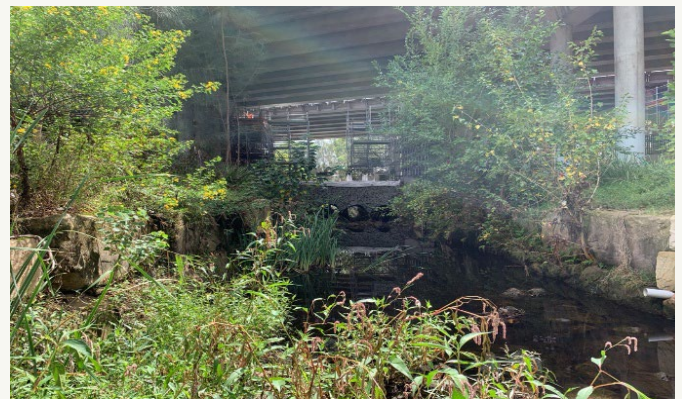
AE 6: Angus creek Upstream

Category	Attribute	AE5 Upstream
Riparian	Vegetation	Dominant overstorey species was <i>C. glauca</i> . Dominant grass/herb was <i>Lomandra (Lomandra longifolia)</i> and groundcover <i>T. fluminensis</i> .
	Stream shading	Moderate
	Exotic vegetation	<i>T. fluminensis</i>
Stream characteristics	Modal width	5 m
	Bank condition	Stable, man made.
	Substrate	Fine sediment and cobble

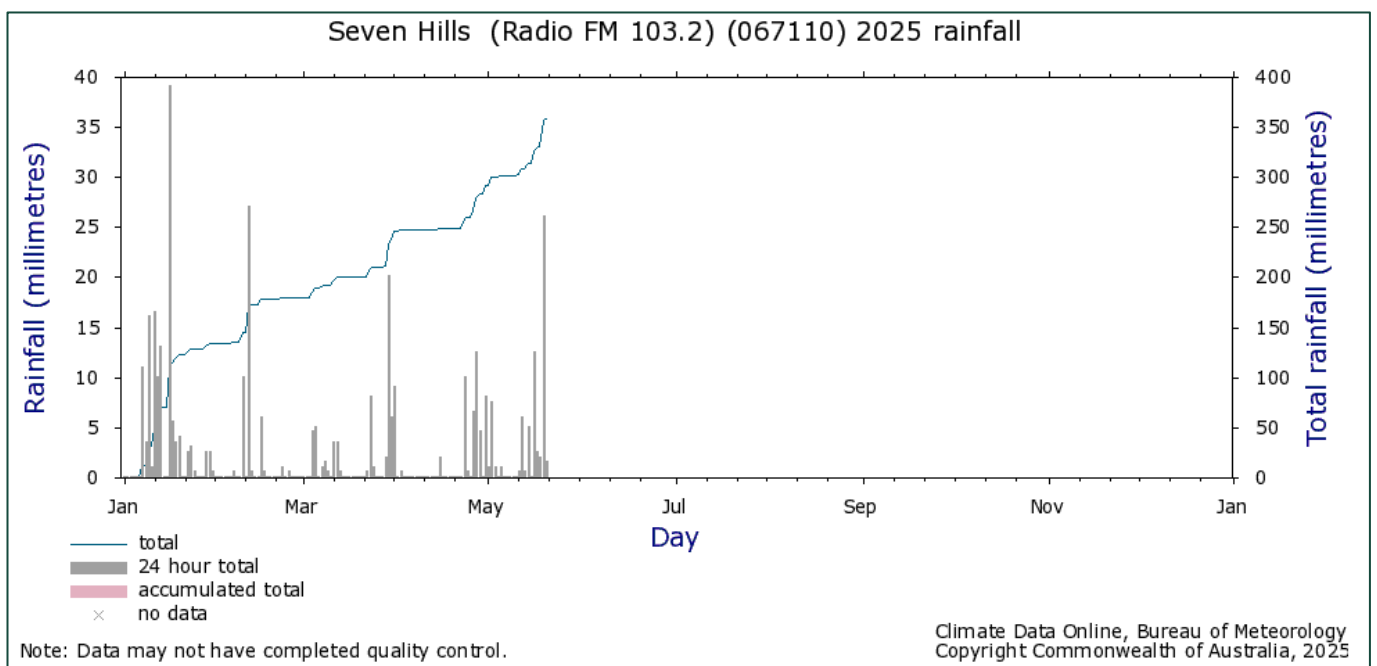
Antecedent rainfall from the two weeks preceding the autumn monitoring totalled 41.5 millimetres (mm) (Figure 2). A total of 10 mm of rain was recorded in the week leading up to the sampling. The water level at the time of sampling was low to moderate.

Figure 2: Rainfall January to May 2025

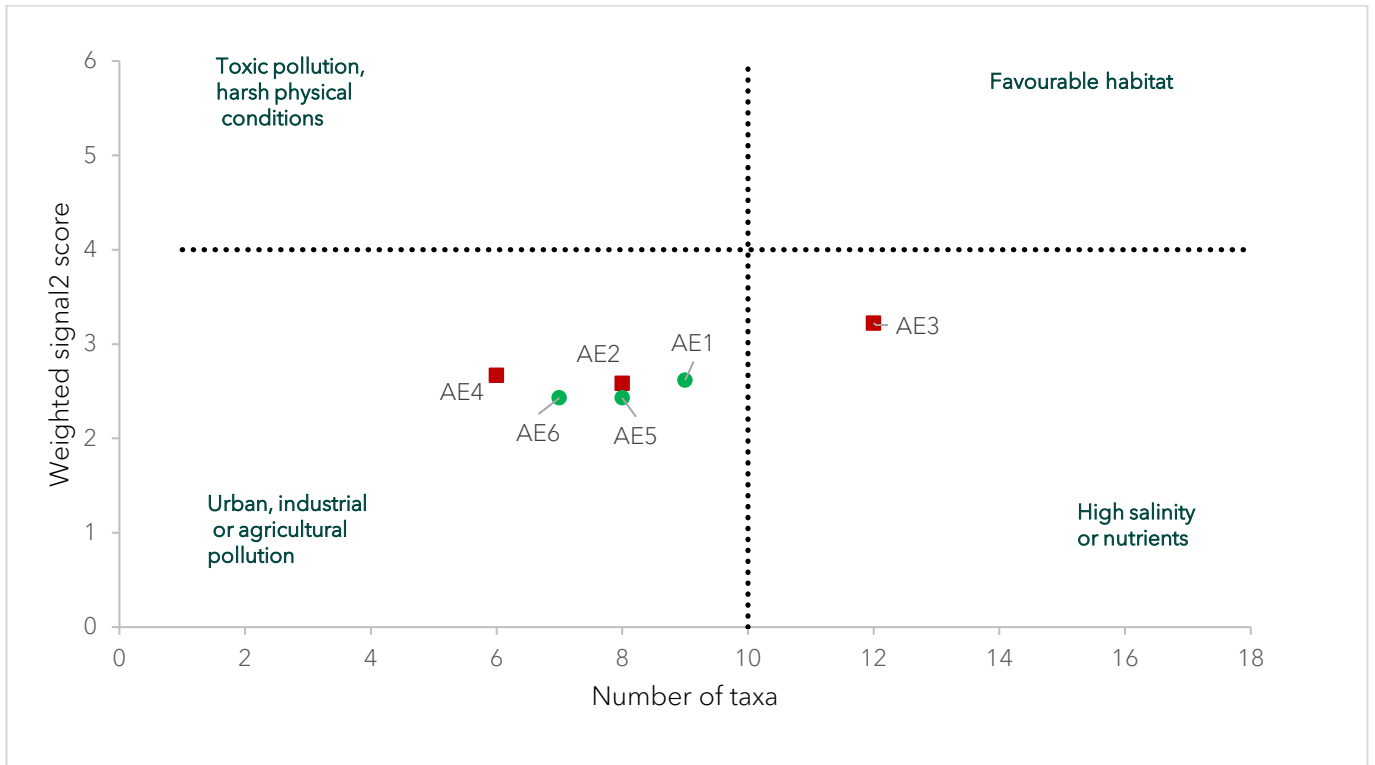
The SIGNAL2 bi-plot (Figure 3) indicates that no sites represent favourable habitat, with all locations exhibiting signs of pollution or natural stress. Potential impact site AE3 recorded the highest SIGNAL2 score and the greatest number of macroinvertebrate taxa; however, the score still falls within a range considered poor. The remaining sites, including all control sites, tended to cluster together, suggesting relatively consistent and similarly degraded conditions across these locations.

Red squares represent downstream potential impact sites. Green circles represent upstream control sites.

Figure 3: Bi-plot - SIGNAL2 and number of taxa scores

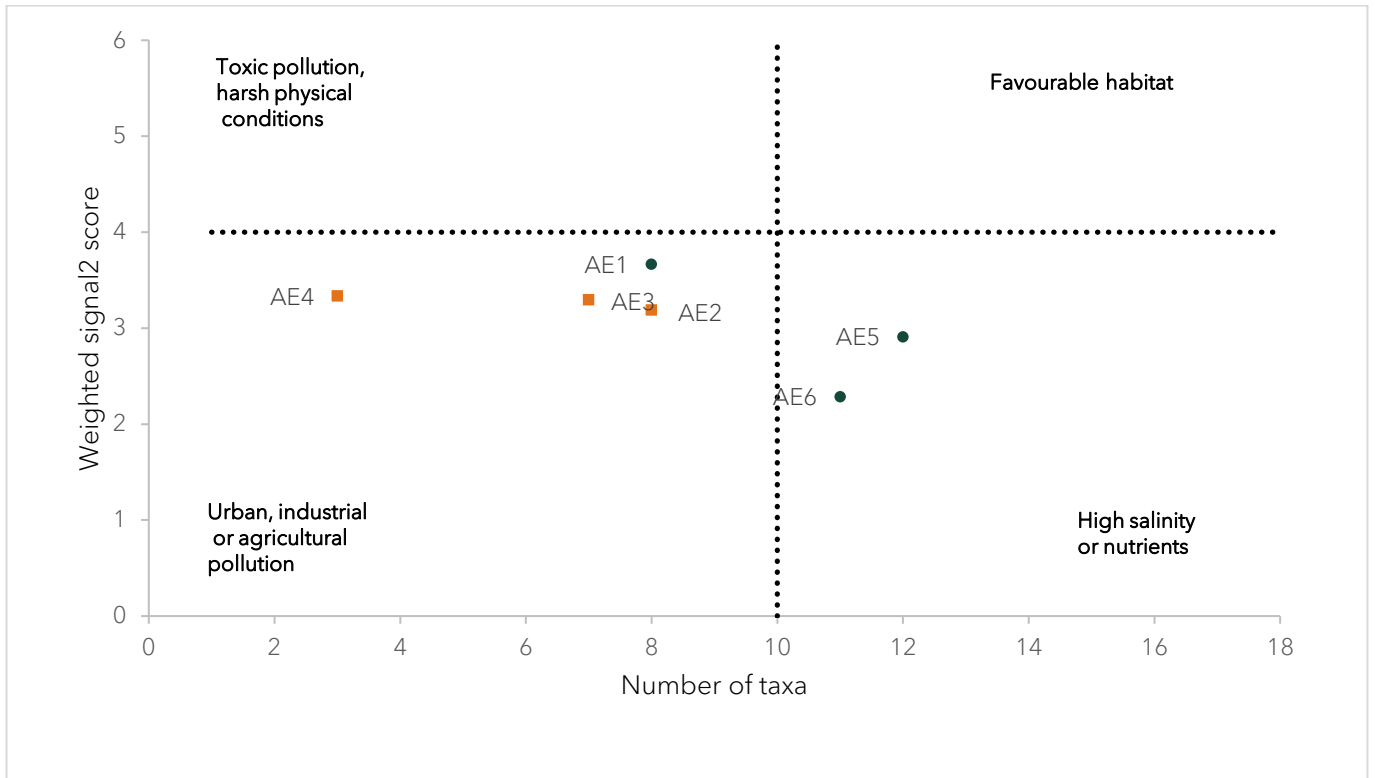
The SIGNAL2 bi-plot (Figure 3) indicates that no sites represent favourable habitat. sites do not show a tendency to cluster together, suggesting a range of conditions or influencing factors may be acting on the sites. While the number of taxa were lower at the potential impact sites, the SIGNAL2 scores are comparable to the control sites.

Orange quares represent downstream potential impact sites. Green circles represent upstream control sites.

Figure 3: Bi-plot - SIGNAL2 and number of taxa scores
