TEVEN QUARRY

2025 Annual Review

Organisation	Holcim (Australia) Pty Ltd
Project	Teven Quarry
Developmental consent / project approval #	SSD 6422
Document Title	Annual Review 2025
Document Revision	A
Author	IEMA
Project Identifier	HOL04-006
Annual review start date	1 January 2025
Annual review end date	31 December 2025
<p>I, Matt Kelly, certify that this audit report is a true and accurate record of the compliance status of the TEVEN QUARRY for the period of 1 JANUARY 2025 – 31 DECEMBER 2025 and that I am authorised to make this statement on behalf of HOLCIM (AUSTRALIA) PTY LTD.</p> <p>Note.</p> <p>a) <i>The Annual Review is an ‘environmental audit’ for the purposes of section 9.42 of the Environmental Planning and Assessment Act 1979 (NSW). Section 9.42(1) provides that a person must not include false or misleading information in, or provide information for inclusion in, an audit report produced to the Minister in connection with an environmental audit if the person knows that the information is false or misleading in a material respect. A contravention of this provision constitutes a Tier 3 offence under the Act (a maximum penalty: in the case of a corporation is \$1 million; an

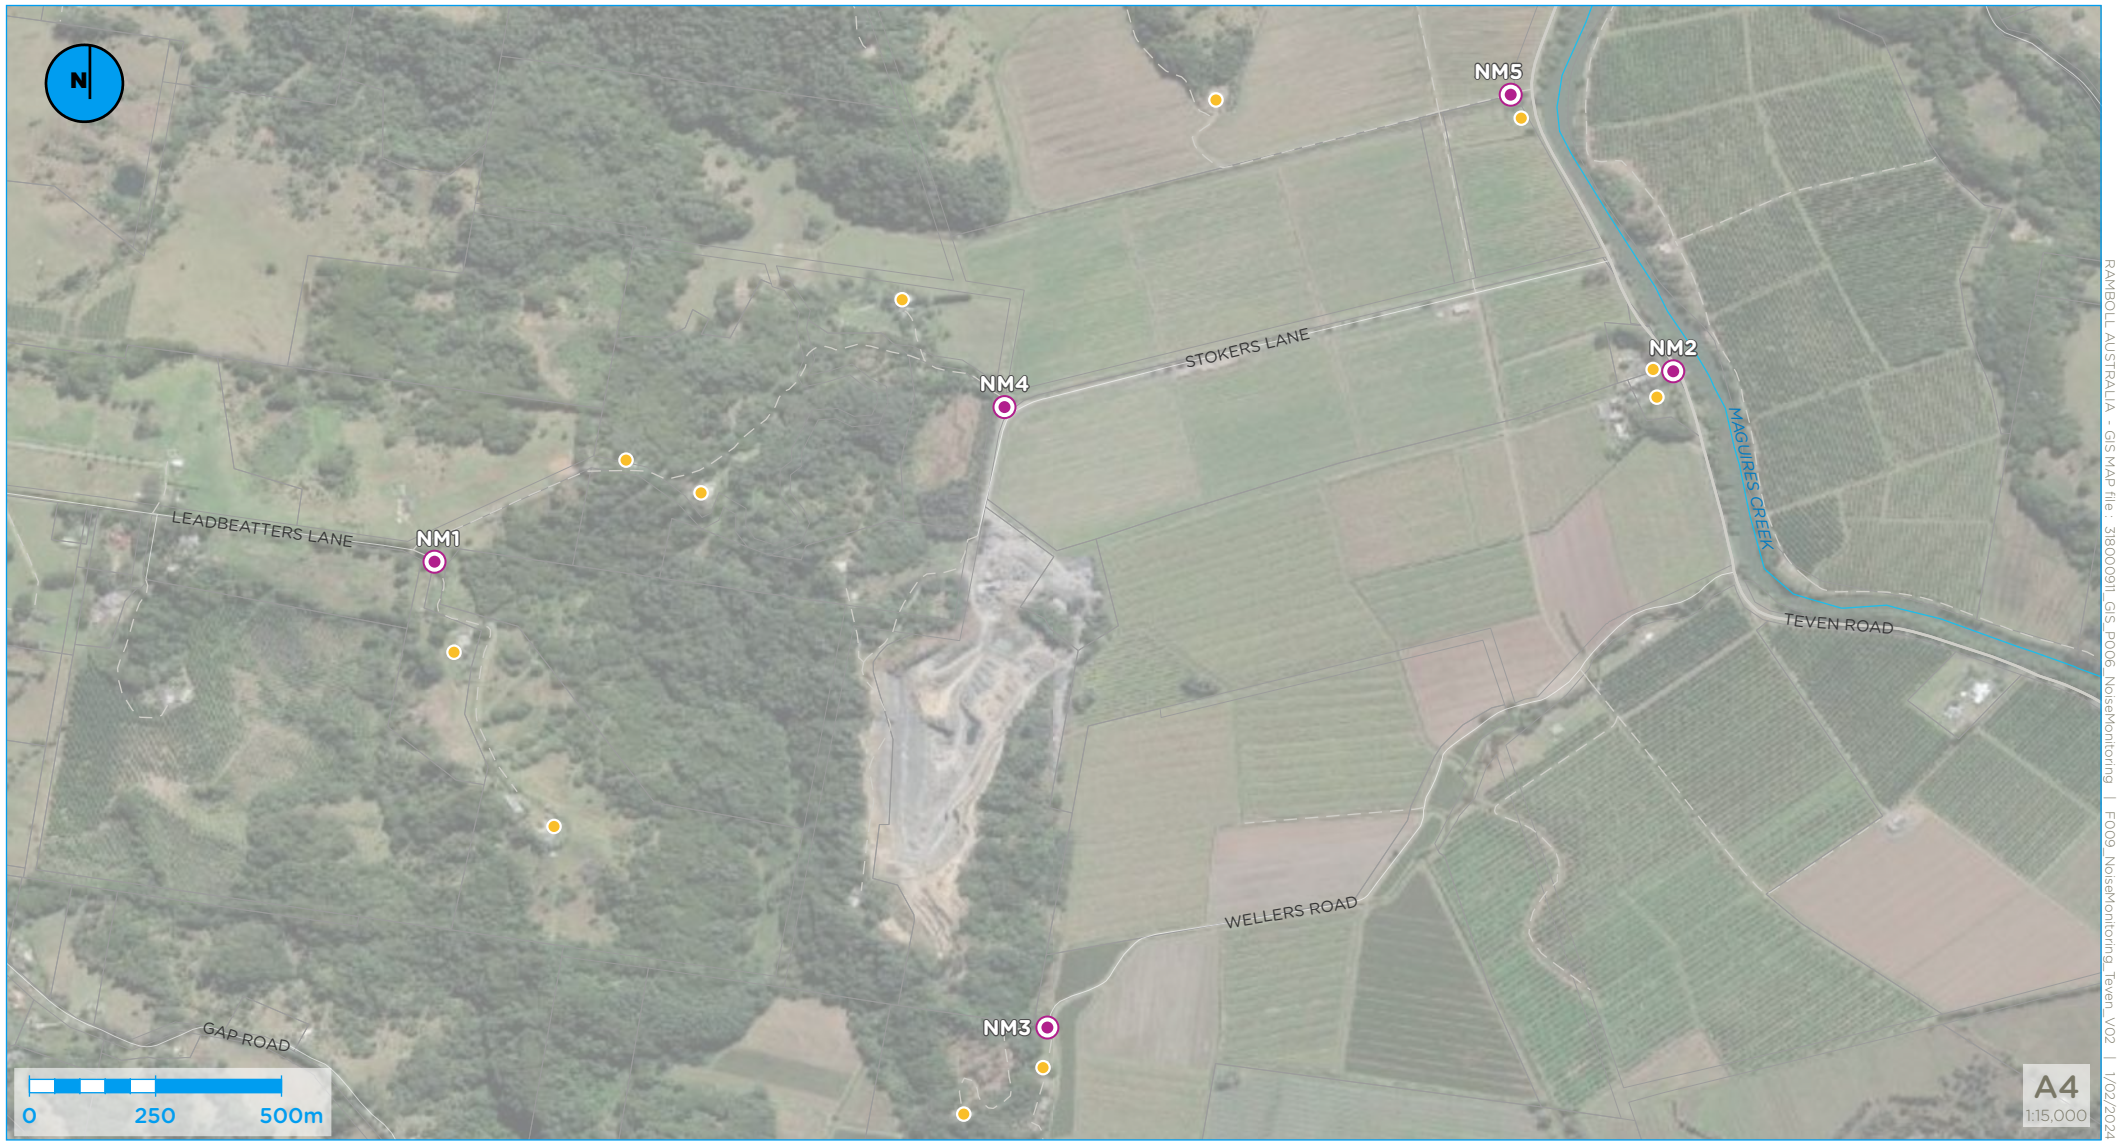
Figure 1: Noise monitoring locations at Teven Quarry

Monitoring Locations	Nearest Receiver	Locality and Sensitive Receivers
NM1	R7	West of the quarry situated at a rural residential property at the end of Leadbeatters Lane
NM2	R3/R4	East of the quarry situated at a rural residential property on Teven Road
NM3	R2	South of the quarry situated at a rural residential property at the end of Wellers Road
NM4	R10	North of the quarry situated at a rural residential property adjacent the site off Stokers Lane
NM5	R14	Northeast of the quarry situated at a rural residential property of Teven Road

The monitoring locations with respect to the quarry and assessed receivers are presented in the locality plan shown in **Figure 1**.

- Noise monitoring location
- Residential receiver location

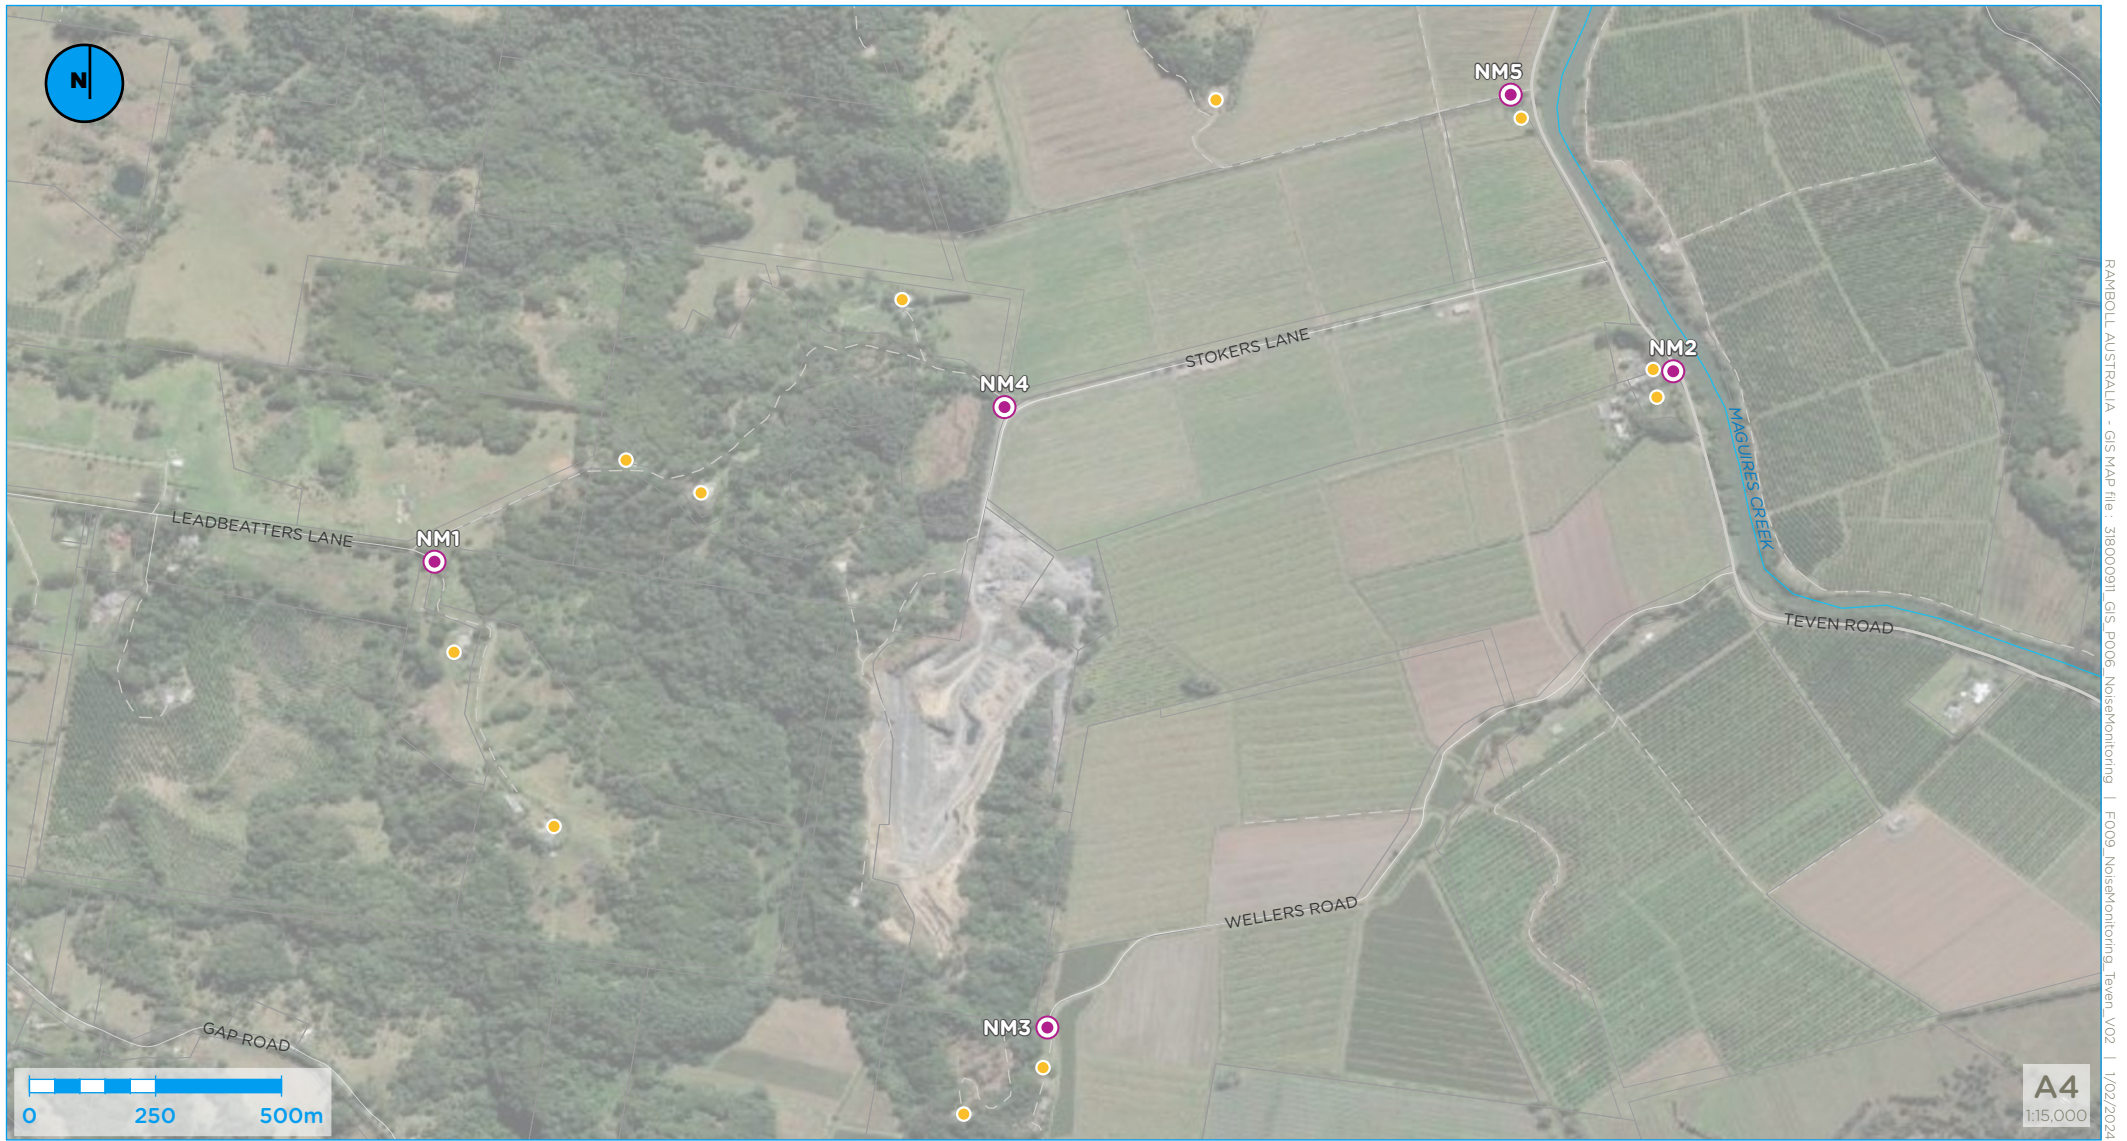
Figure 1: Noise monitoring locations at Teven Quarry

Monitoring Locations	Nearest Receiver	Locality and Sensitive Receivers
NM1	R7	West of the quarry situated at a rural residential property at the end of Leadbeatters Lane
NM2	R3/R4	East of the quarry situated at a rural residential property on Teven Road
NM3	R2	South of the quarry situated at a rural residential property at the end of Wellers Road
NM4	R10	North of the quarry situated at a rural residential property adjacent the site off Stokers Lane
NM5	R14	Northeast of the quarry situated at a rural residential property of Teven Road

The monitoring locations with respect to the quarry and assessed receivers are presented in the locality plan shown in **Figure 1**.

- Noise monitoring location
- Residential receiver location

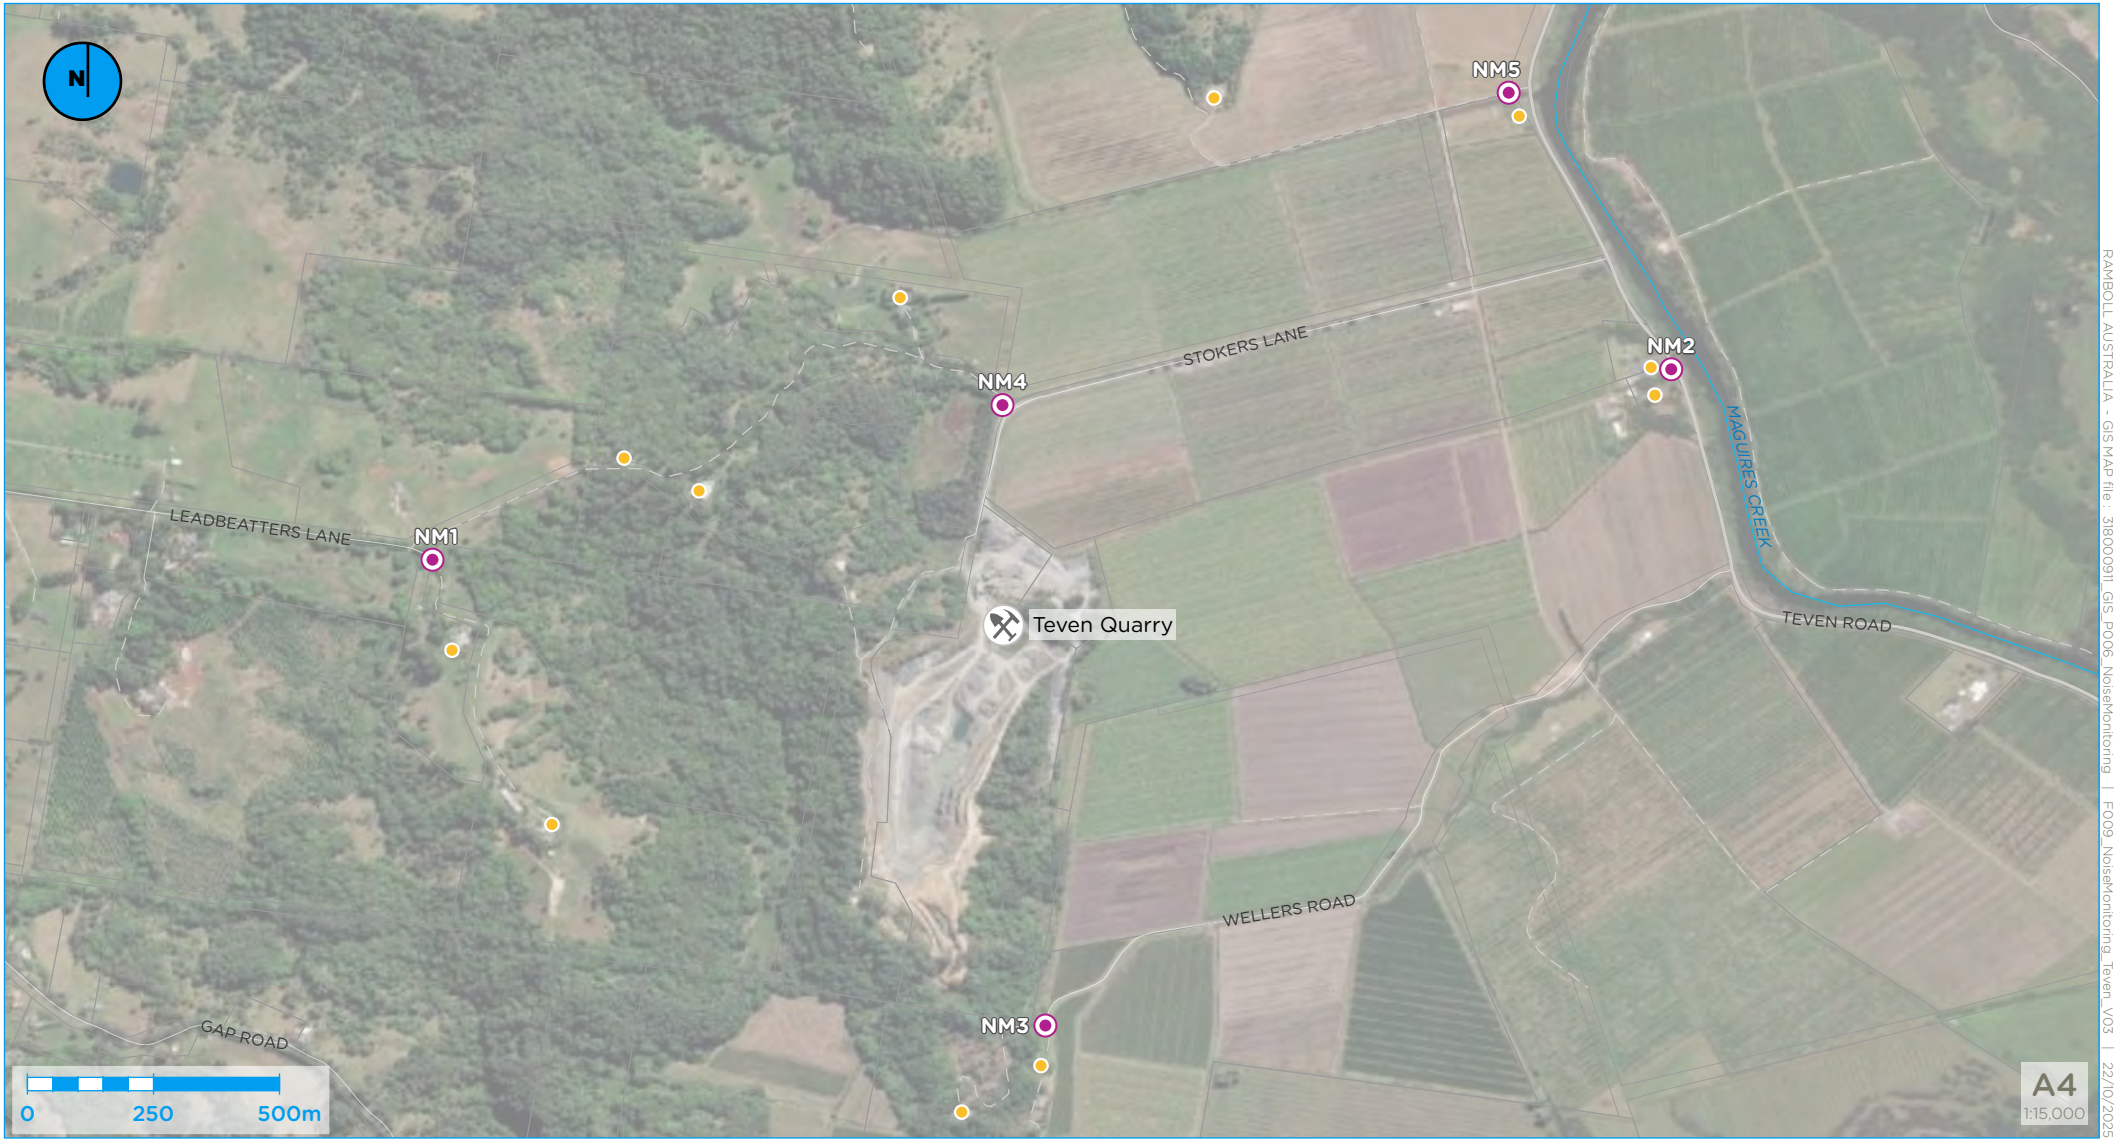
Figure 1: Noise monitoring locations at Teven Quarry

Monitoring Location	Nearest Receiver	Locality and Sensitive Receivers
NM1	R7	West of the quarry situated at a rural residential property at the end of Leadbeatters Lane
NM2	R3/R4	East of the quarry situated at a rural residential property on Teven Road
NM3	R2	South of the quarry situated at a rural residential property at the end of Wellers Road
NM4	R10	North of the quarry situated at a rural residential property adjacent the site off Stokers Lane
NM5	R14	Northeast of the quarry situated at a rural residential property of Teven Road

The monitoring locations with respect to the quarry and assessed receivers are presented in the locality plan shown in **Figure 1**.

- Noise monitoring location
- Residential receiver location

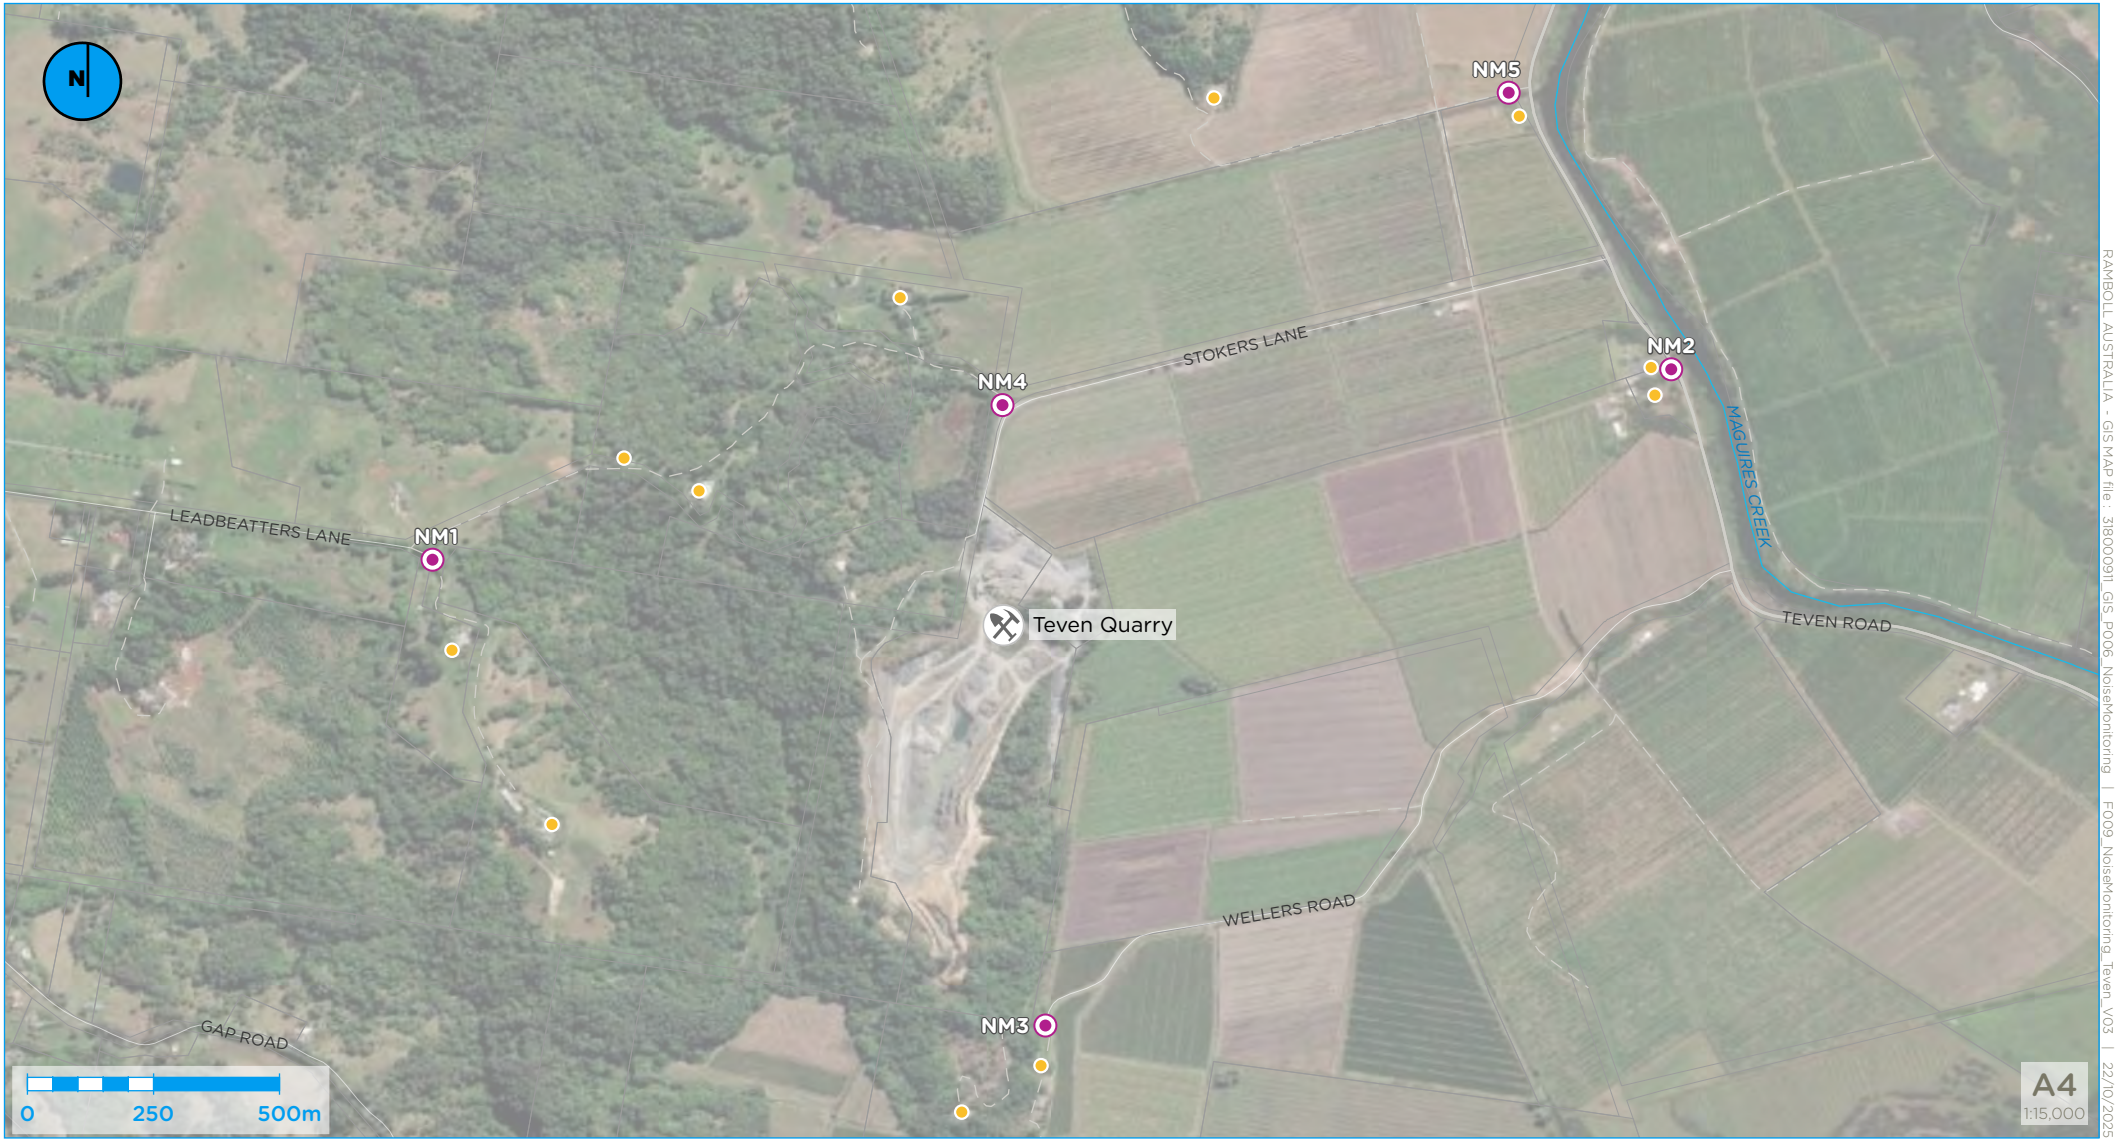
Figure 1: Noise monitoring locations at Teven Quarry

Monitoring Location	Nearest Receiver	Locality and Sensitive Receivers
NM1	R7	West of the quarry situated at a rural residential property at the end of Leadbeatters Lane
NM2	R3/R4	East of the quarry situated at a rural residential property on Teven Road
NM3	R2	South of the quarry situated at a rural residential property at the end of Wellers Road
NM4	R10	North of the quarry situated at a rural residential property adjacent the site off Stokers Lane
NM5	R14	Northeast of the quarry situated at a rural residential property of Teven Road

The monitoring locations with respect to the quarry and assessed receivers are presented in the locality plan shown in **Figure 1**.

- Noise monitoring location
- Residential receiver location
