Annual Environmental Management Review (AEMR)

Rooty Hill Distribution Centre

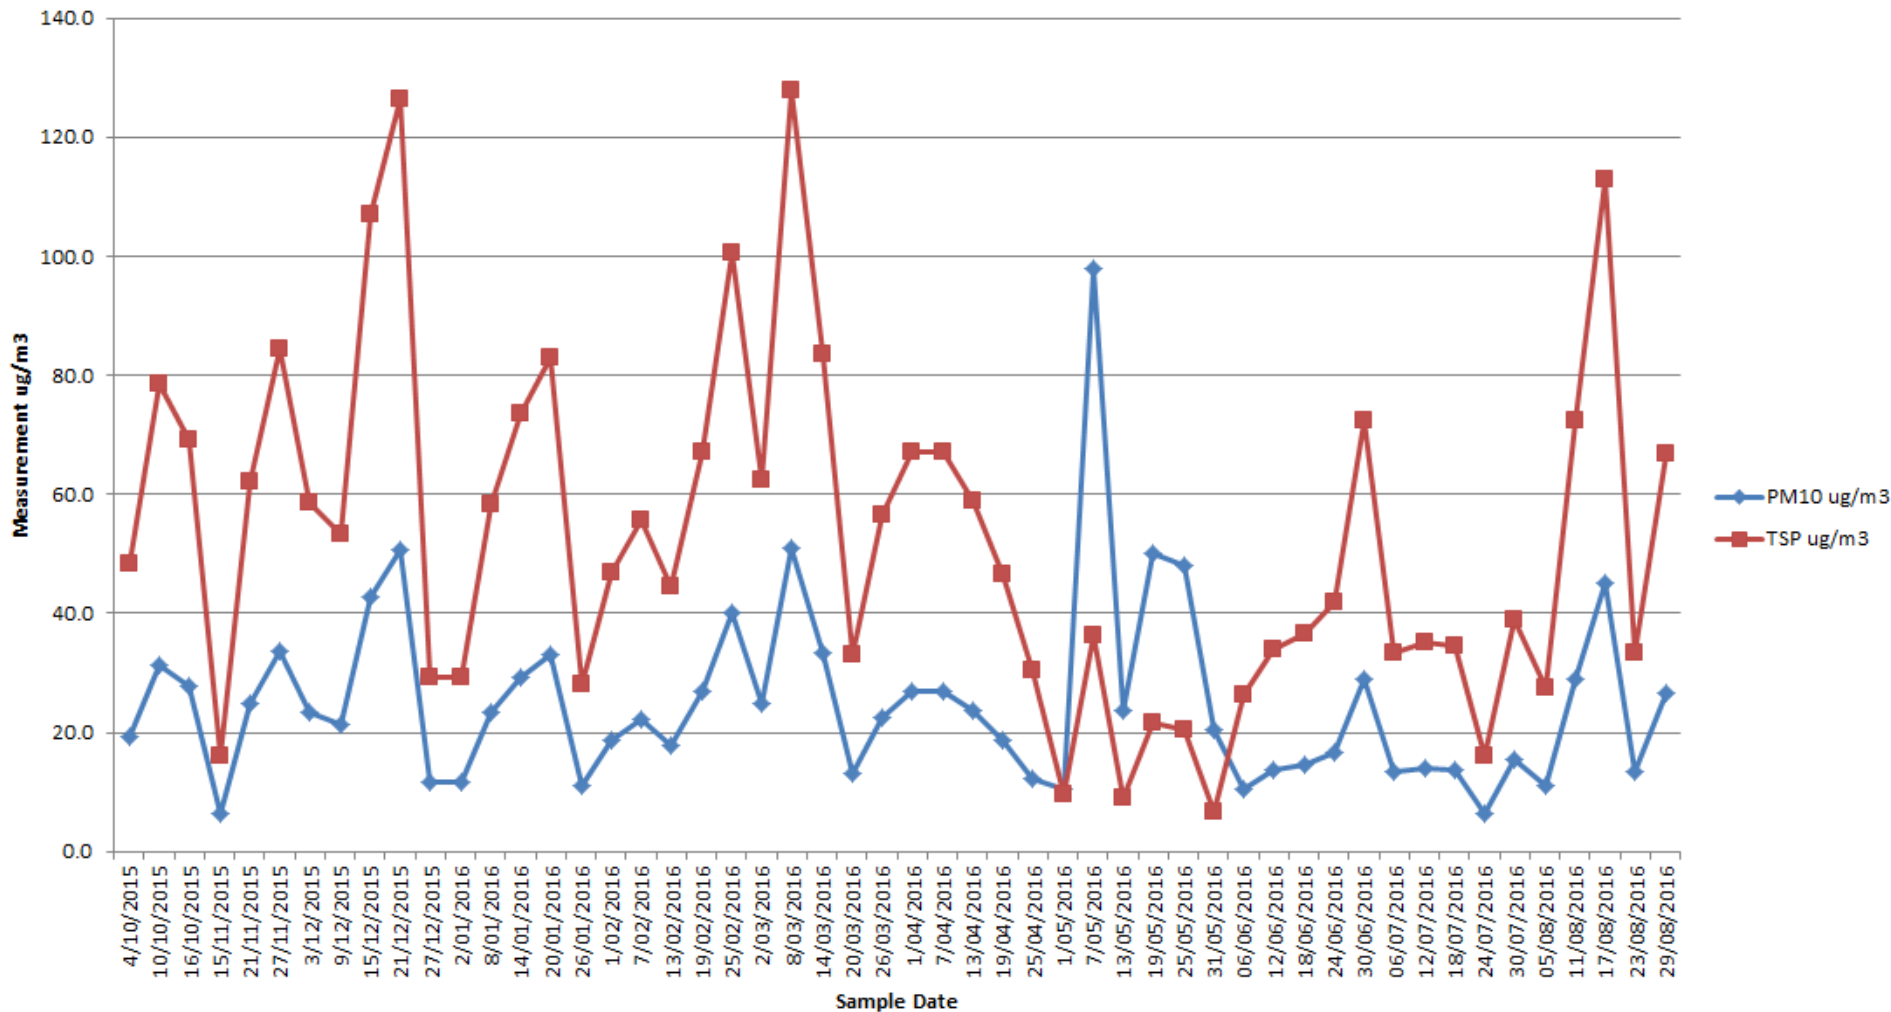
HVAS 2- Holcim Site Office

PM10 and TSP samples were undertaken at 2 HVAS units owned and operated by Holcim. HVAS 1 (located at the Blacktown Sports Centre directly south of the site) registered no exceedances during the reporting period.

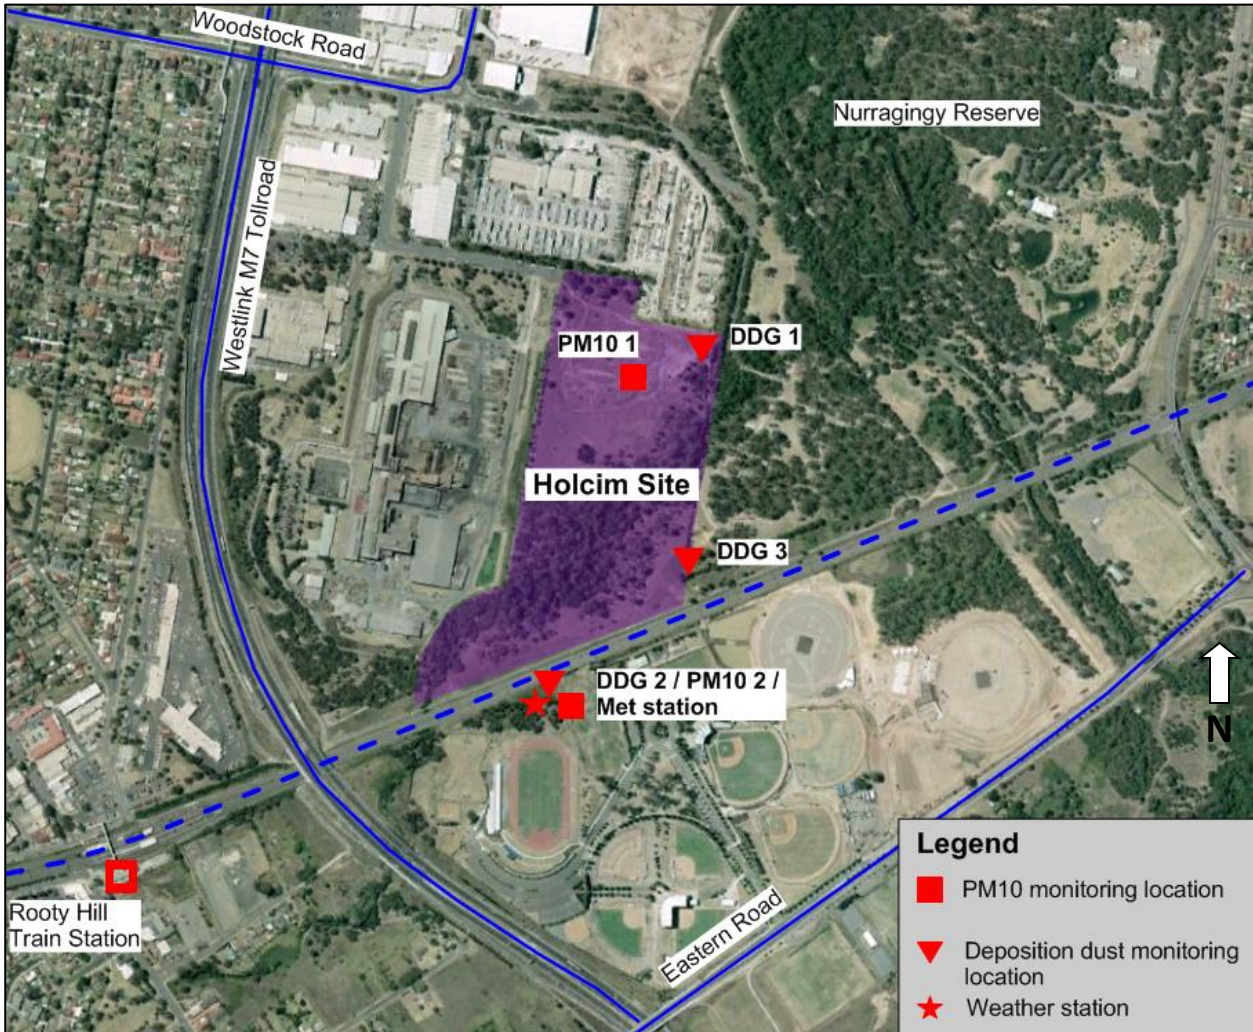
Figure 1 Monitoring locations

The monitoring locations at the Rooty Hill Regional Distribution Centre (RDC) for air quality and meteorology are shown in **Figure 1** and consist of:

- Dust monitoring (PM₁₀): Blacktown International Sportspark (formally Olympic Park)
Holcim Site office
- Dust monitoring (Depositional): Locations 1 to 3
- Meteorology: Blacktown International Sportspark (formally Olympic Park)

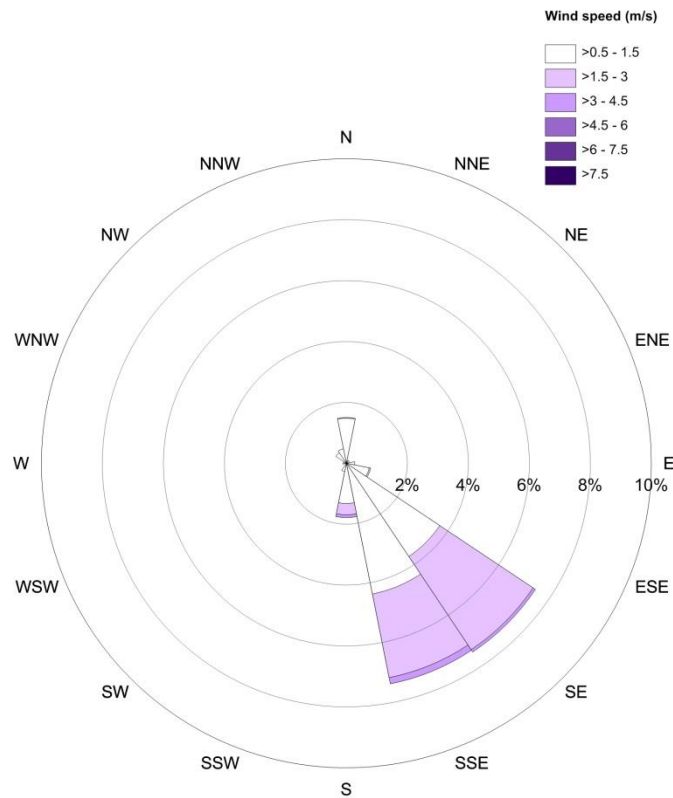
Figure 2: April 2016 Wind rose, Blacktown International Sports Centre meteorological station

The prevailing winds during the monitoring period were predominately from the south-east and south-south-east. Calm conditions occurred often during the monitoring period. Under these conditions, dust impacts are more likely to affect receivers to the north west of the site. This area does not contain any residential properties.

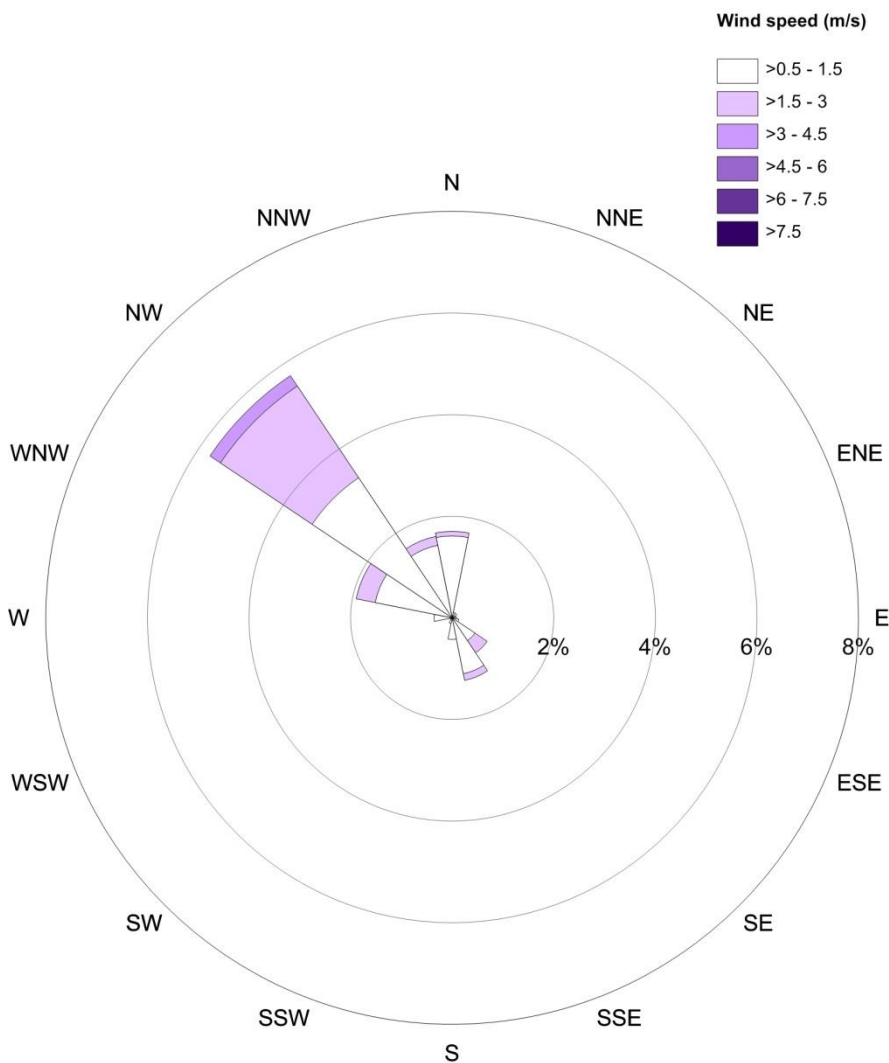
Figure 2: May 2016 Wind rose, Blacktown International Sports Centre meteorological station

The prevailing winds during the monitoring period were predominately from the north-west. Calm conditions occurred often during the monitoring period. Under these conditions, dust impacts are more likely to affect receivers to the south-east of the site.

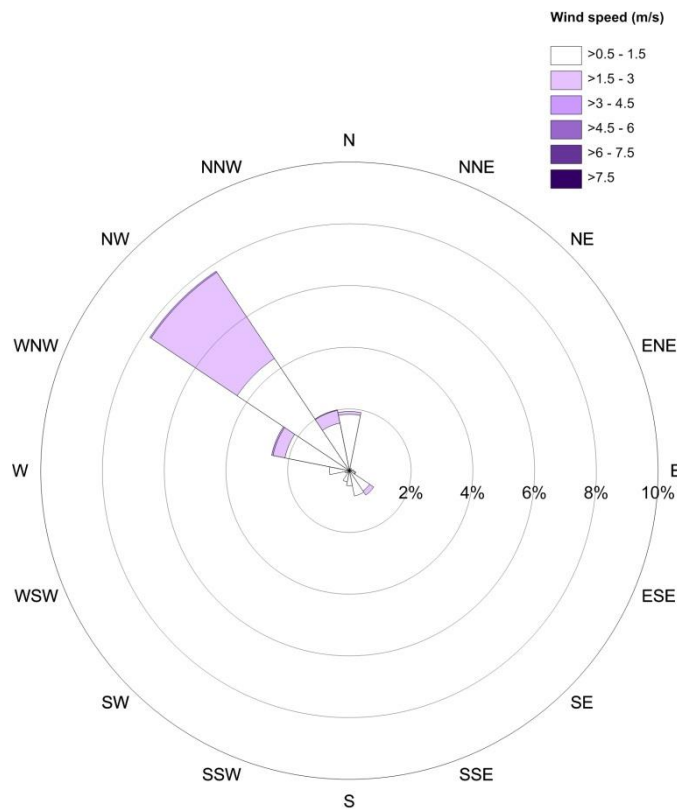
Figure 2: June 2016 Wind rose, Blacktown International Sports Centre meteorological station

The prevailing winds during the monitoring period were predominately from the north-west. Calm conditions occurred often during the monitoring period. Under these conditions, dust impacts are more likely to affect receivers to the south-east of the site.

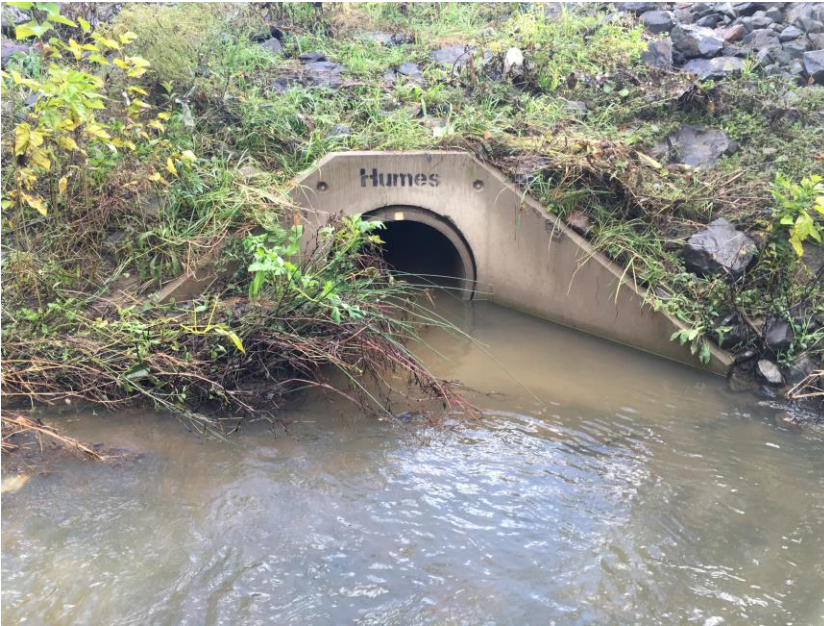
Direct discharges from RHDC enter Angus Creek via a drain, immediately adjacent to the RHDC bridge over Angus Creek. During high flows (wet weather) the drainage pipe is flooded by Angus Creek so sampling of the discharge water from RHDC is not possible. However during dry weather the water level is lower, potentially enabling a grab sample to be collected directly from the discharge point to allow comparison of discharge water quality to Angus Creek and to better understand whether RHDC is having an impact on the receiving environment. Therefore Jacobs recommends additional sampling is undertaken at this location for the current monitoring program.

Recommendation 2: Additional monitoring at RHDC discharge point

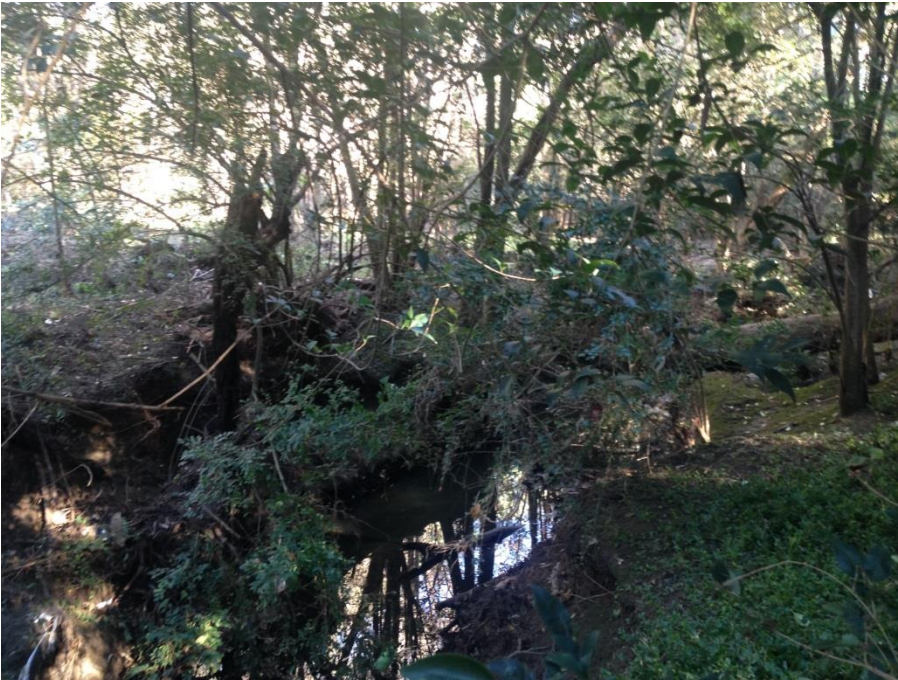
Photo 1 : The creek bank at Site AE1 showing dense woody weed infestation

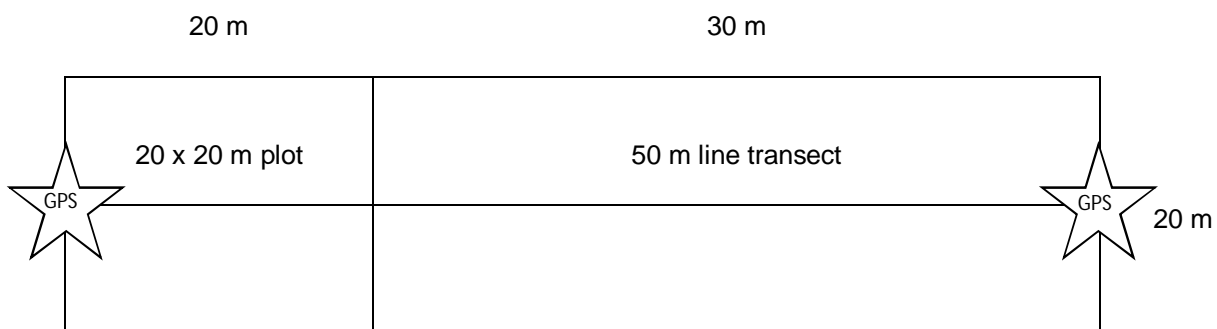
Figure 3-1 Survey plot layout for riparian site value assessments.

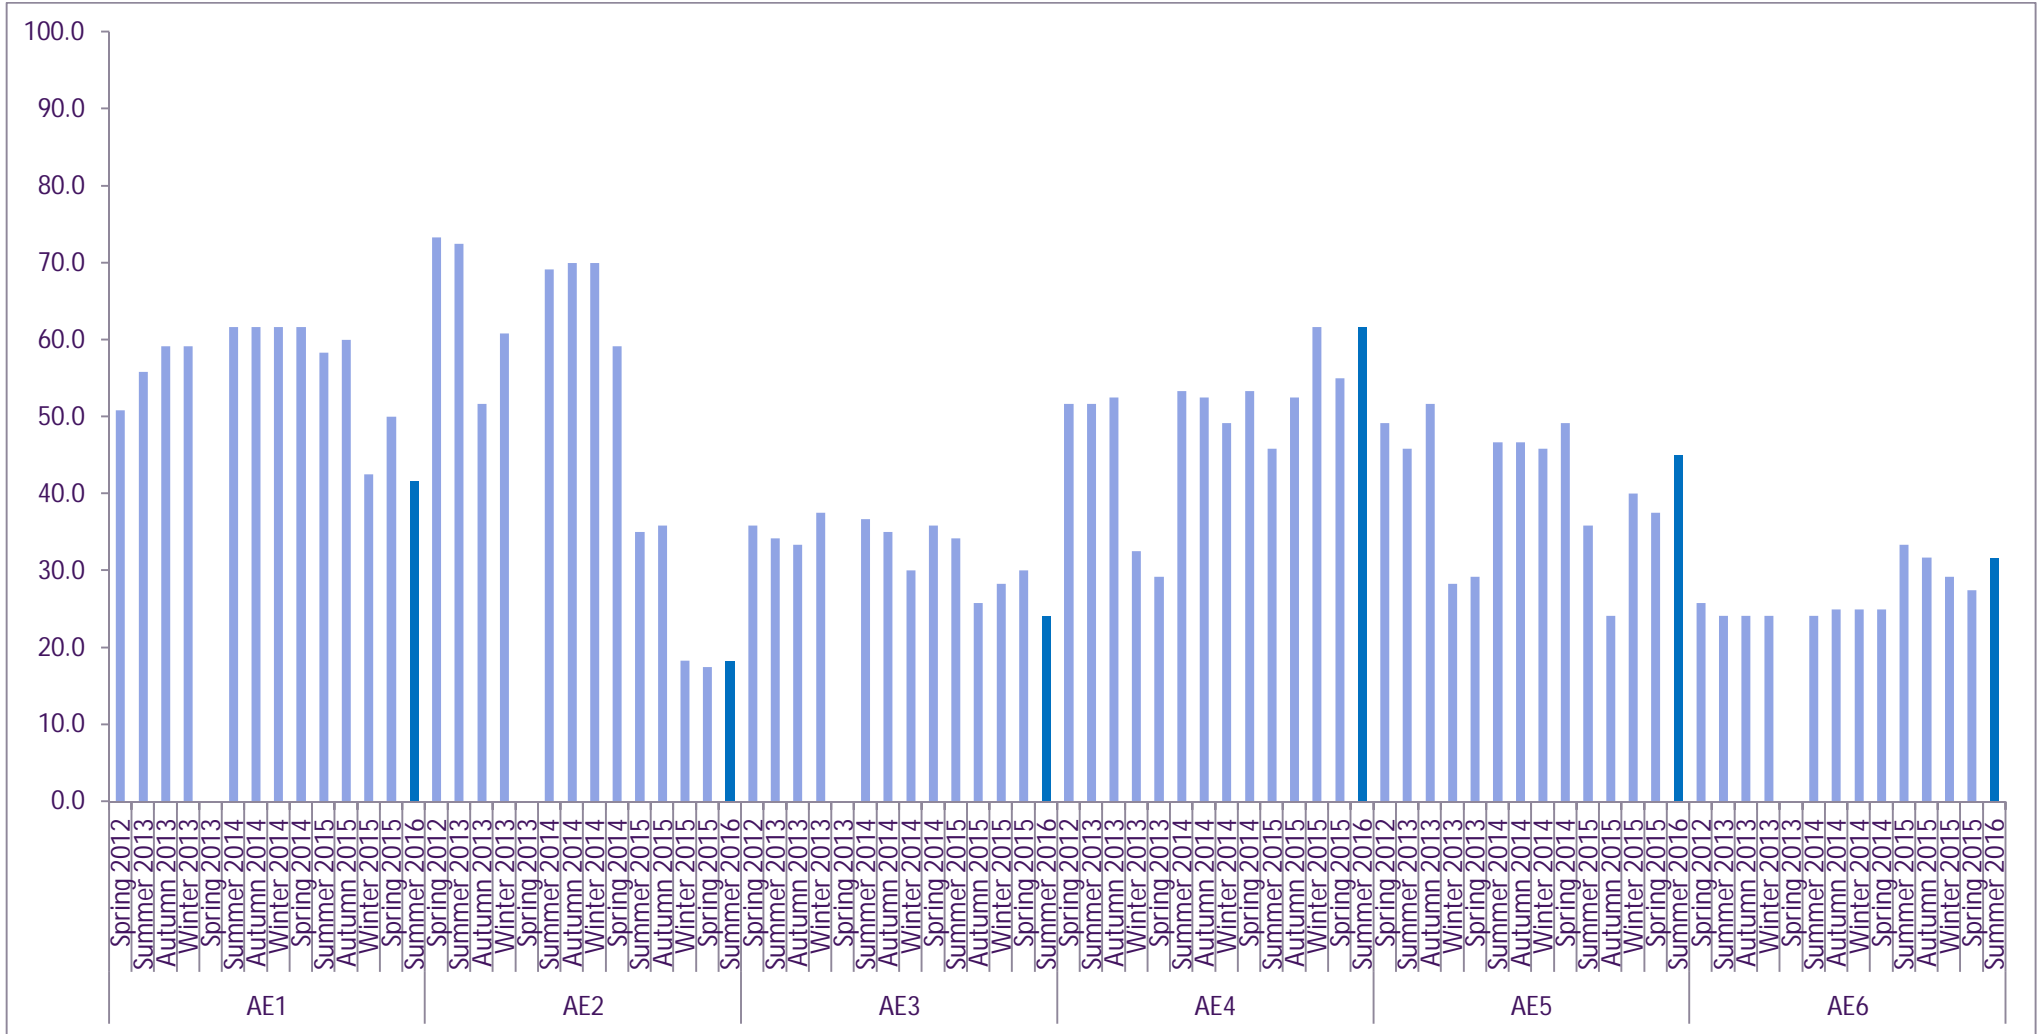
Monitoring site	Site value score	Condition
AE1 (Rooty Hill RDC site)	41.7	Moderate
AE2	18.3	Low-Moderate
AE3	24.2	Low-Moderate
AE4	61.7	Moderate-High
AE5	45	Moderate
AE6	31.7	Low-Moderate

Figure 5-1 Site condition scores for the riparian site value condition assessment (dark blue bars represent results from summer 2016).

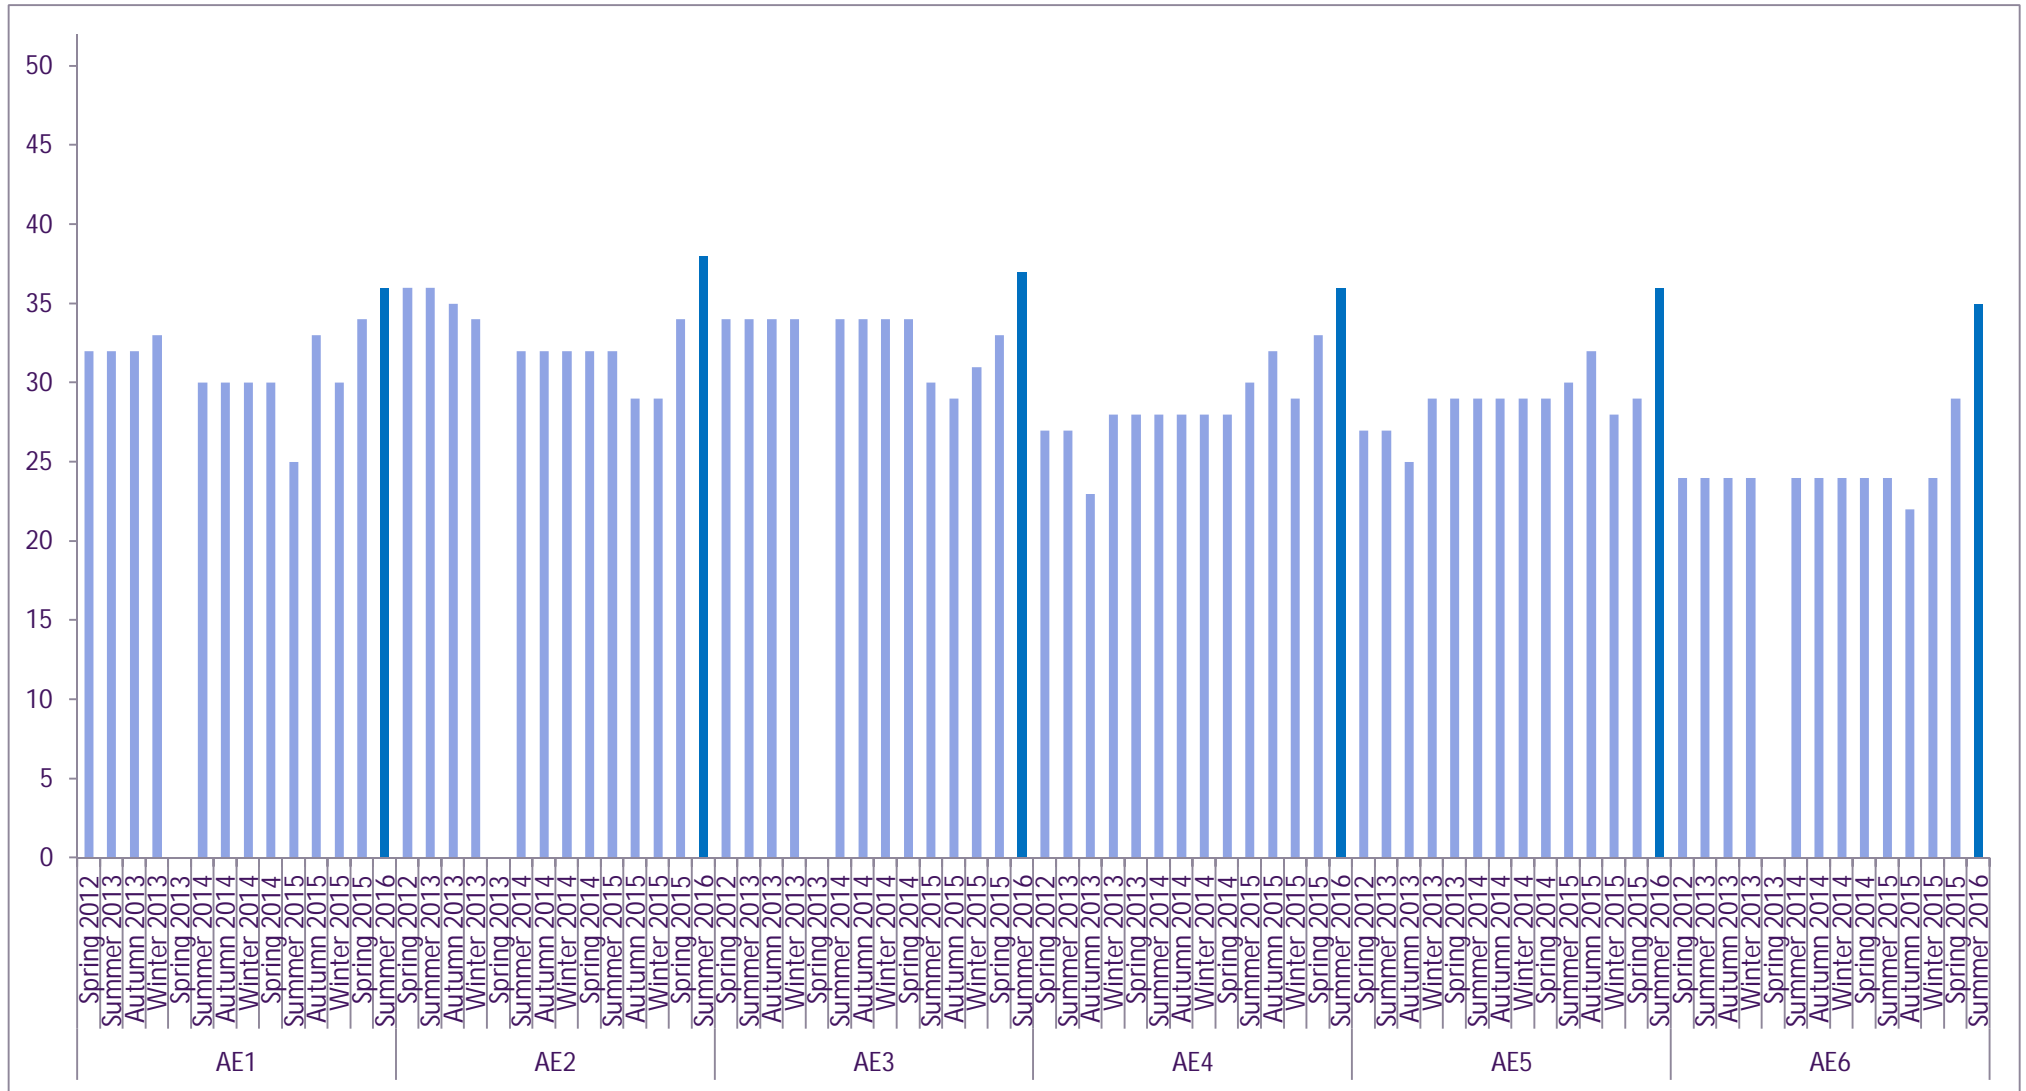
Figure 5-2 Site condition scores for the RCE Inventory (dark blue bars represent results from spring 2015).
