Rooty Hill Regional Distribution Centre

Annual Environmental Monitoring Report 2012 - 2013

Document title: Annual environmental monitoring report 2012-13

Document no. EN03250 170914

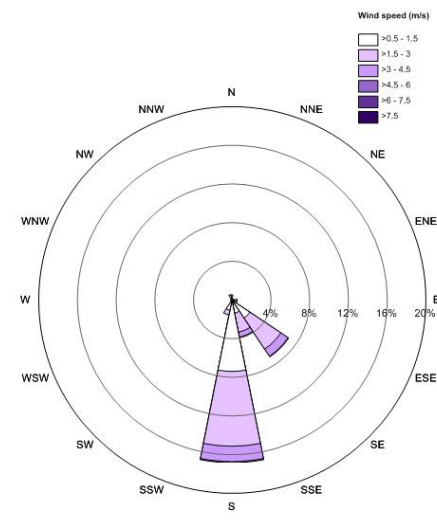
Figure 2-3 Monthly wind roses – October 2012 to June 2013

Available wind speed and direction data have been summarised for each month in Figure 2-3. It can be seen that a large proportion of winds are from the south and south east and are generally light. During all but the spring months, south to south-easterly breezes dominated but in September, the breeze came largely from the north-west.

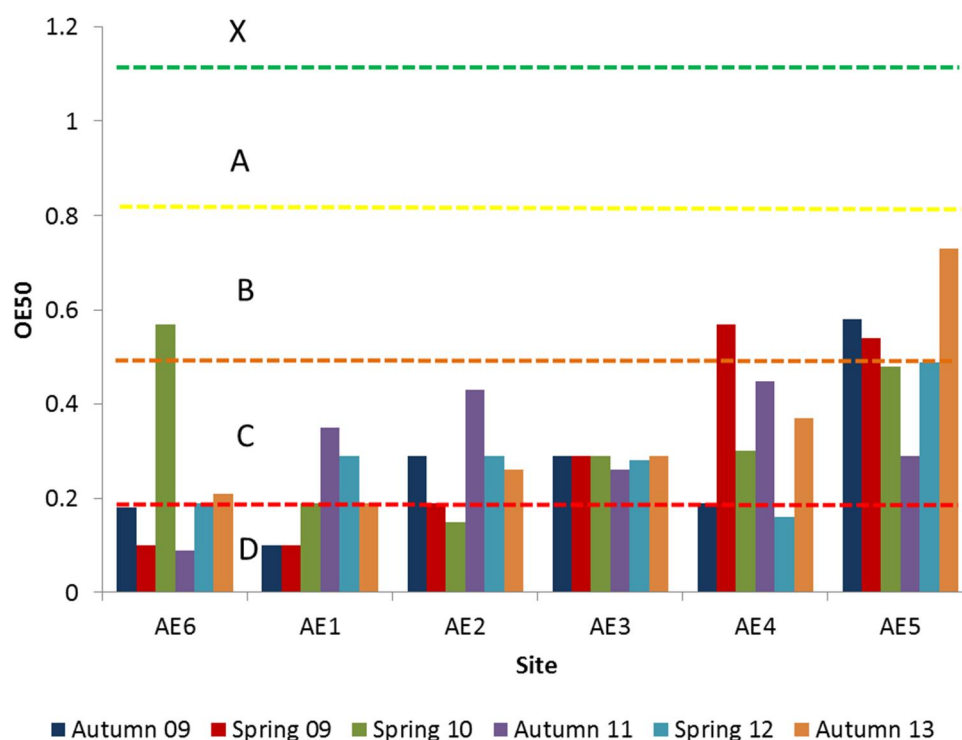
Figure 3-3 AUSRIVAS bands

AUSRIVAS OE50 scores and resulting Bands also indicated that sites were severely (band C) or extremely impaired (band D), except AE5 in Spring which was significantly impaired (band B).

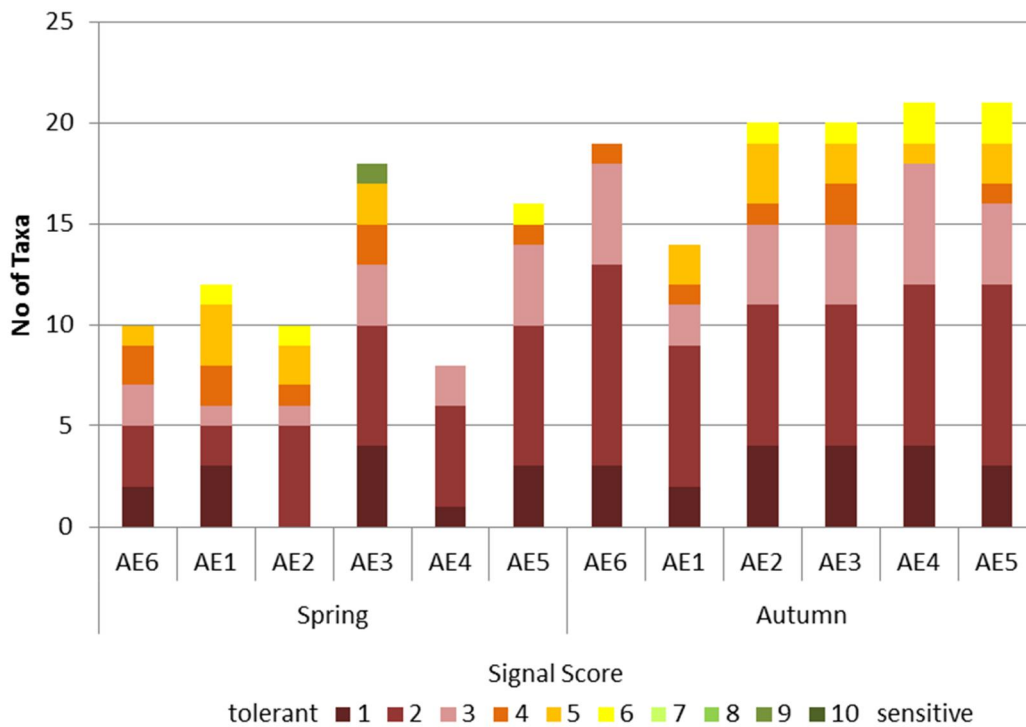
Figure 3-4 Contribution of macroinvertebrate taxa to SIGNAL scores in 2012-2013.

The number of taxa in each SIGNAL grade contributing to overall site SIGNAL scores are displayed Figure 3-4. A large proportion of taxa were tolerant and moderately tolerant taxa from SIGNAL grades 1, 2 and 3. Figure 3-4 also reiterates the lower taxa richness in Spring and highlights the consistent increase in richness in Autumn across all sites. Seasonal effects are probably responsible for the increase in richness as the pattern was evident at both reference and impact sites.

Note: The stacked bars represent the number of taxa which contribute to each SIGNAL score grade, where red bars represent the more tolerant species and yellow and green bars represent the more sensitive species. Sites are listed in order from upstream (AE6) on Angus Creek to downstream. Sites AE4 and AE5 are downstream on Eastern Creek.

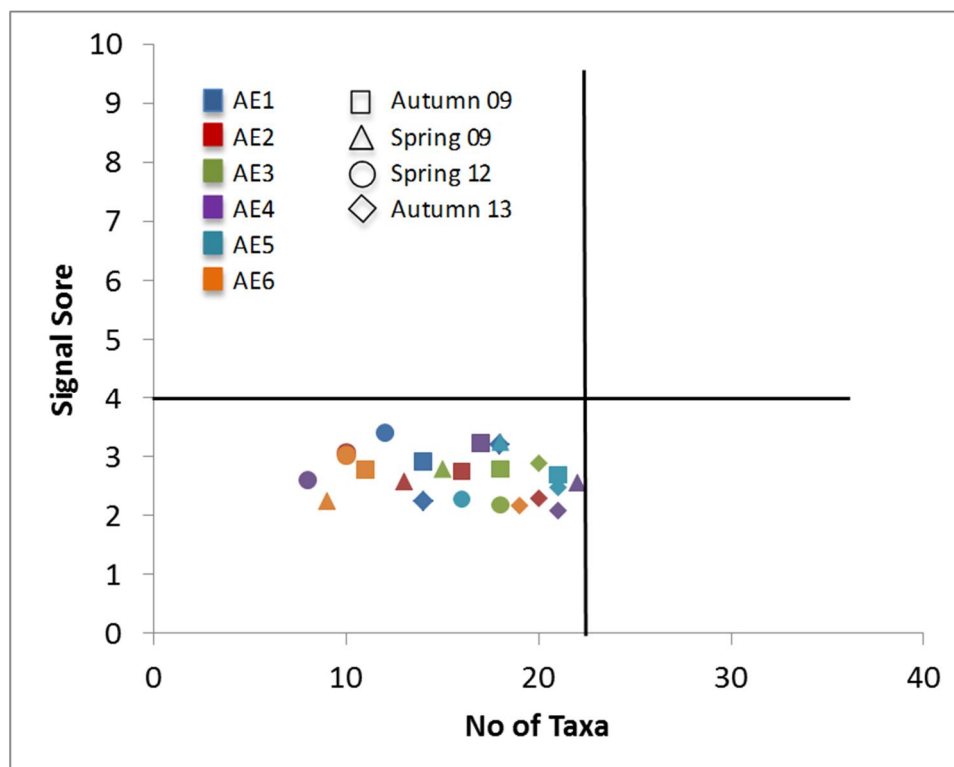
The 2012-13 macroinvertebrate SIGNAL scores were compared to the available data from 2009. A bi-plot of site SIGNAL scores against the number of taxa (richness) was used to identify any temporal changes in the sites (Figure 3-6). No consistent pattern emerged between sites and seasons (refer to legend; sites represented by different colours and seasons represented by different shapes) although sites AE1 (dark blue) and the reference site AE6 (orange) tended to have fewer taxa. SIGNAL scores were relatively consistent across sites although Autumn 2013 (diamond shape) showed overall lower SIGNAL scores but higher number of taxa compared to other seasons.

Figure 3-6 Biplot of macroinvertebrate sites over four sampling seasons from 2009 and 2012-13. Note: Reference sites (AE6:orange and AE5:light blue) did not plot differently to other sites.

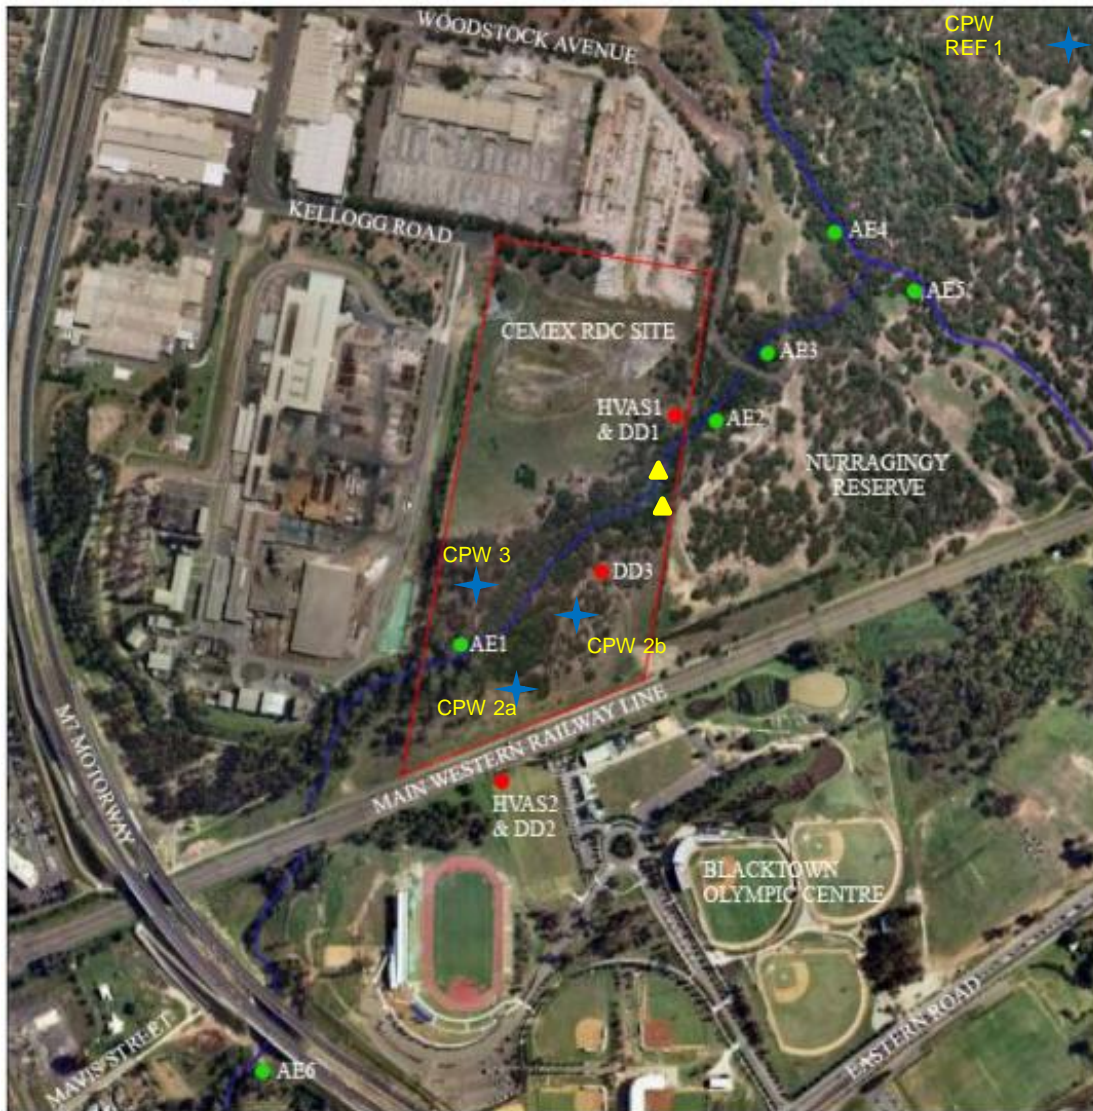
Figure 4-1 Monitoring locations

Monitoring locations included the following, which are illustrated in Figure 4-1.

- ▲ Juniper-leaved Grevillea populations - North and South of Angus Creek
- Riparian health assessment - AE1 to AE6
- ★ Cumberland Plain Woodland CEEC- Rooty Hill RDC site and Nurragingy Nature Reserve (CPW 2a, CPW 2b, CPW 3, CPW Ref)

Riparian health and condition monitoring was conducted at the six established monitoring sites quarterly during dry weather (refer Figure 4-1).

Cumberland Plain Woodland (CPW) was monitored as a baseline assessment (pre-Stage 2 construction) of the three zones (or conditions) of the woodland on the Rooty Hill RDC site and an assessment of one external reference CPW site in close proximity to the site (refer Figure 4-1). The field methodology aligns with current industry best practice for describing vegetation condition in relation to biodiversity offsets. This methodology will provide a useful baseline upon which to describe improvements resulting from bushland regeneration efforts that are required at the site as part of the conditions of approval for the project as well as identifying any condition changes as a result of the project.

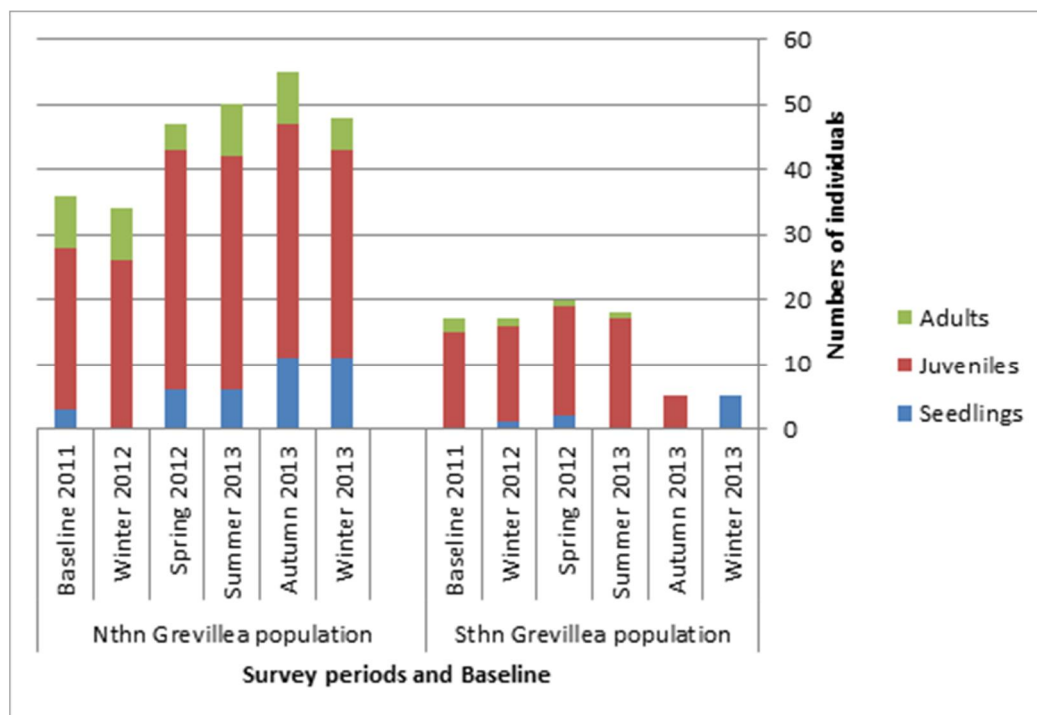
Figure 4-3 Population dynamics of the northern and southern populations of the Juniper-leaved Grevillea since the baseline survey

Figure 4-3 illustrates the population dynamic of the southern population highlighting that juvenile plants dominated the population profile. The winter 2013 data point represents the new growth at the site post-fire which represents 5 seedlings observed during that survey.

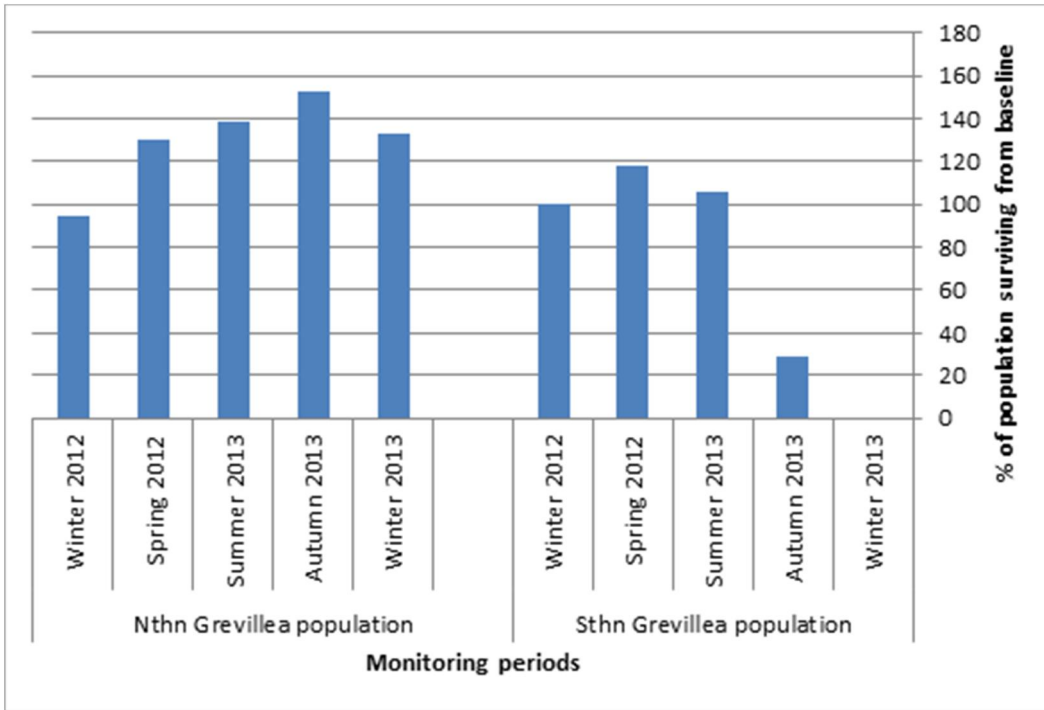
Figure 4-4 The proportion of the northern and southern populations of the Juniper-leaved Grevillea surviving since baseline

Figure 4-4 illustrates the reasonably stable but lower proportion of individuals surviving at the site since the baseline survey in comparison with the northern population which exhibited high juvenile recruitment over the spring and summer period (2012). The reproductive potential of the southern population (demonstrated by the proportion of individuals with evidence of fruiting or flowering) was also lower than the northern population as illustrated in Figure 4-5.

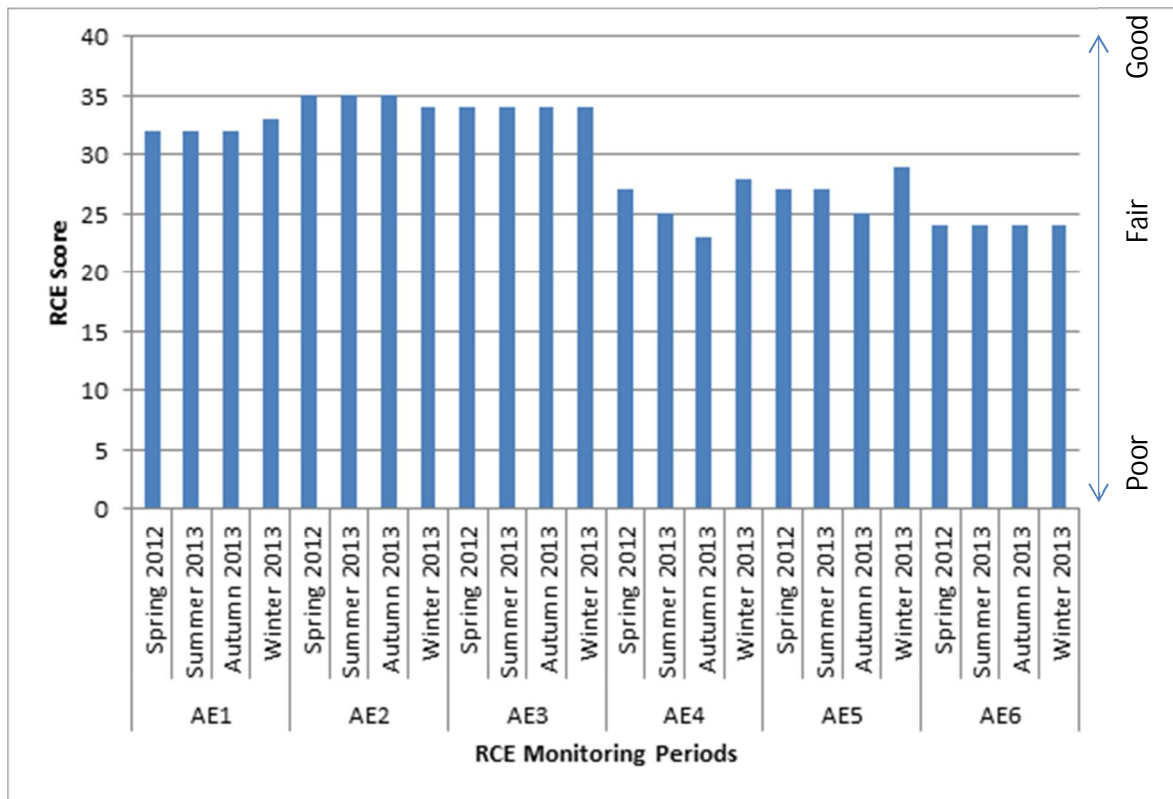
Figure 4-7 Seasonal trends in riparian channel and environment attributes

Figure 4-7 illustrates the seasonal trends in the riparian channel and environment attributes monitored at AE1 to AE6. All monitoring locations have consistently maintained a Fair condition over the four seasonal survey periods. The Rooty Hill RDC monitoring site (AE1) showed more intact riparian channel characteristics than either reference site for almost all parameters.

A small change in stream bank structure was observed at AE1 and AE2; however this was not significant enough to alter the score. These results suggest that major alterations are required to the stability of both Eastern Creek and its tributary both upstream and downstream of the Rooty Hill RDC site.
