Holcim

2020 Annual Review

1 July 2018 – 31 December 2020

Rooty Hill Distribution Centre

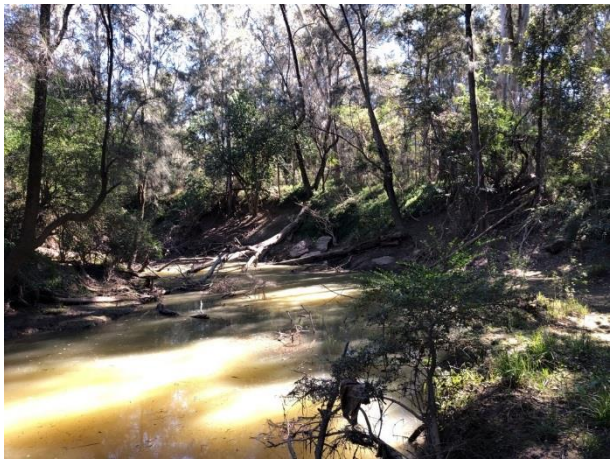
AE4: Eastern Creek downstream

Attribute	AE3 DOWNSTREAM
Riparian	Vegetation	Dominant tree species was *C. glauca*). Dominant grass/herb species was Wandering Jew (*T. fluminensis)*
	Stream shading	Moderate shading
	Exotic vegetation	*L. Lucidum*, *T. fluminensis*
Stream characteristics	Modal width	4 metres
	Bank Condition	Stable, steep, exposed in sections however no significant erosion.
	Substrate	Fine sediment
	Flow/depth	Low flow/~1 metre
	Macrophytes/algae	Ribbon Weed (*Vallisneria* sp.*)*
	Water quality observations	Water opaque in colour.
Comments		Exotic fish *G. holbrooki* observed. Significant amount of rubbish present

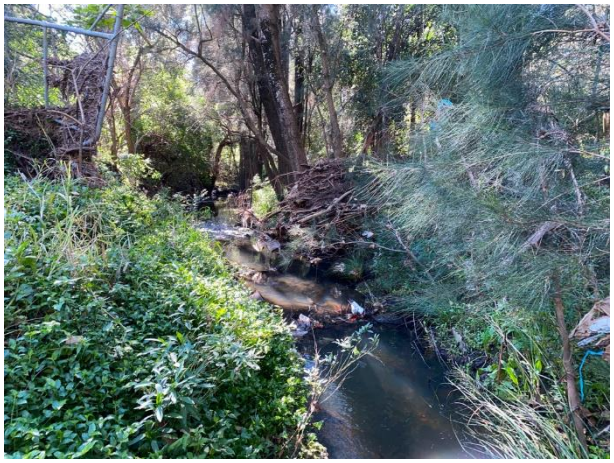
AE2: Angus Creek

Attribute	AE2 DOWNSTREAM
Riparian	Vegetation	Dominant tree species included (*C. glauca*). Dominant groundcover was (*T. fluminensis*) and mixture of exotic and native grasses and herbs.
	Stream shading	Moderate shading
	Exotic vegetation	*T. fluminensis* and other groundcover species.
Stream characteristics	Modal width	2 metres
	Bank Condition	Soft, bank vegetation stripped away in sections
	Substrate	Silt and boulder, large woody debris and organic matter
	Flow/depth	Low-Moderate flow/>1 metre
	Macrophytes/algae	Emergent macrophytes present – Bulrush (*Typha* sp.), *Cyprus* sp. *Potamogeton crispus*
	Water quality observations	Clear, moderate flow
Comments		Weeds and rubbish. Riparian vegetation and bank eroded by water flow and deer tracks

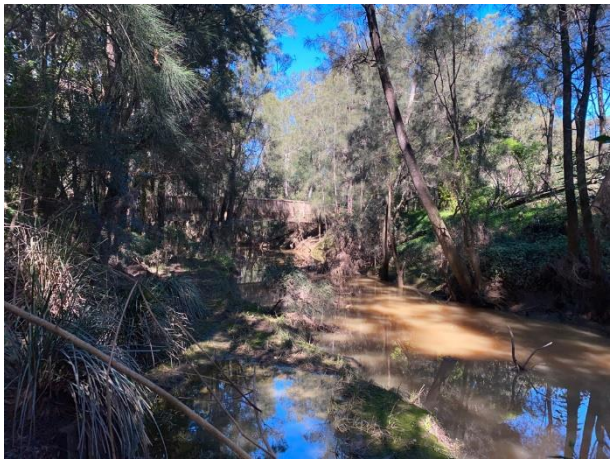
AE4: Eastern Creek downstream

Attribute	AE3 DOWNSTREAM
Riparian	Vegetation	Dominant tree species was *C. glauca*). Dominant grass/herb species was Wandering Jew (*T. fluminensis)*
	Stream shading	Moderate shading
	Exotic vegetation	*L. Lucidum*, *T. fluminensis*
Stream characteristics	Modal width	4 metres
	Bank Condition	Stable, steep, exposed in sections however no significant erosion.
	Substrate	Fine sediment
	Flow/depth	Low- Moderate flow/~1 metre
	Macrophytes/algae	Ribbon Weed (*Vallisneria* sp.*)*
	Water quality observations	Water slightly brown in colour/clear
Comments		Significant amount of rubbish present. Flood debris high on bank and on foot bridge

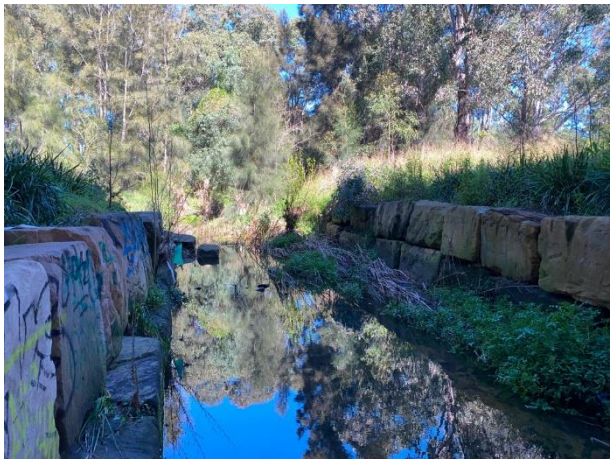
AE6: Angus Creek upstream

Attribute	AE5 UPSTREAM
Riparian	Vegetation	Dominant overstorey species was *C. glauca*. Dominant grass/herb was Lomandra (*Lomandra longifolia*) and groundcover *T. fluminensis.*
	Stream shading	Moderate
	Exotic vegetation	*T. fluminensis*
Stream characteristics	Modal width	5 metres
	Bank condition	Exposed, very soft
	Substrate	Fine sediment and large woody debris.
	Flow/depth	Moderate flow/ >1 metre
	Macrophytes/algae	Macrophytes not present.
	Water quality observations	Turbid
Comments		Significant amount of large woody debris/plastics/picnic table present in creek
