# **ANNUAL REVIEW**

**1 January 2023 – 31 December 2023**

**Jandra Quarry**

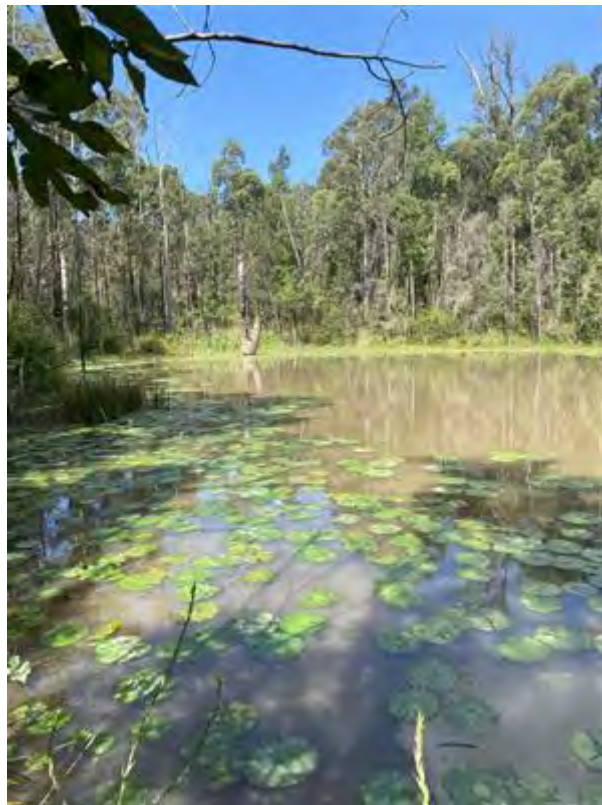
**Plate 2** Dam below rehabilitated area.

A walkover of the edge of the Settlement Dam revealed good vegetation coverage along the dam walls and no areas of erosion or unintended water leakage were apparent. Some exotic species, such as *Lantana camara* (Lantana), *Solanum mauritianum* (Tobacco Bush) and *Paspalum sp.* have established themselves along the dam walls. Despite this, there is still good native species coverage, with species such as *Acacia longifolia*, *Acacia maidenii* and *Eucalyptus spp.* being the most common (**Plate 2**). Some evidence of erosion was noted on the top of the dam wall, this was small in nature and should be monitored for ongoing stability.

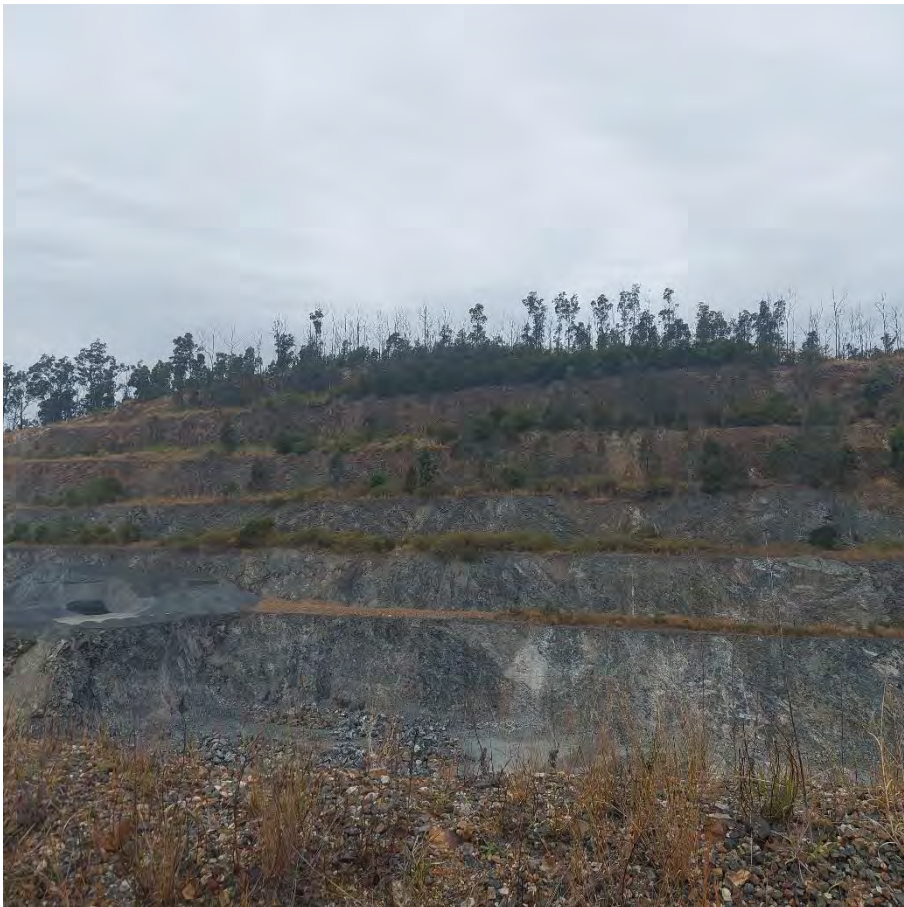
**Plate 4** Rehabilitated benches along the eastern side of the AP area.

Bench condition was interpreted as best as possible from a visual inspection at a safe distance, and via photos (**Plate 4** and **Plate 5**). Some new erosion (minor land slip) was identified along the high wall (above the "white line") access track along the western AP area (**Plate 6**). Along the north-eastern AP area (ROM) previously noted excavated material falling into a Settlement Dam, appears to have settled and roughly matches the previous photograph (**Plate 7** shows June 2023). Furthermore, this area contains a high cover of Lantana (**Plate 8**).

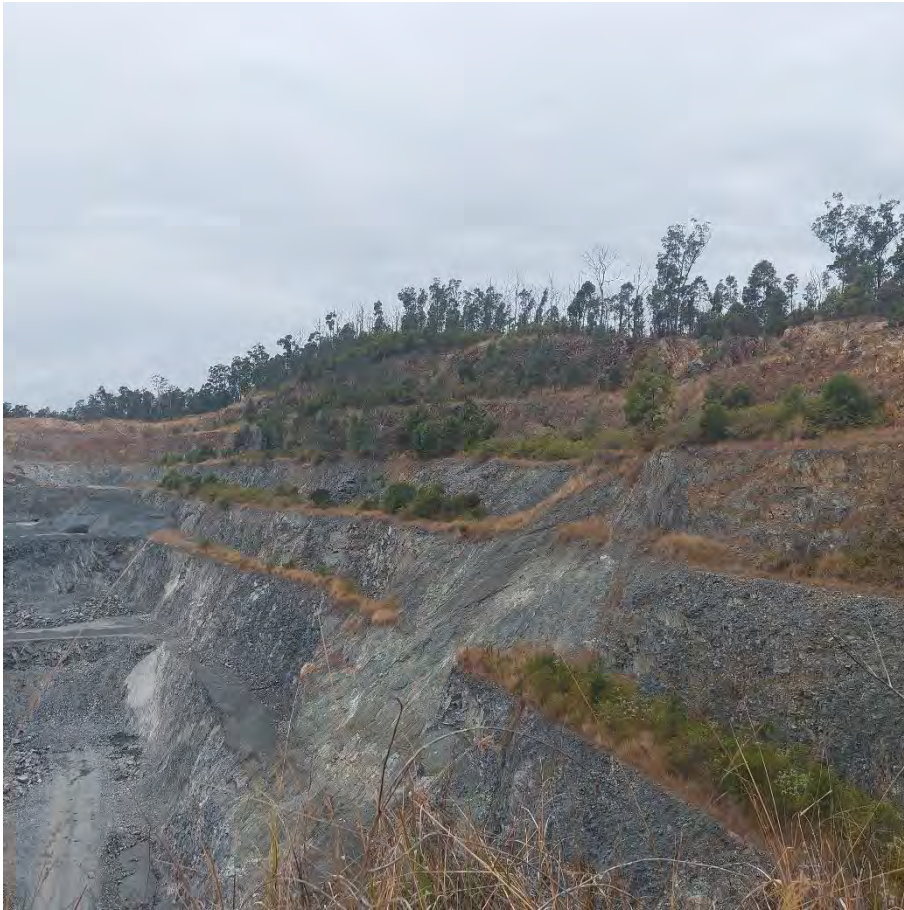
**Plate 5**      **Rehabilitated benches along the eastern side of the AP area.**

Along the eastern rehabilitated benches, the upper benches show the highest cover of native species (namely *Eucalyptus spp.*) which are evidence of previous tubestock planting. The lower benches have been allowed to naturally regenerate. These areas typically contain a greater cover of exotic species, such as *Lantana camara* (Lantana) (**Plate 5**).

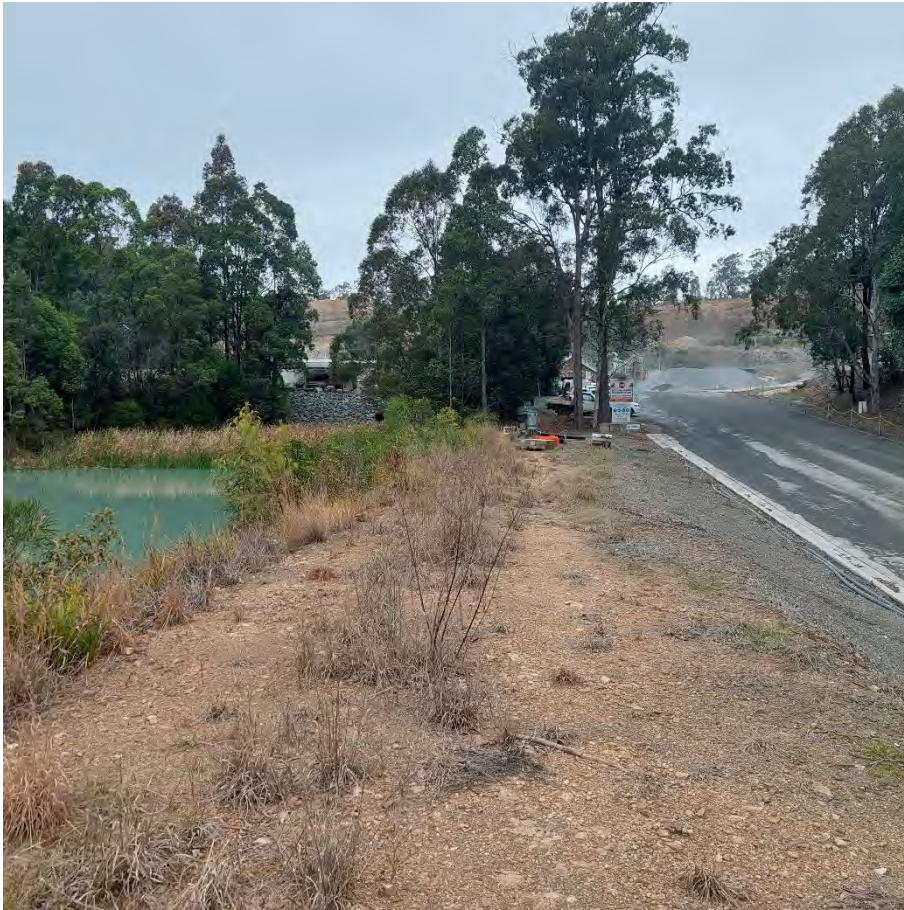
**Plate 9** Native species growth (*Acacia longifolia* and *Eucalyptus* spp.) along the Settlement Dam wall.

A walkover of the edge of the Settlement Dam revealed good vegetation coverage along the dam walls and no areas of erosion or unintended water leakage were apparent. Some exotic species, such as *Lantana camara* (Lantana), *Solanum mauritianum* (Tobacco Bush) and *Paspalum sp.* have established themselves along the dam walls. Despite this, there is still good native species coverage, with species such as *Acacia longifolia*, *Acacia maidenii* and *Eucalyptus spp.* being the most common (**Plate 9**). Some evidence of erosion was found along the bank from the Dam wall towards the road and along the former track from the Overburden Stockpile Area (it can be partially seen in **Plate 9**).

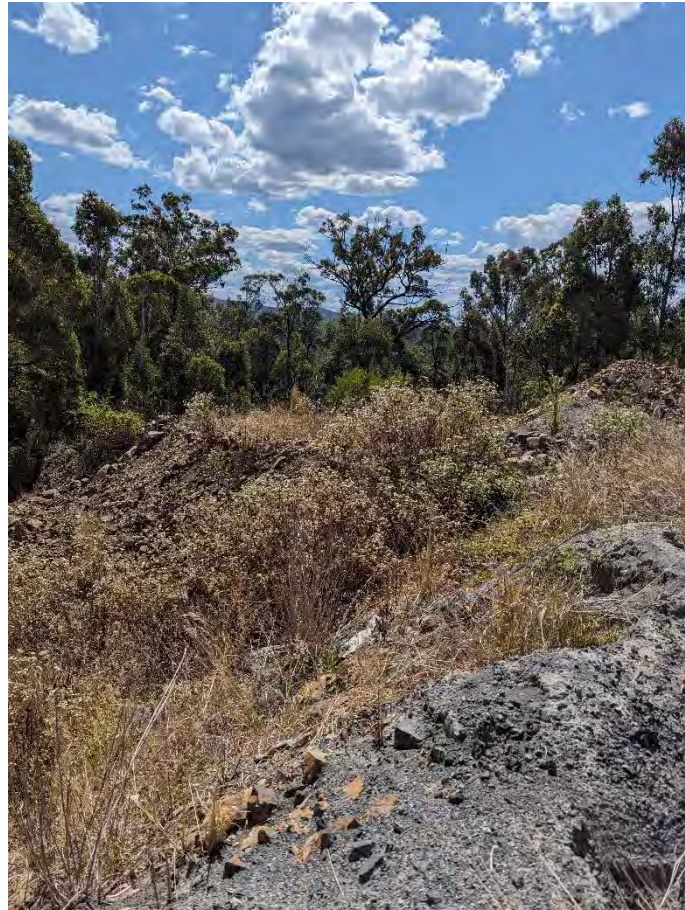
**Plate 3** Top of former track from dam near office to Overburden Stockpile Area.

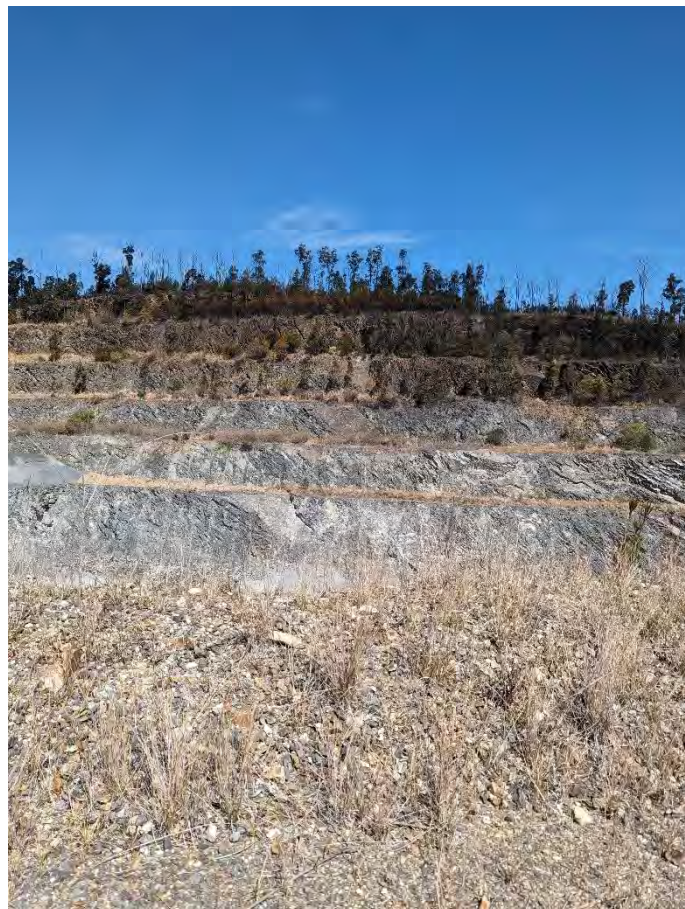
Bench condition was interpreted as best as possible from a visual inspection at a safe distance, and via photos (**Plate 4** and **Plate 5**). The drier weather has resulted in vegetation died off and browning. The weeds and undergrowth on the benches appear to be mainly affected. Some trees have also been affected. The erosion (minor land slip) was identified along the high wall (above the "white line") access track along the western AP area (**Plate 6**) was still evident and this section has been blocked off from vehicle traffic. From the White line looking across the pit it is evident that some grass has grown and been affected by the weather in former slip area. The Settlement Dam, (**Plate 7** shows Quarter 2 2023) contains a high cover of Lantana, though significantly drier in quarter 3 (**Plate 8** shows September 2023). Some blasting has also occurred in September, and was being prepared for when on site. A site further into the pit nearer the White line is being utilised for a dam and whilst onsite it was discussed that the current dam water will be moved to the new location for quarrying activities to take place.

As previously recorded, along the eastern rehabilitated benches, the upper benches show the highest cover of native species (namely *Eucalyptus spp.*) which are evidence of previous tubestock planting. The lower benches have been allowed to naturally regenerate. These areas typically contain a greater cover of exotic species, such as *Lantana camara* (Lantana) (**Plate 5**). As noted above the weather has affected the bench vegetation.

**Plate 4** Rehabilitated benches along the eastern side of the AP area.

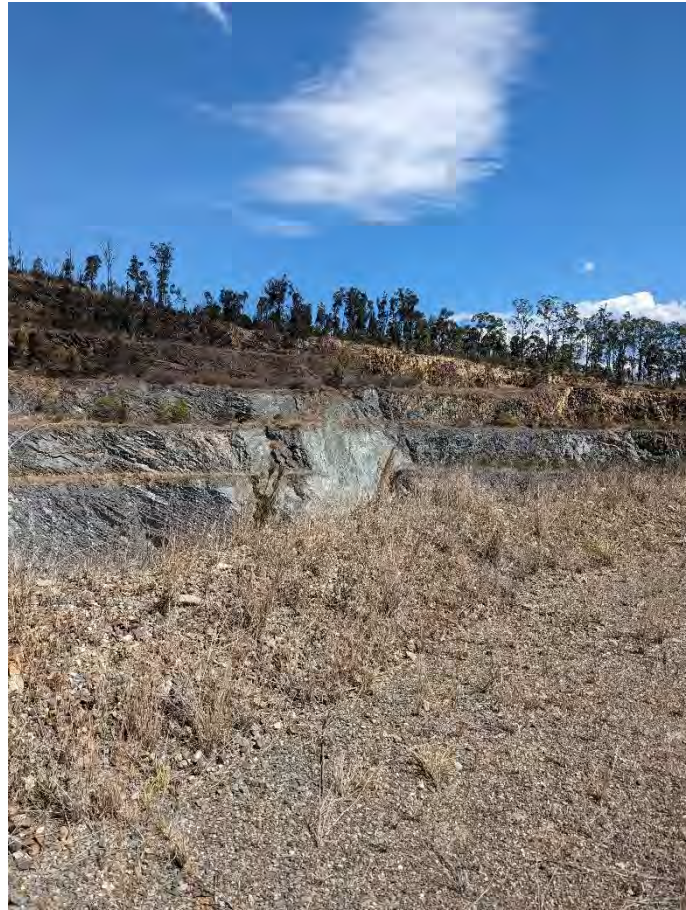
**Plate 5**      **Rehabilitated benches along the eastern side of the AP area.**

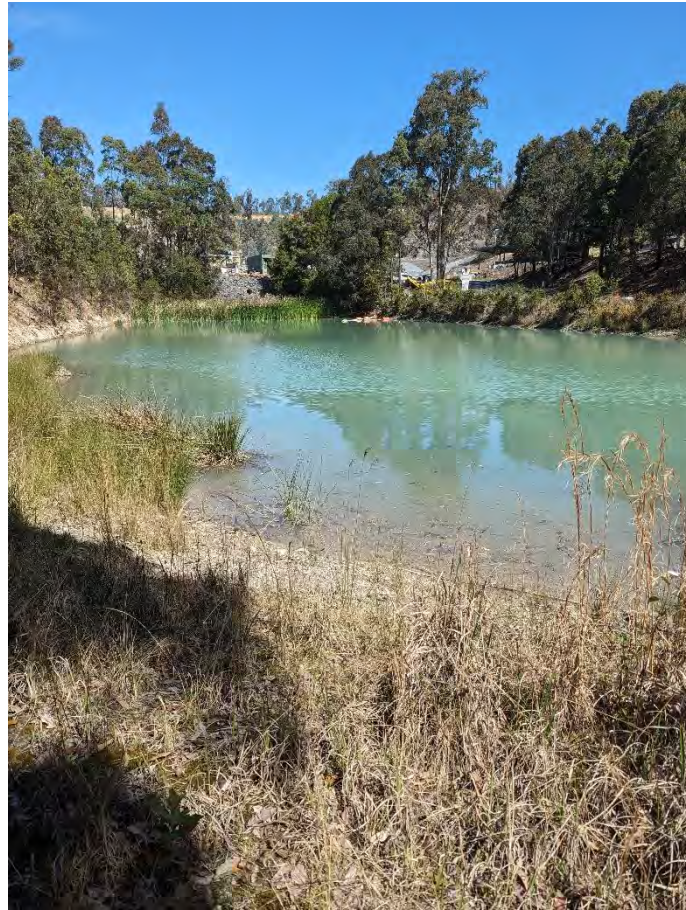
A walkover of the edge of the Settlement Dam revealed good vegetation coverage along the dam walls and no areas of erosion or unintended water leakage were apparent. Some exotic species, such as *Lantana camara* (Lantana), *Solanum mauritianum* (Tobacco Bush) and *Paspalum sp.* have established themselves along the dam walls. Despite this, there is still good native species coverage, with species such as *Acacia longifolia*, *Acacia maidenii* and *Eucalyptus spp.* being the most common (**Plate 9**). As with the Quarter 2 inspection, the September visit still has evidence of erosion along the bank from the Dam wall towards the road and along the former track from the Overburden Stockpile Area (it can be partially seen in **Plate 9**). This appears to be of a similar level of erosion.

**Plate 9** Native species growth (*Acacia longifolia* and *Eucalyptus* spp.) along the Settlement Dam wall.

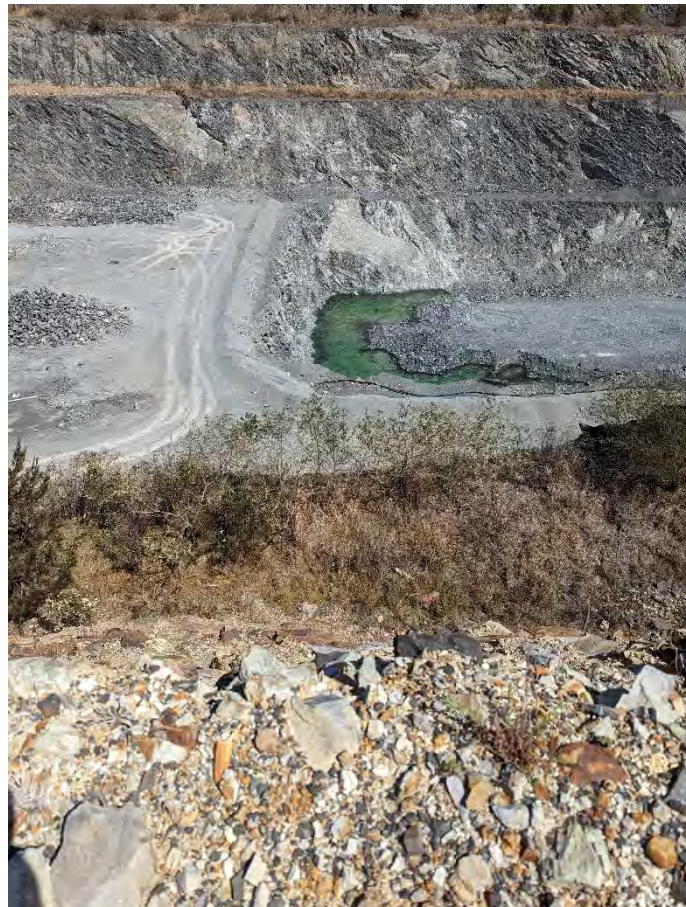
**Plate 10** New Dam Location.

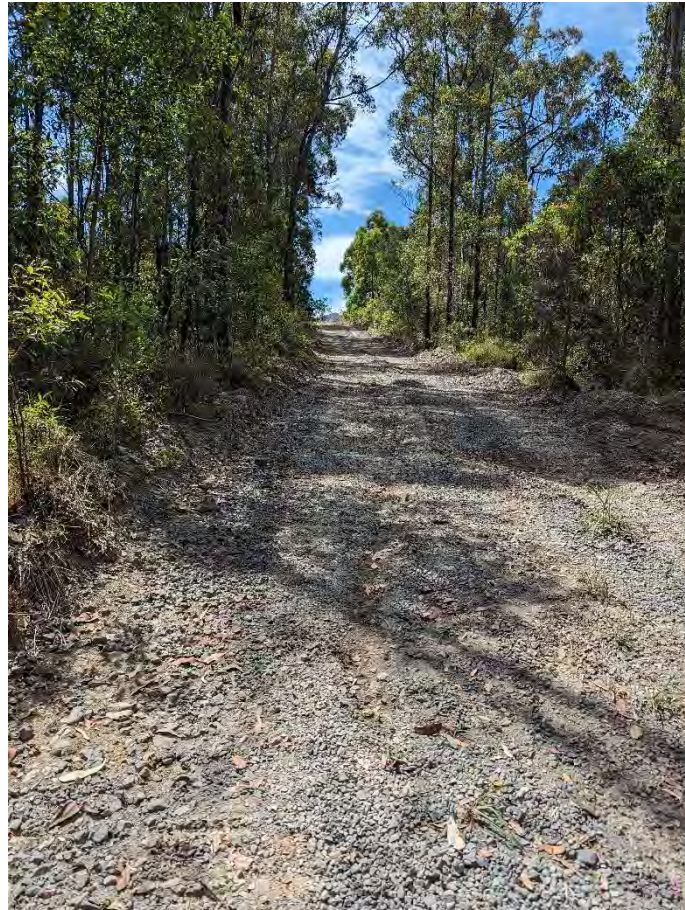
**Plate 3** Renewed office to Overburden Stockpile Area Track.

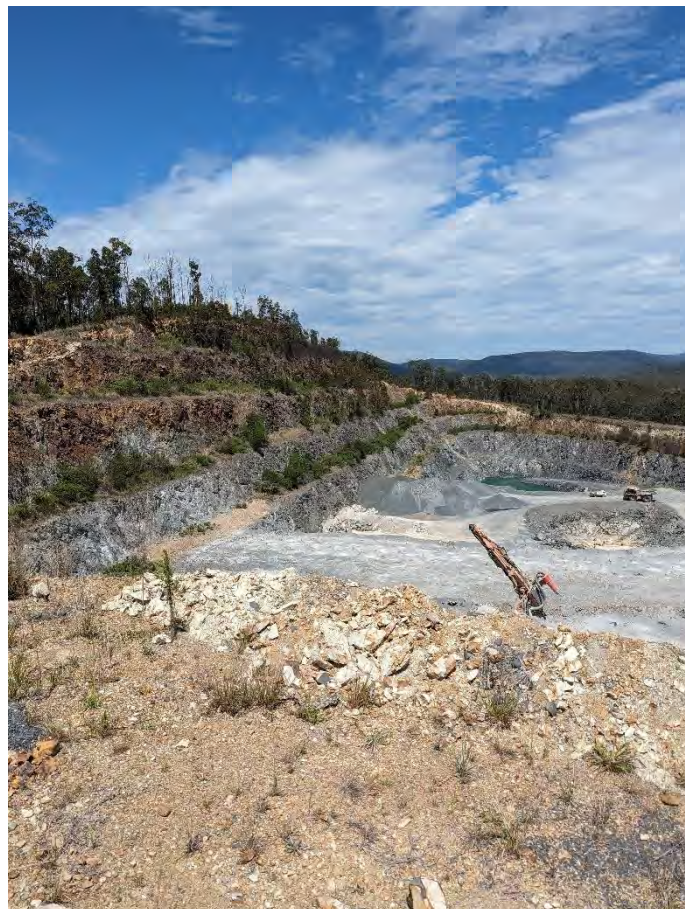
Bench condition was interpreted as best as possible from a visual inspection at a safe distance, and via photos (**Plate 4** and **Plate 5**). As per the September visits, the previous drier weather has resulted in sustained vegetation browning and die-off, predominantly in the undergrowth. However, there was an increase in rainfall between Quarter 3 and Quarter 4 visits, which has promoted the regrowth of the undergrowth vegetation. A minor land slip was identified along the high wall (above the "white line") access track along the western AP area (**Plate 6**) causing this section to be blocked off from vehicle traffic. The end closest to the power line easement (approximately 100 metres) has had substantial regrowth, predominantly grass and weed species that have filled in the track, with minimal soil exposure. The former Settlement Dam in the active pit area, (**Plate 7** shows Quarter 2 2023) contains a high cover of Lantana (**Plate 8** ). A large amount of surface variation has occurred between Quarter 3 and Quarter 4, with the Settlement Dam in the active pit moved to the south and excavation of the former dam occurring. Blasting and excavation work near the benches on the eastern side has also occurred, impacting a very small section of bench vegetation, though this is not considered to be beyond recovery.

**Plate 4** Rehabilitated benches along the eastern side of the AP area.

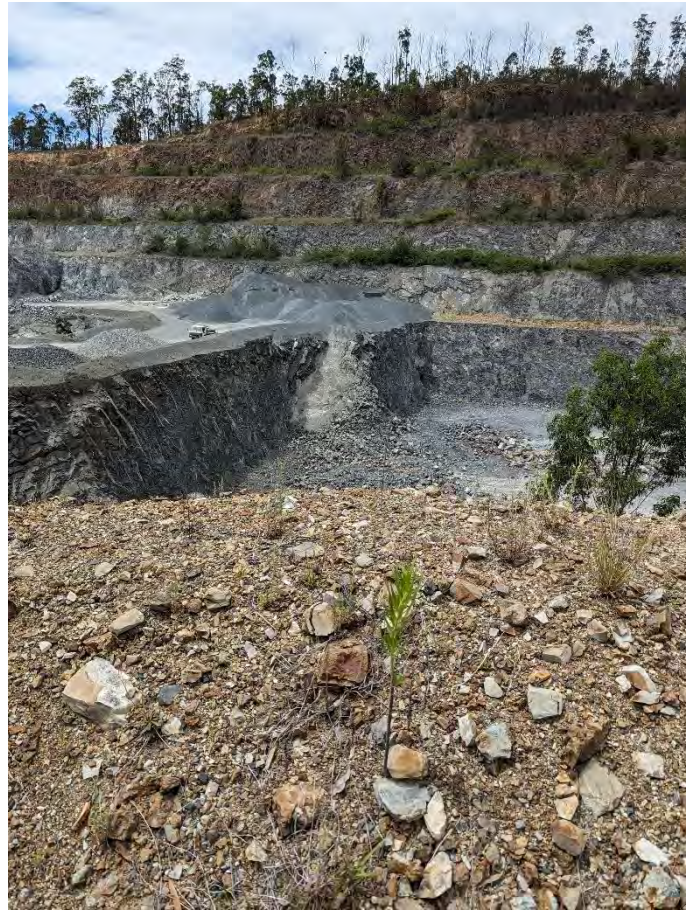
As previously recorded, the upper eastern rehabilitated benches show the highest cover of native species (namely *Eucalyptus spp.*) primarily from previous tubestock planting. The lower eastern benches have been allowed to revegetate, naturally. These areas typically contain a greater cover of exotic species, such as *Lantana camara* (Lantana) (**Plate 5**).

**Plate 5**      **Rehabilitated benches along the eastern side of the AP area.**

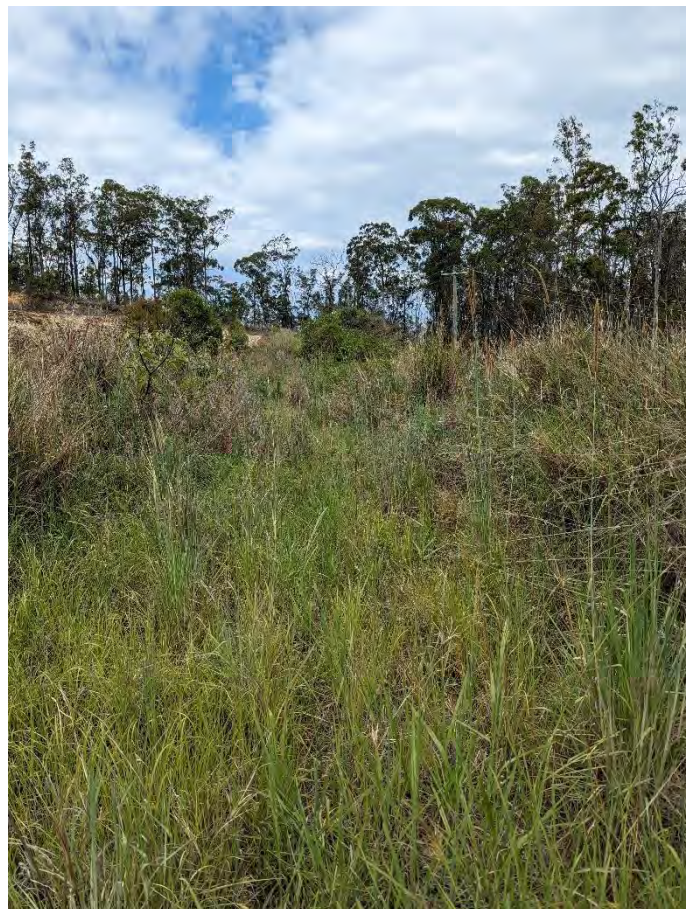
**Plate 6**      **Vegetation regrowth along the high-wall track of the western AP area.**

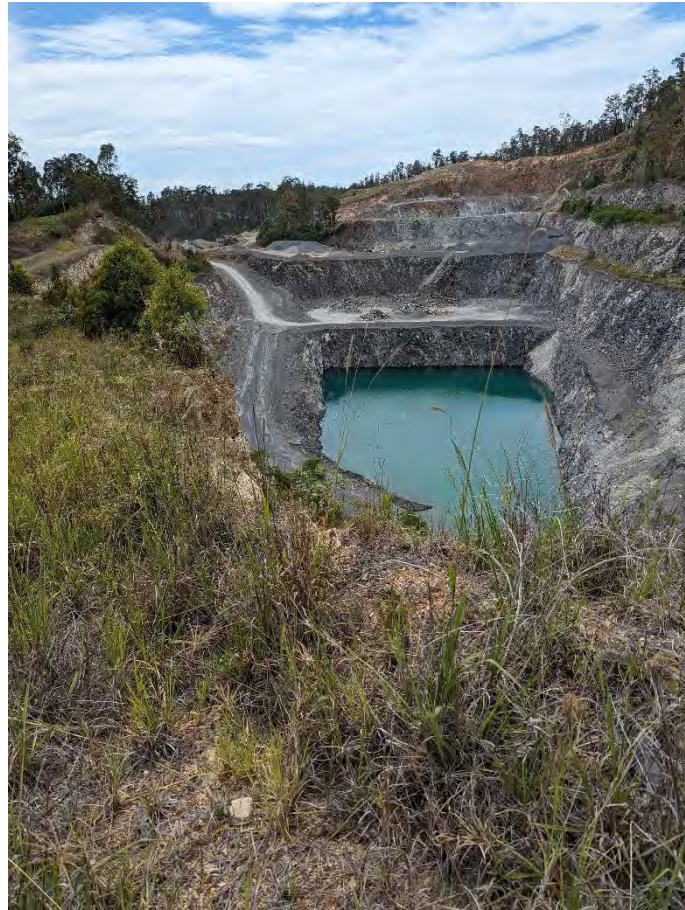
**Plate 7**      **New settlement dam in the AP area.**

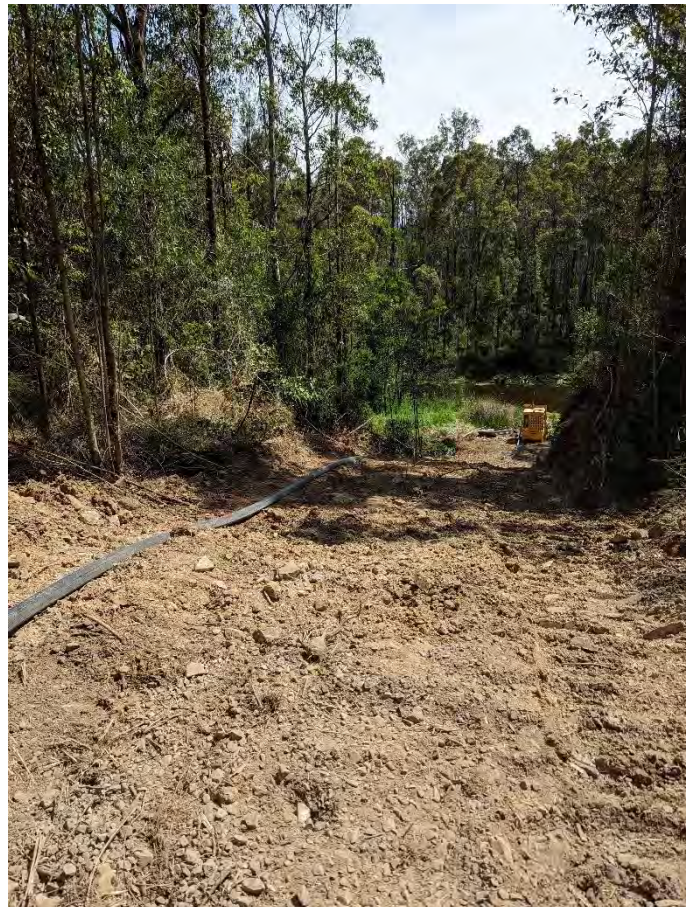
**Plate 10** Access track to lower Dam Location.

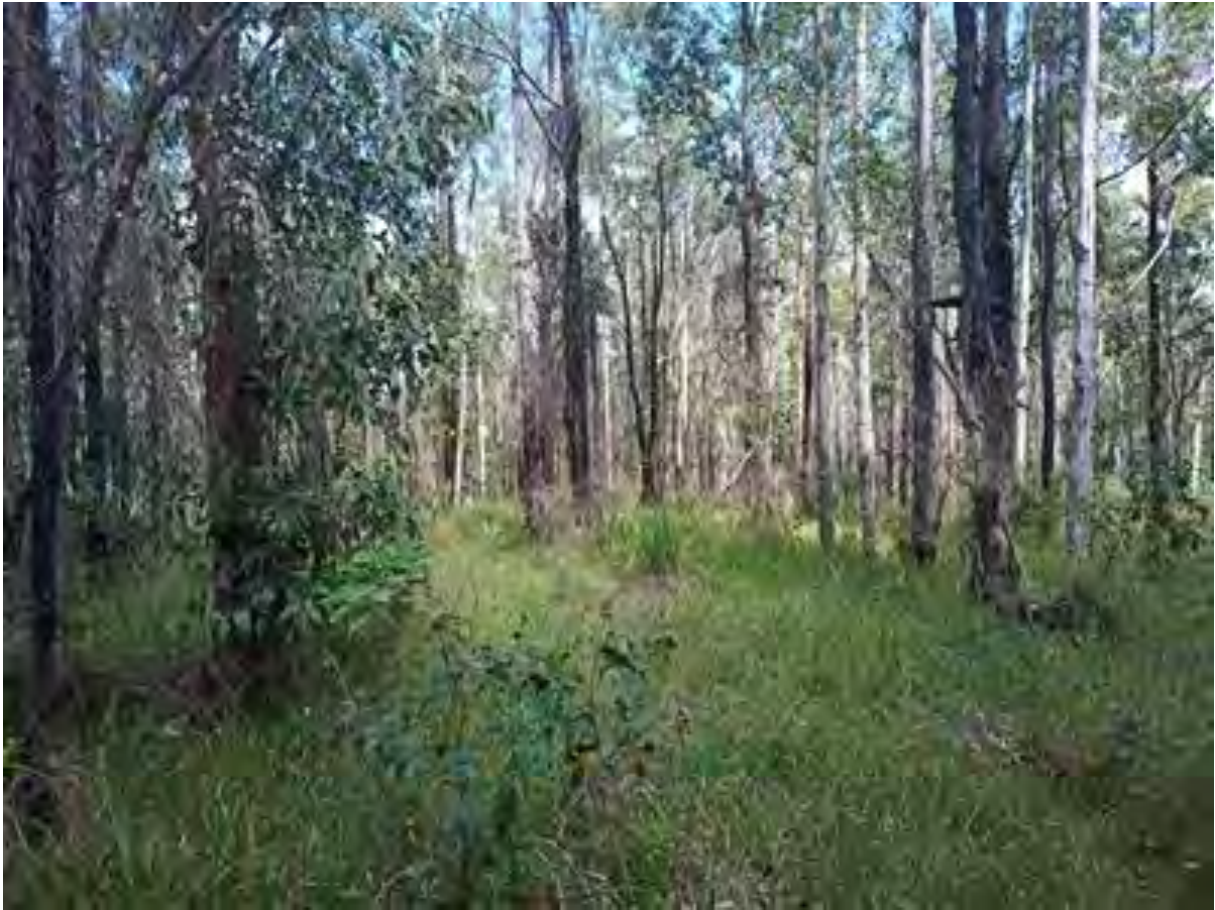
**Plate 1: Quadrat Q1 in the BOA.**

A total of 55 native species were recorded from the across the two vegetation quadrats with an average of 36 native flora species. The northern quadrat (Q1) (**Plate 1**) recorded 31 native species, while the southern quadrat (Q2) (**Plate 2**) recorded 41 native species (**Table 1**). A full species list is provided in **Appendix A**, including estimated numbers and coverage of each quadrat.

A total of 11 different exotic species were recorded from the monitoring quadrats with Q1 recording 9 exotic species and Q2 only 4 exotic species. Three of these species – *Bidens pilosa* (Cobblers Pegs), *Chloris gayana* (Rhodes Grass) and *Megathyrsus maximus* (Guinea Grass) – are listed as “High Threat” indicating that they have the potential to rapidly colonise areas of disturbance e.g. after fires. Of the remaining weed species, the woody weeds *Phytolacca octandra* (Inkweed) and *Solanum mauritianum* (Wild Tobacco) were recorded in both quadrats and can also pose a threat to revegetating or recovering native communities.

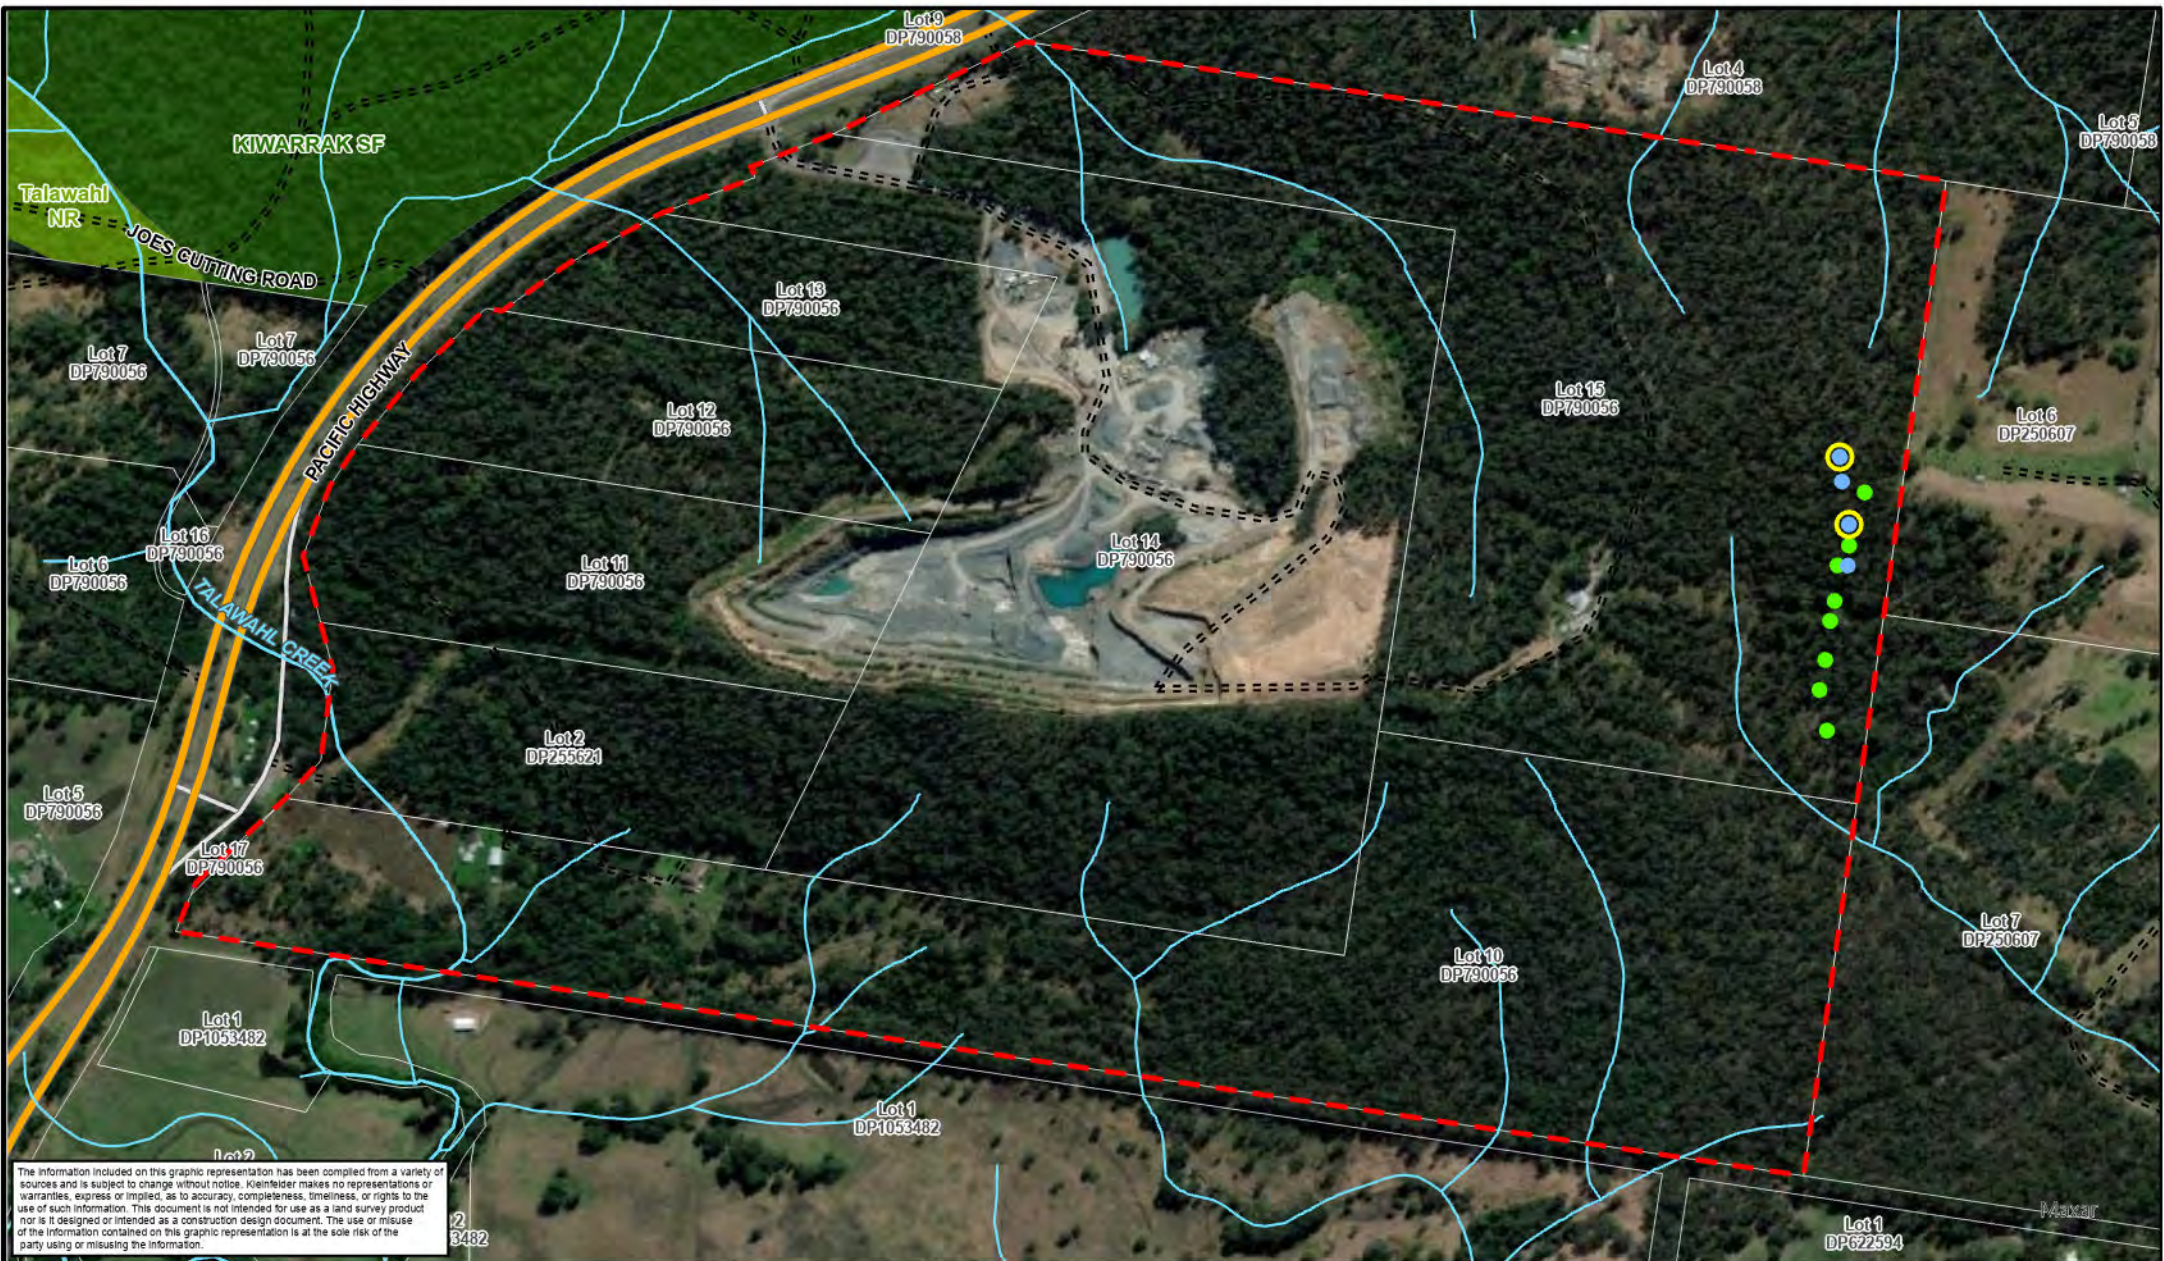
**Table 2: Nest Box Inspection Results**

Box ID	Result	Longitude	Latitude
Old Number 1	Fallen from tree – on ground still intact. Not occupied.	152.4646235	-32.04777824
Old Number 2	Brushtail possum ( <i>Trichosurus vulpecula</i> )	152.464639	-32.04738586
Old Number 3	Unable to be located	-	-
Old Number 4	Not occupied	152.4645639	-32.04697708
Old Number 5	Brushtail possum ( <i>Trichosurus vulpecula</i> )	152.4645398	-32.04674159
New Number 1	Not occupied	152.4644223	-32.04830722
New Number 2	Not occupied	152.4643657	-32.04867722
New Number 3	Not occupied	152.464299	-32.04896389
New Number 4	Not occupied	152.4643807	-32.04935222
New Number 5	Not occupied	152.464474	-32.04811556
New Number 6	Not occupied	152.464509	-32.04777556
New Number 7	Not occupied	152.464639	-32.04758722
New Number 8	Not occupied	152.4648173	-32.04708055

The BRMP recommends that nest boxes be checked for the first five years from initial installation phase. It is recommended that the eight new boxes installed in 2022 are monitored for the first five years, then as per the management plan, reassess the monitoring program, as required. Additionally, maintenance should be performed on the nestboxes, such as Old Nest Box Number 1 which has fallen from the tree and should be reattached for continued function. Inspections are required for maintenance / general condition, and could be associated with monitoring going forward.
