ANNUAL REVIEW
1 April 2022 – 31 March 2023

Northern Dune Extension

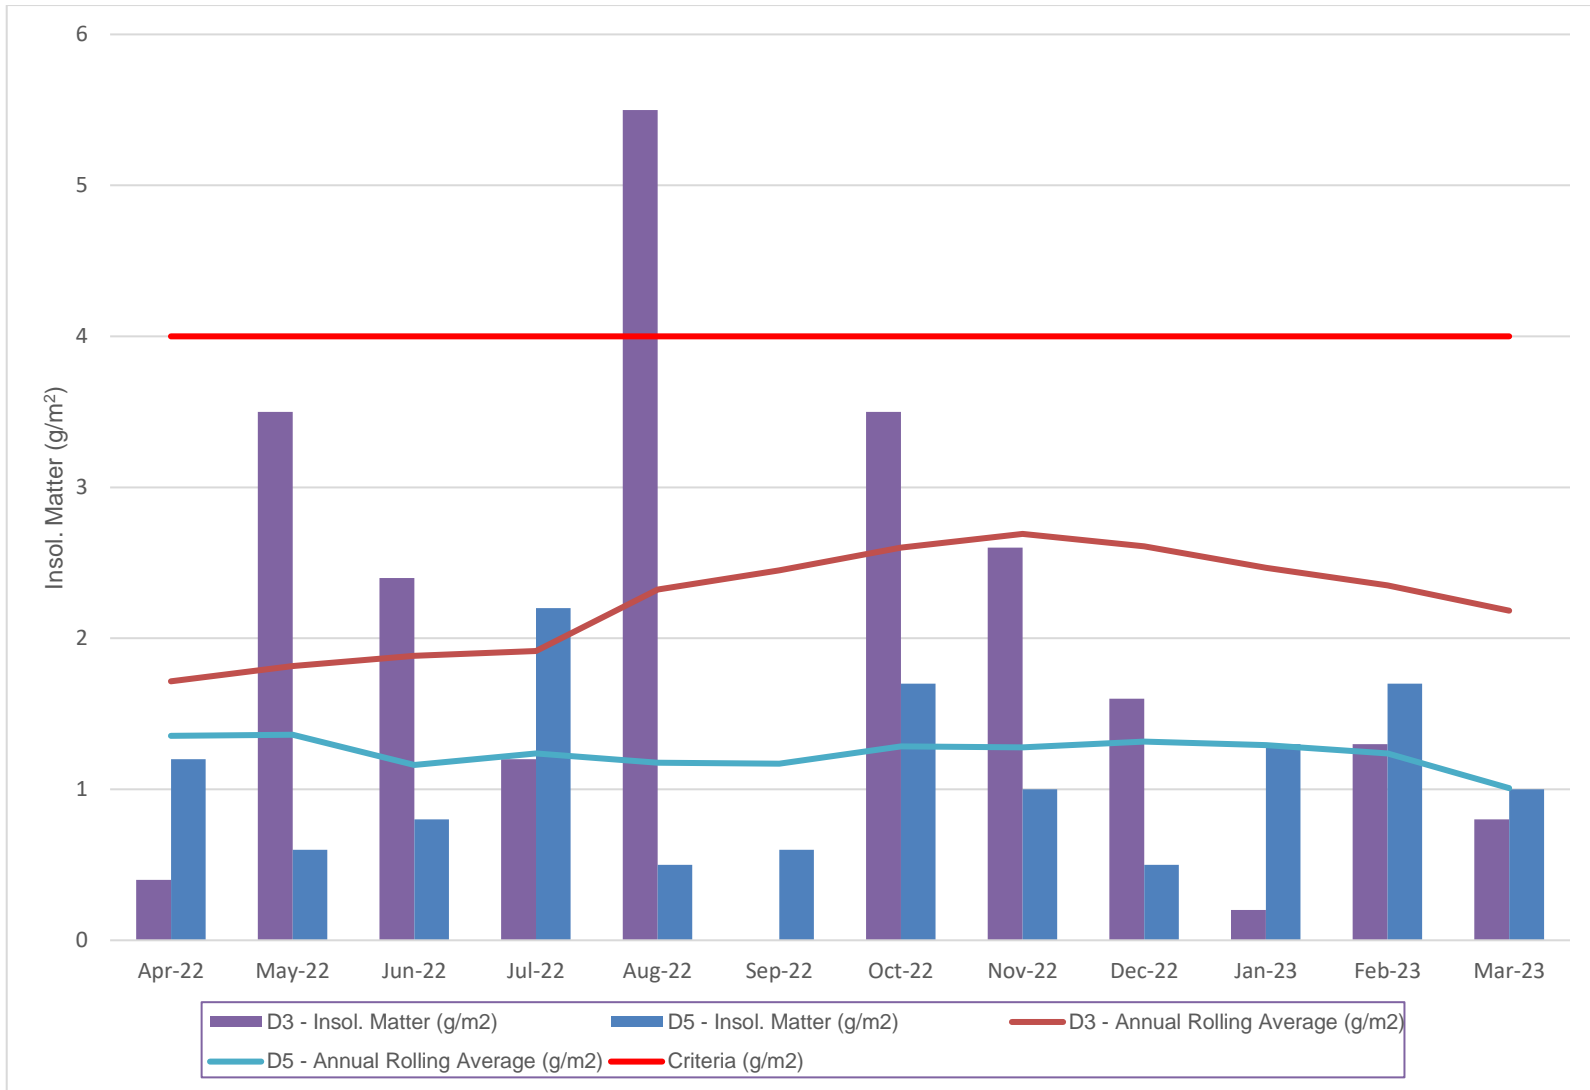
Figure 5: Insoluble Matter (g/m²) Monitoring results for the D5 / TB3 Monitoring Station and D3 / TB4 Monitoring Station

As seen in Table 10 and Figure 5, there was one single instance where measured deposited dust exceeded 4 g/m²/month at monitoring station D3 / TB4

The annual rolling average for both D3 / TB 4 and D5 / TB3 are below the trigger threshold under Schedule 3, Clause 6 of the conditions of approval for all months within the monitoring period.

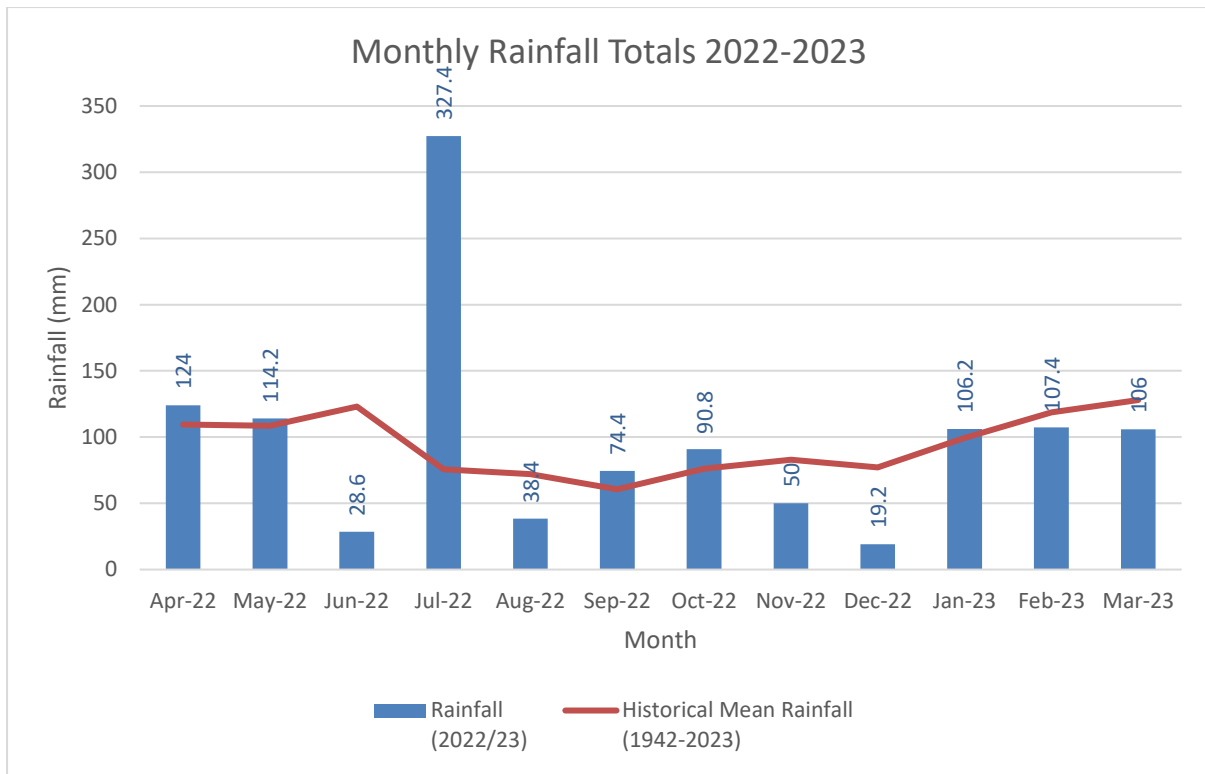
Figure 7: 2022/23 Monthly Rainfall at Williamtown RAAF

Annual rain monitoring data recorded at Williamtown throughout the reporting period has been included in Figure 7 for reference. During the reporting period, the highest recorded rainfall was in July 2022 with 327.4 mm being recorded. This was a very significant rain event that resulted in more than three times the monthly average rainfall. During this event, the majority of this rain fell heavily and consistently for consecutive days. There were further significant rainfall events in April 2022 (124 mm) and May 2022 (114.2 mm), and also above average rainfall in September 2022 (74.4mm), October 2022 (90.8mm) and January 2023 (106.2mm). December 2022 saw the lowest rainfall, with 19.2 mm falling throughout the month. The rainfall received is likely to influence the groundwater levels which respond to rainfall.

Table 16) demonstrate that there has been one exceedance of the Predicted Maximum Groundwater Extent (PMGE) during the reporting period except for during the exceptional rain events described. Rainfall such as this was experienced in the previous reporting period and is attributed to the La Nina weather phenomenon that has been experienced throughout the summers of 2021 and 2022/23 resulting in significantly increased rainfall events as demonstrated in Figure 7 which resulted in exceedances of the PMGE at ACI-3, ACI-4 and ACI-13.

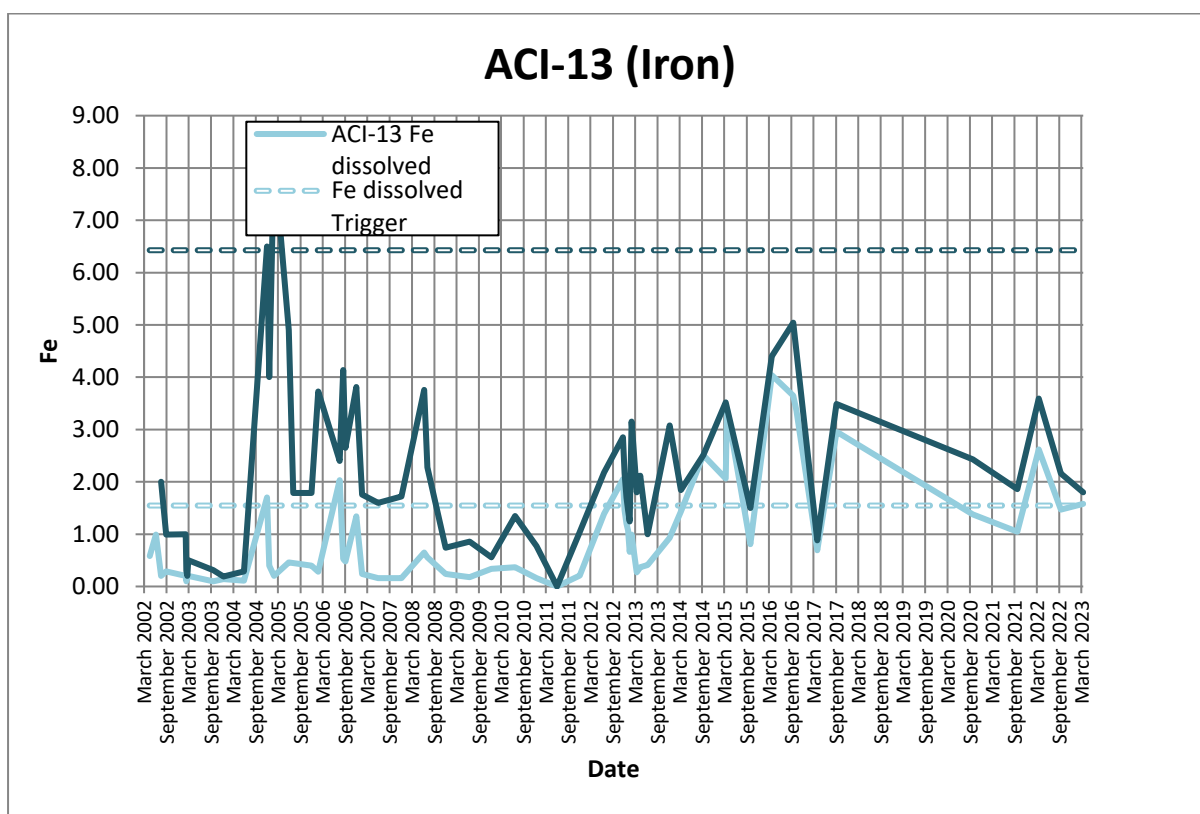
Figure 8: ACI-13 Iron Results Trend History

Groundwater quality at Northern Dune is driven by the nature of rainfall and properties of the unsaturated zone. Rainfall entering the soil zone undergoes significant changes in chemical composition and pH by processes such as root respiration and decomposition of organic matter via chemical reactions such as sorption and redox. The chemical constituency of infiltrating water in turn modifies groundwater chemistry by processes such as leaching, dilution but not concentration (which is protected against by licence conditions limiting depth to groundwater) as well as dissolution/precipitation. The effect of multiple processes on groundwater quality parameters and therefore setting Trigger Values is that water quality data is often multiple-modal (non-normal distribution) and so simple statistical analysis using mean and standard deviation may not adequately represent processes leading to water quality change. Water quality is dependent upon the nature of rainfall (ie. timing, intensity, duration...etc.) which determines whether infiltration provides a diluting effect and/or a leaching effect on ions and/or metals. Water quality can improve or deteriorate with rainfall and therefore timing of a small, limited sample set strongly influences the calculated trigger value.

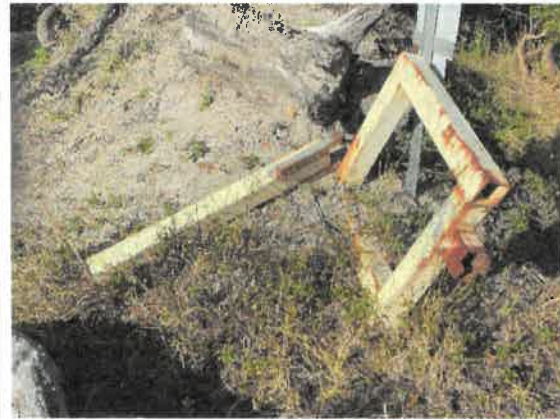
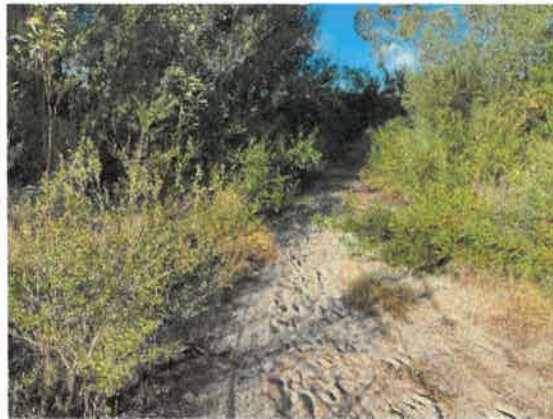
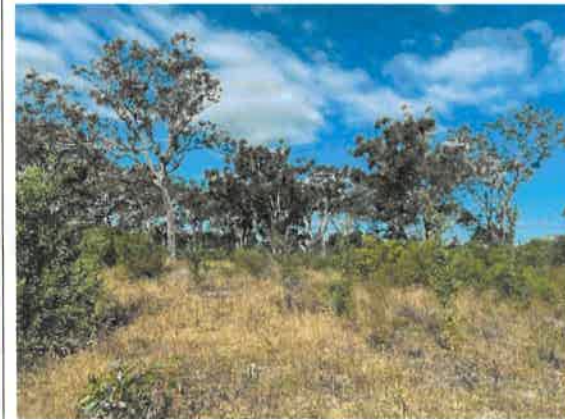
Site no longer extracting, site now non-operational and is under rehabilitation.	Compliance		Comments	Action	Who	When
	Yes	No				
GENERAL						
Complete a site boundary check to ensure that any risks posed by neighbours (such as discharge onto HOLCIM site, incorrect storage near fences, etc.) are identified and actioned.	✓		No material is stored near any fences or the likelihood of discharge onto Holcim site.			
Check that all known hazards, incidents and complaints that have occurred throughout the month have been correctly recorded in ICare and effective action is being taken.	✓		All hazards, incidents and complaints are placed into ICare			
GENERAL HOUSEKEEPING						
Haul road at area "M" Will starting to be removed as part of the rehabilitation and land handback.	✓		Roads are starting to be removed and replaced by sand	All road base to be removed from site.

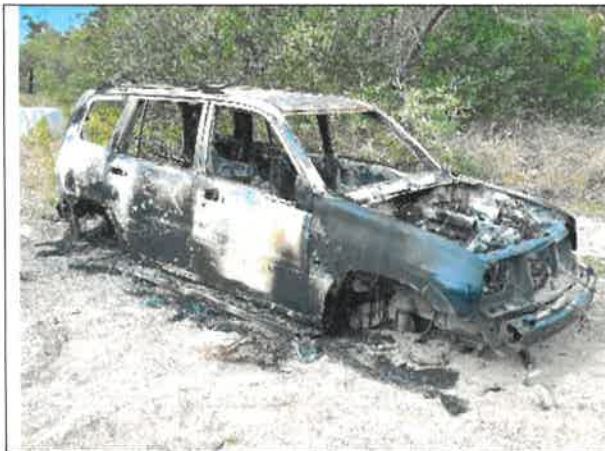
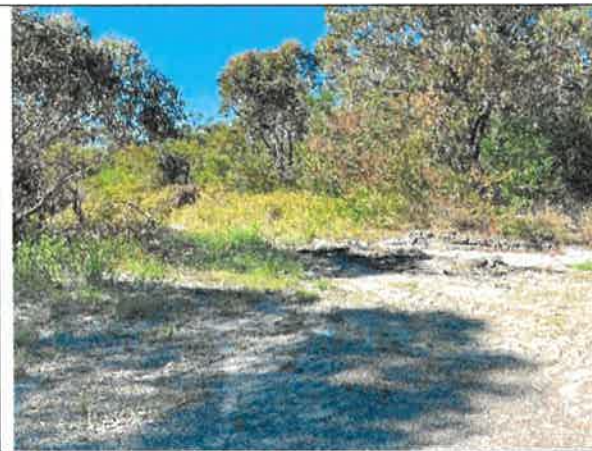
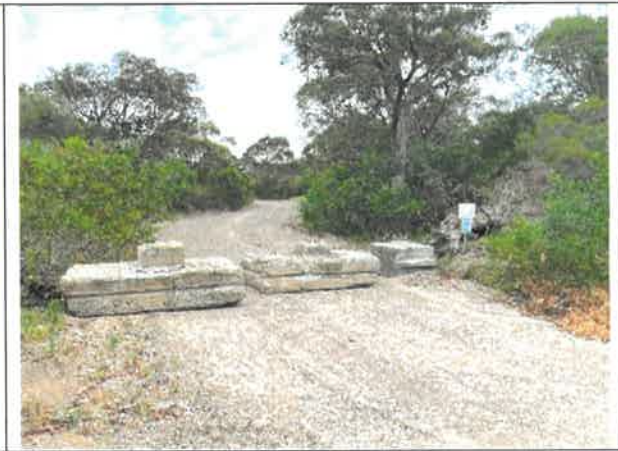
Site no longer extracting, site now non-operational and is under rehabilitation.	Compliance		Comments	Action	Who	When
	Yes	No				
GENERAL						
Complete a site boundary check to ensure that any risks posed by neighbours (such as discharge onto HOLCIM site, incorrect storage near fences, etc.) are identified and actioned.	✓		No material is stored near any fences or the likelihood of discharge onto Holcim site.			
Check that all known hazards, incidents and complaints that have occurred throughout the month have been correctly recorded in ICare and effective action is being taken.	✓		All hazards, incidents and complaints are placed into ICare			
GENERAL HOUSEKEEPING						
Haul road at area starting to be removed as part of the rehabilitation and land handback.	✓		Roads are starting to be removed and replaced by sand	All road base is being removed from site to fix haul road.

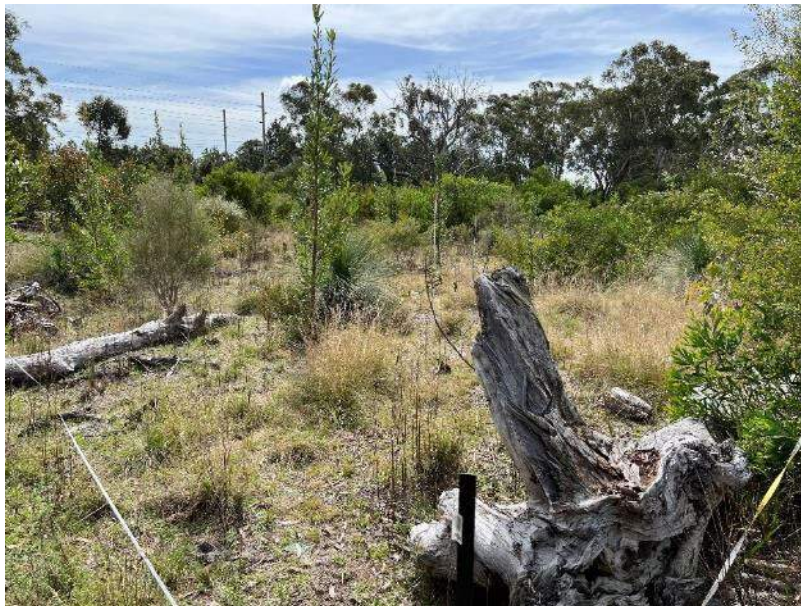
Plate 2: Quadrat Q48 from the SW corner showing exotic groundcover, planted key species and prevalence of *A. longifolia*.

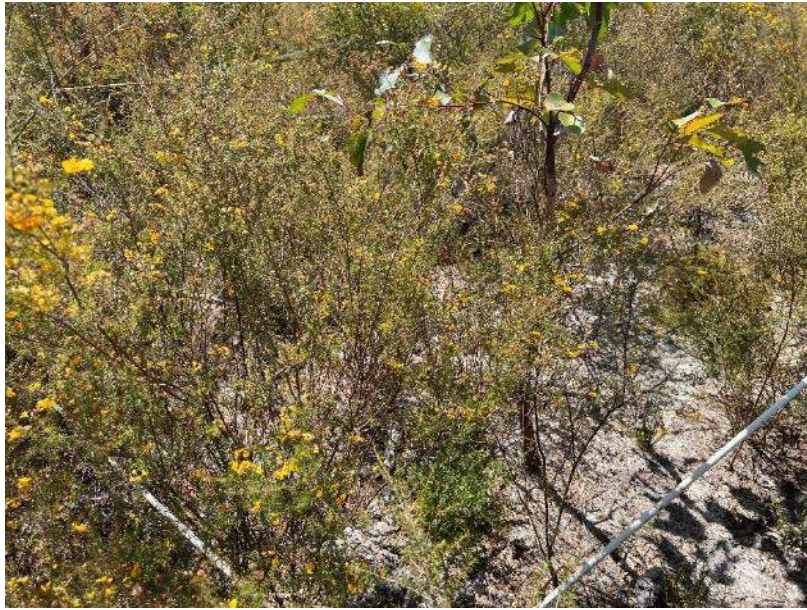
This quadrat recorded excellent growth parameters with increased average cover, average height, above target native species diversity in the quadrat and in the plots. Targets for numbers of plants per plot is below target, but probably reflects that achievement of analogue density will require some more development, rather than any shortfall in the revegetation effort (**Plate 4**). All key species and *E. robusta* were recorded in this quadrat with excellent numbers and increasing CA scores. This quadrat is still dominated by early succession species such as *D. retorta*, which with a CA score of 5 is the most abundant species.

Plate 4: Block Q4, Quadrat 50, plot 2 showing that despite the excellent growth parameters, there is still considerable space between individual plants.

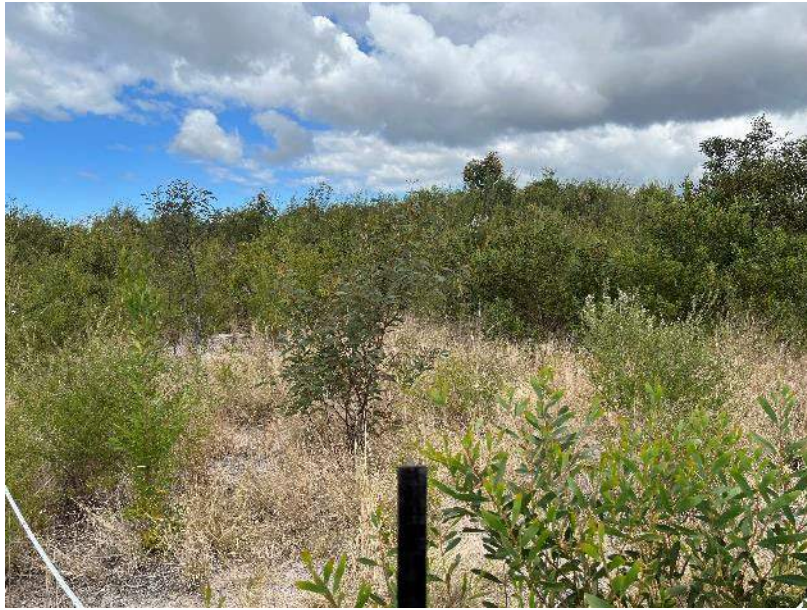
This quadrat is dominated by three species – *L. laevigatum* (CA score of 5), *E. curvula* (CA. of 4) and *A. longifolia* (CA of 4). Two other native species present in good numbers and/or size were *L. polygalifolium* and *X. glauca*, both with CA scores of 3. The remaining natives were only recorded in small numbers and CA scores of 1 (<5% and infrequent) or 2 (<5% but numerous). The growth parameters in **Table 8** show that while average height and average cover have increased for the last biannual monitoring event, all other parameters have decreased and remain well below targets. The high proportion of ground stratum species is attributable to the weedy grasses that are quite prevalent in this block (**Plate 5**).

Plate 5: Block Q5, Quadrat 52 from the NW corner. Note the presence of *E. curvula*, *A. longifolia* and *L. laevigatum*.

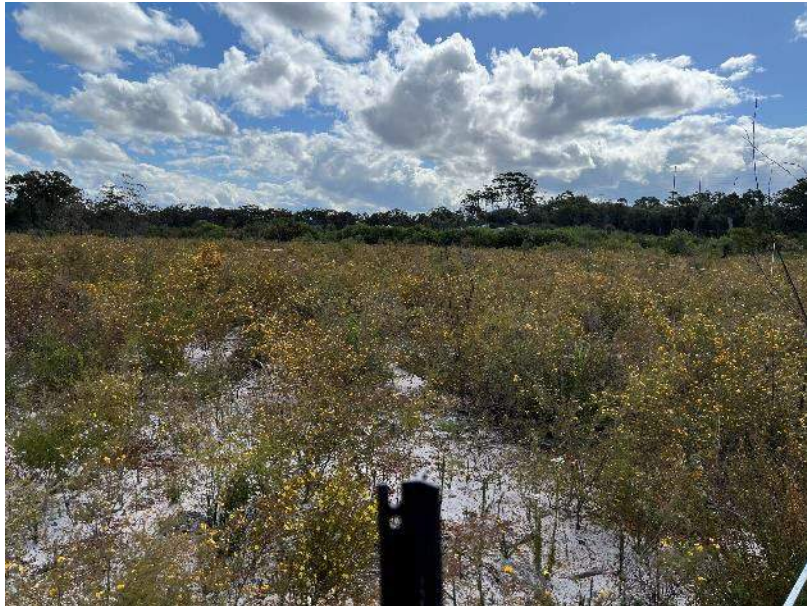
The growth parameters for this quadrat are little perplexing with average height remaining largely unchanged and average cover declining slightly from the last biannual monitoring event (**Table 9**). Conversely, the total native species diversity is above target for both the quadrat as a whole (38 species) and the average for the plots (14.0), with the average number of plants per 4m² plot right on target. This quadrat recorded all seven key species with *B. aemula* and *L. polygalifolium* recording CA scores of 3 each indicating very good numbers. This quadrat is still dominated by early succession species with *D. retorta* the most common species with a CA score 4 (**Plate 6**). Other early succession species that were abundant included *H. linearis* and *C. recurvata* with CA scores of 3 each. The remaining native species all recorded CA scores of 1 or 2 indicating relatively few and/or young plants. No weed or exotic species were recorded in the quadrat.

Plate 6: Block Q6 Quadrat Q53 showing that there is still a considerable amount of bare sand intermixed with excellent vegetation. Note the proliferation of flowers - largely *D. retorta* with some *H. linearis*.

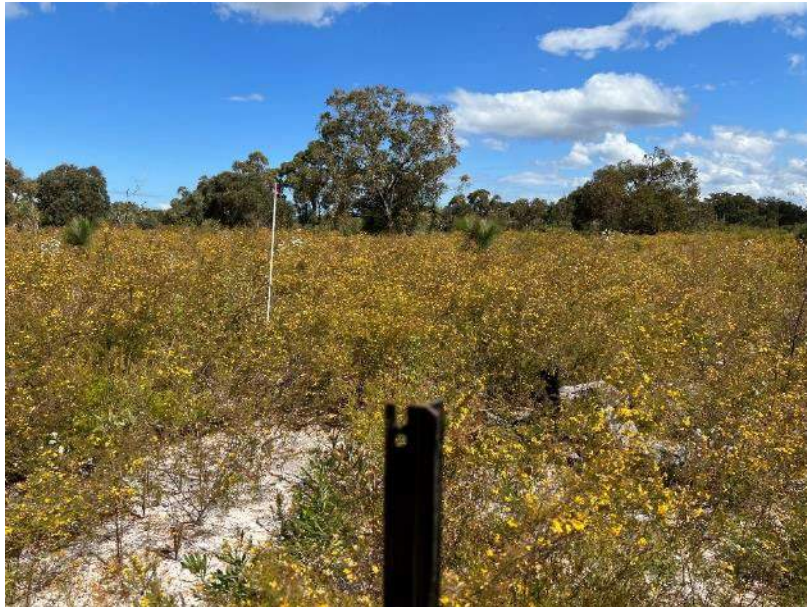
Plate 7: Block Q6 Quadrat Q54 from the NE corner showing the lack of height (poles are 2m high), the profusion of flowers and the occasional bare patch of sand.

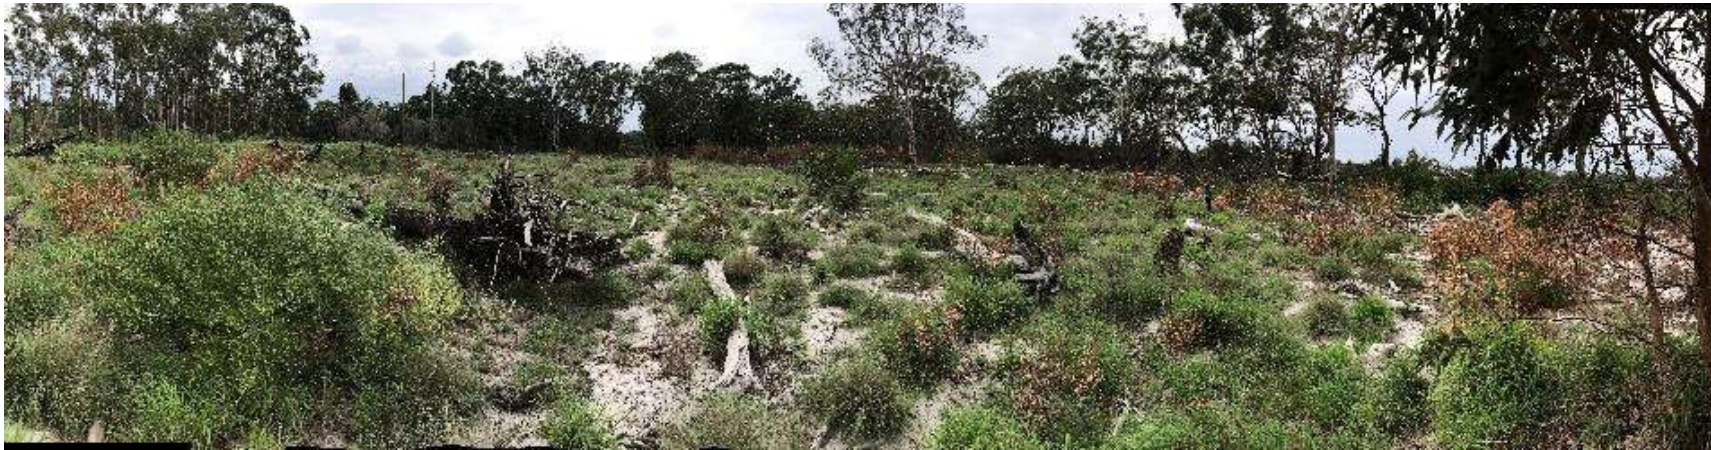
Plate 22: Block Q2 looking east January 2020. Note the die back of *Acacia longifolia* around the perimeter of the block

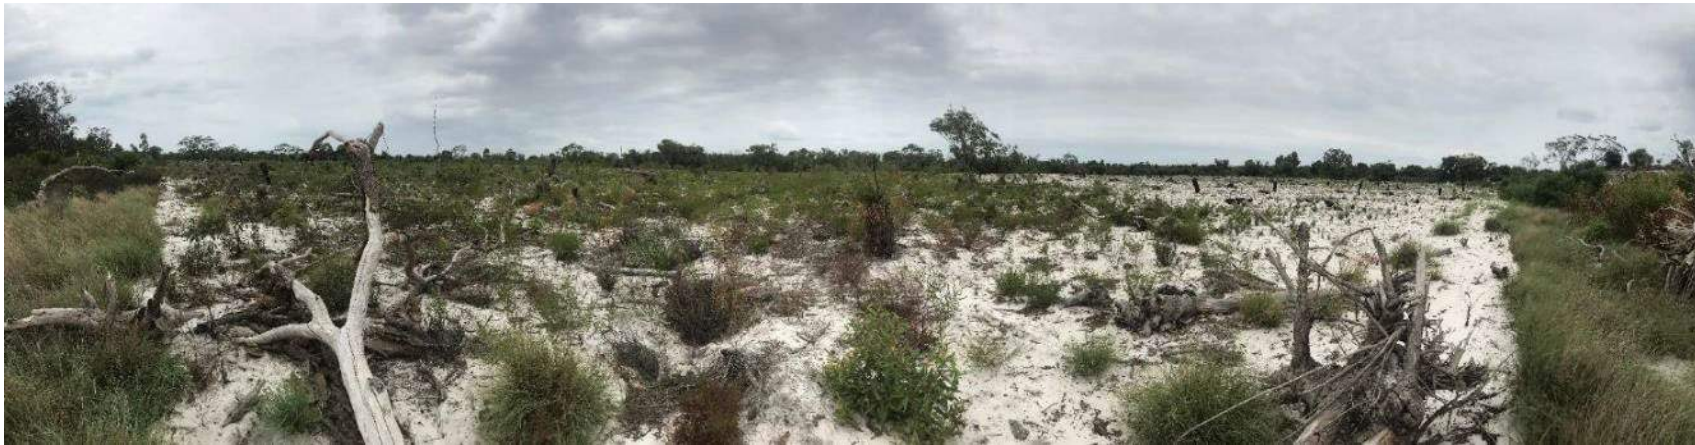
Plate 45: Block Q4 west (looking east) January 2020. Note the grassy weeds adjacent to this block (far left and right of photo)

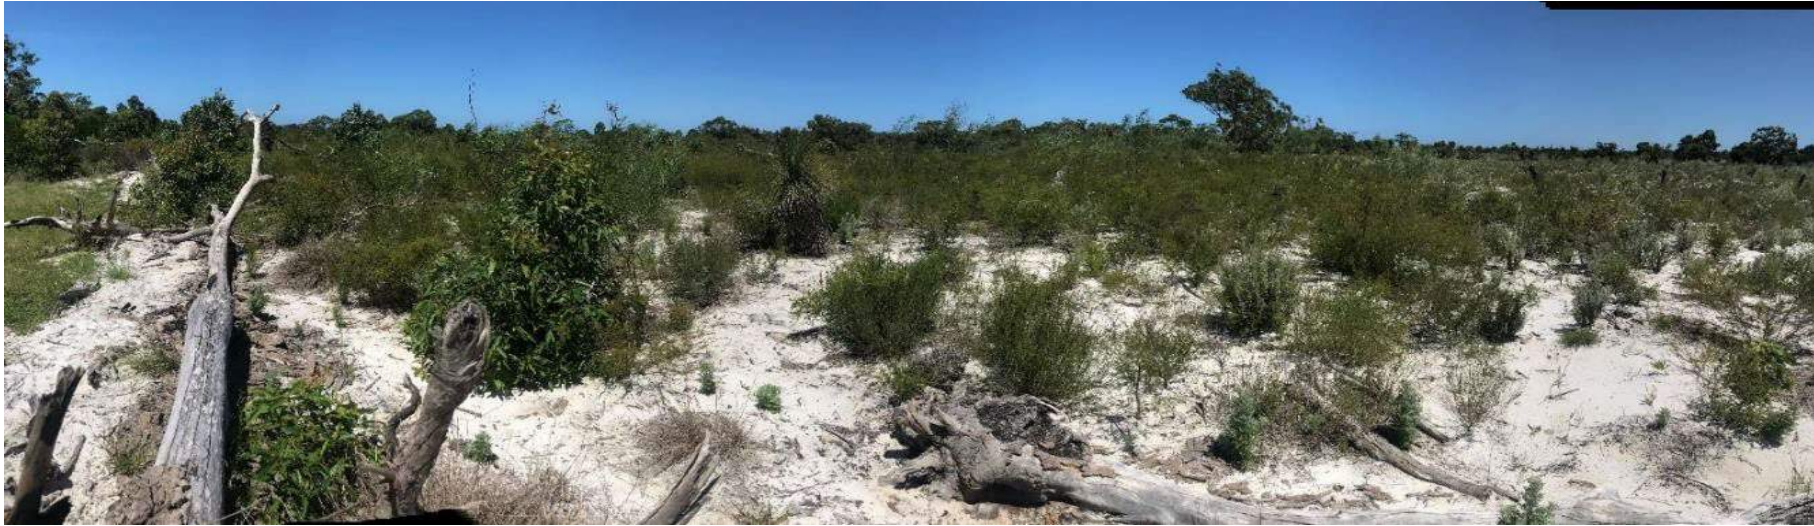
Plate 47: Block Q4 west (looking east) January 2021. Note the dense weedy grass infestation in Block Q1 (left of photo) and the encroachment into this block.

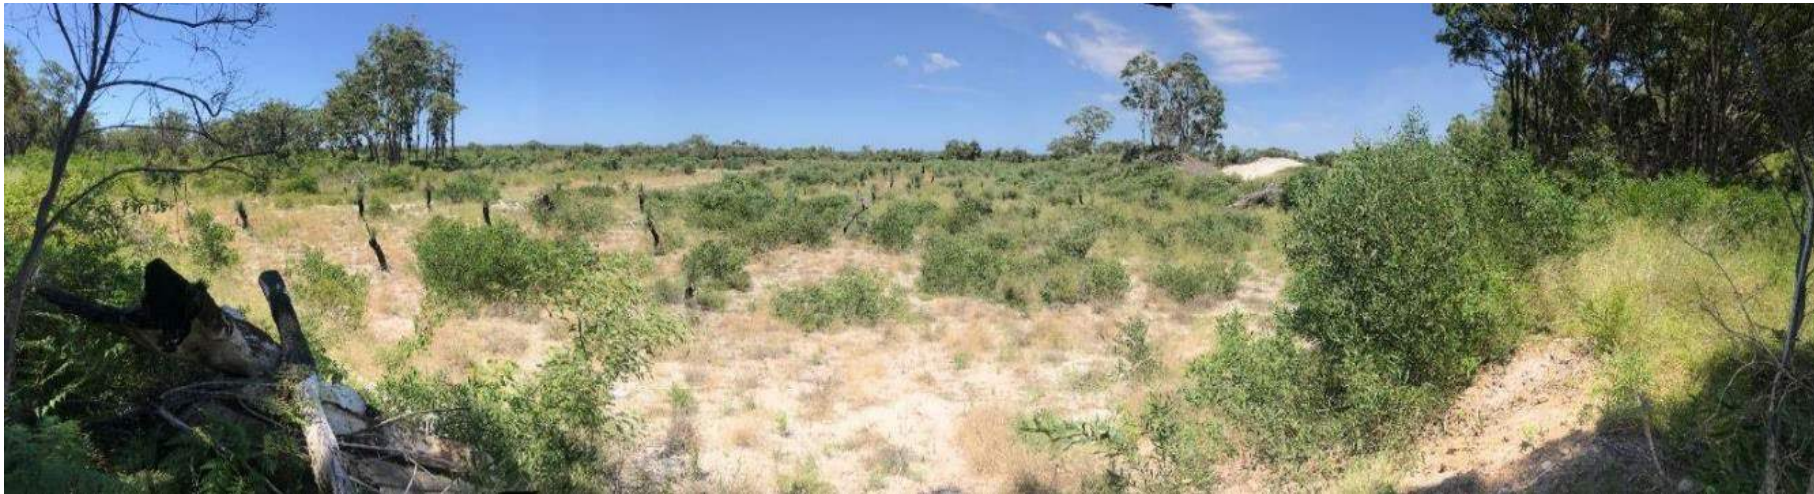
Plate 53: Block Q5 north (looking south) January 2021. Growth of vegetation necessitated the relocation of the photo point for this block. Note the dominance of grasses (brown) and *Acacia longifolia* (large green shrubs)

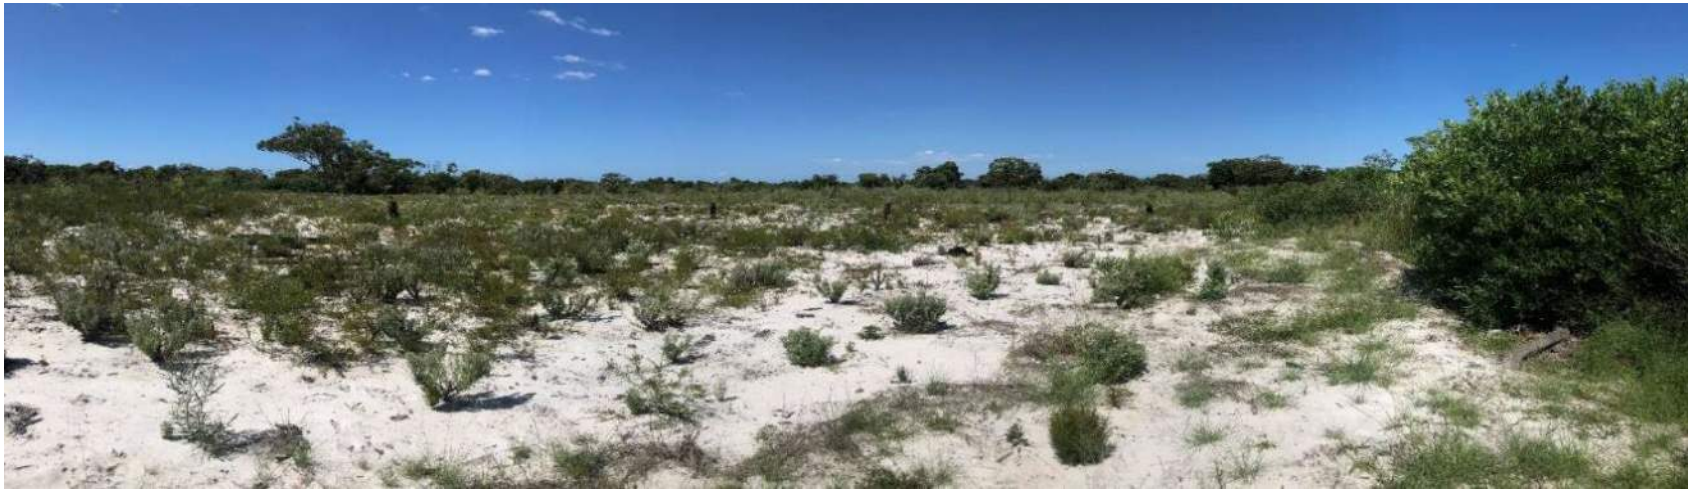
Plate 59: Block Q6 North-east (looking south and west) January 2021. Note the grassy weeds encroaching from Block Q1 at right of photo

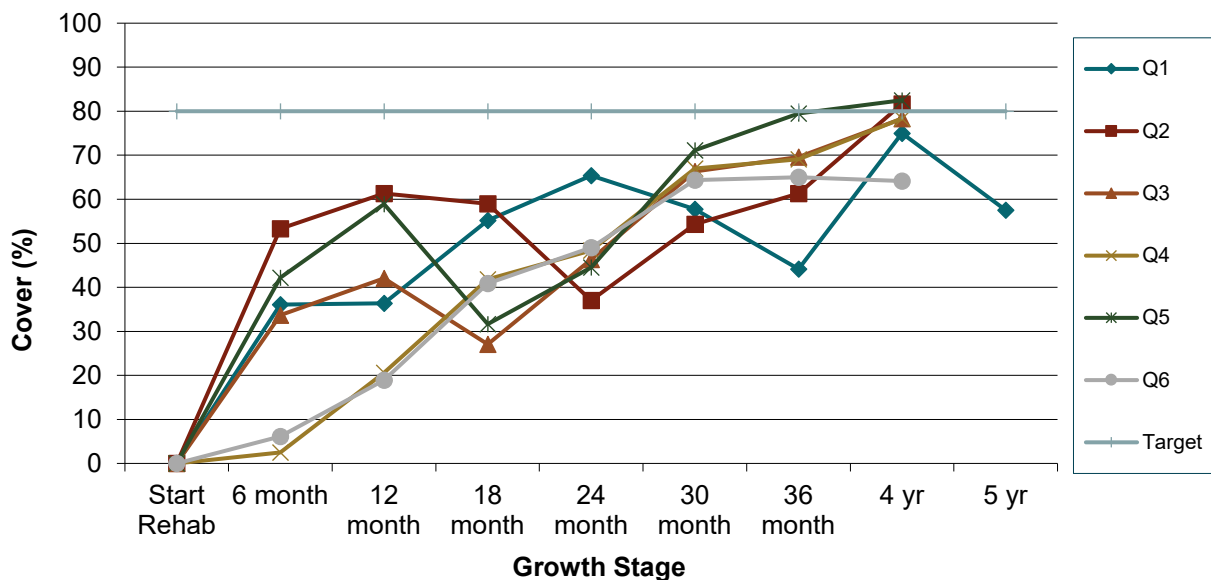
Chart 1: Comparison of average foliage cover across the blocks for the period of monitoring to date.

Chart 1 shows the average vegetative cover over the course of the monitoring. While reductions in cover are evident for individual blocks, the overall trend is for increasing cover with age. The results of the latest weed efforts are apparent for Block Q1 with the latest reduction in cover at the 5 Year point. The ability of the vegetation to recover and increase after disturbances due to drought (18 month point) suggests a degree of resilience that indicates good self-sustaining development.

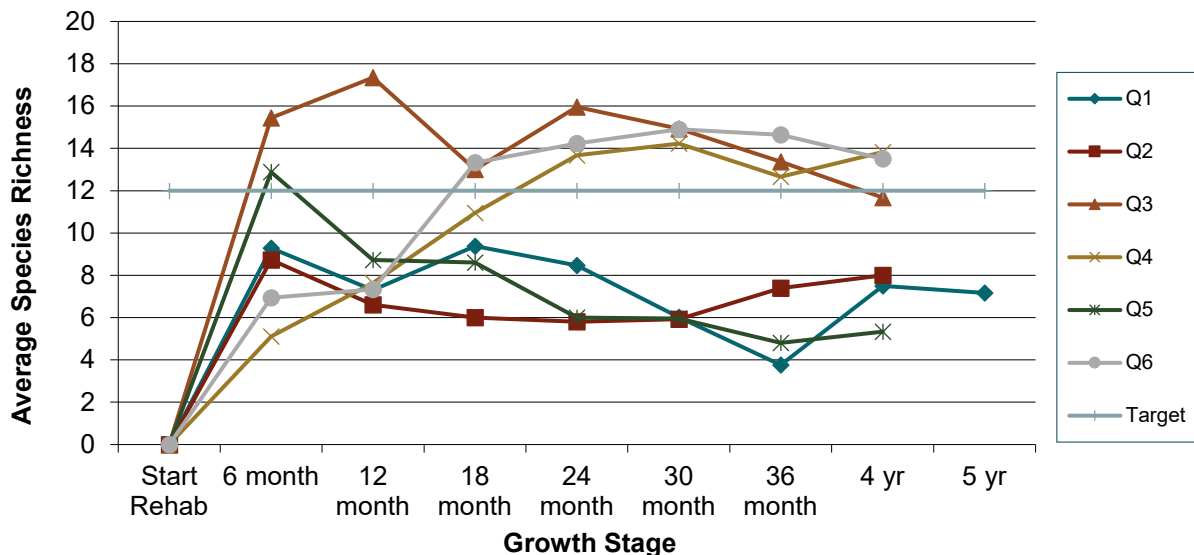
Chart 3: Comparison of the average species richness per 4m².

Chart 3 shows the average species richness or diversity per 4m² in the quadrats. There is clear a difference between the northern blocks (Q1, Q2 and Q5) and the southern blocks (Q3, Q4 and Q6) with the southern blocks recording higher species diversity. This higher species diversity is equated to better revegetation, possibly due to better quality topsoil at the original clearing of the NDE.

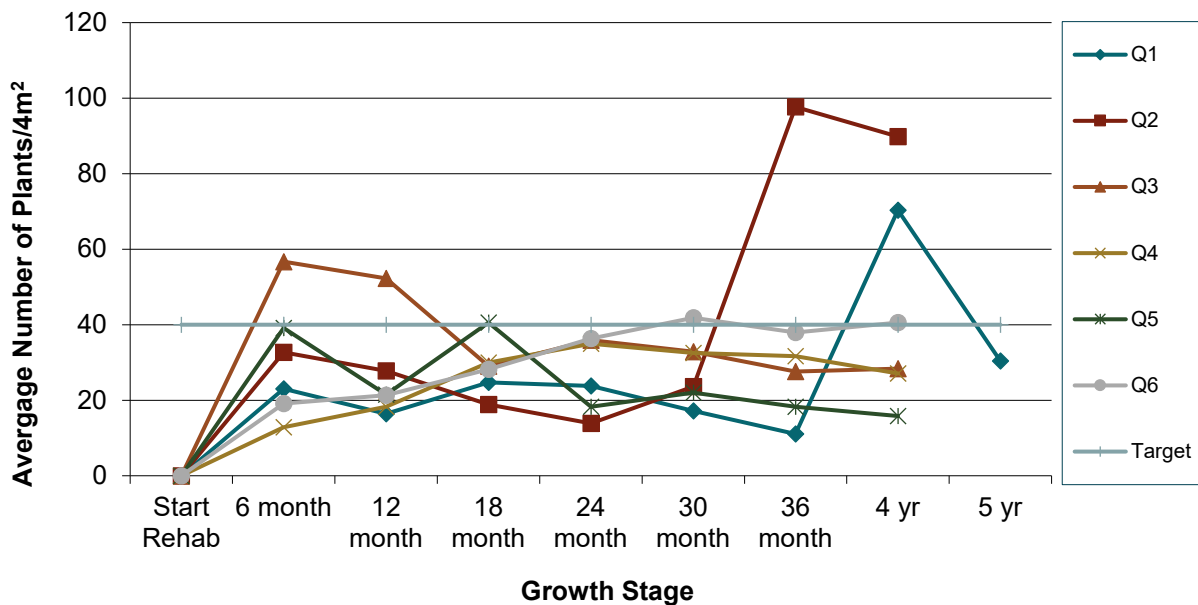
Chart 4: Comparison of the average number of plants/4m².

Chart 4 shows the average number of plants per 4m² plot within the monitoring quadrats. The two blocks with the highest plant numbers – Q1 and Q2 – have the greatest numbers of weeds, especially *E. curvula*. The results of weed control efforts shows as sharp reductions in plant numbers. Block Q5 has had consistently low plant numbers due to the prevalence of larger shrub species such as *A. longifolia* and *L. laevigatum*.

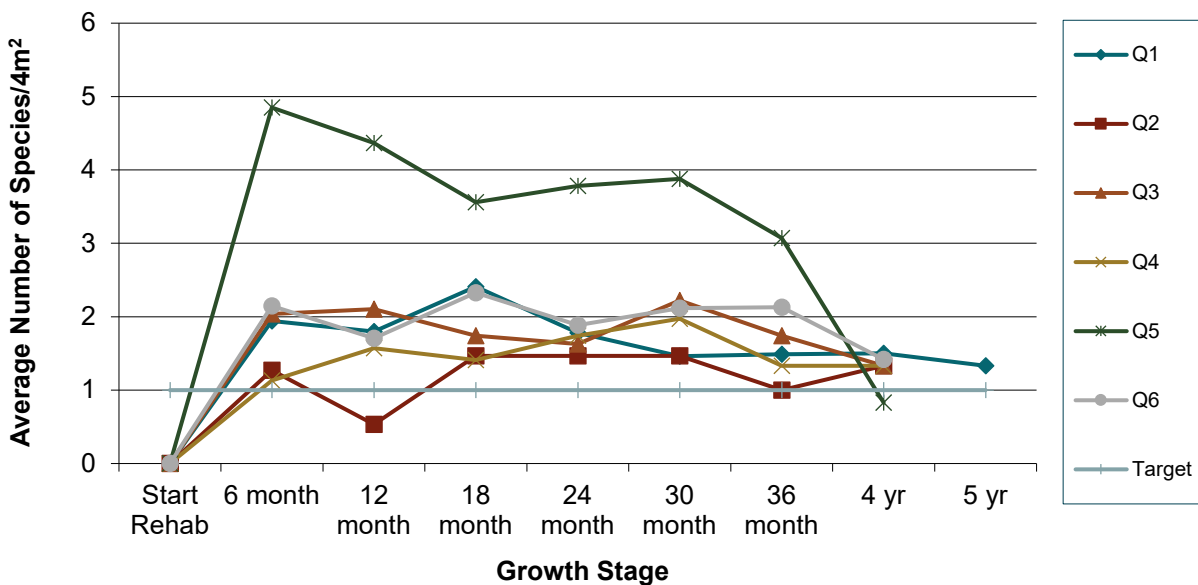
Chart 5: Comparison of the average number of fire-resistant species/4m²

The average number of fire-resistant species has been fairly consistent across the blocks and throughout the revegetation and above target. The exception is Block Q5. Examination of past monitoring data reveals very high numbers of *L. laevigatum* in a small number of 4m² plots with evident die back of these plants.

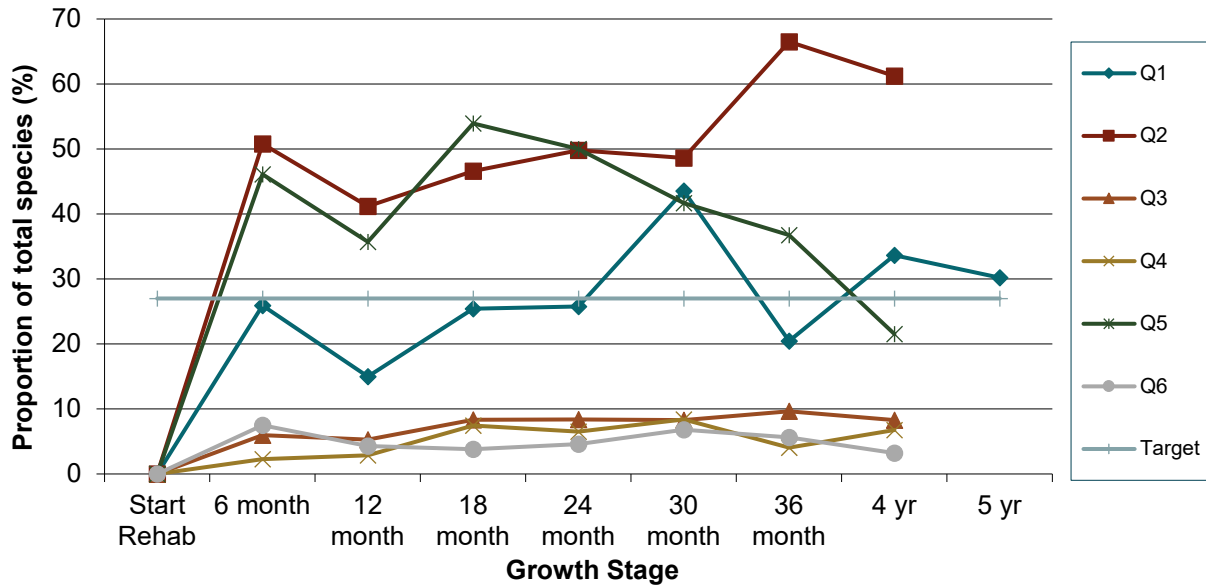
Chart 6: Comparison of the average proportion of ground stratum species/4m².

Chart 6 shows the relative proportions of ground species across the blocks. Blocks Q1, Q2 and Q5 have a much higher proportion of ground species compared to Blocks Q3, Q4 and Q6. The weed species that have been recorded in these blocks are largely ground stratum species. The lack of native ground species has been noted throughout revegetation of the North Dunes and North Dunes Extension.

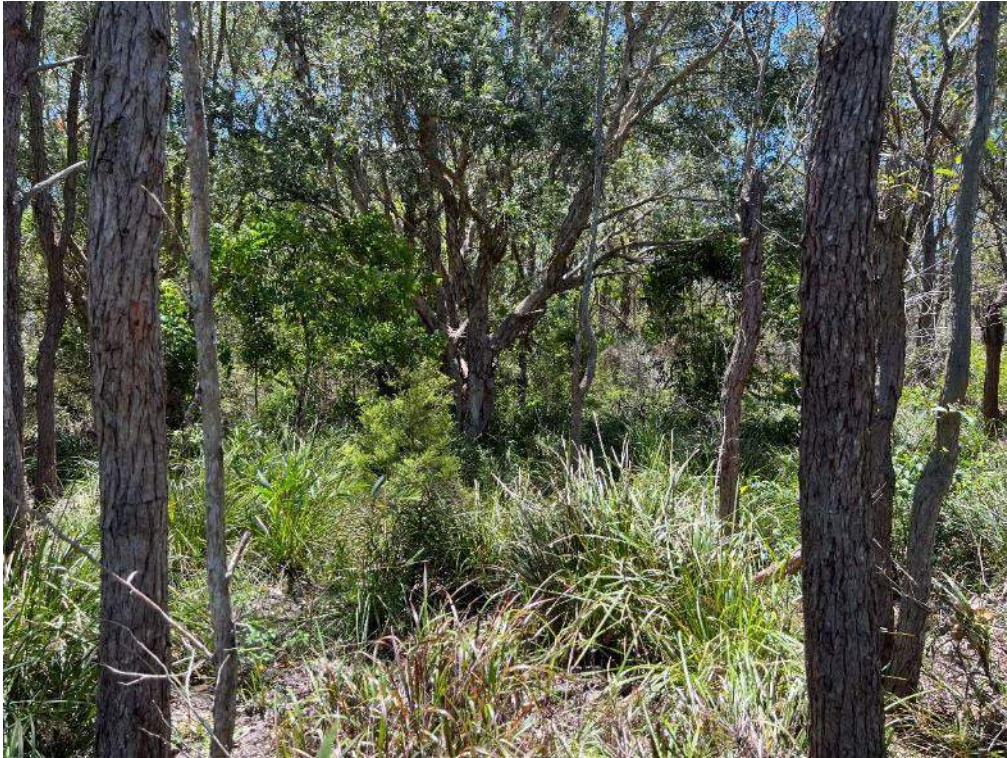
Plate 9: PP3 looking north showing typical understory

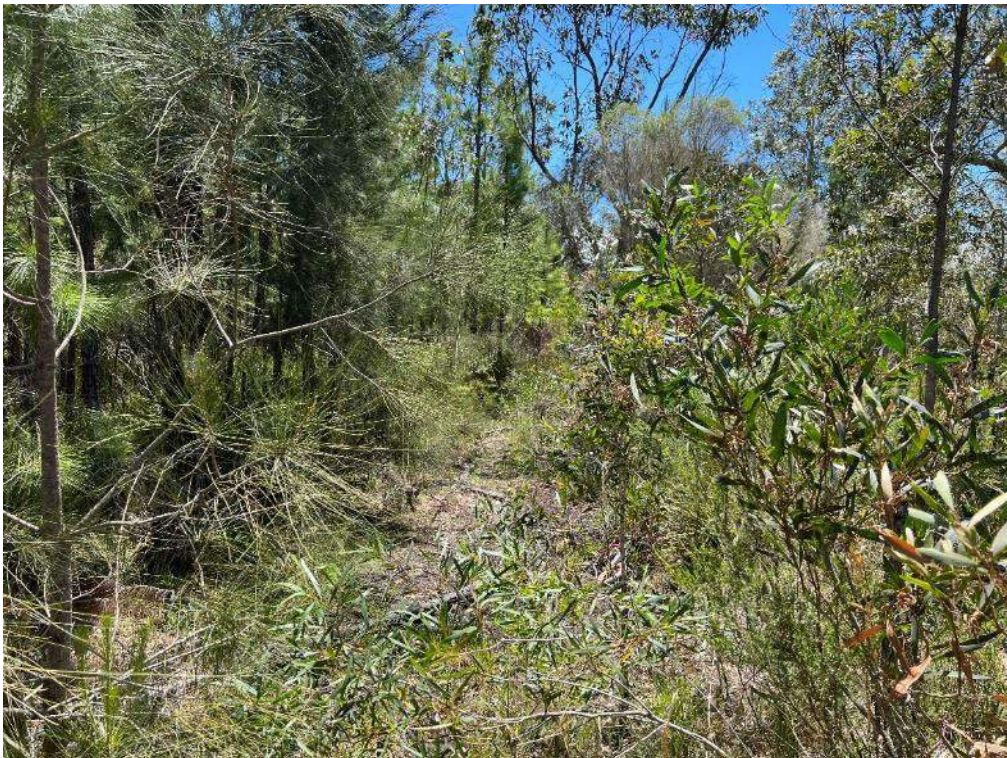
An access track is becoming overgrown at PP4 (**Plate 10**). There is historical illegal rubbish dumping along this track that requires removal. Improving the access track via clearing of vegetation would facilitate the removal of this rubbish and the removal of felled Slash Pines, but may facilitate access by the public.

Plate 10: PP4 looking north along access track showing Slash Pine infestation and control works (bottom left).

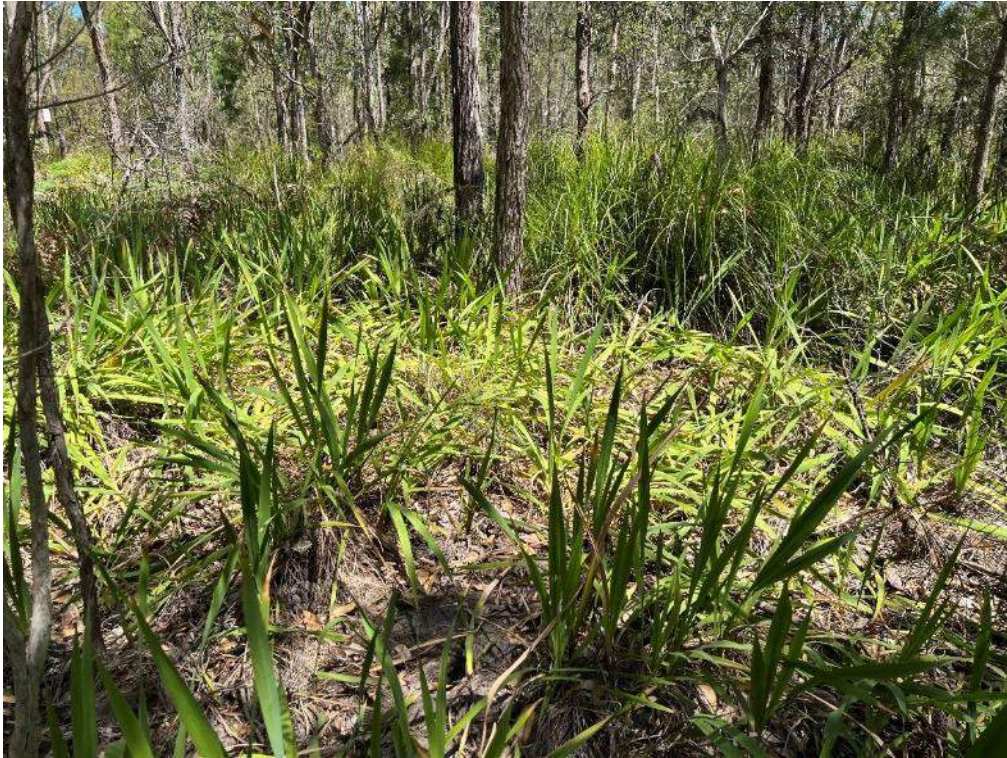
Plate 11: PP5 looking south showing dense Bugle Lily infestation

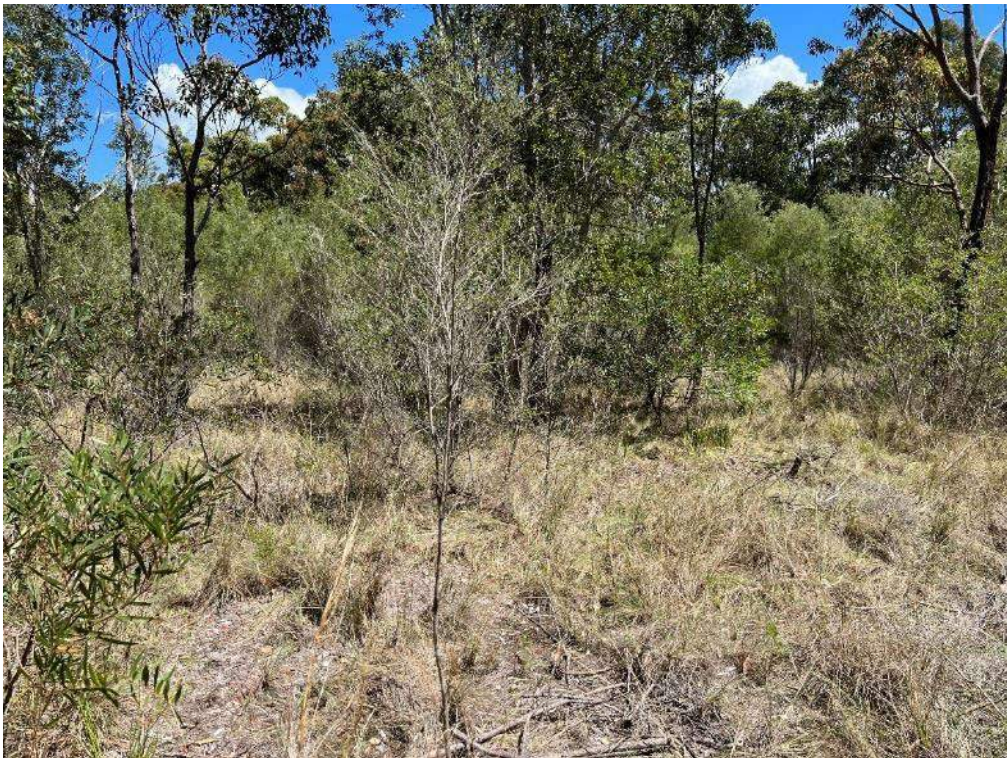
Two areas at the western end of the NBOA are classified as regenerating grassland where the density of trees and shrubs is greatly reduced. Since the initial survey in 2013, natural regeneration has occurred, with many shrubs and some midstorey species self-seeding (**Plate 12**). However, very few *E. robusta* have established in these areas, and the southern-most section adjacent to Rutile Rd is a dense thicket of *Leptospermum laevigatum* (Coast Teatree) that will prevent any other re-growth of native species. **Table 4** has field notes of observations of native species in and around the grassland area traversed by the transect.

Plate 12: PP6 looking west showing the regenerating grassland area (north). Note the shrubby regrowth.

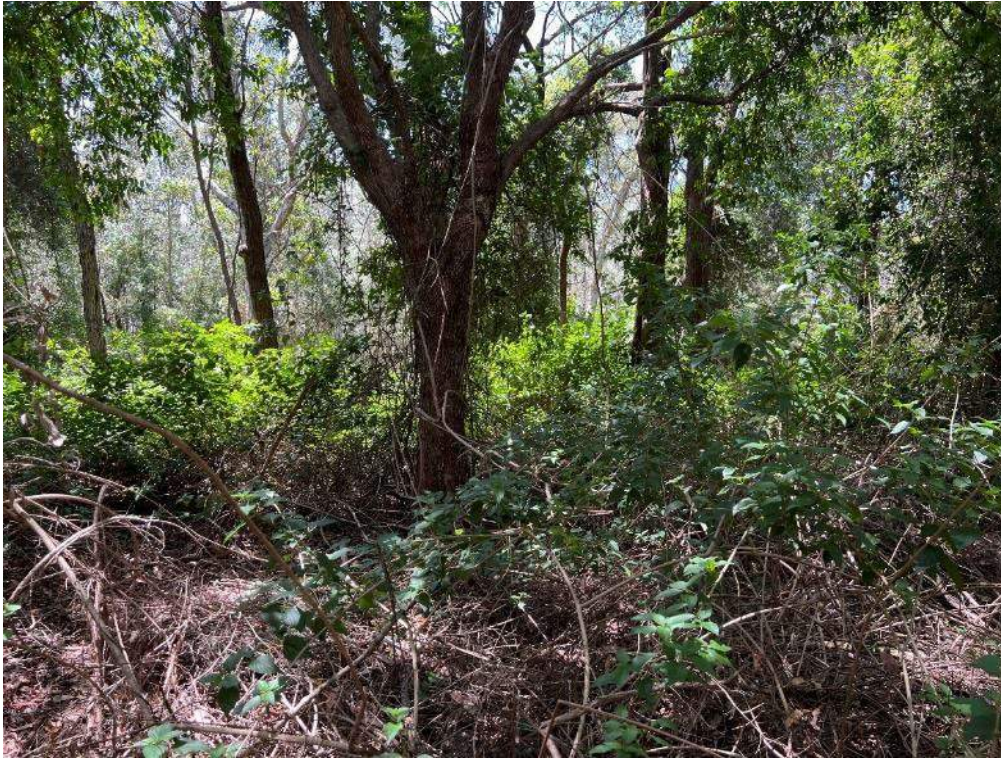
The northern most section of the NBOA has been classified as mature Swamp Mahogany – Paperbark Swamp Forest. This area contains mature *E. robusta* and *Melaleuca quinquenervia* trees with an understorey of Tall Saw-sedge (*Gahnia clarkei*) and other swamp flora. Lantana has colonised this section of the BOA with infestation levels varying from scattered individuals to very heavy (<75% cover), with a belt of dense Lantana acting to separate this section from the southern regenerating section of the BOA (**PP7 Plate 13**). Evidence of previous control works is visible, as is regrowth and re-sprouting.

Plate 13: PP7 looking north at the dense Lantana "belt" that separates the regenerating and mature Swamp Mahogany – Paperbark Swamp Forest. Control efforts are visible in the foreground.
