ANNUAL REVIEW
1 April 2022 – 31 March 2023

Northern Dune Extension

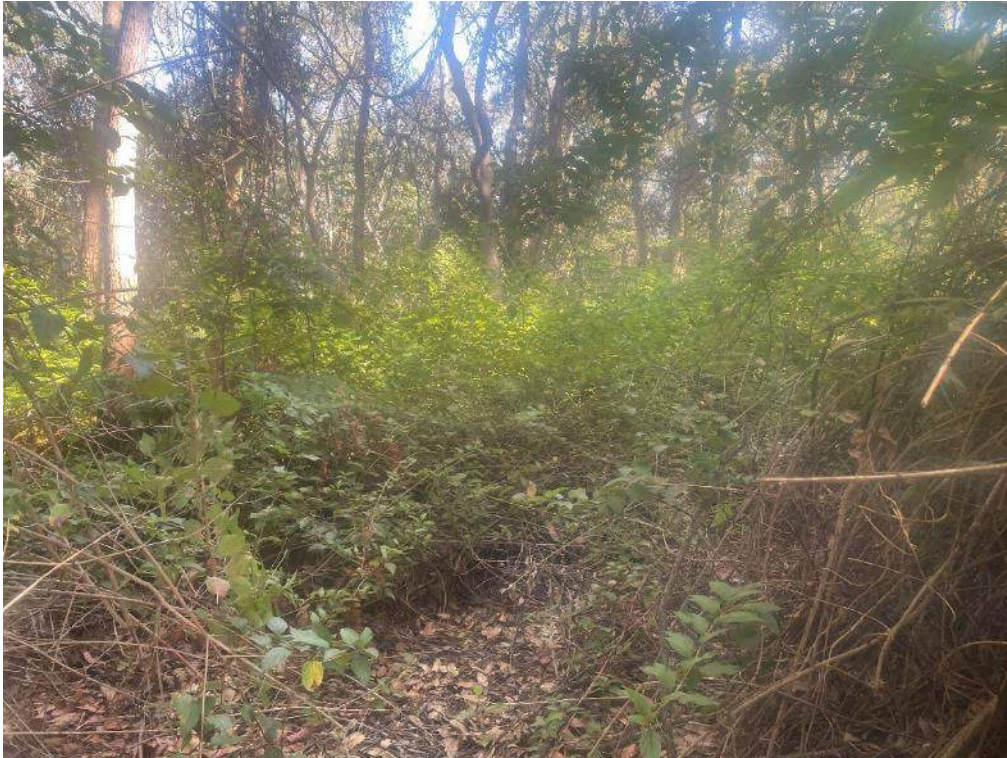
Lantana is the major threatening weed in the BOA, forming dense thickets at ground level and climbing into the mature tree canopies and covering a substantial portion of the BOA (**Figure 6**). The infestation density covers the full spectrum from isolated or scattered individuals to the dense thicket or belt referred to earlier (**Plate 15**). At its most dense, these thickets have the potential to hinder movement of koalas through the BOA and effectively divides the Swamp Mahogany – Paperbark Swamp Forest into two sections. This year’s weed mapping highlights the continued spread of this weed into the mature Swamp Mahogany – Paperbark Swamp Forest where scattered individuals are maturing and spreading into infestations.

Plate 15: Example of the dense Lantana that threatens to overwhelm native flora and restrict movement of native fauna.

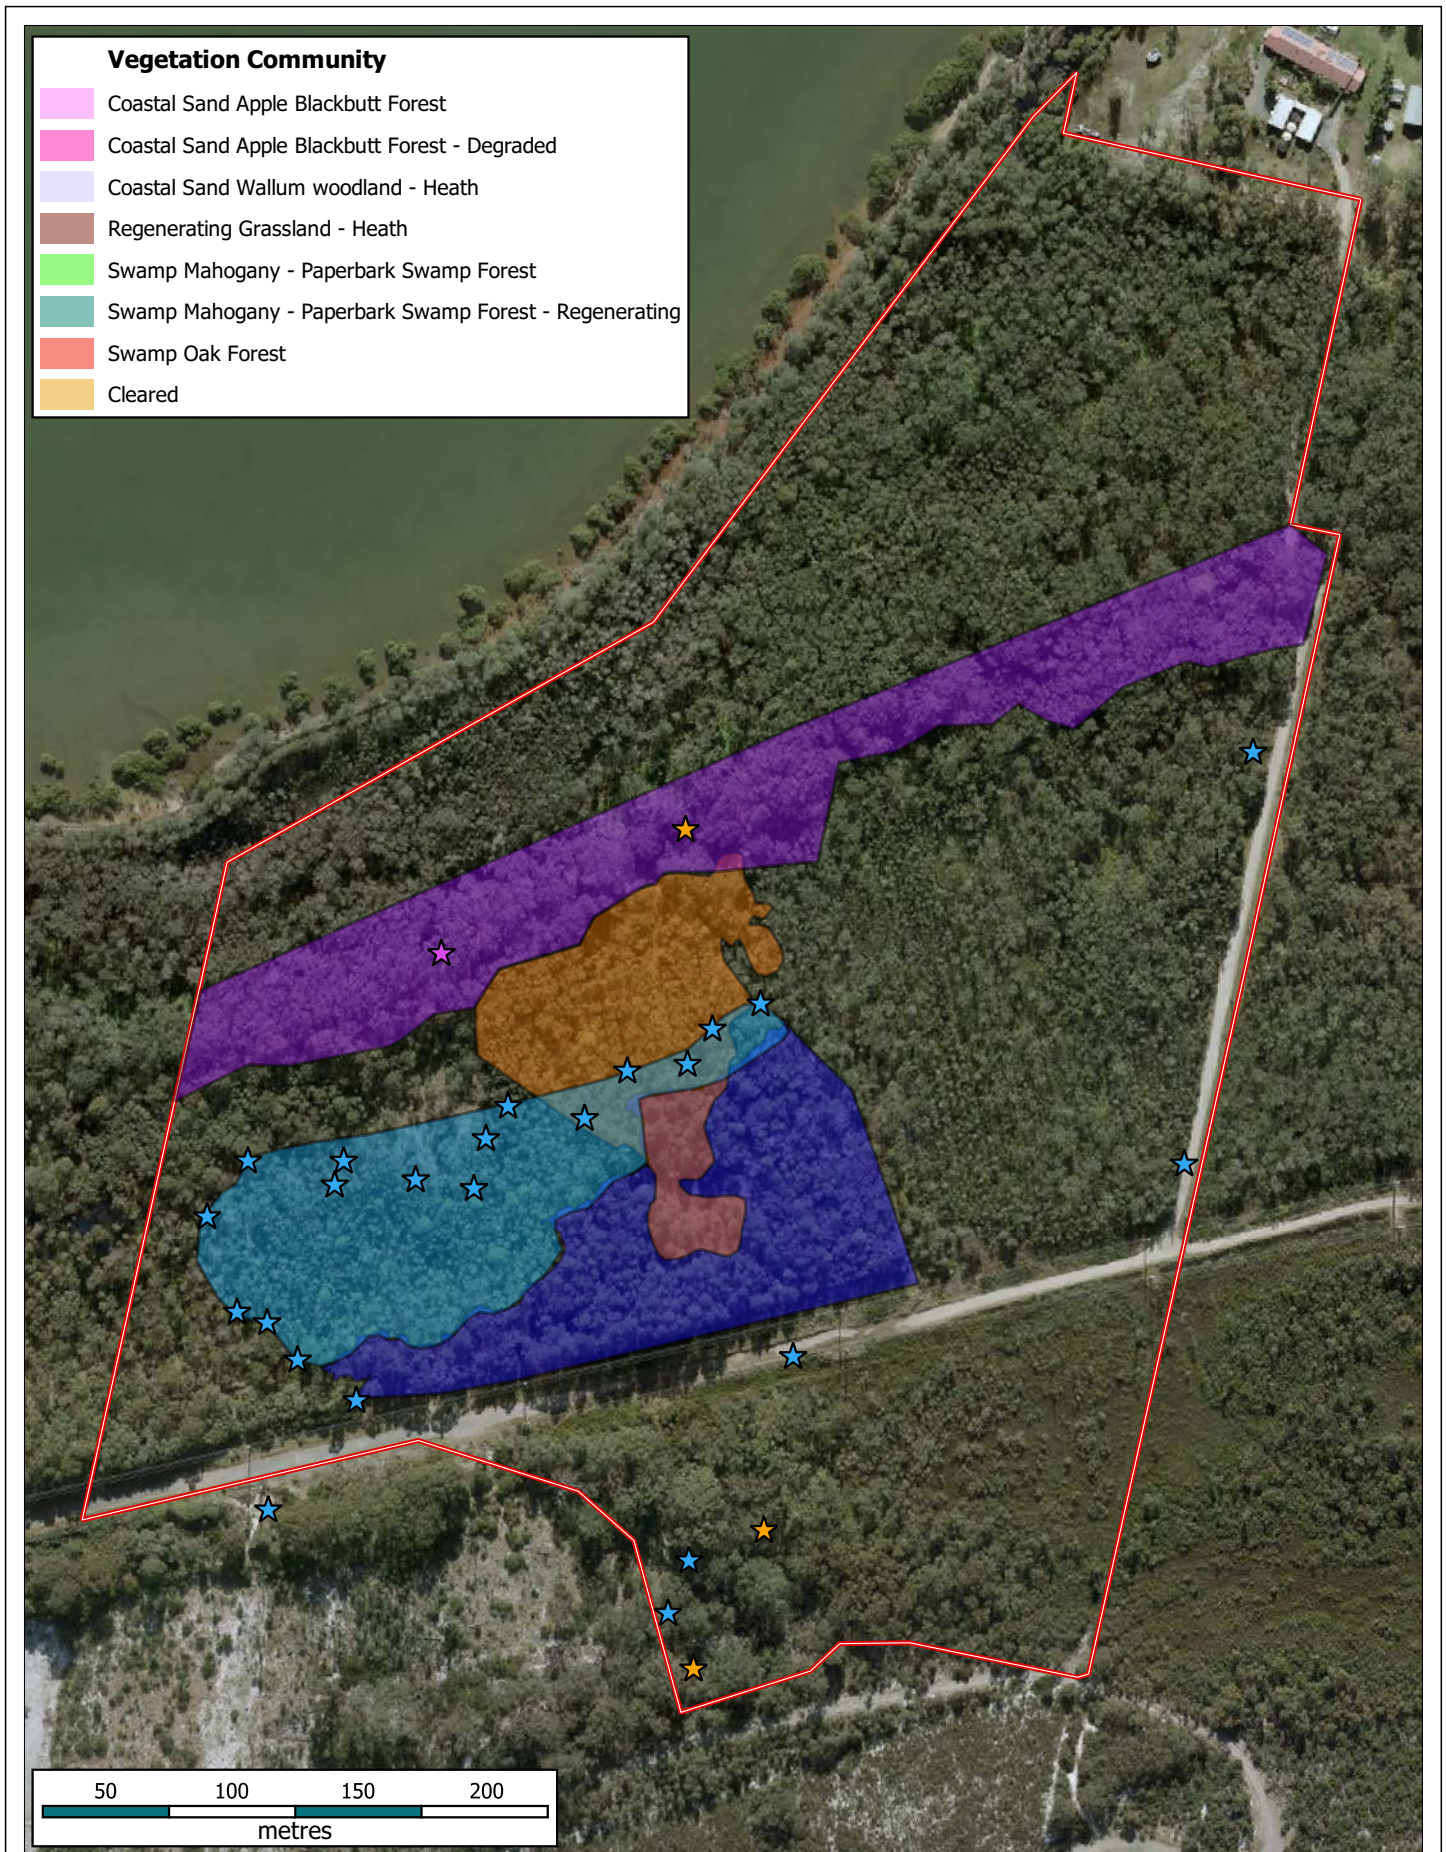
Weed mapping was conducted as part of the monitoring of the BOA (**Figure 6**). The key weed species recorded on site that have the potential to restrict revegetation or native fauna use are the Slash Pine, Lantana and Bugle Lily, all mentioned previously with minor occurrences of Senna and Pampas Grass (*Cortaderia selloana*).

The Slash Pine is concentrated along Rutile Rd in the regenerating Swamp Mahogany – Paperbark Swamp Forest, but seedlings and saplings have spread throughout this entire section of the BOA. The density has been mapped from medium to heavy in these areas and there are many scattered immature and mature trees in other areas. The Slash Pine is rapidly spreading through the BOA and does pose a threat to the viability of the area as an offset if not controlled. To date, control of this species has been limited to slowing the spread into the northern NBOA and to the east into the adjacent Gur-um-Bit State Recreation Area (**Plate 14**). Prolific seed production, rapid growth and production of pine needles that serves to suppress other vegetation acts to degrade the condition of the BOA, providing competition for the *Eucalyptus* species that are the preferred koala feed trees. Native fauna – with the possible exception of bird species such as Glossy-Black Cockatoo and Sulphur Crested Cockatoo and other large seed eating birds - do not use the pines for foraging or habitat.

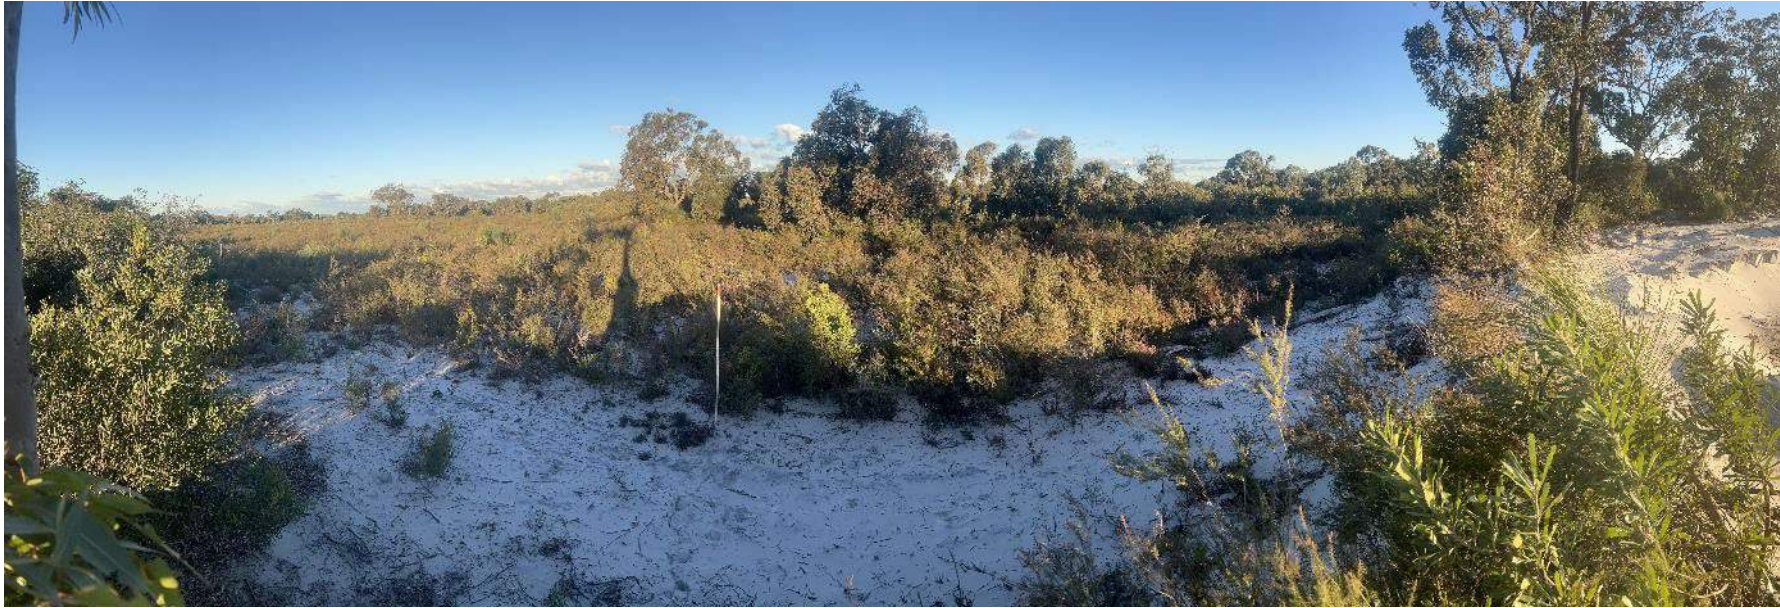
Plate 1: NW Photo point (looking southeast) over Block Q6. Retained vegetation island is in centre of photo. Vegetation coverage and height is progressing well.

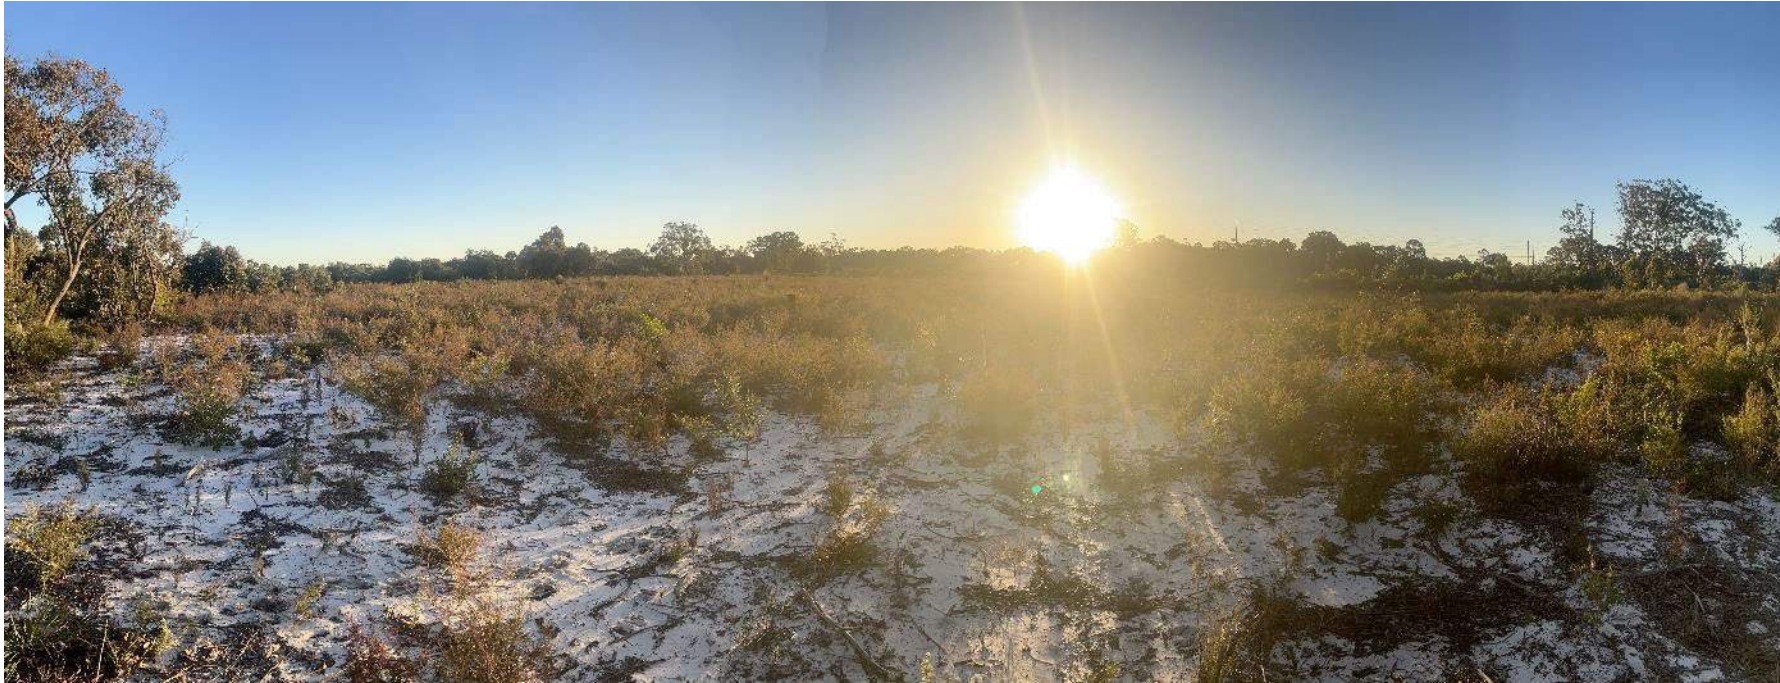
Plate 2: SE Photo point (looking NW). This photo was taken late in the afternoon but does show that the vegetation coverage is sparser in this section of the block and could benefit from some additional seeding and/or brush matting.

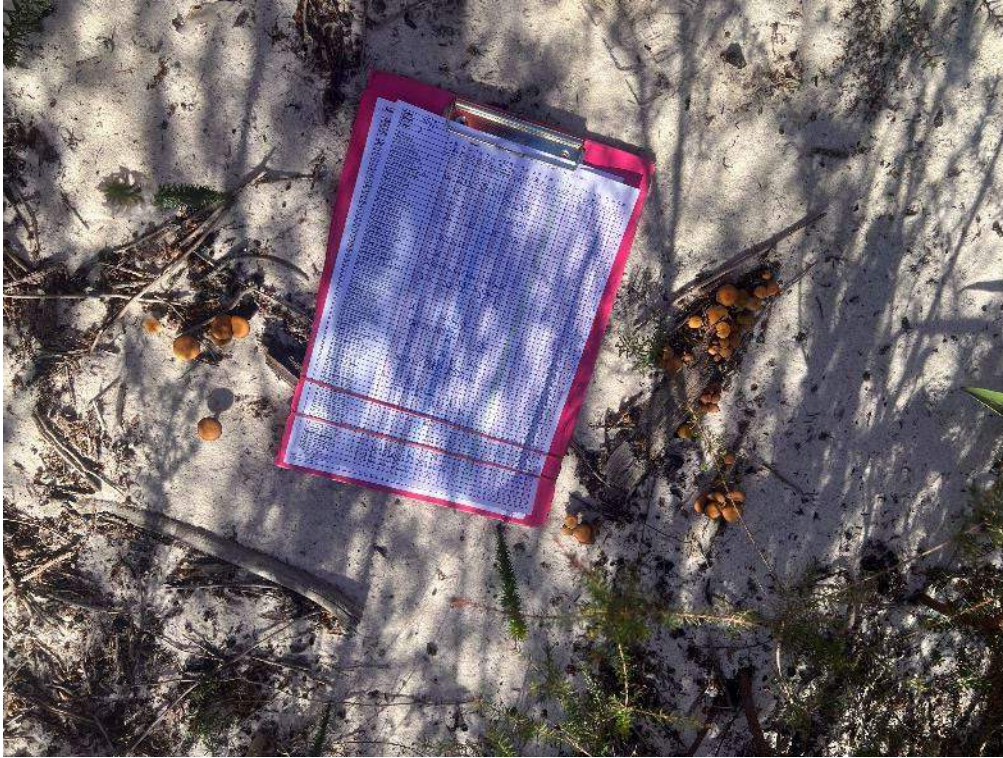
A total of 62 flora species was recorded, composed of 55 native and seven exotic species. Natural recruitment of canopy species was observed in the vicinity of the retained vegetation islands, with multiple seedlings of *C. gummifera* having germinated. While this was a winter survey, a total of 18 species were observed to have fruit, flowers or seed indicating the establishment of a self-sustaining ecosystem. Litter build-up is also evident, with several patches of decomposing fungi observed (**Plate 3**).

Plate 3: Photo of litter and decomposing fungi indicating nutrient cycling and increasing maturity of the revegetation
