#### Review and Amendments Schedule - PLANIT CONSULTING PTY LTD

Development consent for Ramtech Pty Ltd's (Ramtech) proposal to construct and operate a sand quarry at Lot 1 in DP 755721 & Lots 1 & 2 in DP 780199 Pottsville Mooball Road, Mooball was granted by the Minister for Planning on 24th November 2008. Schedule 3 of the development consent requires that individual management plans for the key environmental issues be prepared and that environmental management and monitoring conditions be fulfilled. To this end, an EMP was approved by the Department of Planning which integrates the prescribed environmental monitoring programs in accordance with Condition 2 of Schedule 5 into a planning and operations framework.

This report represents a six monthly report for presentation to the CCC and for presentation to the DOP. This will be incorporated in to the formal 12 monthly report when appropriate.

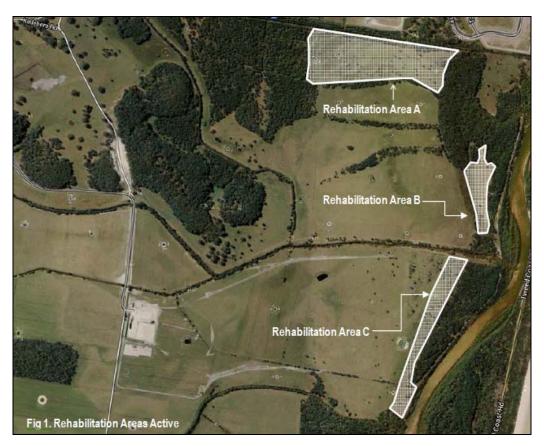
The regenerative works have been undertaken via a combination of assisted and natural regrowth and all areas have been fenced so as to limit the intrusion of cattle. In this regard, depending on soil types and topography, each of the areas has been very successful in establishing quality regrowth. The only limiting factors have been some cattle getting in and around existing fences (primarily at low tide where they have been able to traverse the creek lines. There are also some areas of extensive grass intrusion that will be subject to ongoing spray control so as to allow for further natural regrowth to occur. The works have been successful to date as referred to above.
