Donazzan's Dam- Pakenham Quarry

Intermediate Inspection

Client: Holcim (Australia) Pty Ltd

08-Jan-2021

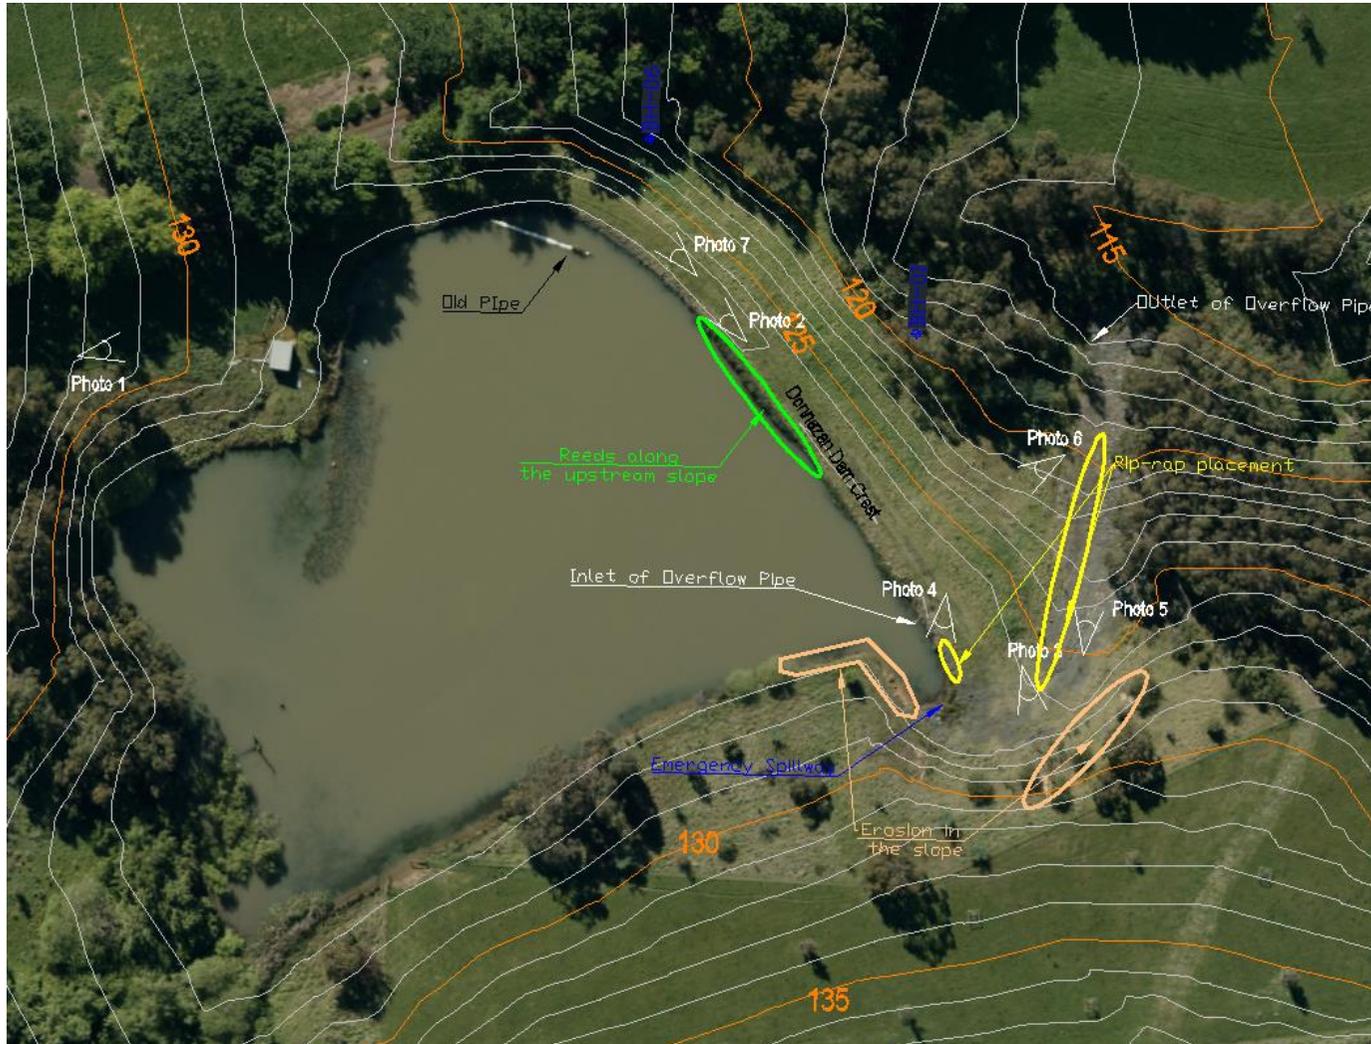
Figure 1 General Plan View of the Donazzan's Dam

Figure 1 shows the general site layout of Donazzan's Dam and identifies its main components. The site survey shown on the figure was carried out on October 12, 2020. Figure 1 also shows the location of the two monitoring wells (BH-1 and BH-6) measured during the inspection and the location of seven (7) photos taken during the 2020 Inspection. These photos are presented in Appendix A and are compared to photos taken in the 2015 Coffey Intermediate Inspection at the same location.

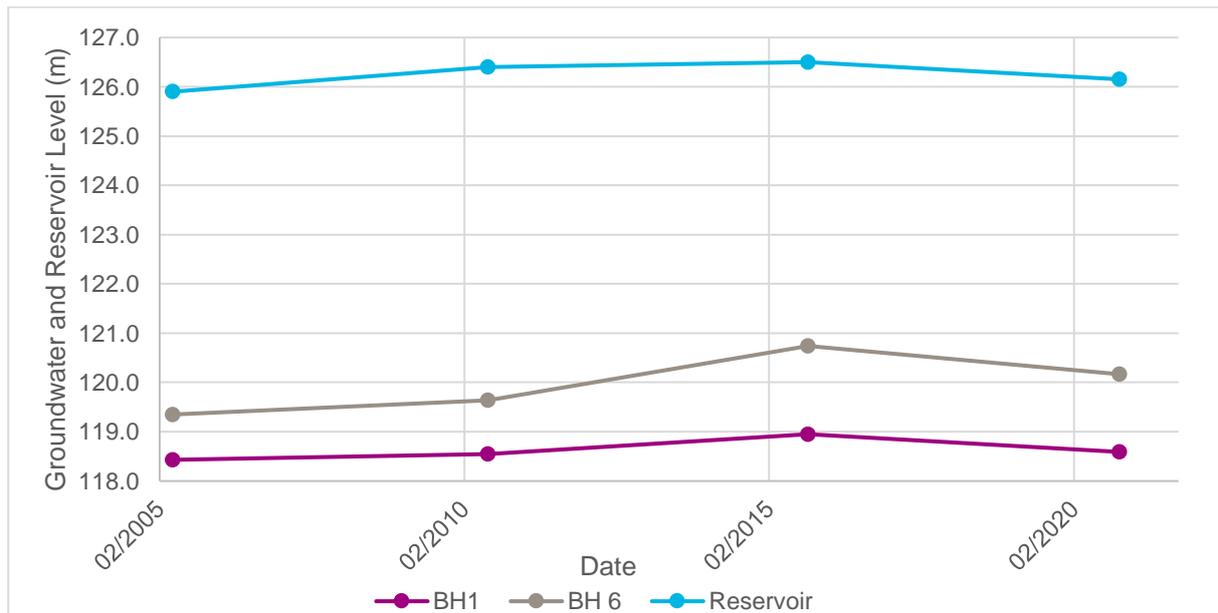
Figure 2 Fluctuation of the Water level in BH-1 and BH-6 and the reservoir water level

Groundwater levels were measured in the monitoring wells BH-1 and BH-6 located at the toe of the dam. The water level in the reservoir was also assessed based on measurement from the crest of the Dam. The 2020 water levels and historical levels are given in Table 2 and shown in Figure 2.

Monitoring of the water level once every five year does not allow for a lot of interpretation. It can be noted that according to these few measures the water level and reservoir level do not fluctuate a lot and the fluctuation seems to indicate that there is a small response in the downstream piezometer levels and the reservoir level however without rainfall data, this cannot be confirmed..

We recommend, the installation of a survey staff gauge with elevation marks every 0.1 m to help determine more precisely the water level in the reservoir. This water level is a critical input parameter to carry-out stability assessment and would allow to rapidly confirm that the water level is kept below the recommended full supply level.

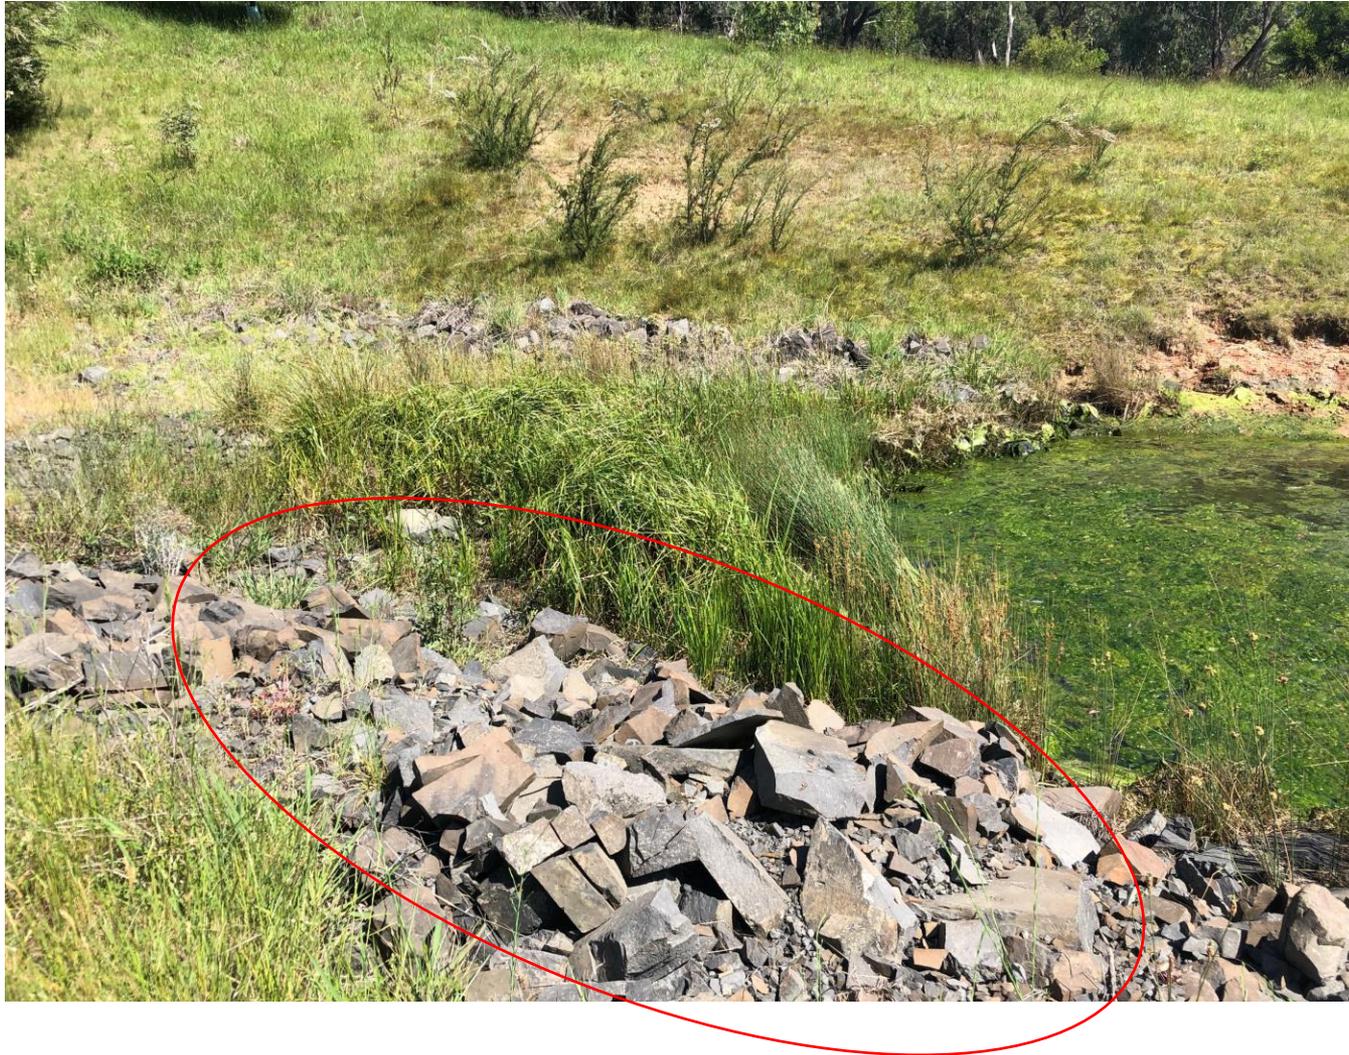
Beaching, comprising 50 to 150mm diameter crushed rock, is present along the south-eastern edge of the dam, to reduce erosion of the embankment due to wave action. Photo A-4a and A-4b show the beaching condition in 2015 and 2020 respectively, and we note that it is in good condition.

b) 2020 – Beaching in the Downstream Slope

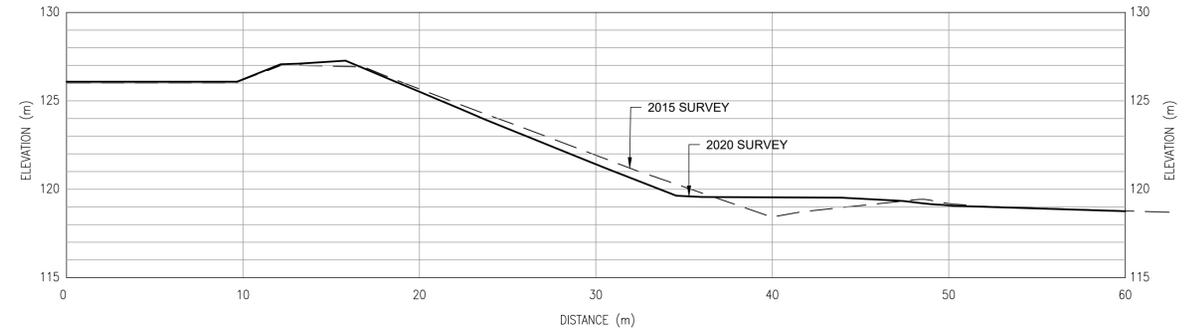
PLAN
Scale 1:1000

An aerial survey of the dam was carried on October 12, 2020 and the layout plan was updated. Cross-sections of the Donazzan's Dam and longitudinal section of the emergency spillway showing the 2015 survey and the October 2020 survey were prepared and are shown in Appendix B.
