3 March 2022

Leigh Elliott
Quarry Manager- Pakenham
Holcim (Australia) Pty Ltd
95 Mount Shamrock Road, Pakenham

2021 Groundwater and Spring Review, Pakenham Quarry

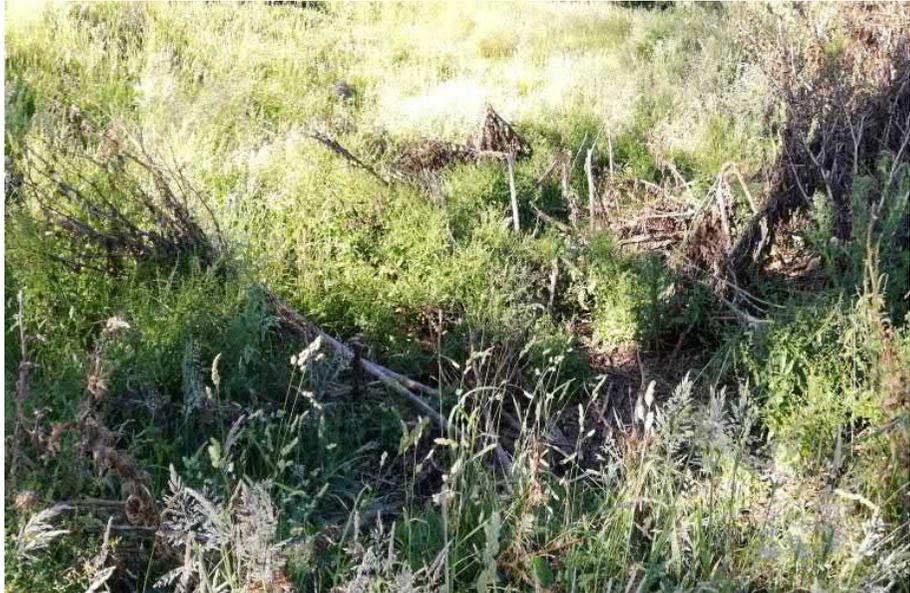
| <p>Plate 4 Spring 4 June 2021</p> | <p>Plate 4 Spring 4 December 2021</p> |

| <p>Inaccessible</p> | A photograph showing a dense thicket of green and brown vegetation, likely a spring area, with various grasses and shrubs. The scene is brightly lit, suggesting a sunny day. |
