17 February 2020

Matthew Dodd  
Quarry Manager  
Holcim (Australia) Pty Ltd  
Mt. Shamrock Road

## **Mt. Shamrock Quarry - Toomuc Valley Slope Inspection, January 2019**

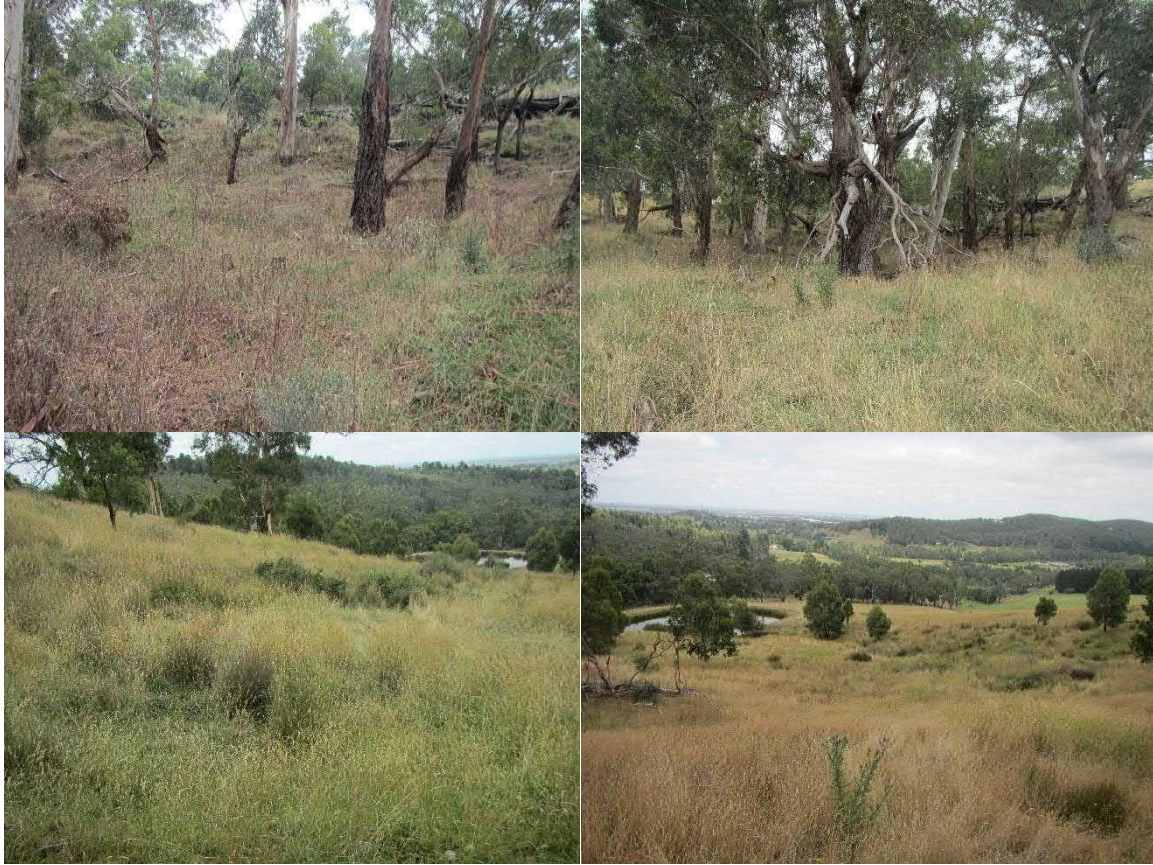
## Mass06 Dam

In addition to the landslip monitoring and revegetation recommendations discussed above, the site investigation observed five farm dams exhibiting varying levels of degradation, namely: Small farm dam within Mass02; moderately sized farm dam to southwest of Mass05; larger farm dam on southern side of Mass06; larger farm dam on southern side of Mass13; and small farm dam to south of Mass16.
