20 January 2021

Matthew Dodd
Quarry Manager
Holcim (Australia) Pty Ltd
Mt. Shamrock Road
Pakenham, Victoria 3810

Mt. Shamrock Quarry - Toomuc Valley Slope Inspection, January 2020**1.0 Introduction and Background**

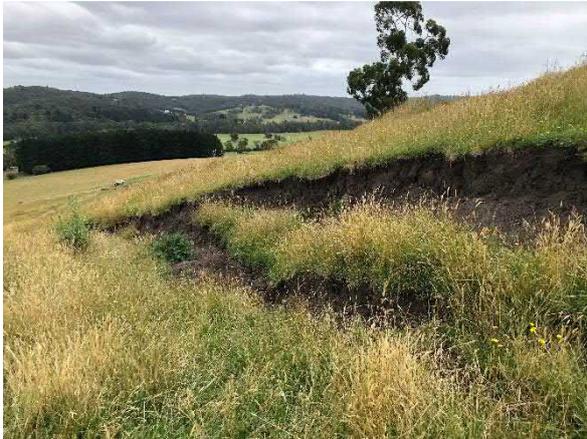
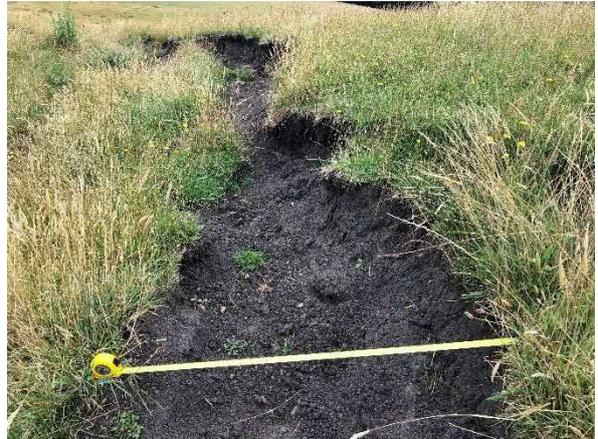
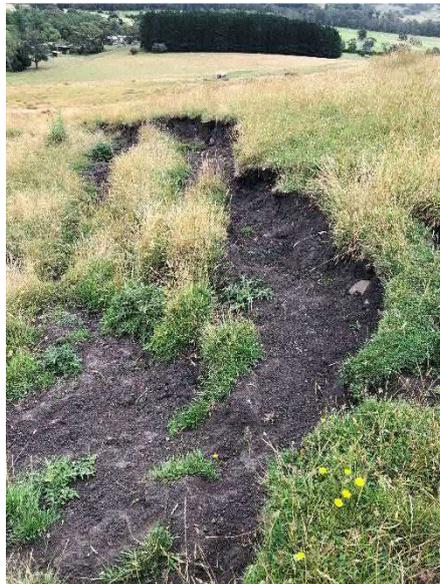
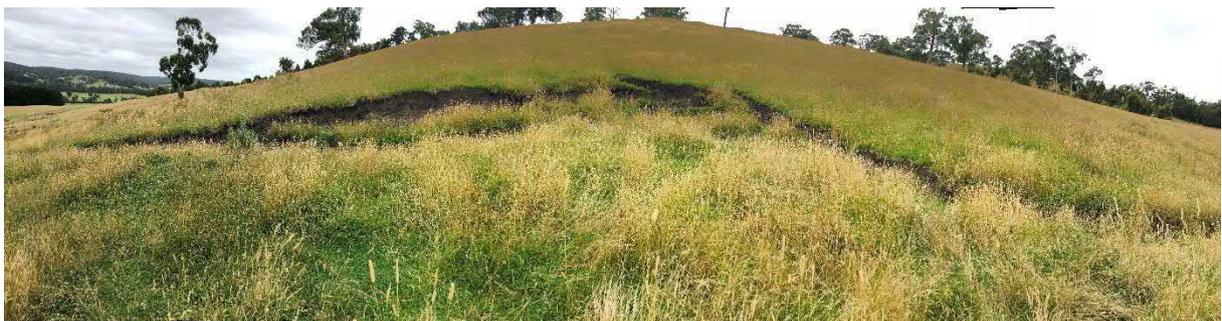
Circular Failure of an Existing Old Backscrap

- Mass 05 shows new areas of instability with a local failure due to cattle traffic and a circular slope failure of an existing backscarp extending over 15 m.
- No sign of new areas of instability were identified on the other Masses located within slopes surrounding the quarry.
- the Mass06 Dam Crest has deteriorated due to cattle traffic and in some section, the crest is locally reduced to a 1.2 - 1.5 m width compared to 2.5 – 3.0 m elsewhere.
- Significant seepage has been noted at the toe of the Dam located upstream of Mass 14. This dam is not within Holcim Land.
