2 December 2021

Matthew Dodd
Quarry Manager
Holcim (Australia) Pty Ltd
Mt. Shamrock Road
Pakenham, Victoria 3810

Mt. Shamrock Quarry - Toomuc Valley Slope Inspection, December 2021

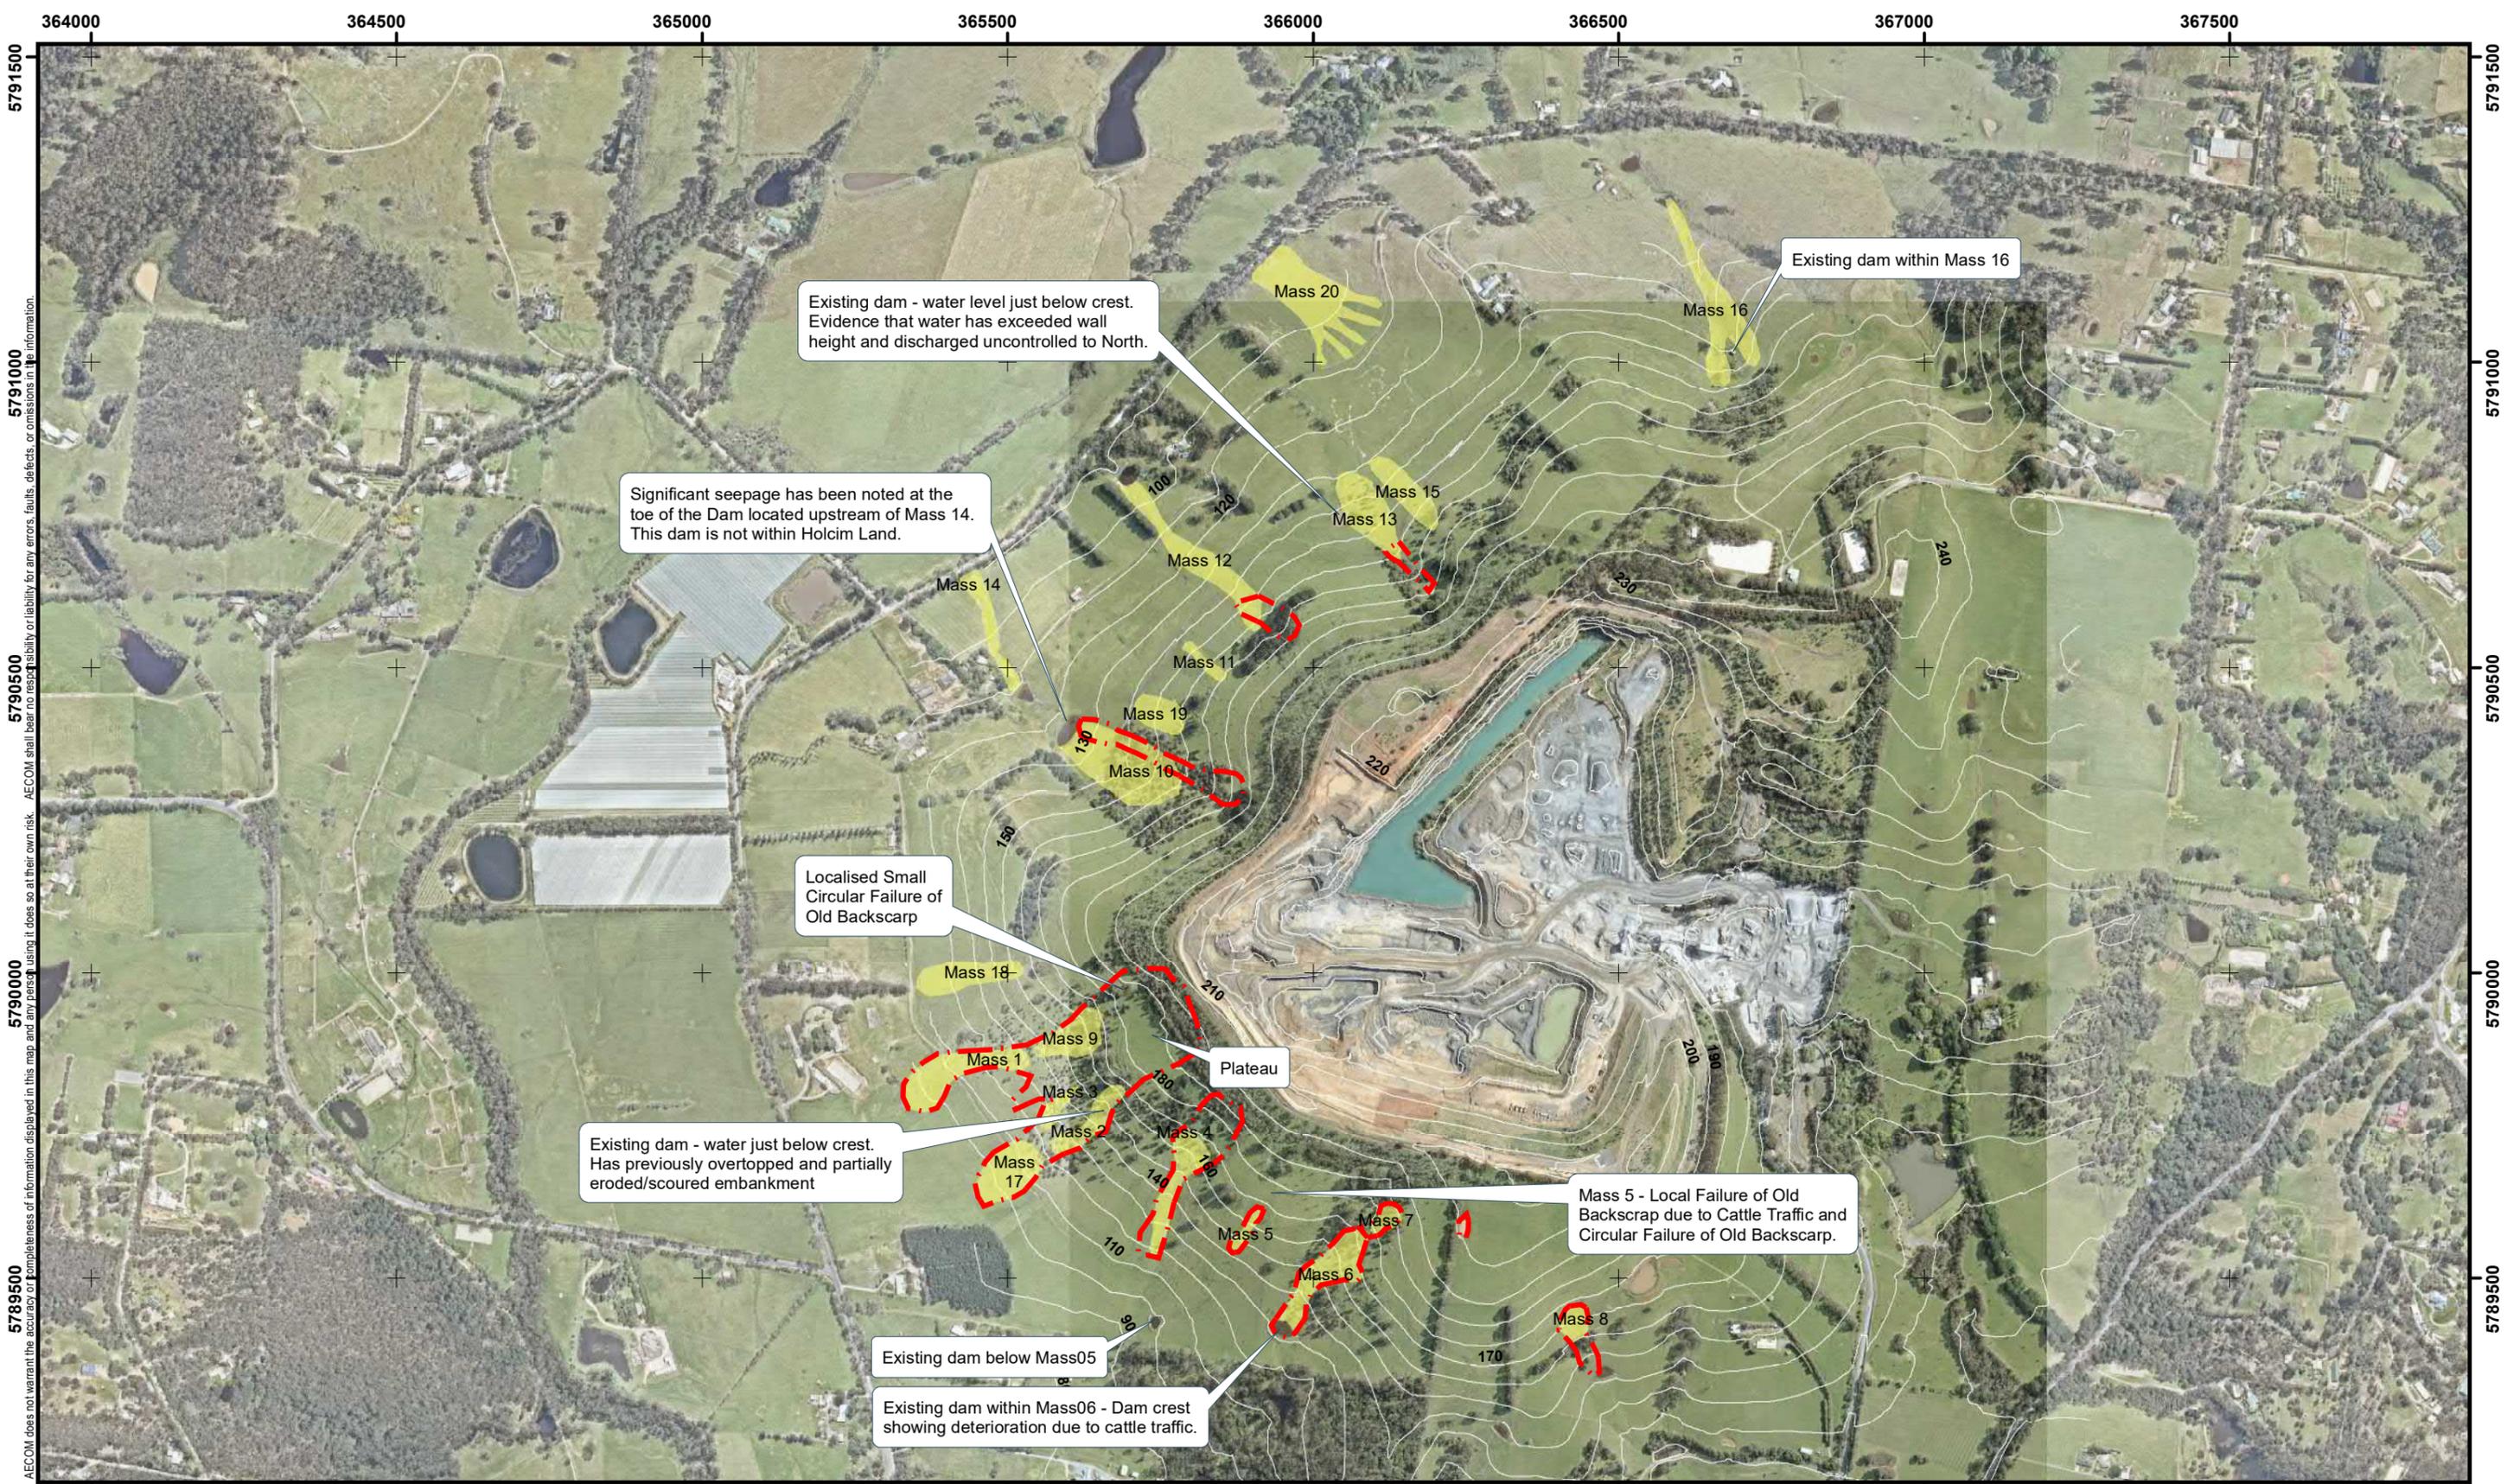
The outline of large old landslides, originally identified from 2001 *Google Earth* aerial imagery and updated to overlie geological setting maps and recent flyover mapping has been included on Figure 1 and Figure 2 of Attachment 1, respectively.

AECOM Note: Review of the regional geology and contour information (Figure 1) notes that the identified springs appear to be positioned around elevation 135 m to 165 m AHD which corresponds approximately to the basalt / granodiorite geological boundary; and

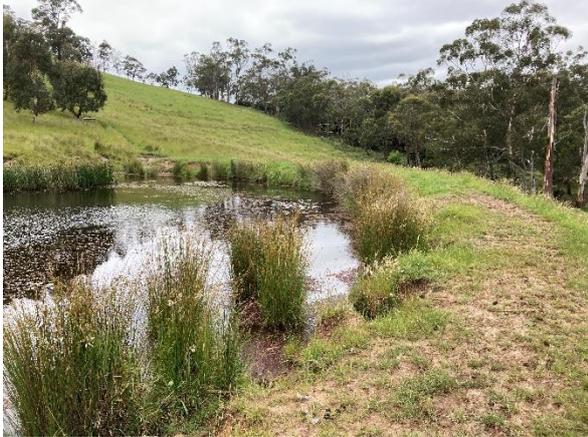
- No sign of new areas of instability were identified on the Masses located within slopes surrounding the quarry.
- Mass06 Dam Crest has deteriorated due to cattle traffic and in some section, the crest is locally reduced to a 1.2 - 1.5 m width compared to 2.5 – 3.0 m elsewhere.
- Significant seepage has been noted at the toe of the Dam located upstream of Mass 14. This dam is not within Holcim Land.

4. Remedial treatment of Mass06 Dam with reinstatement of the dam crest and construction of a barricade to prevent animal access to the dam crest.
5. Holcim should notify the landowner of the dam located upstream of Mass 14 of the important seepage observed and recommend the dam be inspected by an experienced and qualified dams or geotechnical engineer.

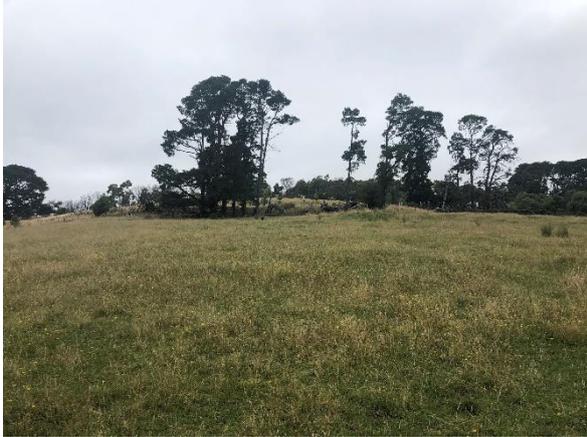
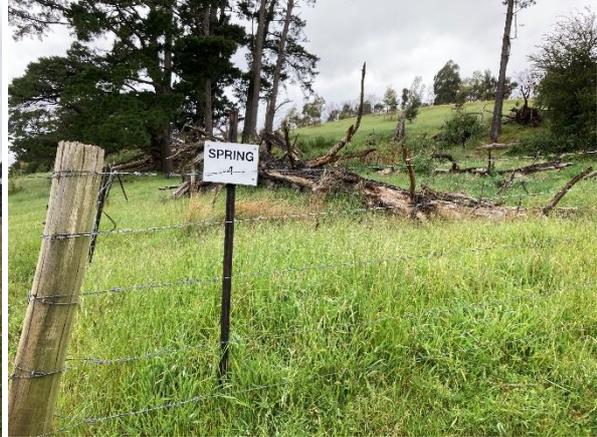
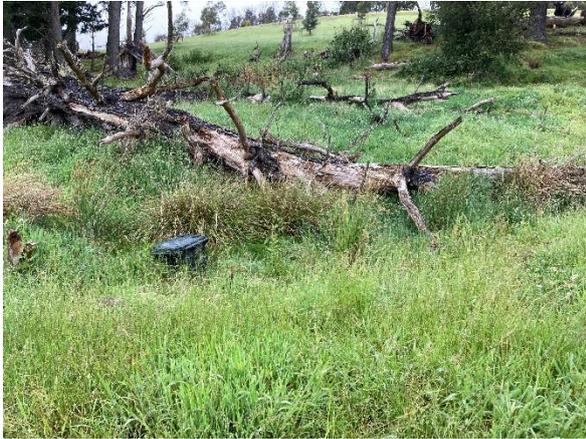
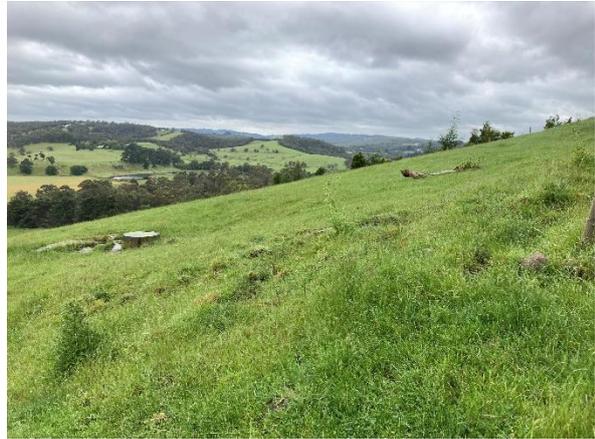
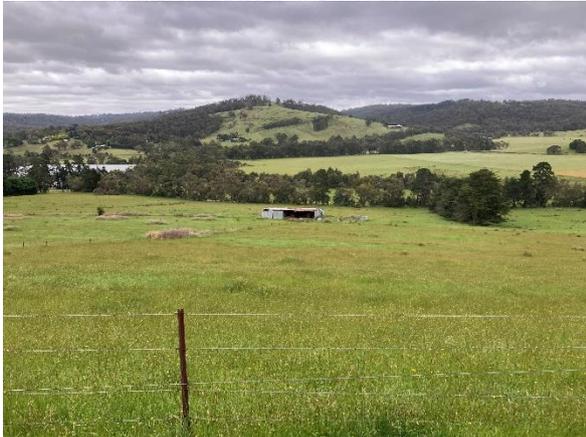
Mass19

- Spring 4 within Mass 19 was observed to be overflowing and a pipe was added to convey water downstream. Since then no overtopping was noticed at Spring 4;
