26 February 2024

Leigh Elliott  
Quarry Manager  
Holcim (Australia) Pty Ltd  
Mt. Shamrock Road

**Mt. Shamrock Quarry - Toomuc Valley Slope Inspection, January 2024**

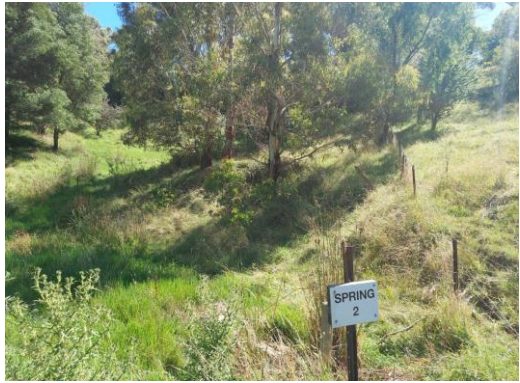
Spring ID	Site Observations	Location of Spring (Relative to Slope Mass)	Photo
Spring 01	Not inspected *		
Spring 02	Spring water impounded by embankment.  Refer "Mass 2" entry in Attachment 1.	Within Mass 2, mid- upslope.

On this basis, it is recommended that Holcim investigates alternative ways to manage surface water from the springs at the locations where standing water is considered to present a risk to the slope. A primary consideration of this will be to establish good surface drainage to avoid standing water.

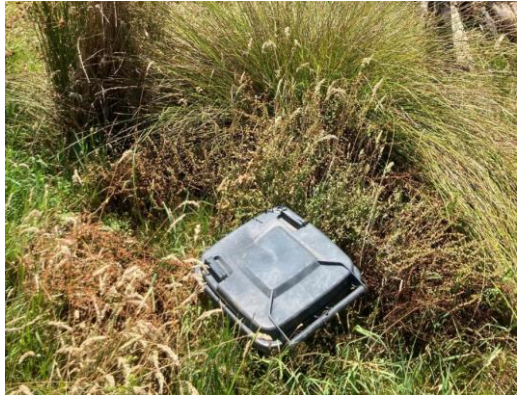
Spring 03	Heavily vegetated.  Plastic bin placed over spring.  Ground surface appeared wet around bin.	Within Mass 19, upslope.

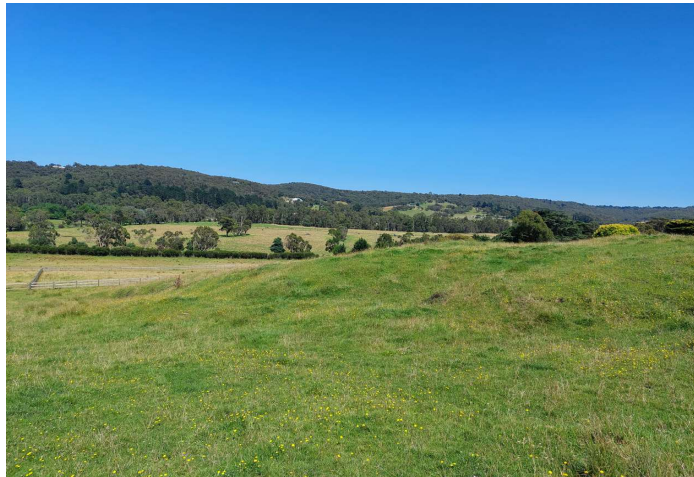
**Plate M01-B**

Standing midslope and looking north. Rotated trees

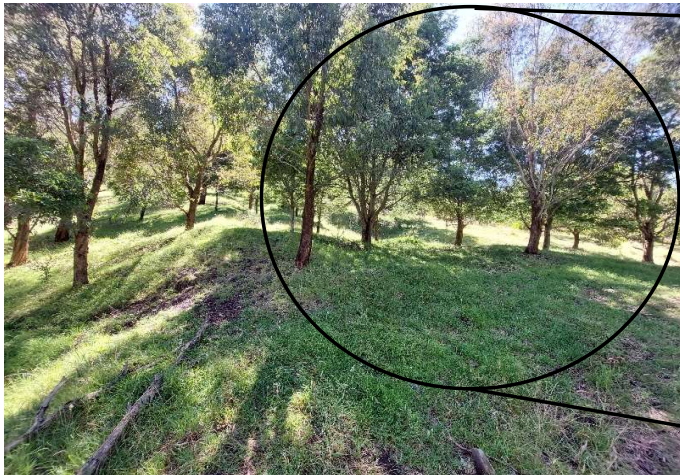
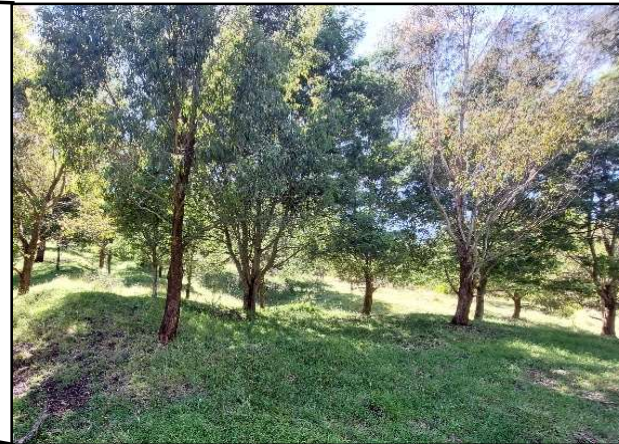
<b>Mass 3</b>	<p>Overall, the land surface in this area is hummocky but well vegetated with dense grass and dense tree cover (medium to large trees) (Plate M03-A).</p> <p>The trunks of multiple trees are rotated (Plates M03-A and M03-C). Attachment 3 shows the location where this has been observed. The trunks are rotated generally towards the downslope direction, by amounts less 5° (estimated visually)</p>
<b>Mass 4</b>	<p>Overall, the land surface in this area is hummocky but well vegetated with dense grass cover, small to medium shrubs and medium to large trees (mostly within the downslope area).</p> <p>The backscarp of an old slump was observed and was densely vegetated (Plate M04-A). Immediately overlying the scarp, a medium-sized tree was present with roots protruding into the scarp.</p>
<b>Mass 5</b>	<p>Overall, the land surface in this area is hummocky but well vegetated with dense grass cover and scattered medium to large trees (Plates M05-A and M05-B).</p> <p>At a location south (downslope) from Mass 5, backscarps of up to 1 – 1.5 m height were observed, which appeared to be associated with a localised area of historical slumping. Attachment 3 shows the location of where this has been observed.</p> <p>The backscarps were either bare or poorly vegetated.</p> <p>In some parts, mostly along the western flank of the slump, the backscarps were flattened and covered with dense grass (Plates M05-C and M05-D).</p>

**Plate M03-C**  
(Left) Looking north east, upslope. (Right - zoomed in) - trunks rotated in downslope direction

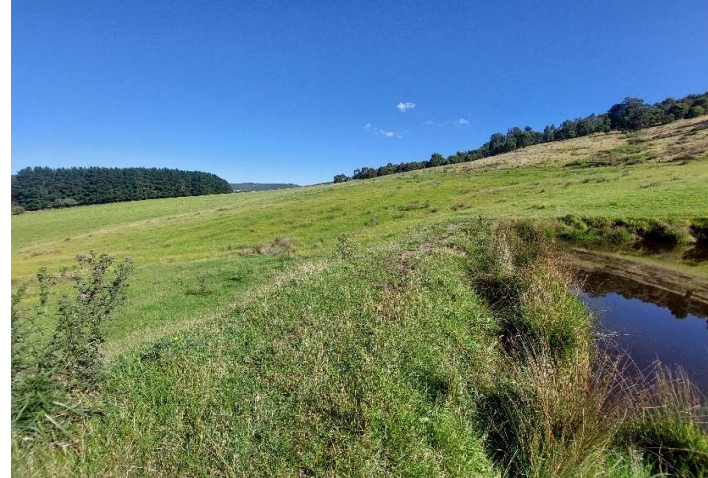
**Plate M05DAM-A**

Upstream depression partially obstructed with rubble

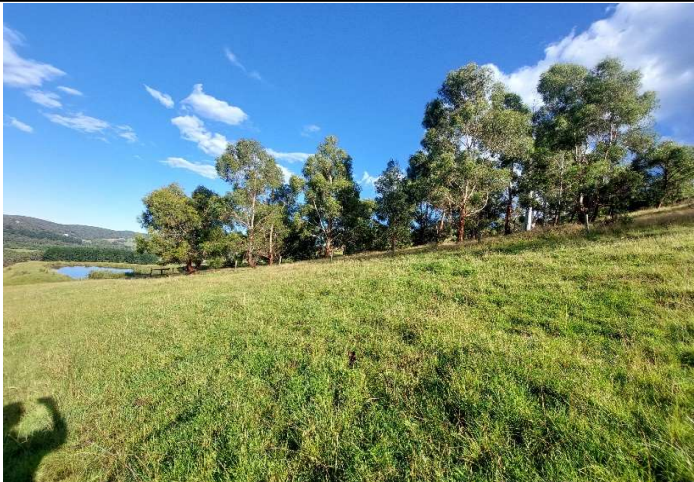
**Plate M05DAM-D**

Looking downstream. Dam on brink of overflowing.

The risks associated with the impacts of dam failure should be investigated by Holcim. We draw your attention to the DELWP publication “Your dam: Your responsibility. A guide to managing the safety of small dams” for further details ([https://www.water.vic.gov.au/\\_data/assets/pdf\\_file/0027/668610/your-dam-your-responsibility.pdf](https://www.water.vic.gov.au/_data/assets/pdf_file/0027/668610/your-dam-your-responsibility.pdf)).

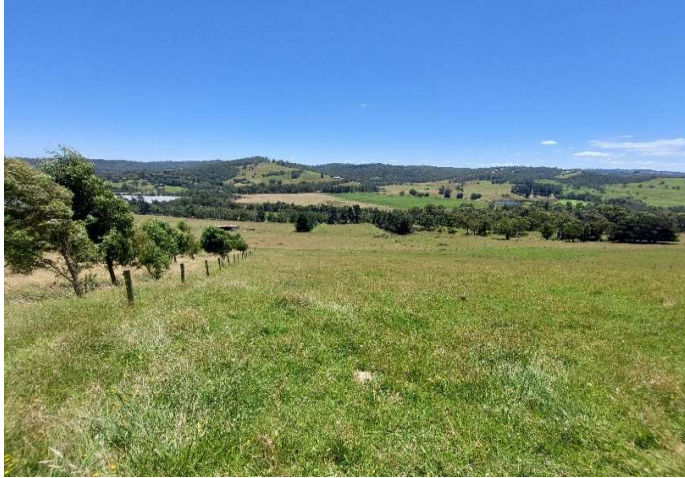
**Plate M10-D**

- **Masses 2, 4, 6, 7, 9, 11 – 13, 15 and 17 – 19:** no visual signs that could indicate recent ground movement were observed.
- **Mass 8:** backscarps were observed, which appeared to be associated with a localised area of historical slumping. In the remaining areas, no visual signs that could indicate recent ground movement were observed.
- **South (downslope) of Mass 5:** backscarps were observed within an area south of Mass 5 (outside of the Mass 5 extent, refer Attachment 3), which appeared to be associated with a localised area of historical slumping.
- **Masses 1, 3 and 10:** visual signs suggesting that recent ground movement has occurred were observed, which included:
  - **Mass 1:** rotated tree trunks.
  - **Mass 3:** rotated tree trunks.
  - **Mass 10:** rotated tree trunks and rotated fence line.

Steel post fence (right of photo) rotated. Trees with curved trunk

As such, our present recommendation is to continue to maintain regular documented inspections of all slope masses in accordance with the requirements of Sub-section 2.5.4 of the EMP.

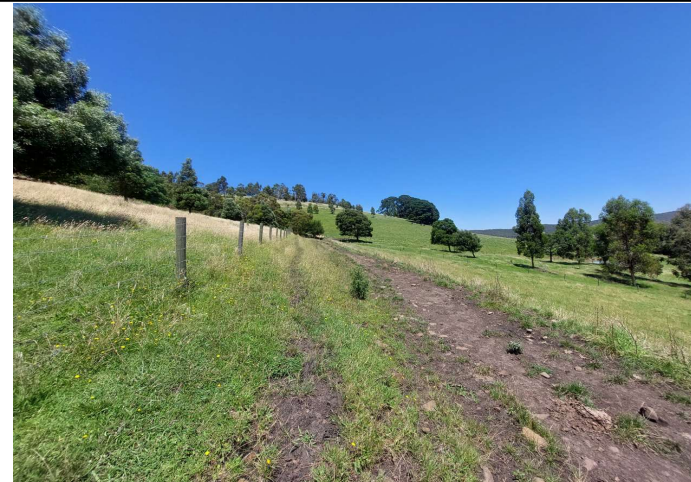
**Plate M13-A**

Standing near dam and looking north east (upslope)

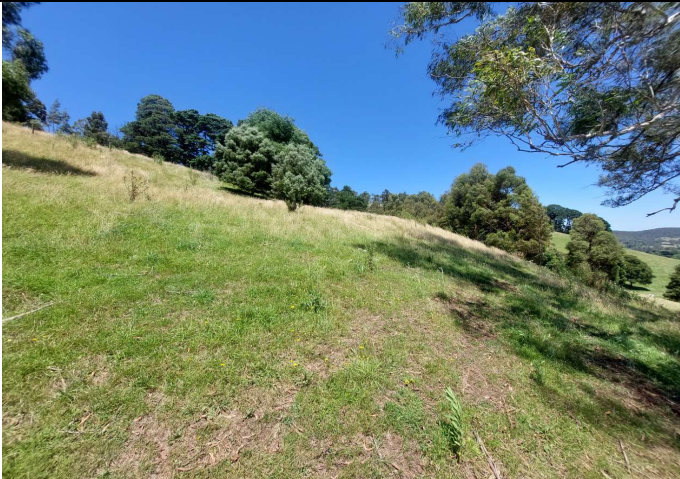
**Plate M13-B**

Standing near top of Mass 13 and looking west

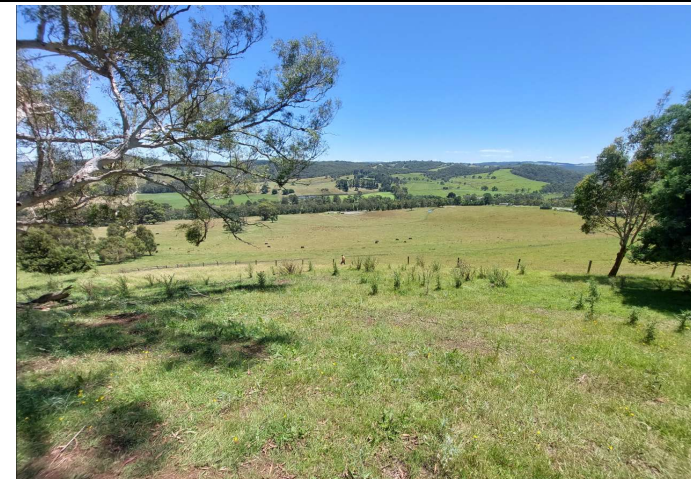
**Plate M13-C**

Mass 13 typical conditions - grass and tree cover

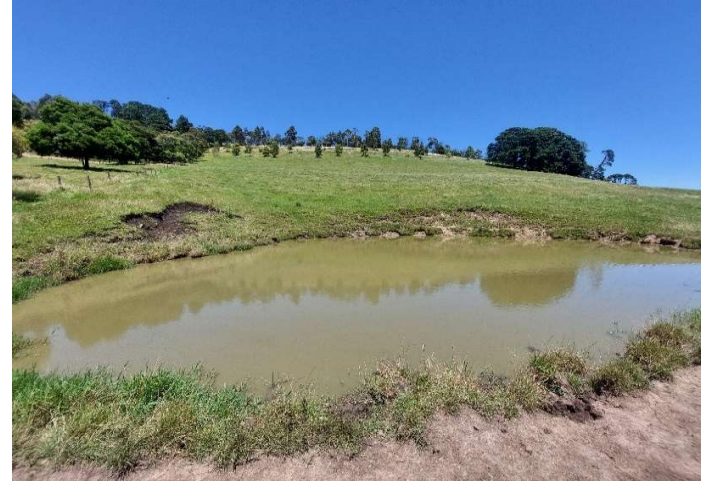
**Plate M13DAM-A**  
Looking west

<b>Farm Dam West of Mass 13</b>	<p>The dam water level was observed to be some 250 – 500 mm below the embankment crest. The crest surface was mostly bare (Plate M13DAM-A).</p> <p>The dam was on the verge of overflowing through a point at roughly where the embankment abuts the natural ground surface on the northeastern side.</p> <p>The ground surface at the point of discharge was rugged and wet.</p> <p>A shallow slump on the southern (upslope) side was present (Plate M13DAM-B). The slump surface was poorly vegetated.</p> <p>On the northeastern (upslope) side of the dam, a shallow slump in topsoil was present. Its scarp did not exceed 200 mm in height (Plate M13DAM-C).</p> <p>The dam crest appeared narrower in localised sections of the embankment, but by amounts not exceeding about 300 mm (Plate M13DAM-A).</p> <p>The downstream face of the embankment was well-vegetated with grass (Plate M13DAM-D).</p>
