**2025 TOOMUC VALLEY
SLOPE INSPECTION**

PAKENHAM QUARRY

Date: 14th January 2026

File Name	2025 Toomuc Valley Slope Inspection
Last Edited	14/01/2026
Report Status	Final

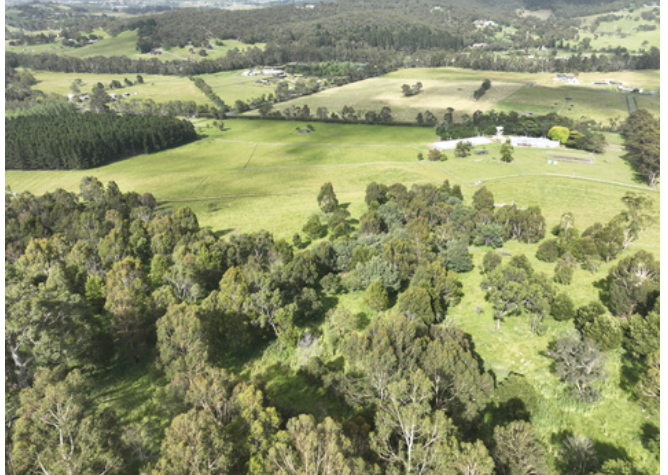
Mass 04 - looking north

REFERENCE	INSPECTION NOTES
Mass 04	Observation
	Overall, the land surface in this area is hummocky but well vegetated with dense grass cover, small to medium shrubs and medium to large trees (mostly within the downslope area).
	No evidence of recent or ongoing instability was observed.
	Recommendation
	-
Mass 05	Observation
	Overall the area is well vegetated with dense grass cover throughout.
	Minor historical circular failures were observed in four locations: these failures were observed to be associated with exposed (bare) scarps and a change in the natural topography locally downslope with remnant mobilised material. The mobilised material is well vegetated whereas the backscarps were either bare or poorly vegetated. There has been some planting around Mass 5 which has improved the erosion around the failed areas.
	The most recent failure (downslope) measures about 15 m in width and ~1.0 m in height. The circular failure is small in volume and given that the location is isolated from any downhill infrastructure it is not considered to be of significant geological risk. No observable change in instability conditions since previous geotechnical inspection.

Recommendation
	Continued revegetation of scarp surfaces with grasses.
Mass 06	Observation
	Overall, the land surface in this area is hummocky but well vegetated with dense grass cover and medium to large trees throughout.
	No evidence of recent or ongoing instability was observed.
	Recommendation
	-
Mass 07	Observation
	Overall, the land surface in this area is hummocky but well vegetated with dense grass cover and medium to large trees throughout.
	No evidence of recent or ongoing instability was observed.
	Recommendation
	-

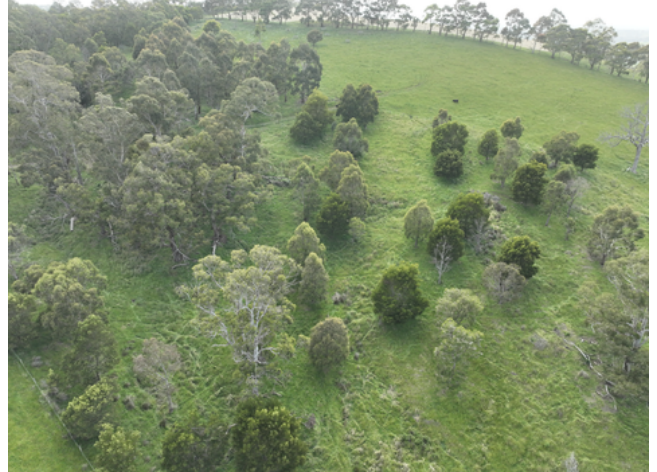
Mass 08 - looking northeast

REFERENCE	INSPECTION NOTES
Mass 08	Observation
	Overall the area is well vegetated with dense grass cover throughout. There are some historical scarps up to 1m height.
	The local area immediately below scarp is poorly to moderately vegetated. Bare ground was observed at the toe of the scarp
	No evidence of recent or ongoing instability was observed.
	Recommendation
Mass 09	Observation
	Overall the area is well vegetated with dense grass cover and small to medium shrubs and trees throughout.
	No evidence of recent or ongoing instability was observed.
	Recommendation
	-
Mass 10	Observation
	Overall, the land surface in this area is hummocky but well vegetated with dense grass and dense tree cover (medium to large trees).
	The trunks of a few random trees are rotated which appear in isolation and not grouped together.
	No evidence of recent or ongoing instability was observed.
	Recommendation
Mass 11	Observation

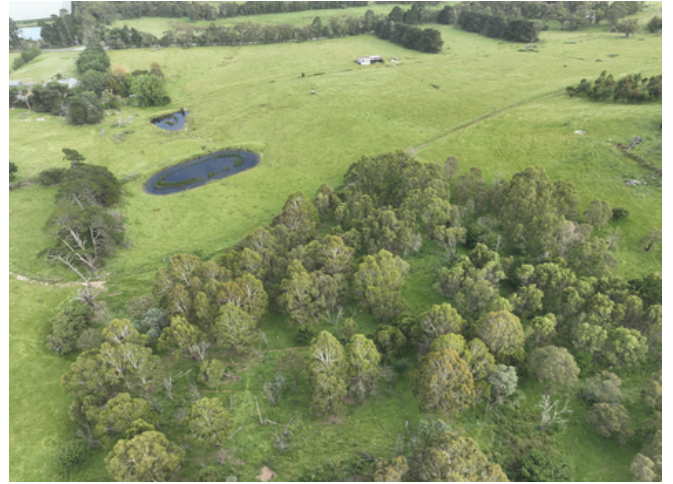
Mass 11 - looking northwest

Overall, the land surface in this area is hummocky but well vegetated with dense grass cover and medium to large trees.
	No evidence of recent or ongoing instability was observed.
	Recommendation
	-

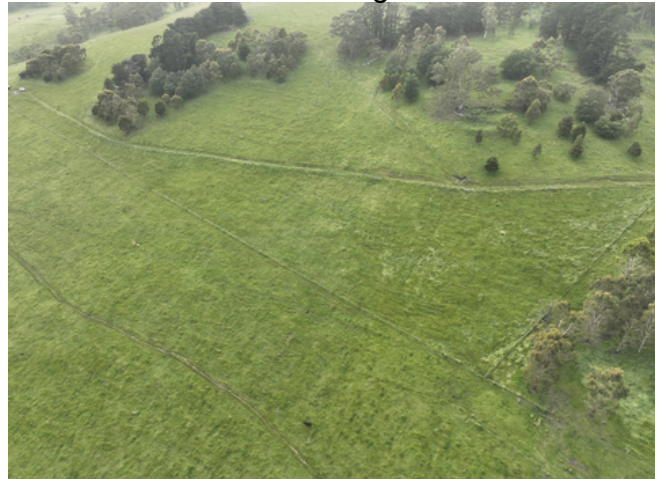
Mass 16 - looking east

Recommendation
	-
Mass 16	Observation
	Overall the area is well vegetated with dense grass cover.
	No evidence of recent or ongoing instability was observed.
	Recommendation
	-
