Electrical Safety - Bushfire Mitigation Plan (BFMP)

Oaklands Junction Quarry 2024-2025

Revision 7

HOLCIM QUARRY OAKLANDS JUNCTION 2024

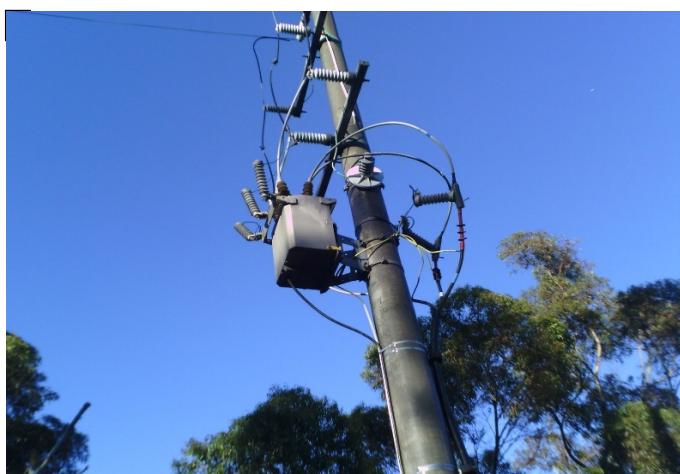
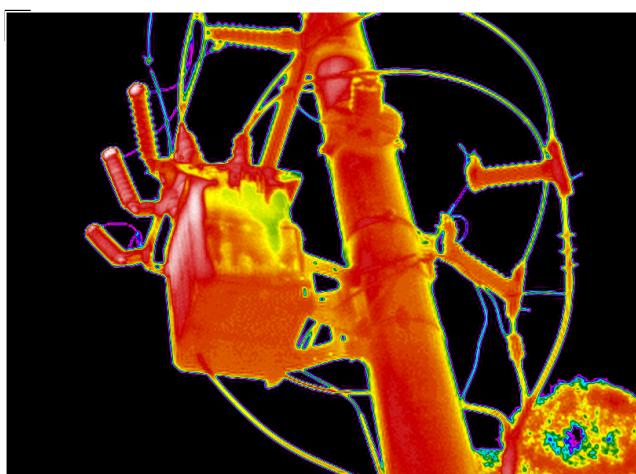
1059

EQUIPMENT SURVEYED:		POLE				
LOCATION:	HOLCIM 290 OAKLANDS ROAD OAKLANDS JUNCTION					
GOOGLE MAPS LAT LONG	N/A					
COMPONENT NAME	POLE NO.3					
CODE	N/A					
SERIAL No.	N/A					
MANUFACTURER	N/A					
RATING	VOLTS	22KV	AMPS	N/A	KW/HP	N/A
ELECTRICAL LOADING	RED PHASE	N/A	AMPS	WHITE PHASE	N/A	AMPS

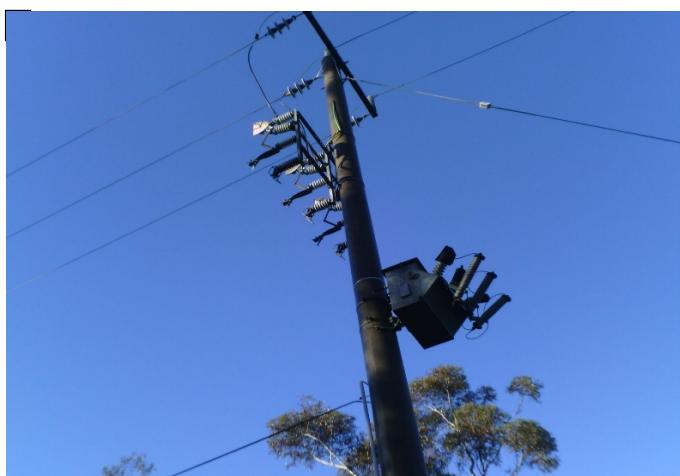
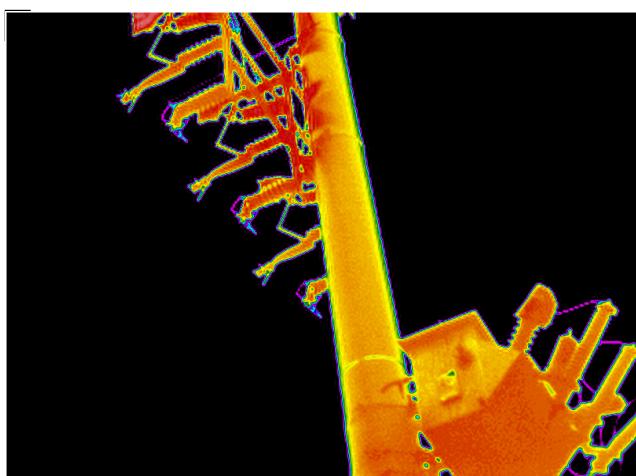
1061

EQUIPMENT SURVEYED:		POLE				
LOCATION:	HOLCIM 290 OAKLANDS ROAD OAKLANDS JUNCTION					
GOOGLE MAPS LAT LONG	N/A					
COMPONENT NAME	POLE NO.4					
CODE	N/A					
SERIAL No.	N/A					
MANUFACTURER	N/A					
RATING	VOLTS	22KV	AMPS	N/A	KW/HP	N/A
ELECTRICAL LOADING	RED PHASE	N/A	AMPS	WHITE PHASE	N/A	AMPS

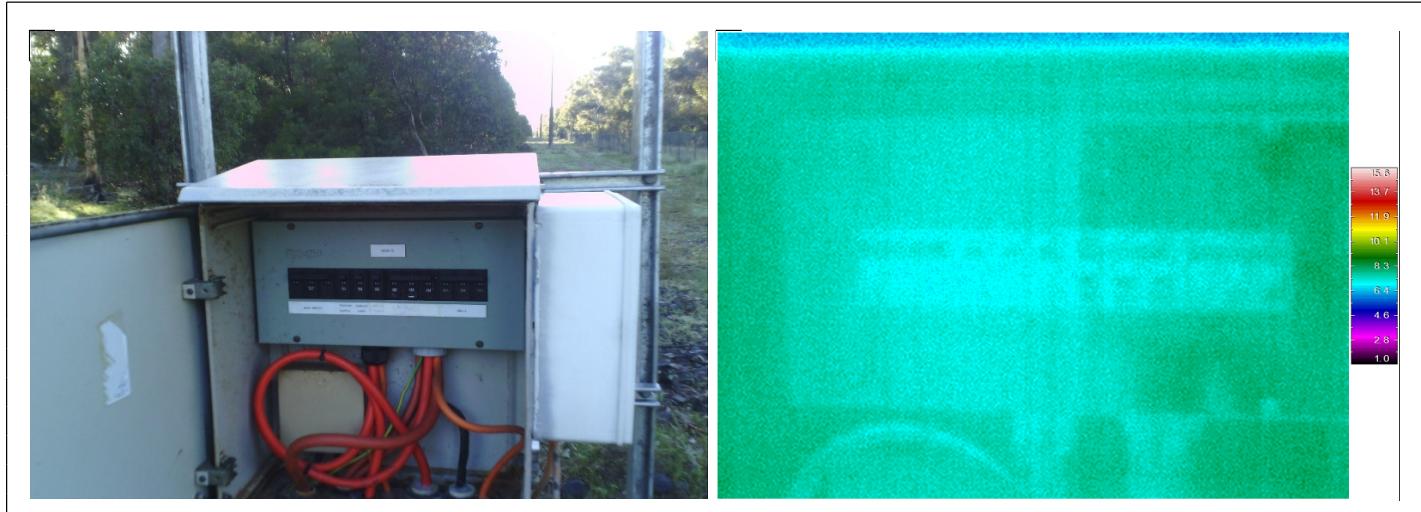
1062

EQUIPMENT SURVEYED:		POLE				
LOCATION:	HOLCIM 290 OAKLANDS ROAD OAKLANDS JUNCTION					
GOOGLE MAPS LAT LONG	N/A					
COMPONENT NAME	MSB 5					
CODE	N/A					
SERIAL No.	N/A					
MANUFACTURER	N/A					
RATING	VOLTS	22KV	AMPS	N/A	KW/HP	N/A
ELECTRICAL LOADING	RED PHASE	N/A	AMPS	WHITE PHASE	N/A	AMPS

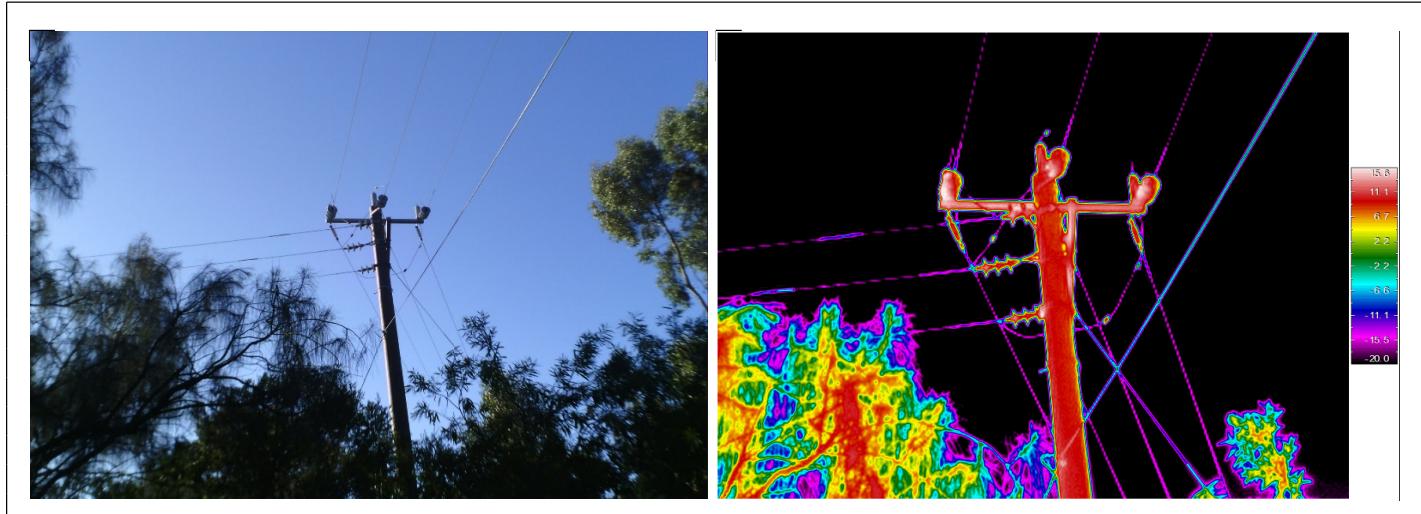
1065

EQUIPMENT SURVEYED:		POLE					
LOCATION:	HOLCIM 290 OAKLANDS ROAD OAKLANDS JUNCTION						
GOOGLE MAPS LAT LONG	N/A						
COMPONENT NAME	POLE NO.10	CODE	N/A	SERIAL No.	N/A	MANUFACTURER	N/A
RATING	VOLTS	22KV	AMPS	N/A	KW/HP	N/A	
ELECTRICAL LOADING	RED PHASE	N/A	AMPS	WHITE PHASE	N/A	AMPS

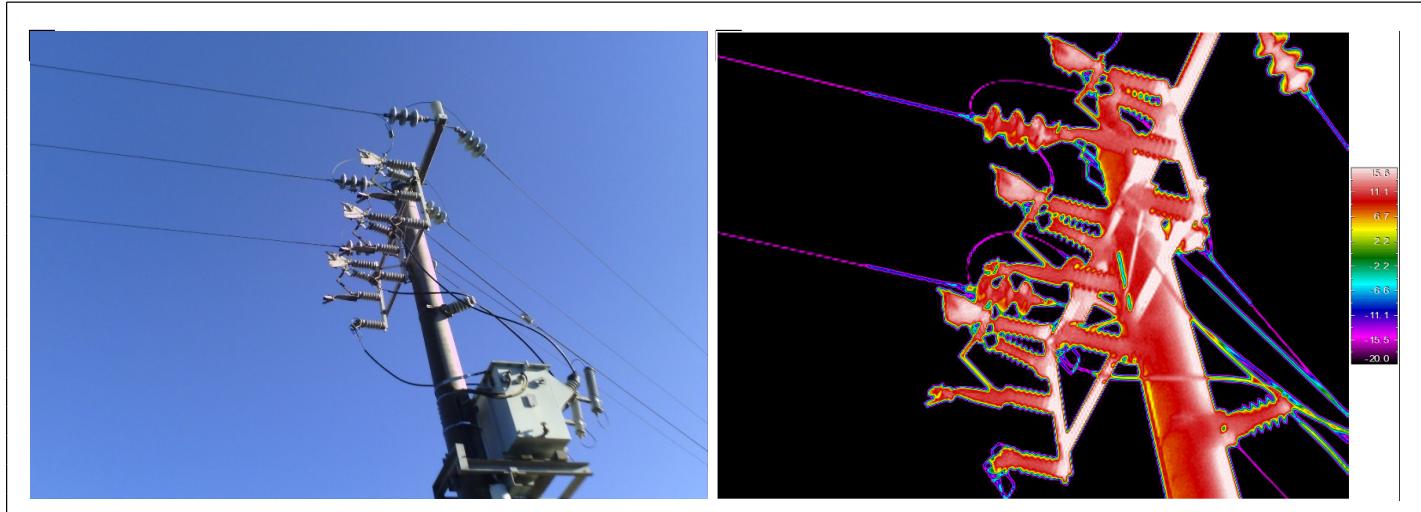
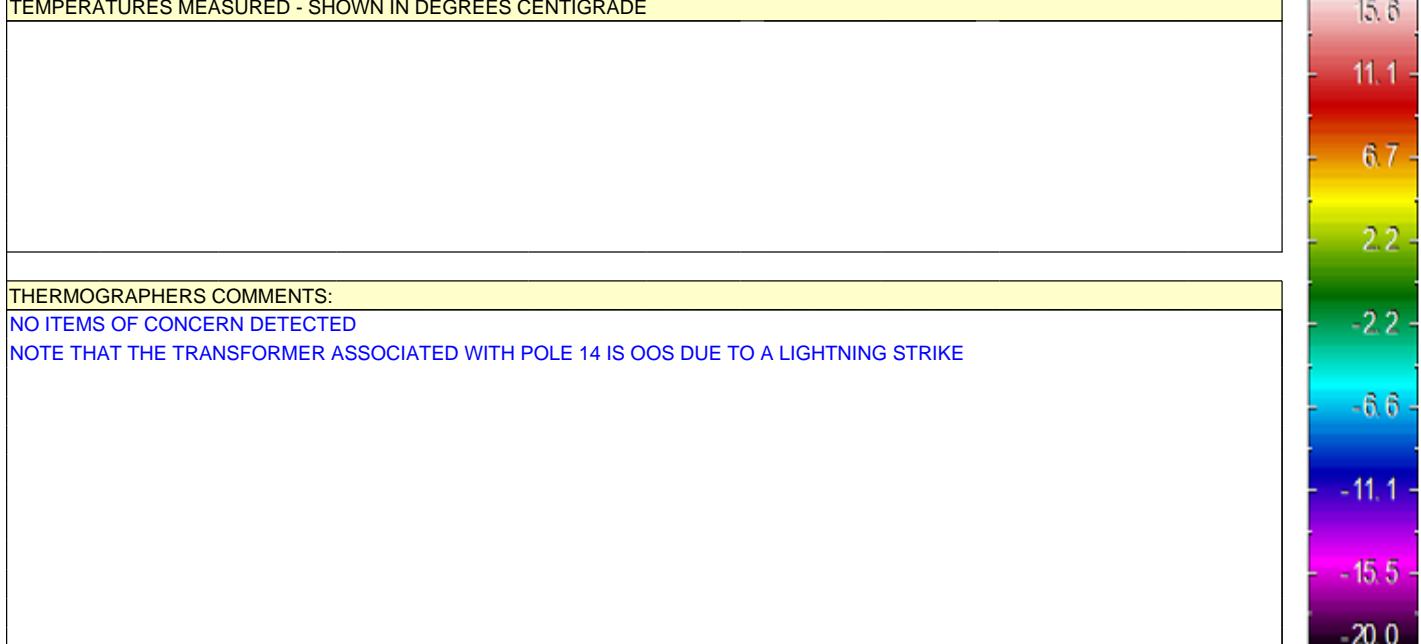
1068

EQUIPMENT SURVEYED:		POLE					
LOCATION:	HOLCIM 290 OAKLANDS ROAD OAKLANDS JUNCTION						
GOOGLE MAPS LAT LONG	N/A						
COMPONENT NAME	POLE NUMBER 14	CODE	N/A	AMPS	N/A	KW/HP	N/A
SERIAL No.	N/A	MANUFACTURER	N/A	AMPS	AMPS	AMPS	AMPS
RATING	VOLTS	22KV	AMPS	WHITE PHASE	N/A	AMPS	AMPS
ELECTRICAL LOADING	RED PHASE	N/A	AMPS	WHITE PHASE	N/A	AMPS	N/A

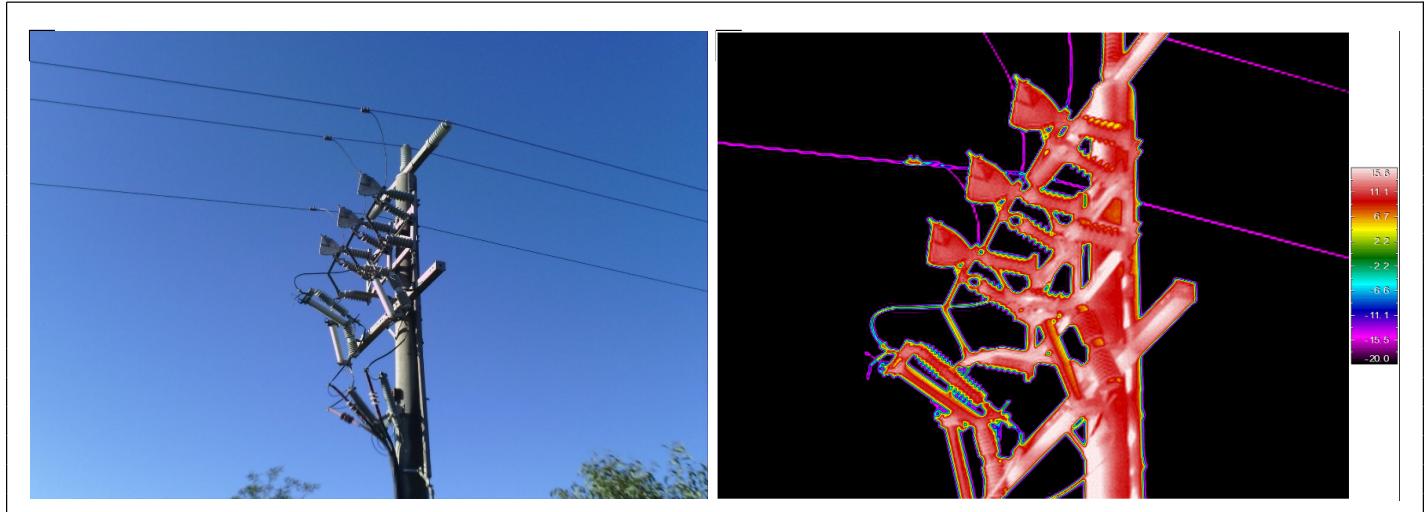
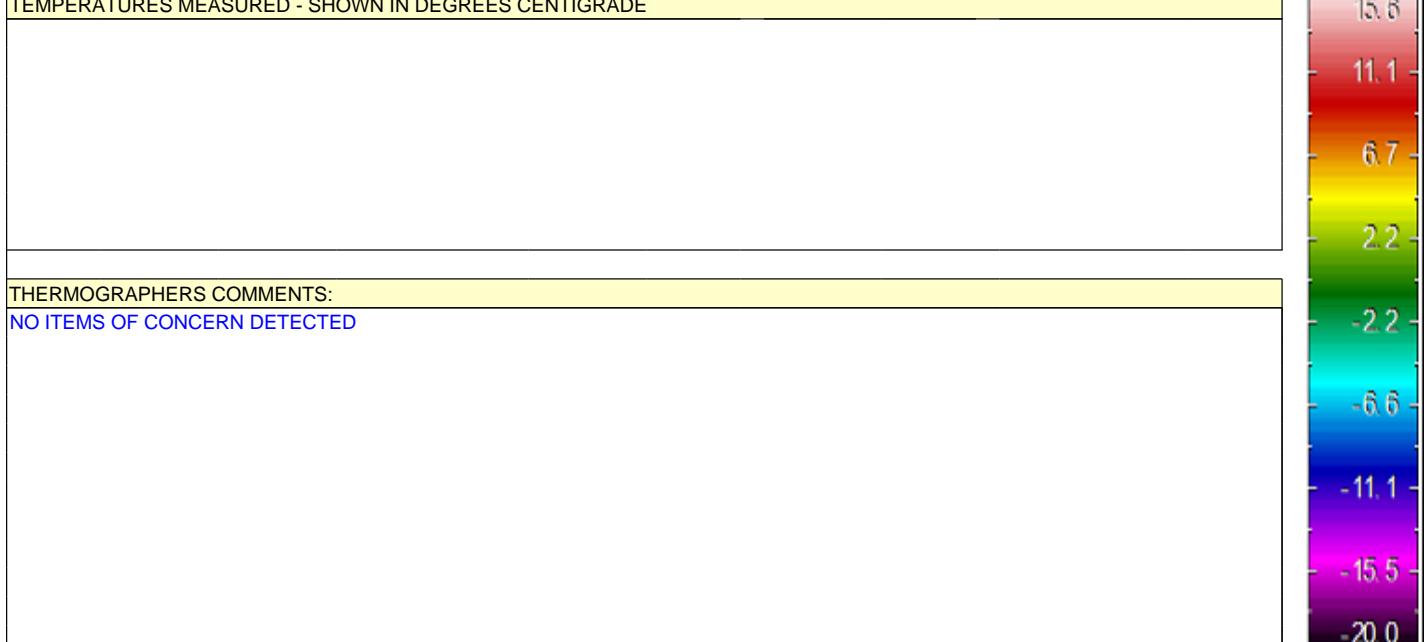
1070

EQUIPMENT SURVEYED:		POLE				
LOCATION:	HOLCIM 290 OAKLANDS ROAD OAKLANDS JUNCTION					
GOOGLE MAPS LAT LONG	N/A					
COMPONENT NAME	POLE NO.17					
CODE	N/A					
SERIAL No.	N/A					
MANUFACTURER	N/A					
RATING	VOLTS	22KV	AMPS	NO LOAD	KW/HP	N/A
ELECTRICAL LOADING	RED PHASE	N/A	AMPS	WHITE PHASE	N/A	AMPS

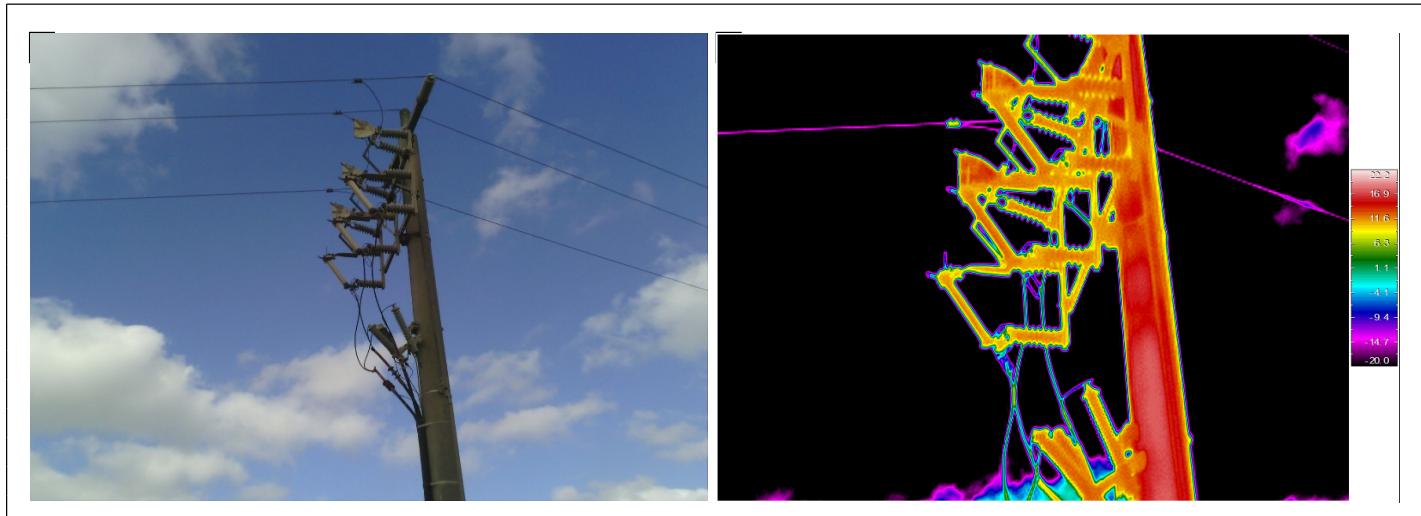
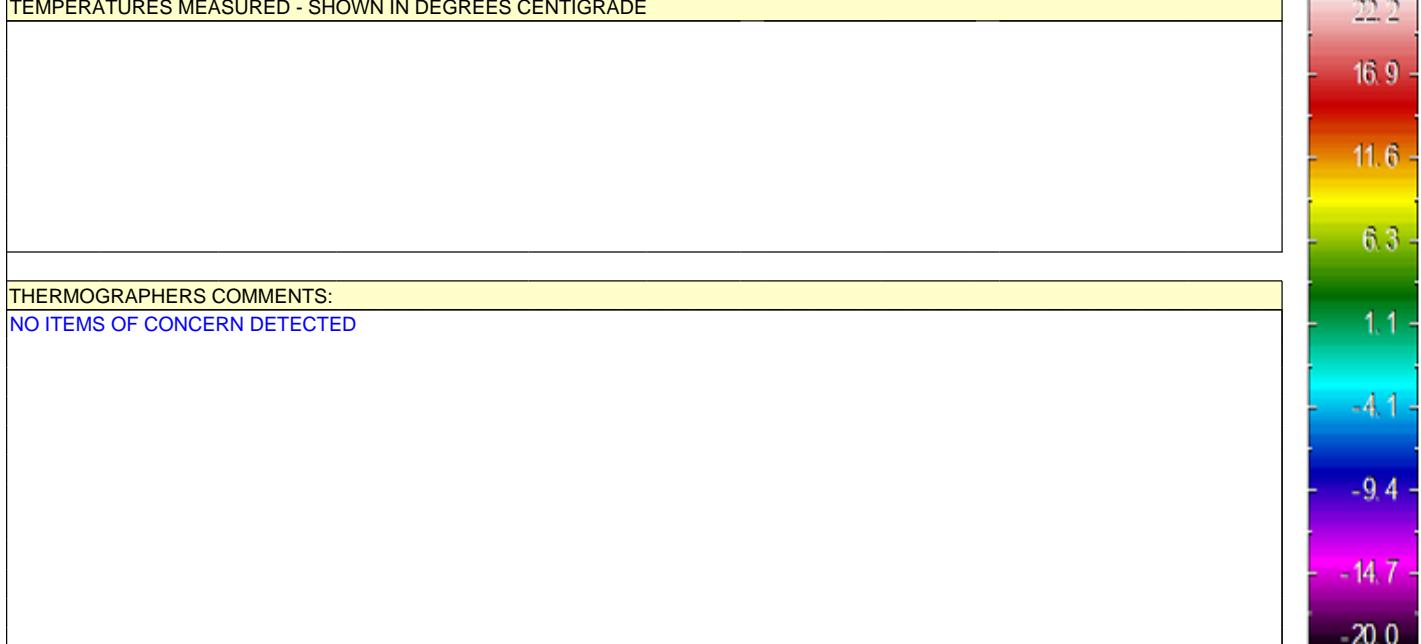
1075

EQUIPMENT SURVEYED:		TRANSFORMER					
LOCATION:	HOLCIM 290 OAKLANDS ROAD OAKLANDS JUNCTION						
GOOGLE MAPS LAT LONG	N/A						
COMPONENT NAME	POLE NO.19	CODE	N/A	SERIAL No.	N/A	MANUFACTURER	N/A
RATING	VOLTS	22KV	AMPS	N/A	KW/HP	N/A	
ELECTRICAL LOADING	RED PHASE	N/A	AMPS	WHITE PHASE	N/A	AMPS

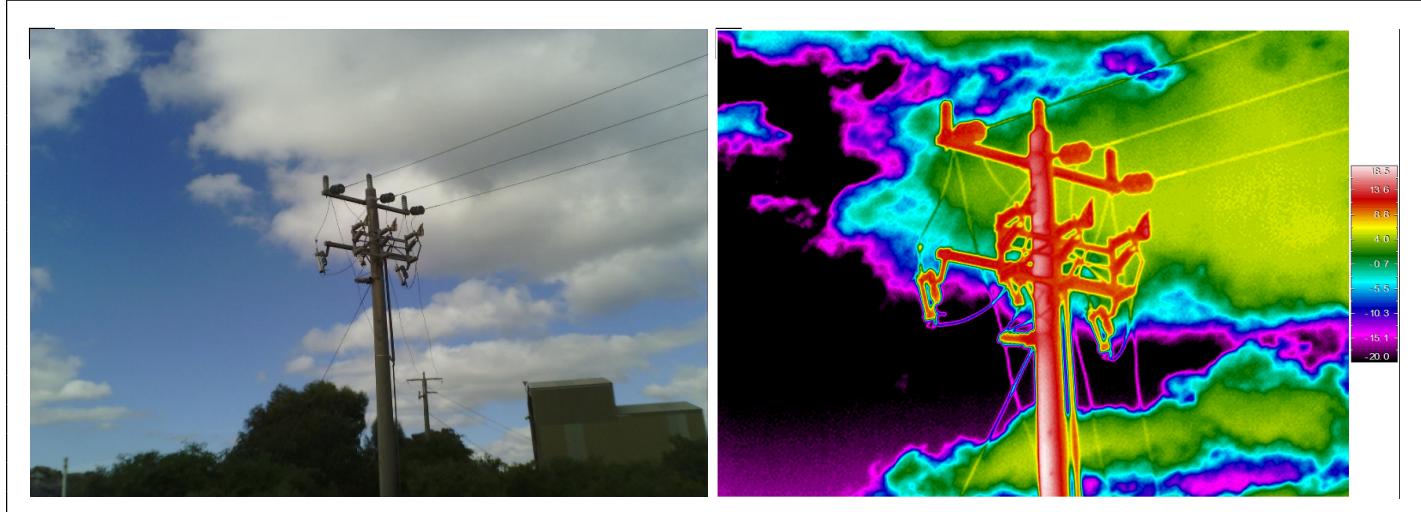
1076

EQUIPMENT SURVEYED:		POLE					
LOCATION:	HOLCIM 290 OAKLANDS ROAD OAKLANDS JUNCTION						
GOOGLE MAPS LAT LONG	N/A						
COMPONENT NAME	POLE NO.22						
CODE	N/A						
SERIAL No.	N/A						
MANUFACTURER	N/A						
RATING	VOLTS	22KV	AMPS	N/A	KW/HP	N/A	
ELECTRICAL LOADING	RED PHASE	N/A	AMPS	WHITE PHASE	N/A	AMPS	BLUE PHASE
							N/A AMPS

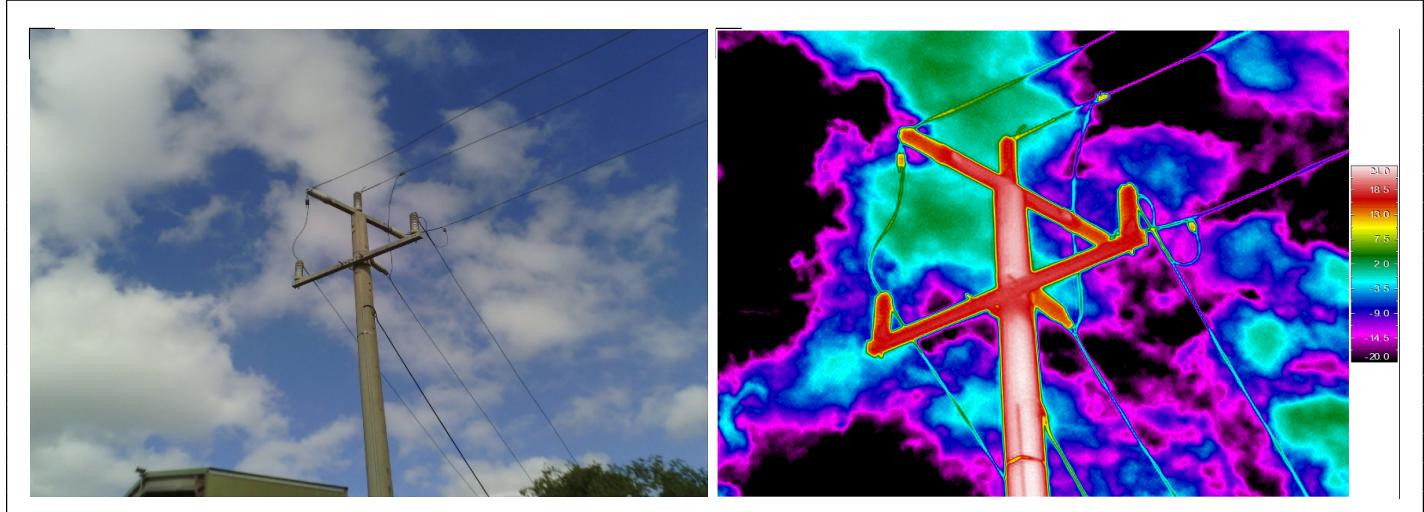
1077

EQUIPMENT SURVEYED:		POLE					
LOCATION:	HOLCIM 290 OAKLANDS ROAD OAKLANDS JUNCTION						
GOOGLE MAPS LAT LONG	N/A						
COMPONENT NAME	POLE NUMBER 23	CODE	N/A	AMPS	N/A	KW/HP	N/A
SERIAL No.	N/A	MANUFACTURER	N/A	AMPS	AMPS	AMPS	AMPS
RATING	VOLTS	22KV	AMPS	WHITE PHASE	N/A	AMPS	AMPS
ELECTRICAL LOADING	RED PHASE	N/A	AMPS	WHITE PHASE	N/A	AMPS	N/A
