ANNUAL REVIEW
1 April 2023 – 31 March 2024
Northern Dune Extension

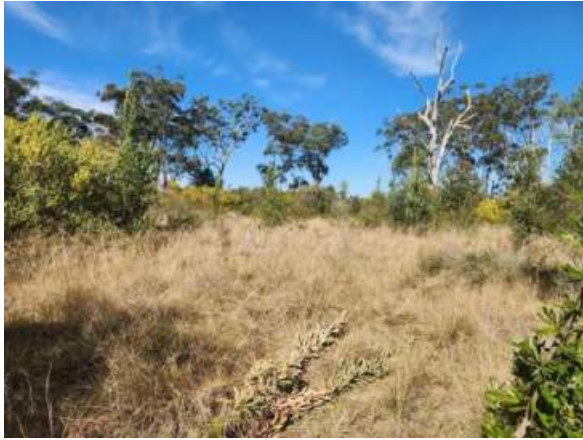
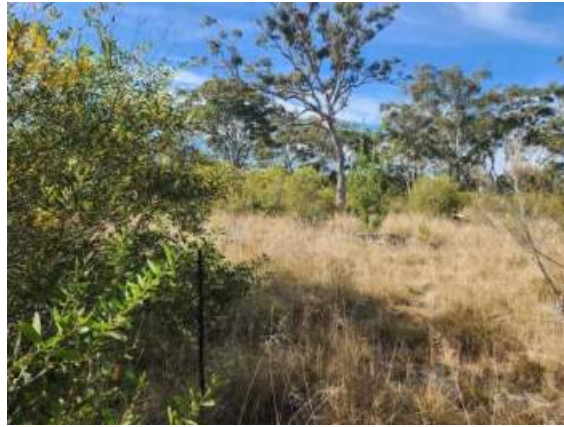
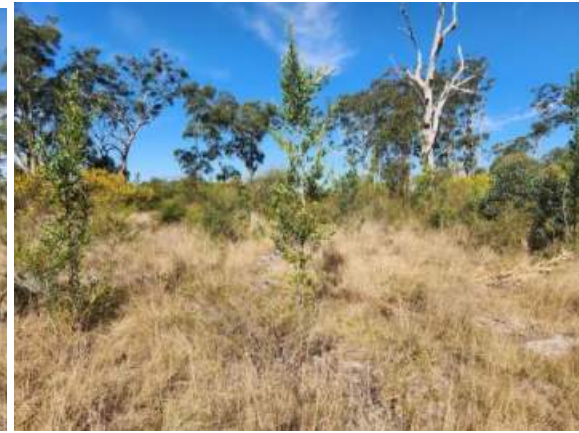
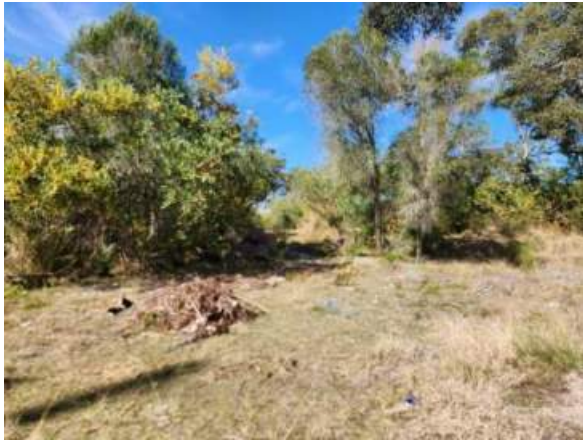
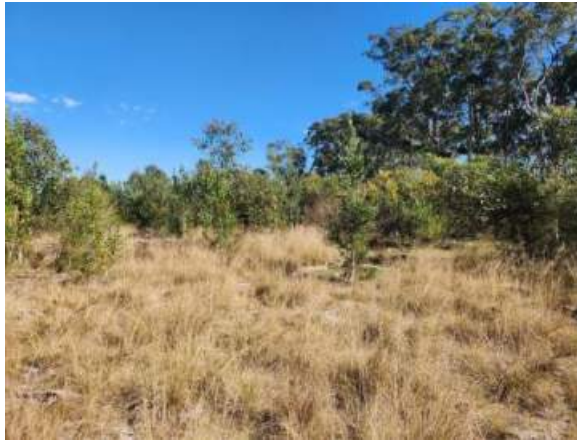
Grass Old Haul Rd, Area Q

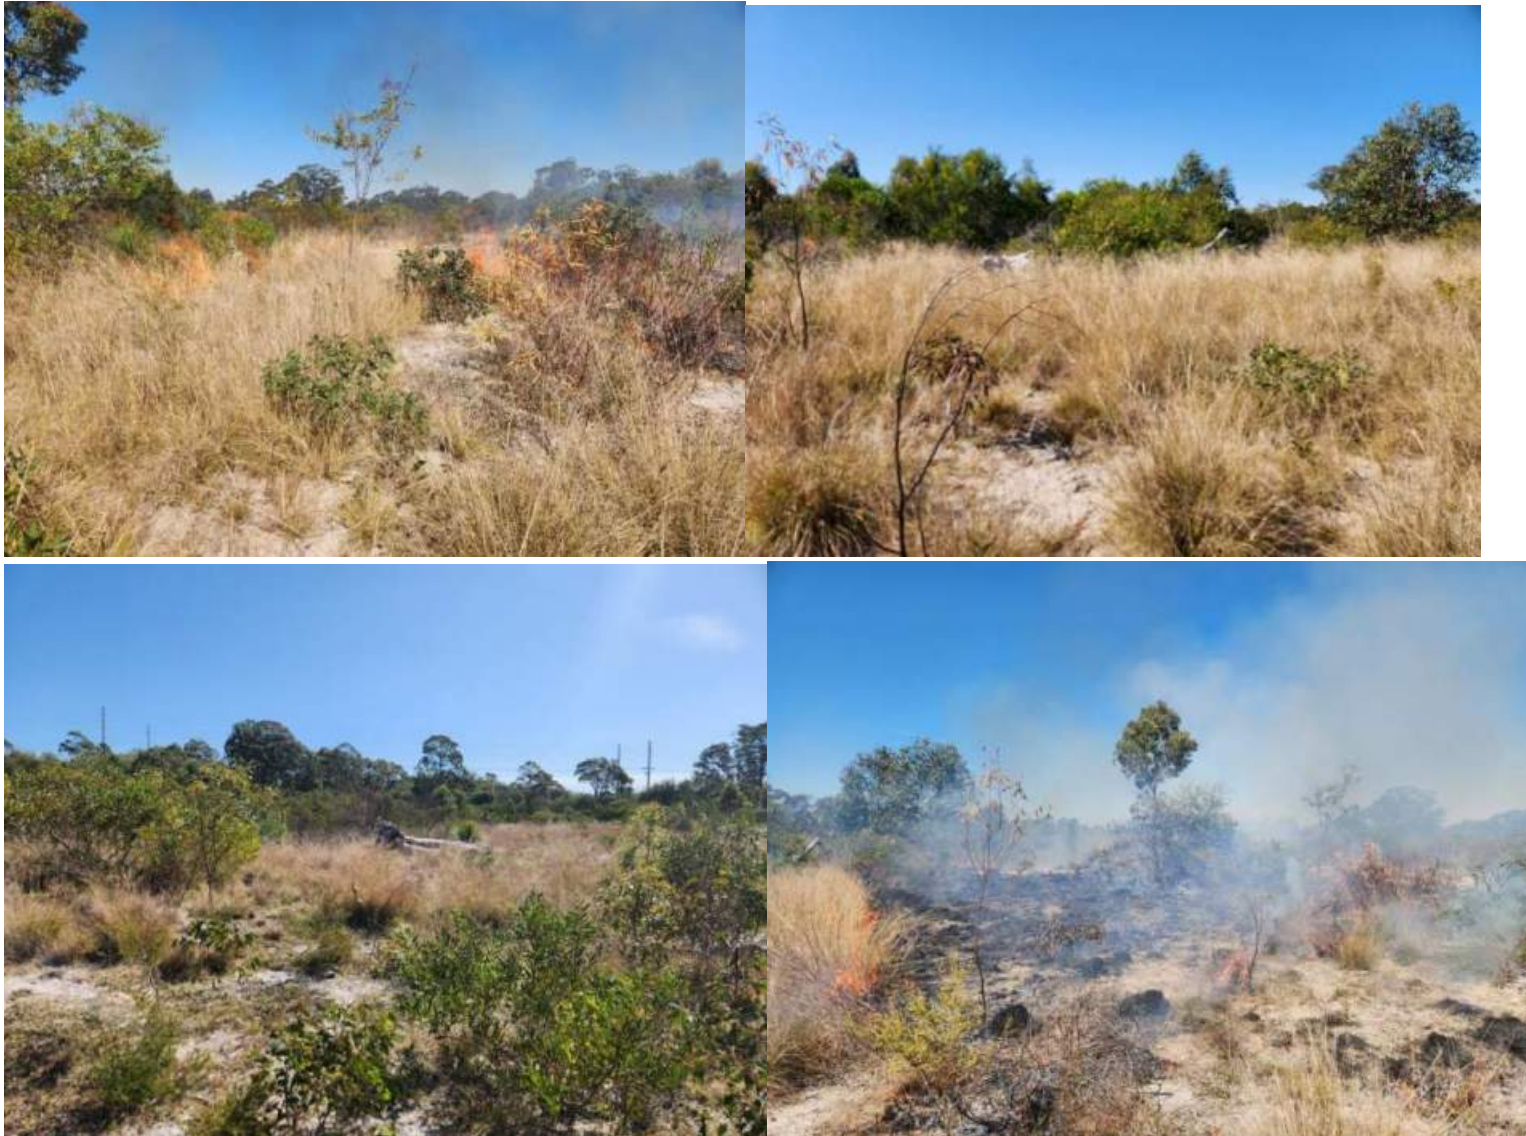
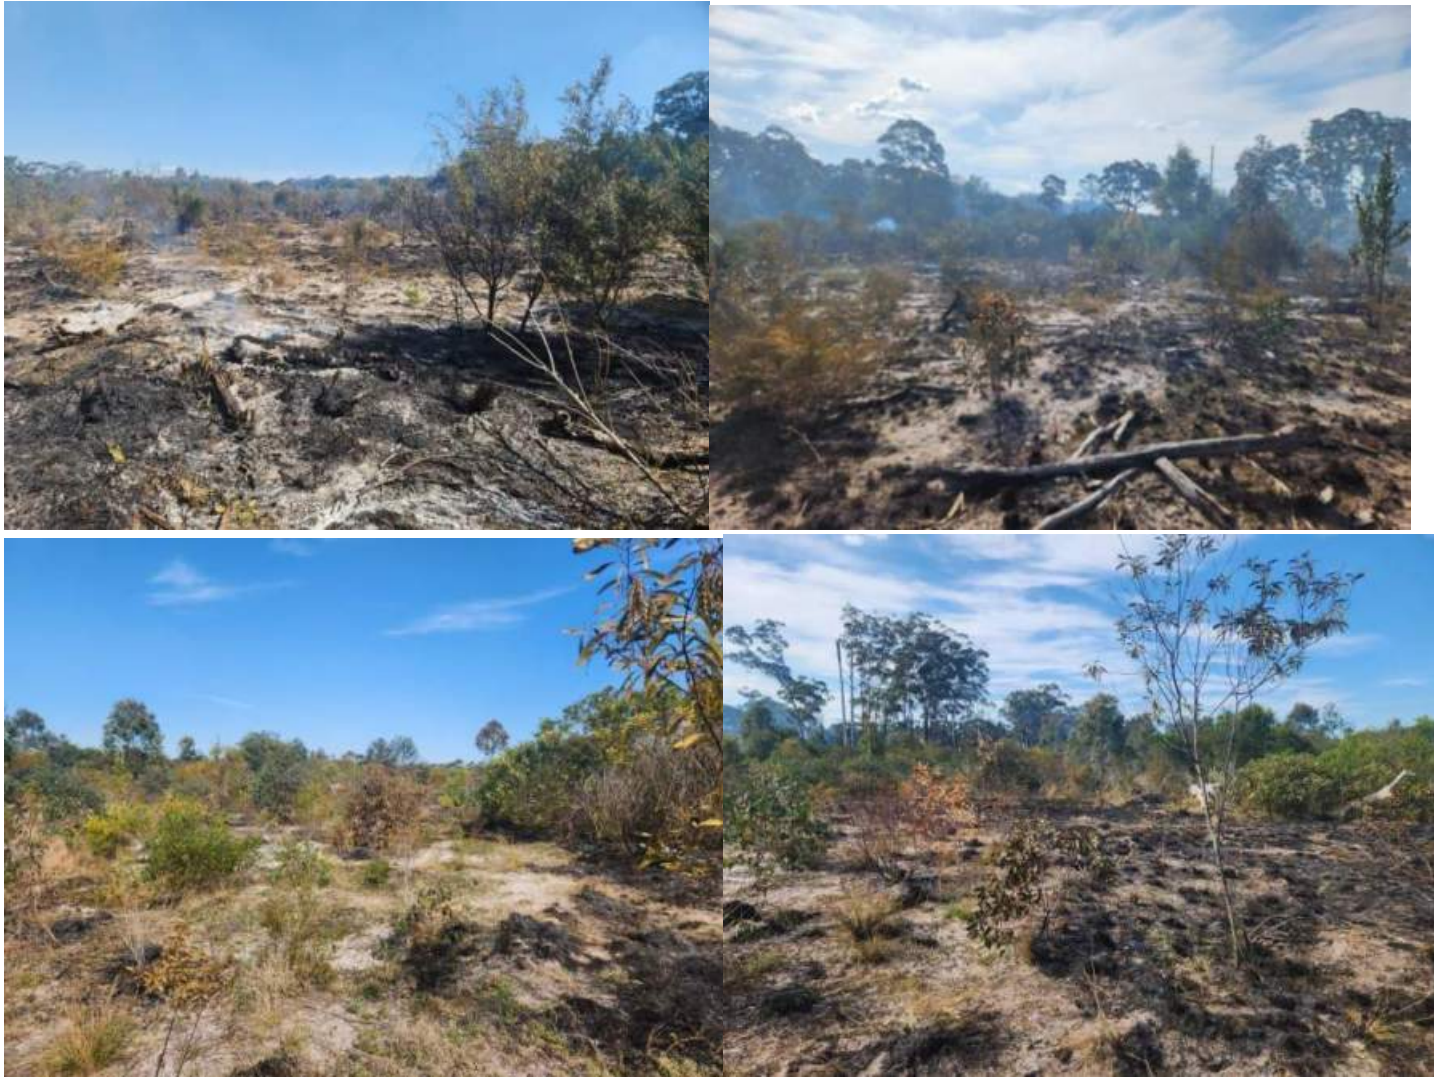
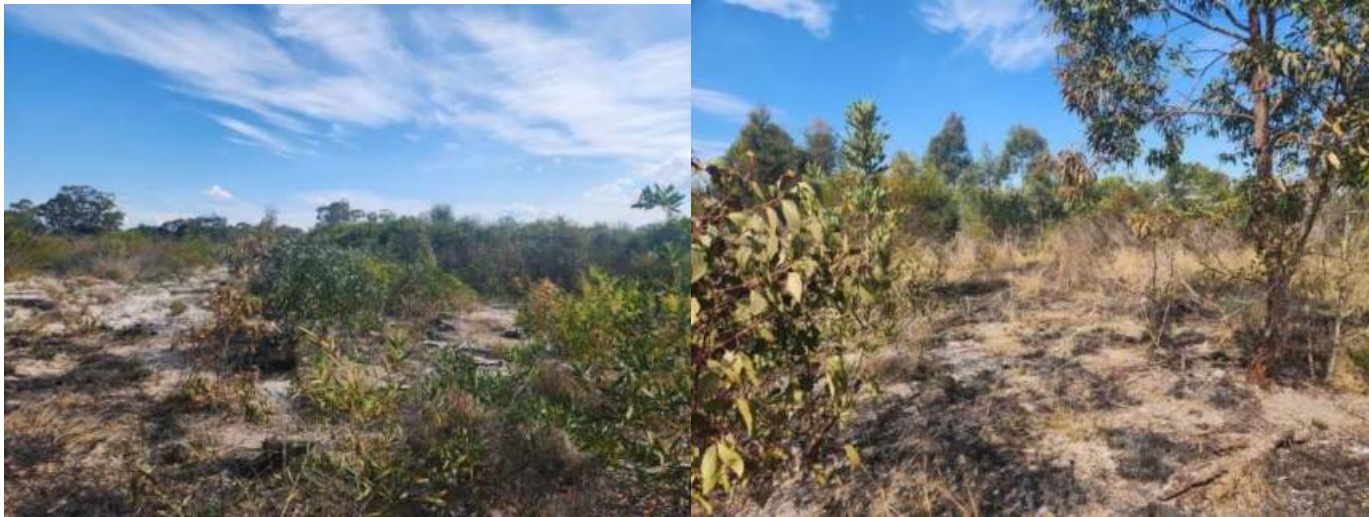
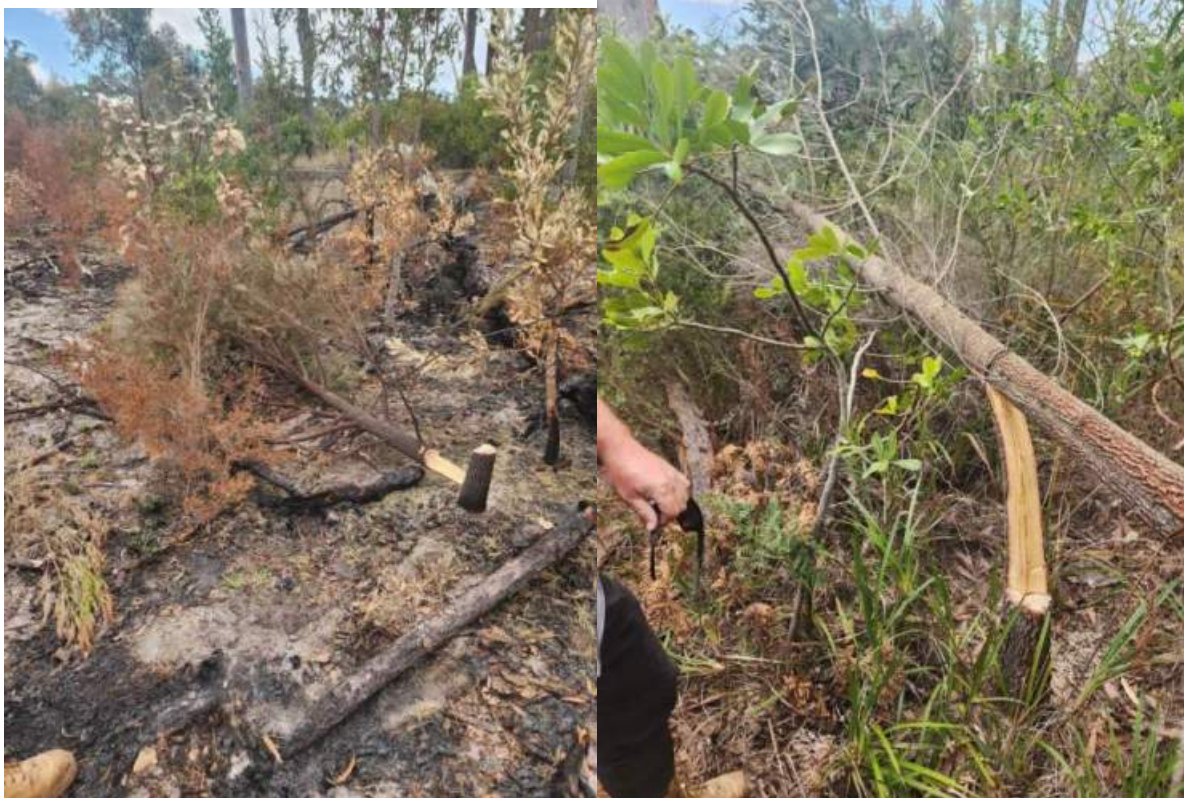
FLORA AND FAUNA						
Inspect site for any new outbreak of weeds. If new weeds are identified, take appropriate action to control the outbreak.	✓		Burnt grass in Area Q (photos attached) Cut down 2 pine trees in Area Q. (photos attached)

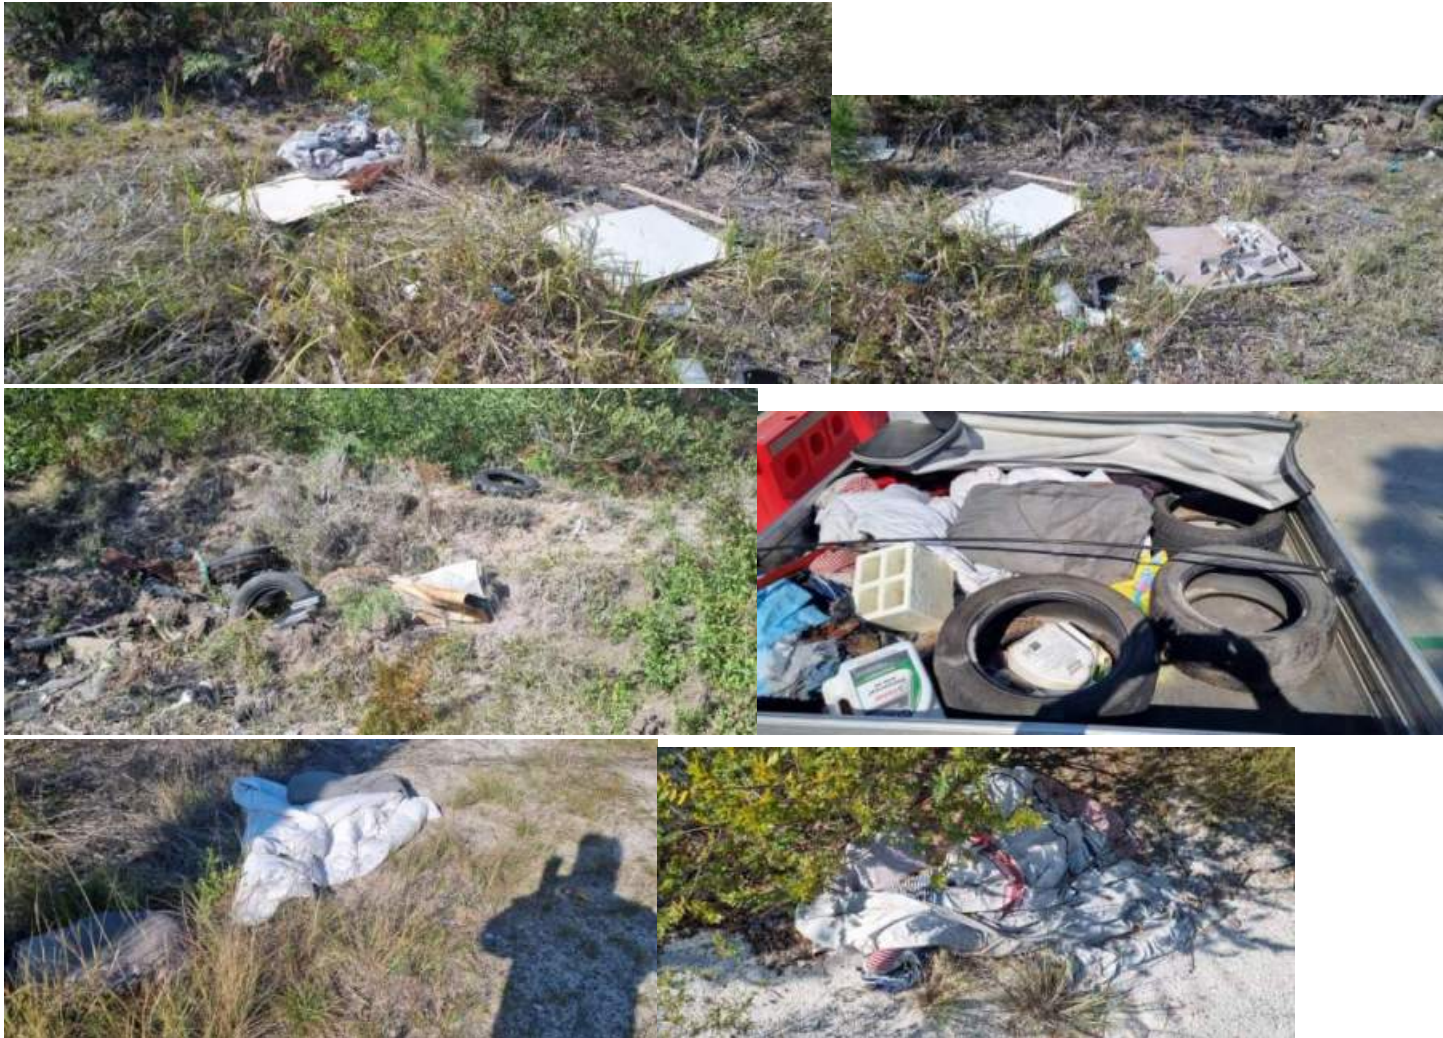
Waste removed from Rutile Rd 20&21/9/23 disposed of at Salt Ash site, waste bin and Tyres awaiting collection.

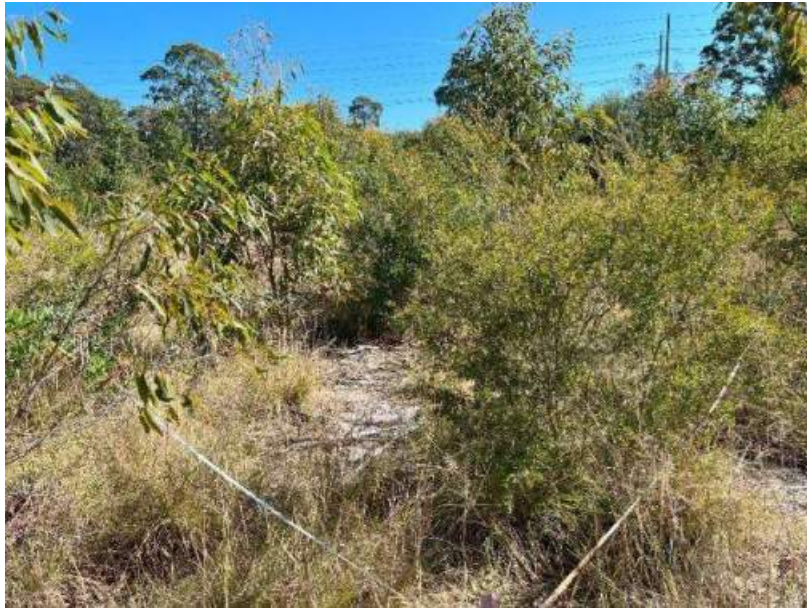
Plate 2: Quadrat Q48 from the SW corner. Vegetation has increased in height and cover from the previous year's monitoring.

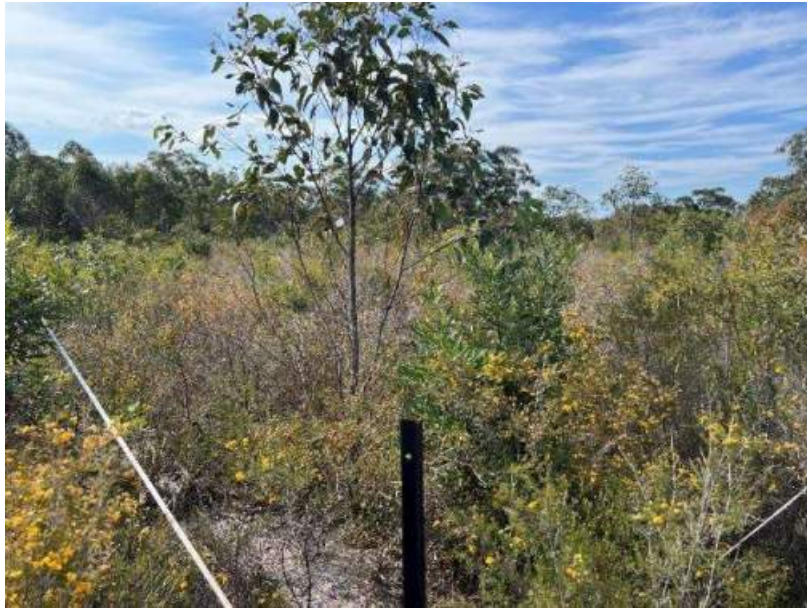
Plate 4: Block Q4, Quadrat 50, showing good growth and diversity, but senescence and some bare ground is still visible.

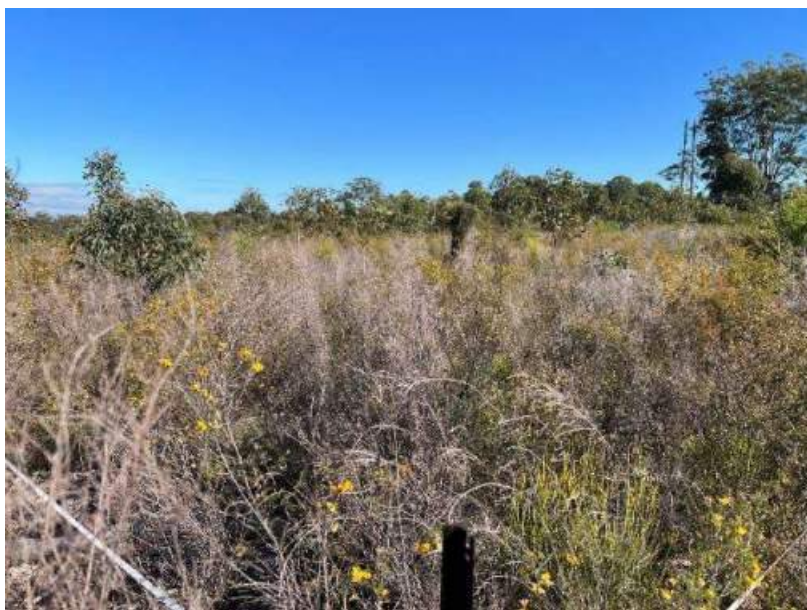
Plate 5: View Q51 from the SE corner showing extensive die back of the early succession natives, but also the good growth of the overstorey species.

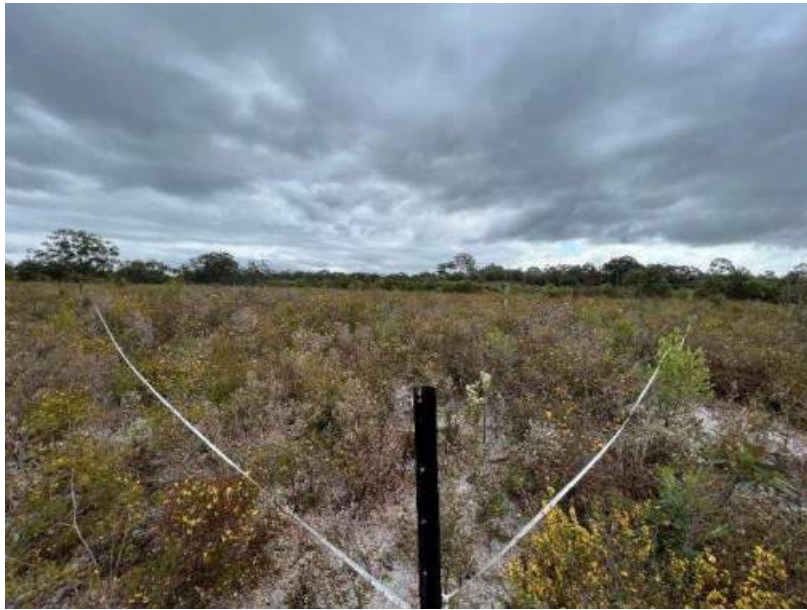
Plate 8 Block Q6 Quadrat Q53 from the SE corner, Note the proliferation of flowers - largely *D. retorta*, *H. linearis*, and *L. ericoides*. Some die back is visible.

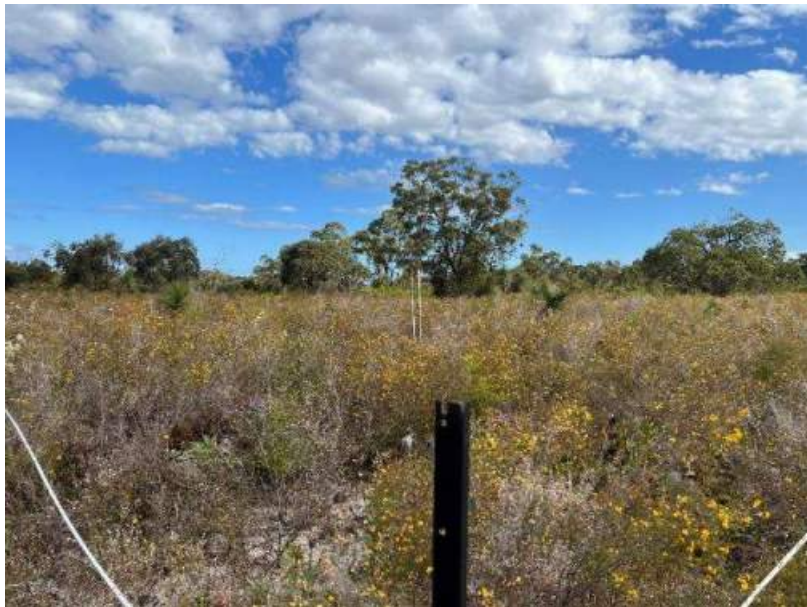
Plate 9: Block Q6 Quadrat Q54 from the NE corner showing the improved height (poles are 2 m high), and coverage. The quadrat is still dominated by early succession species, but some key species are visible.

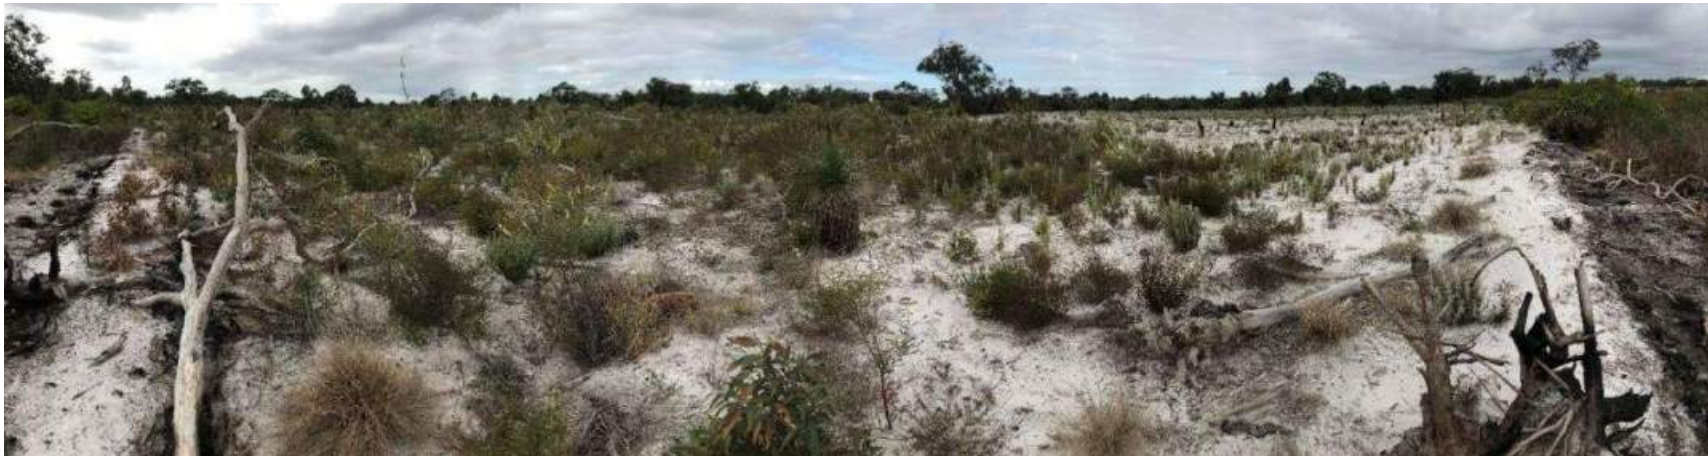
Plate 50: Block Q4 west (looking east) January 2020. Note the grassy weeds adjacent to this block (far left and right of photo)

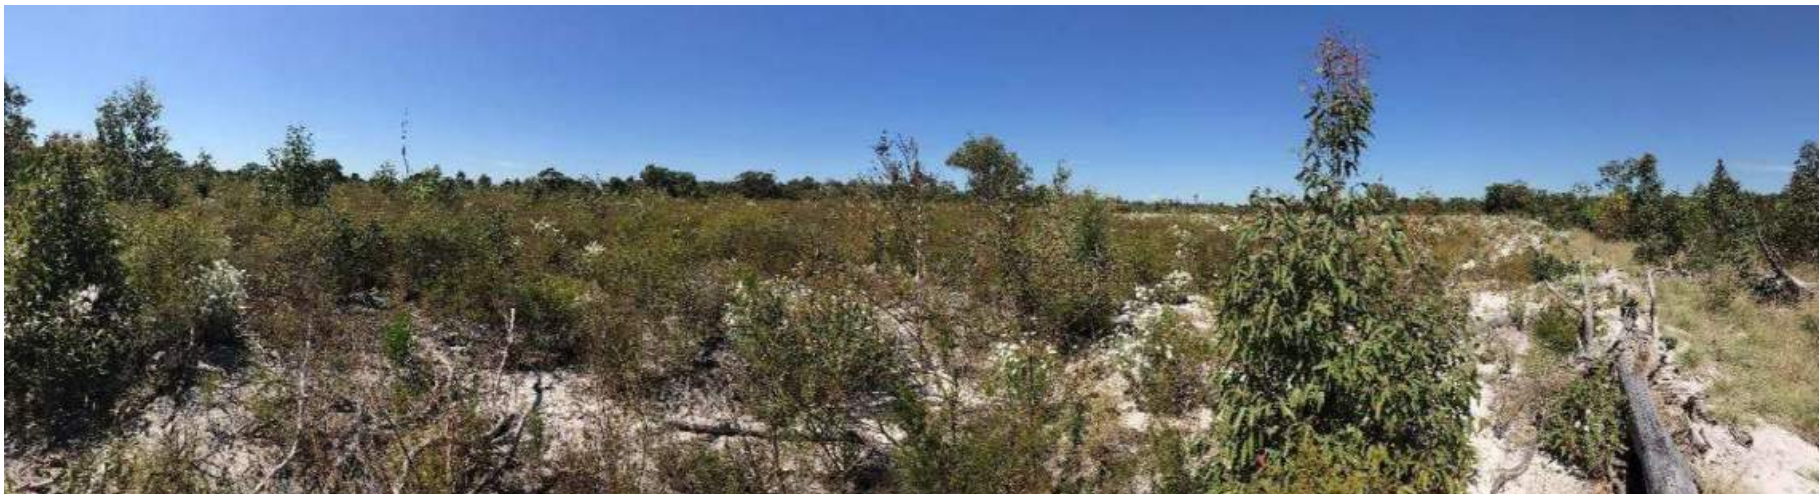
Plate 52: Block Q4 west (looking east) January 2021. Note the dense weedy grass infestation in Block Q1 (left of photo) and the encroachment into this block.

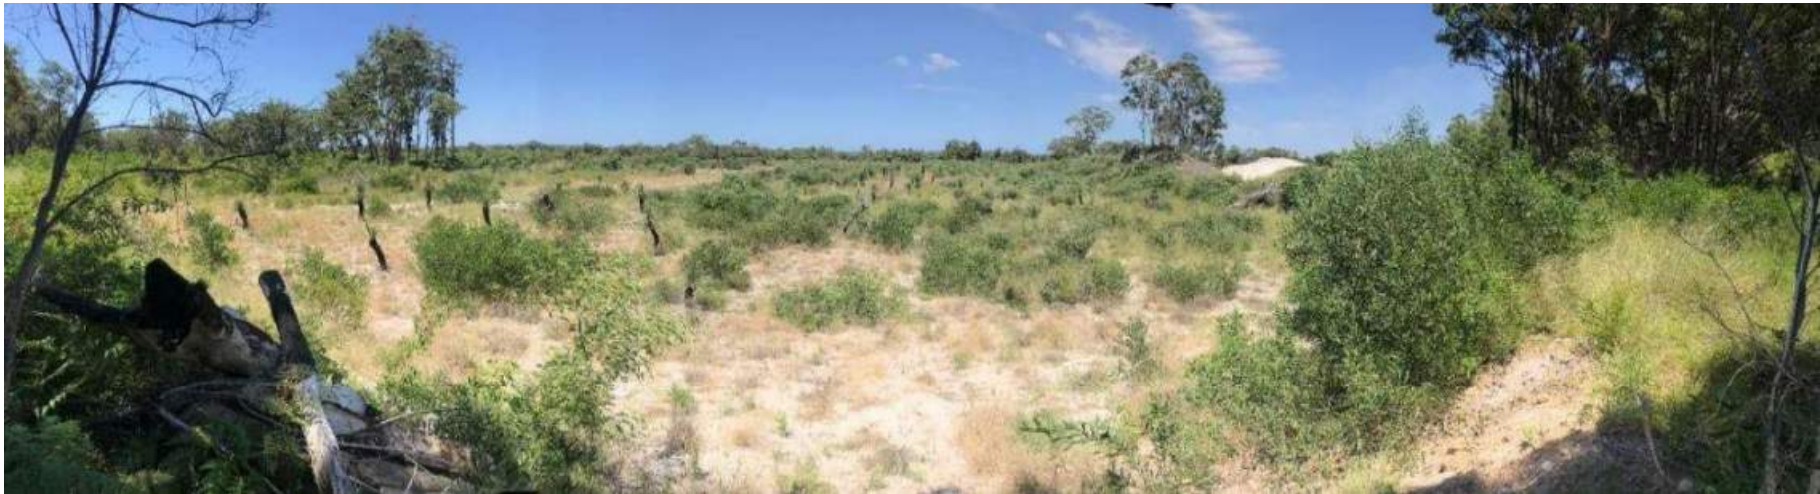
Plate 58: Block Q5 north (looking south) January 2021. Growth of vegetation necessitated the relocation of the photo point for this block. Note the dominance of grasses (brown) and *Acacia longifolia* (large green shrubs)

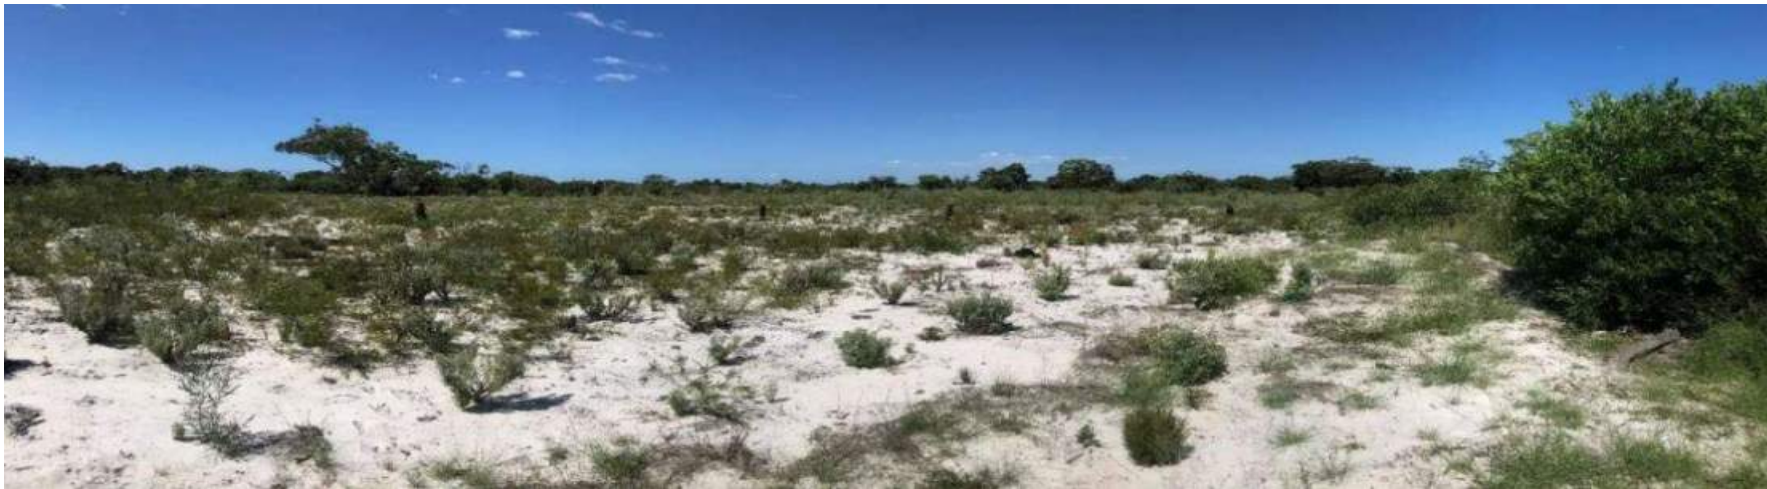
Plate 65: Block Q6 North-east (looking south and west) January 2021. Note the grassy weeds encroaching from Block Q1 at right of photo
