# 2019 Annual Environmental Management Report

## Tanilba Northern Dune

<b>Author:</b>	Kleinfelder Australia Pty Ltd
<b>Name of Site:</b>	Tanilba Northern Dune
<b>Name of Project:</b>	Annual Environmental Management Report
<b>Document Version:</b>	1.0

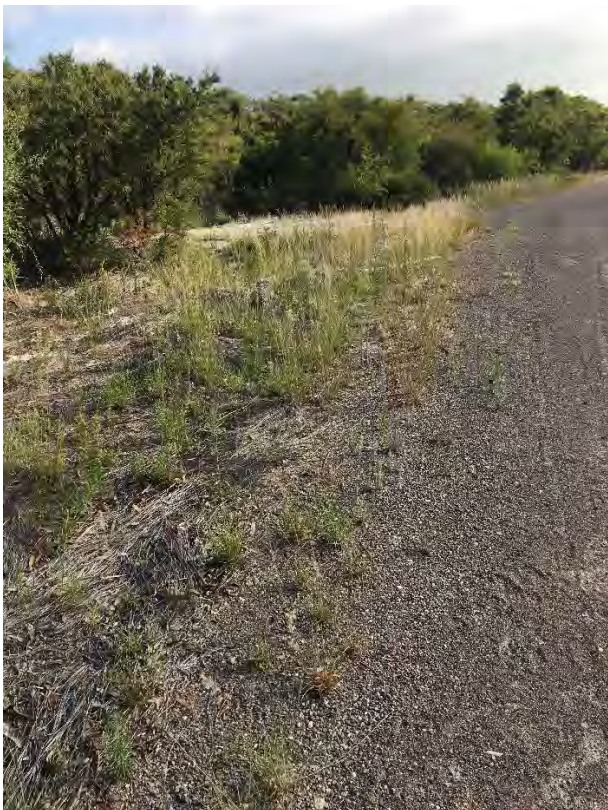
*Figure 2 Roadway Weed Growth*

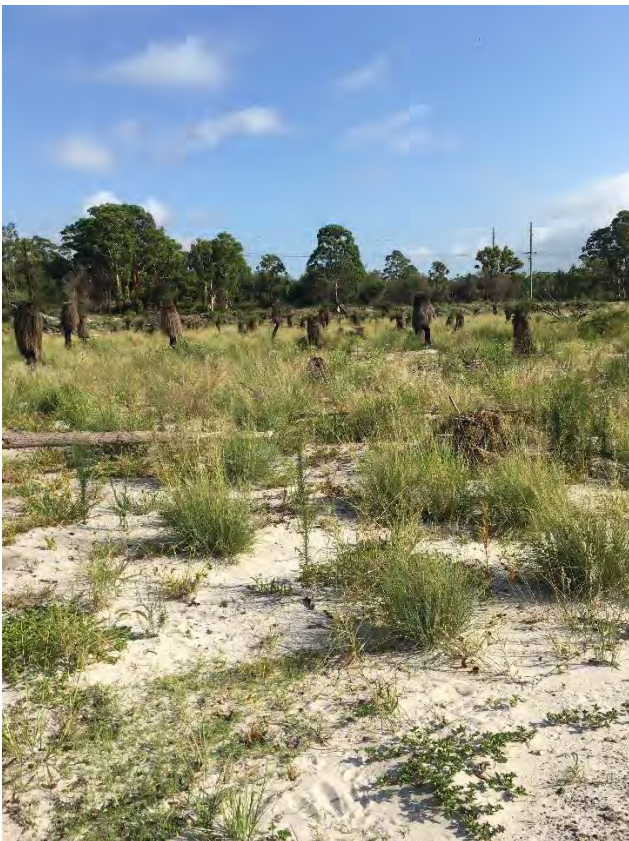
*Figure 4 Rehab Regrowth*

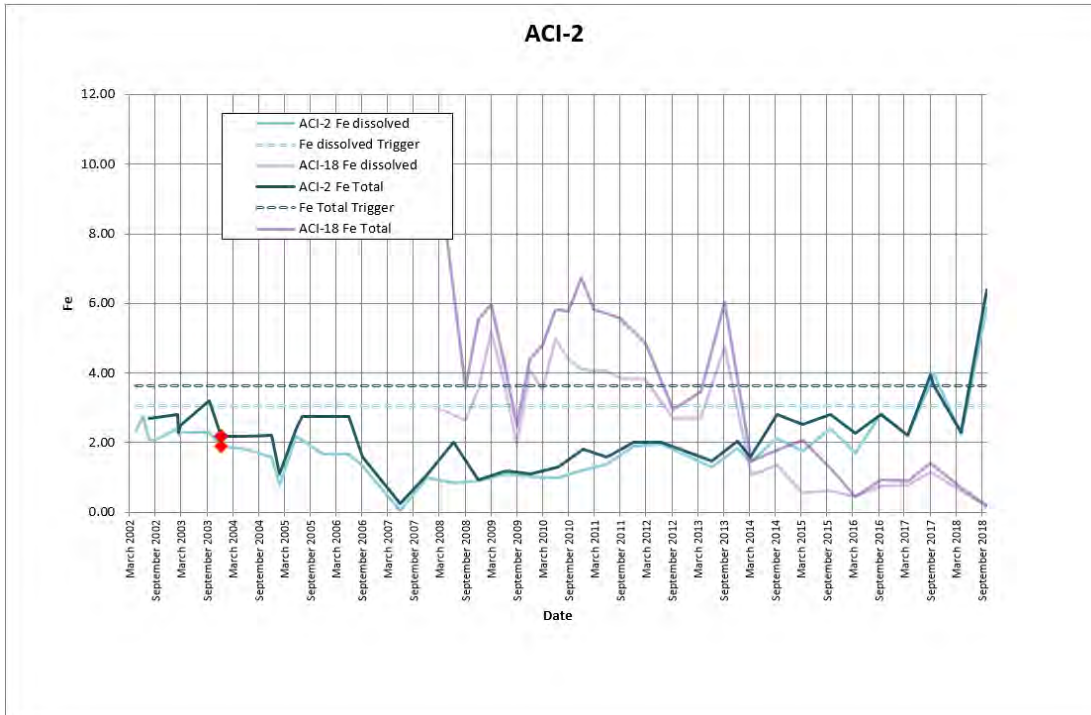
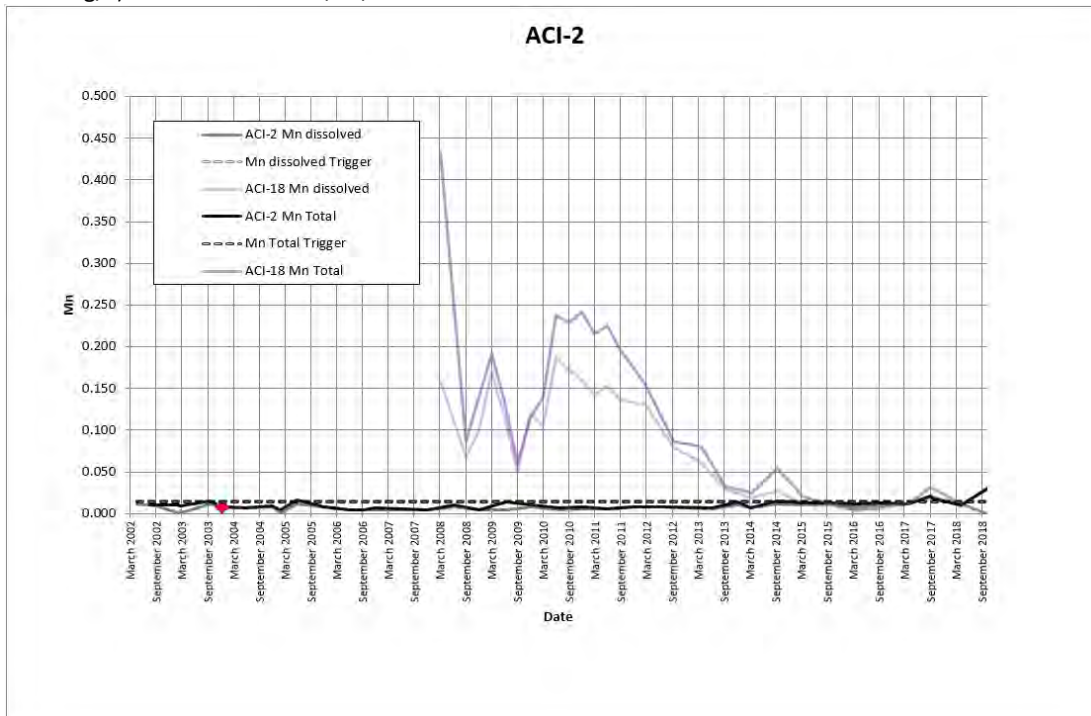
ACI-2 is located in Zone 1, mining Block B1 which was rehabilitated in May 2005.

Iron results are on a rising trend and have exceeded the assigned triggers (3.058mg/L dissolved Fe and 3.62mg/L Total Fe) on 3 out of 4 sampling events since Sept 2017. The latest dissolved Fe results were 5.87mg/L on 3/10/2018 (trigger value of 3.058mg/L) and 6.40mg/L Total Fe (trigger 3.62mg/L) on 3/10/18.

Dissolved Manganese recorded 0.03mg/L (trigger 0.015mg/L) on 3/10/18. Total Mn of 0.029mg/L (trigger 0.014mg/L) was recorded on 3/10/18.

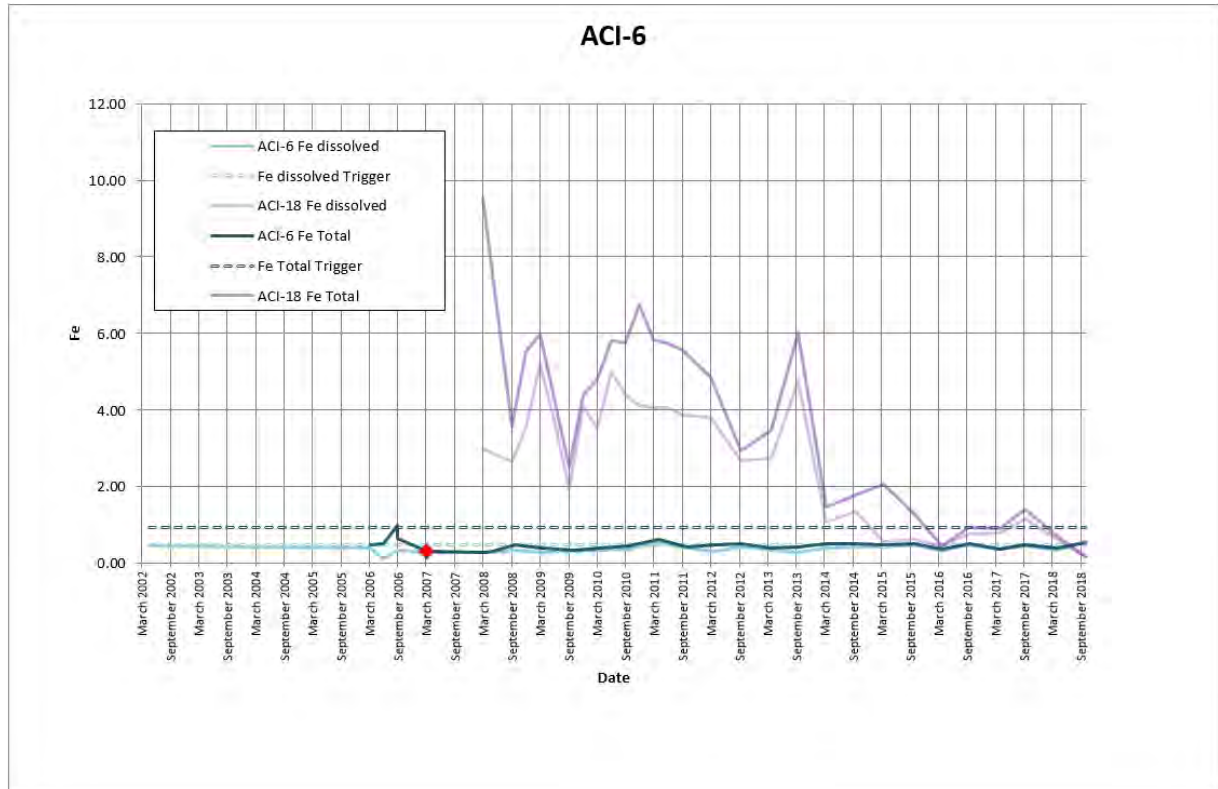
### ACI-6

ACI-6 is located south of the mining area and closest to Mining Block E of Zone 2.

Dissolved Fe results for latest monitoring (2/10/18) returned marginally above triggers being 0.56mg/L (trigger 0.493mg/L). Total Fe of 0.54mg/L was below trigger level of 0.935mg/L.

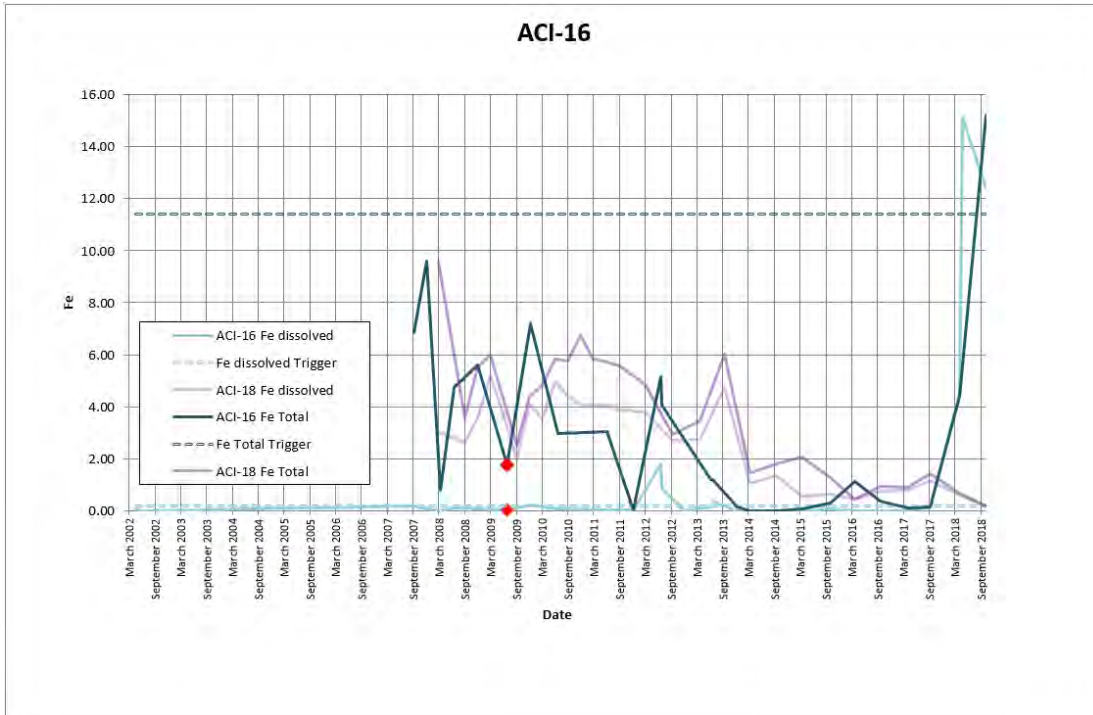
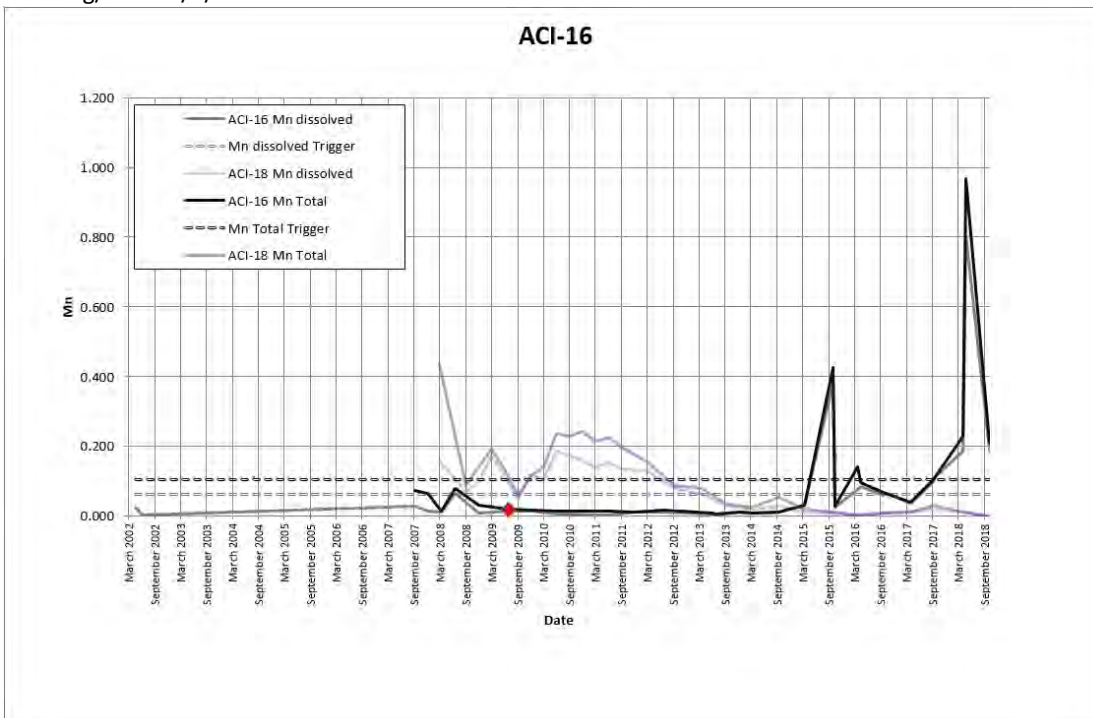
### ACI-16

ACI-16 is in an area from which sand was extracted in 2010-12. Iron results have declined in recent years but the latest sampling has shown higher levels returned for both dissolved and total iron. The latest dissolved Fe results were 12.4 mg/L on 3/10/2018 (trigger value of 0.188mg/L) and 15.2mg/l total Fe on 3/10/18. A follow up re-sample should be undertaken and will be the focus of the next round of sampling. The Fe dissolved trigger level for ACI-16 has been set too low compared to the Fe total trigger of 11.419mg/L.

Dissolved Mn results were 0.19mg/L on 3/10/2018 (trigger value of 0.061mg/L) coming off a previous high of 0.805mg/L on 23/4/2018. Total Mn results were 0.211mg/L (trigger value of 0.104mg/L) with a previous high of 0.968mg/L on 23/4/2018.

Resampling should be undertaken following a proper purging exercise of the bore.

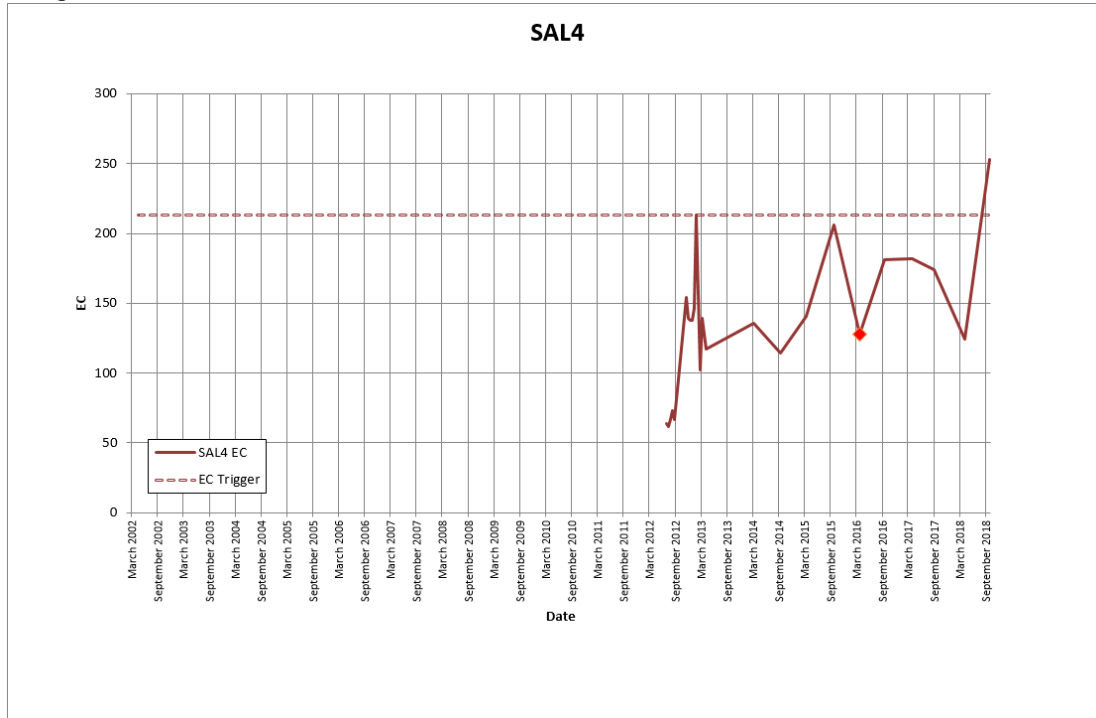
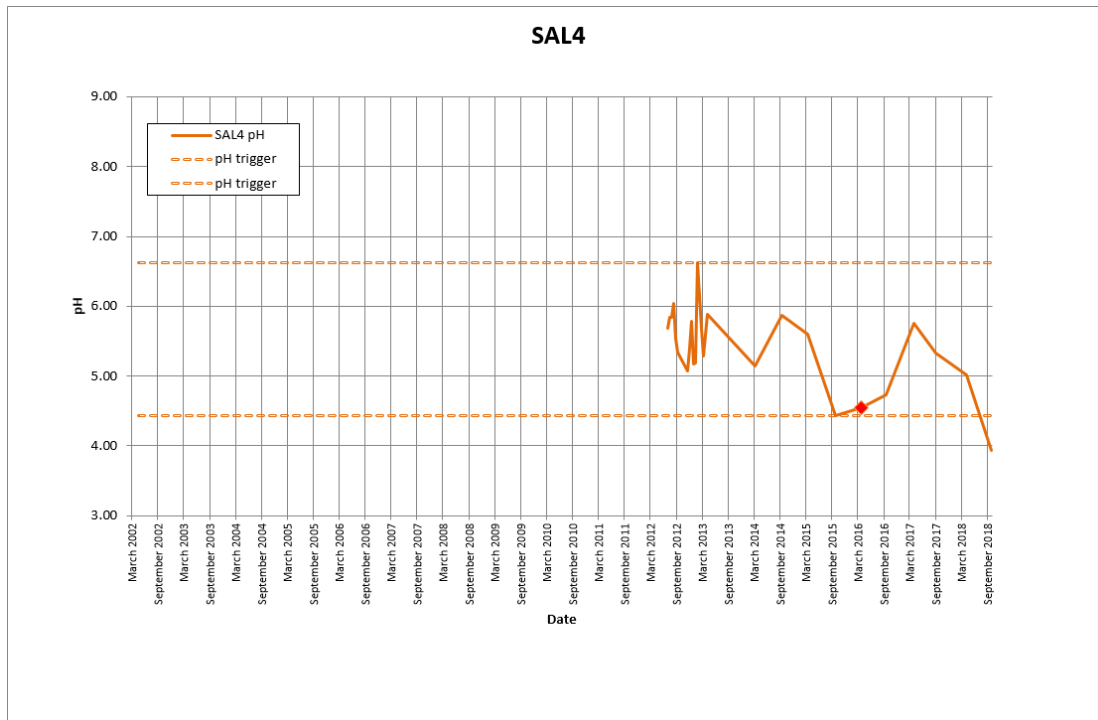
**SAL 4**

It is likely the collar of the bore may have surface water interaction and the influence of recent land disturbance from nearby mining has caused some changes to redox reactions which will affect the pH and also EC.

It is recommended the collar be inspected to ensure surface water has no potential to flow directly into the bore casing.

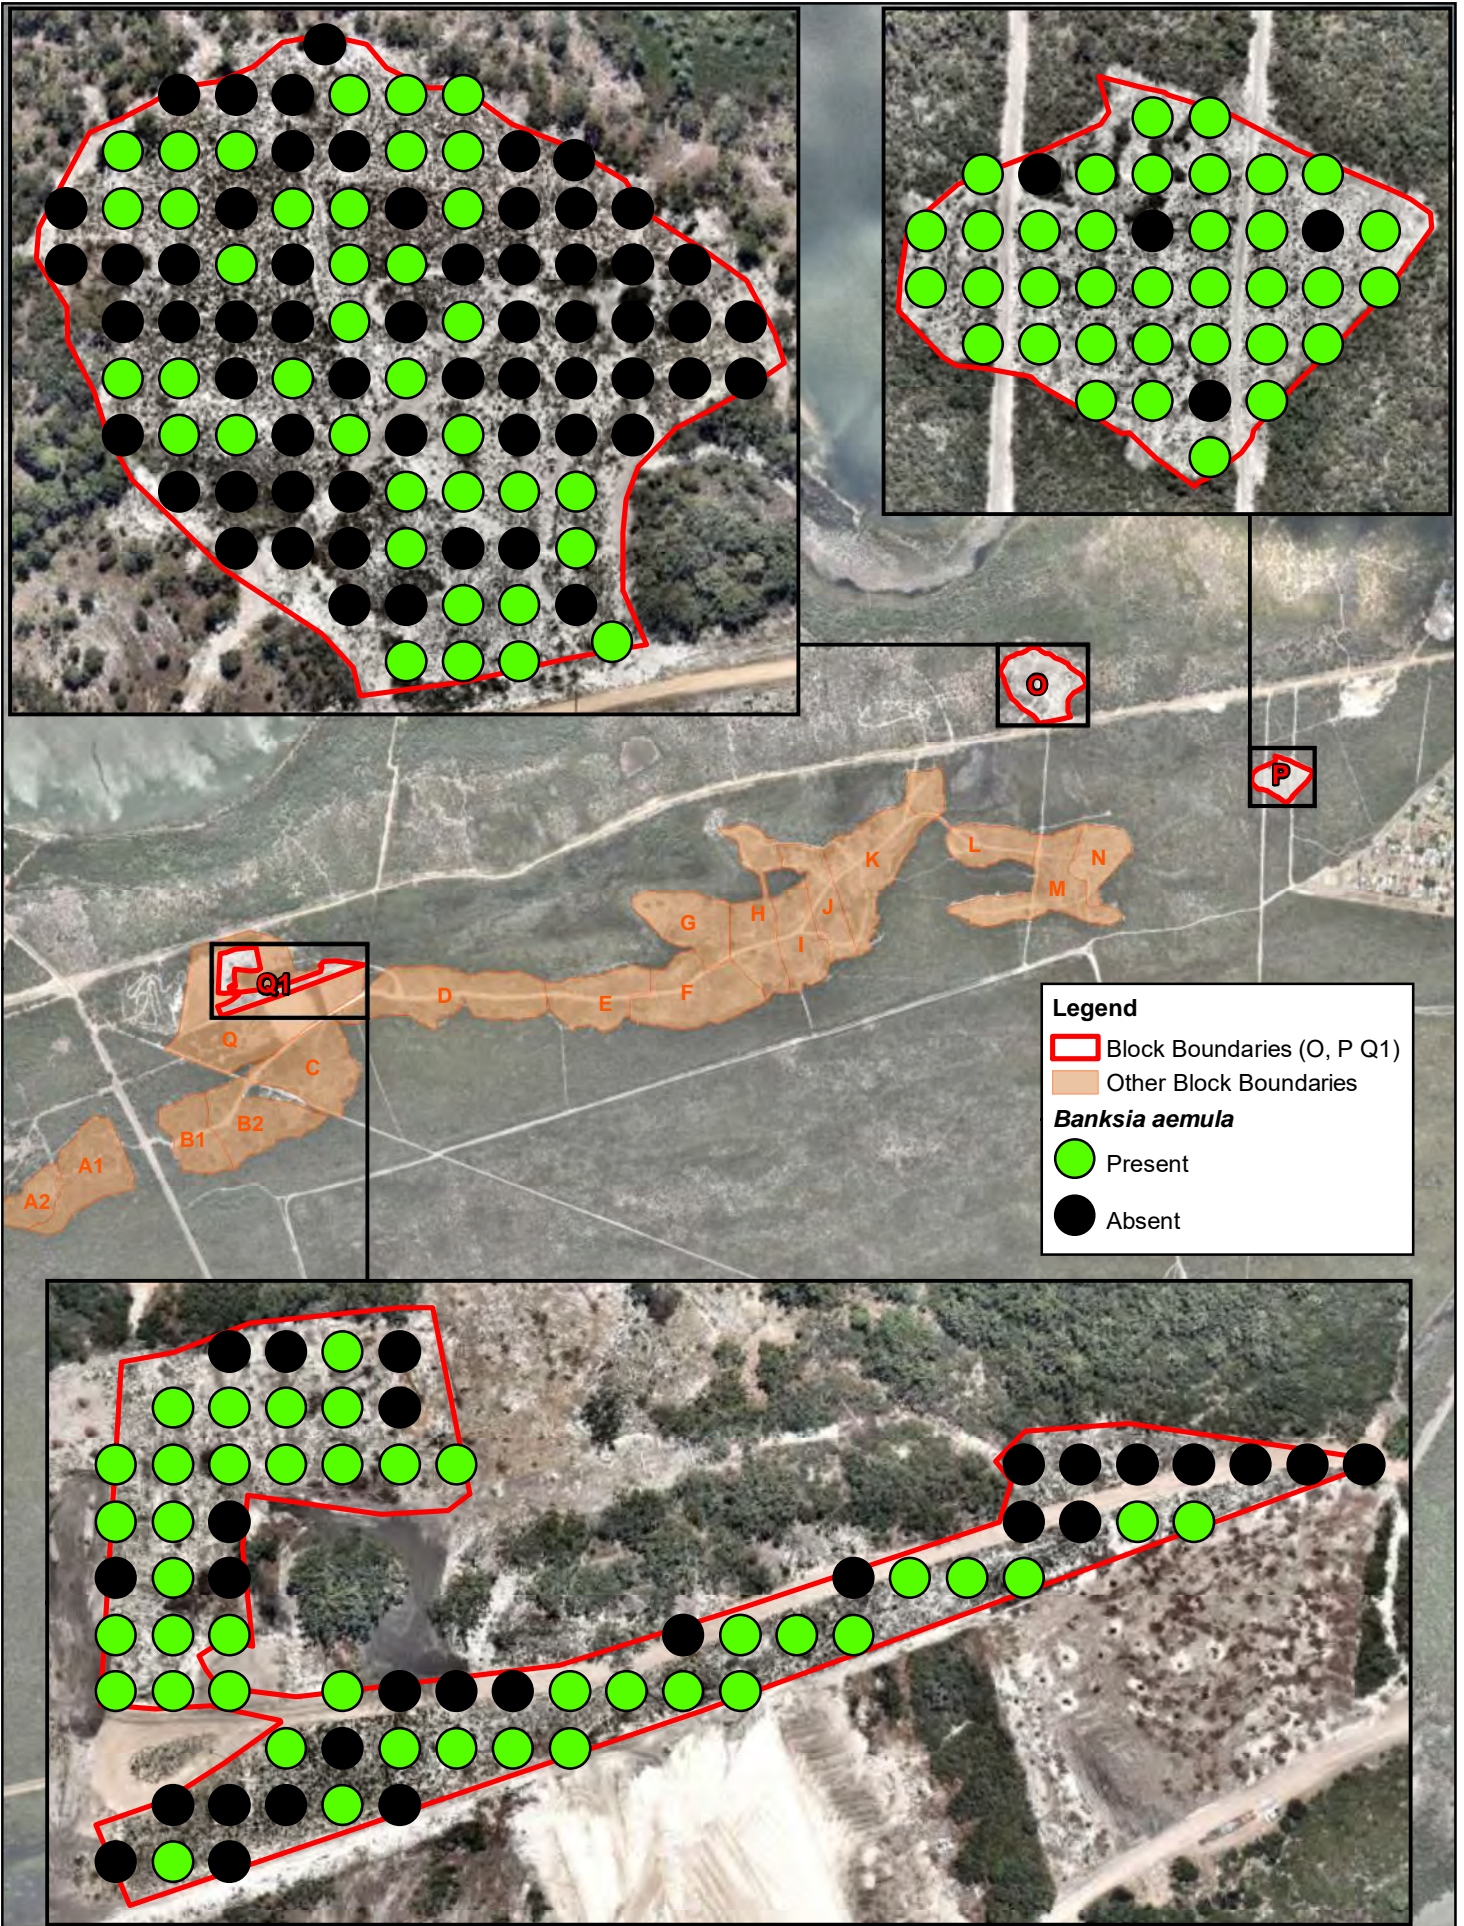
FIGURE:  
**3**

3. Figure 3) – no further planting is required;
4. *Corymbia gummifera* (**Figure 4**) – this species is over target in all three blocks surveyed. No further planting is required;

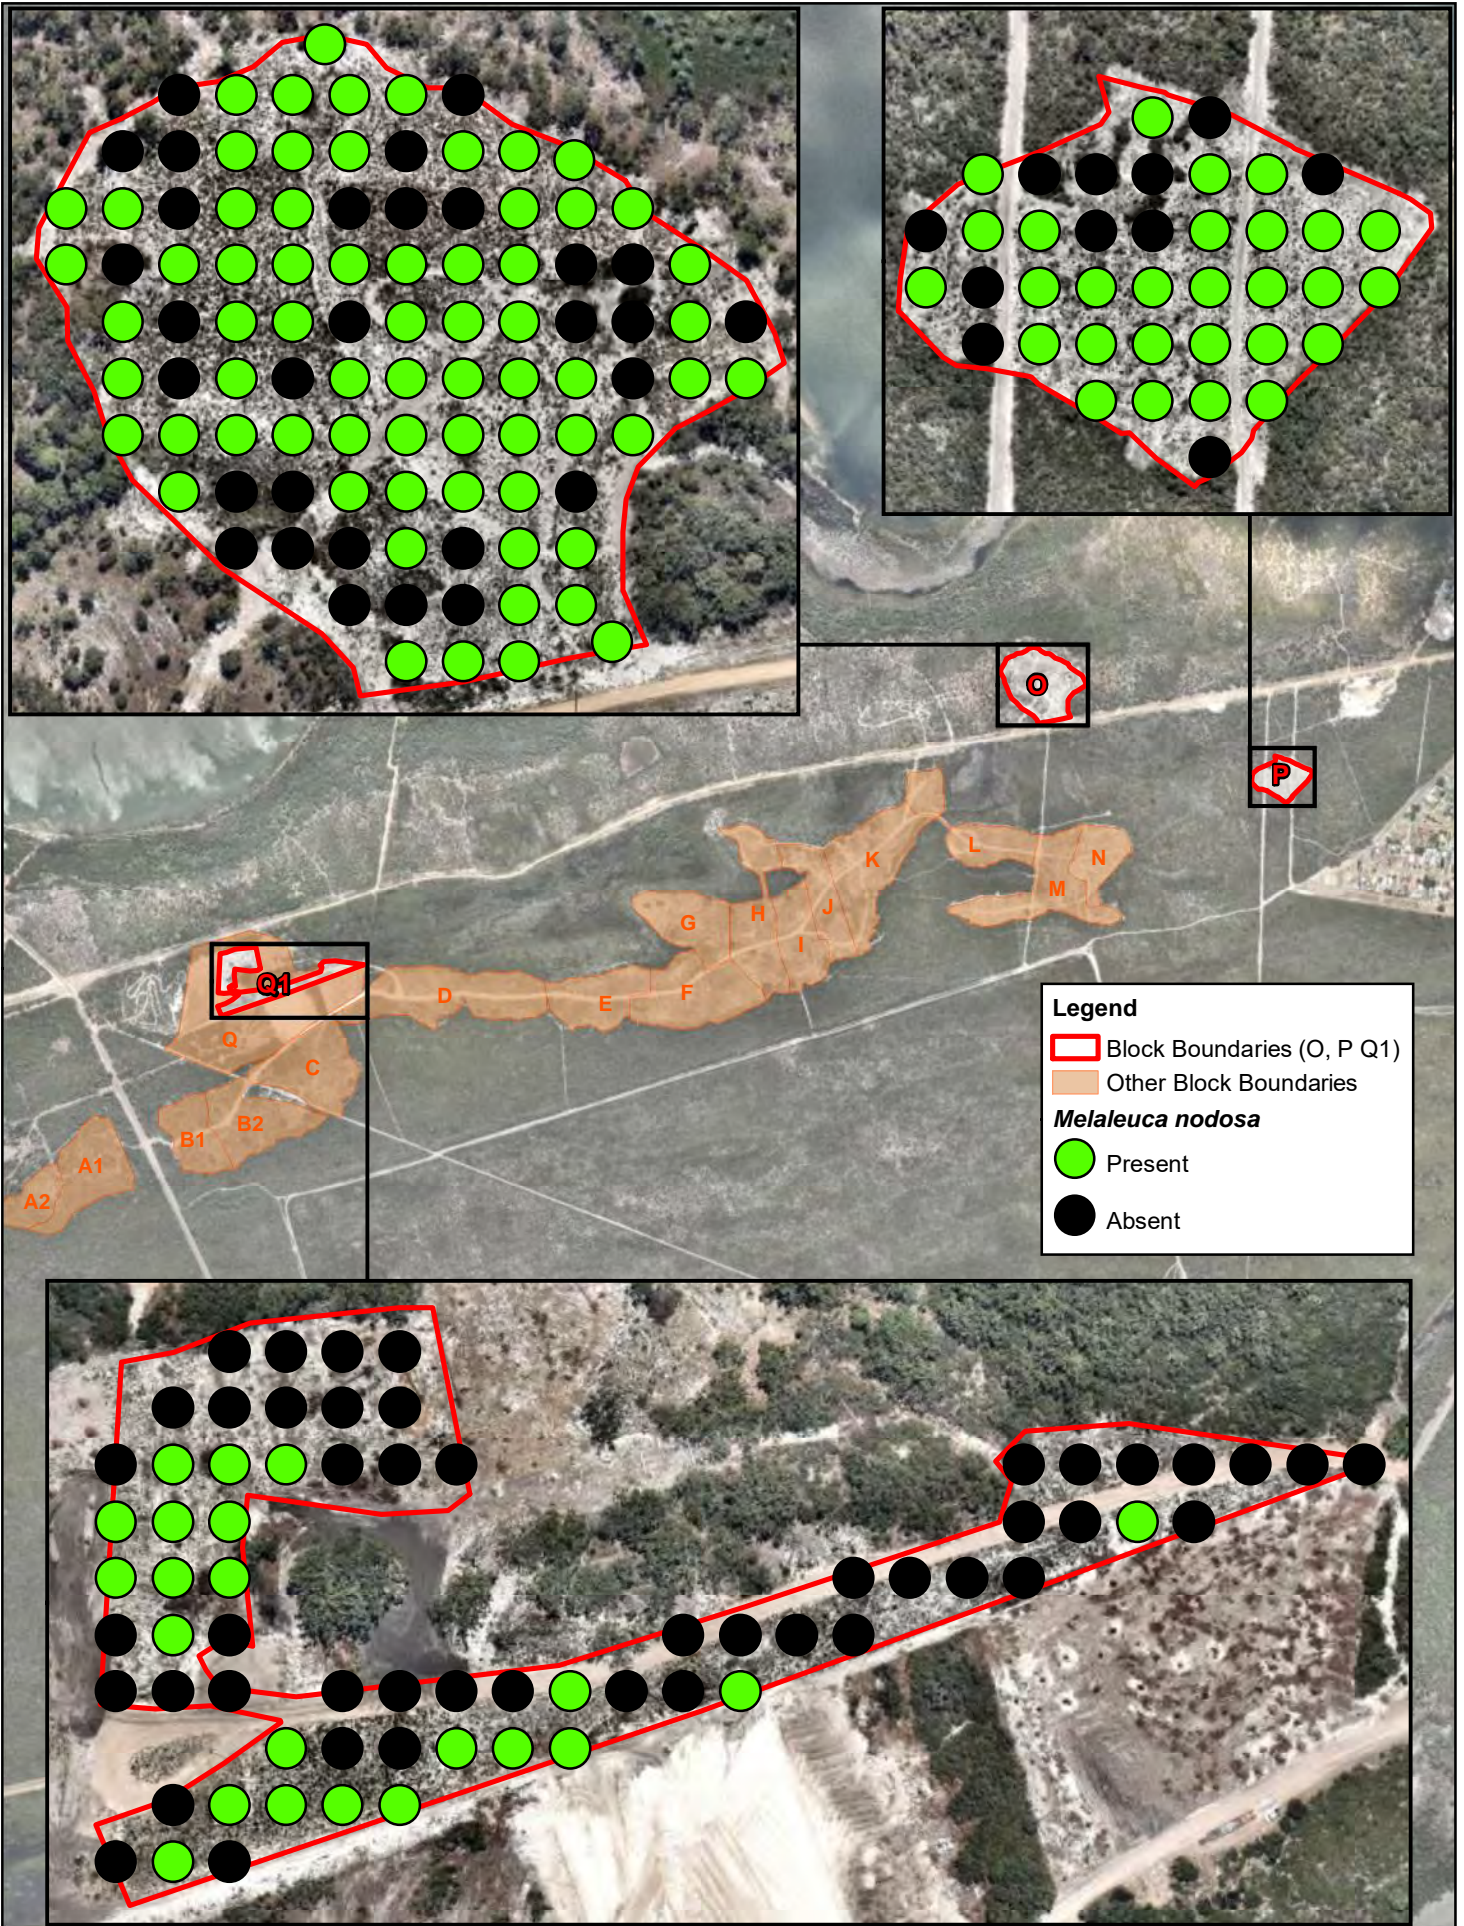
FIGURE:  
8

8. *Melaleuca nodosa* (**Figure 8**) – this species is not at target in any of the surveyed blocks but is over 70% in Blocks O and P, with fairly low numbers in Block Q1. Further planting should be considered for this species in Block Q1; and,
