COOMA ROAD

2024 Annual Review

Organisation	Holcim (Australia) Pty Ltd
Project	Cooma Road Quarry
Developmental consent / project approval #	SSD-5109-MOD-2
Document Title	Annual Review 2024
Document Revision	Α
Author	IEMA
Project Identifier	HOL01-005
Annual review start date	1 January 2024
Annual review end date	31 December 2024

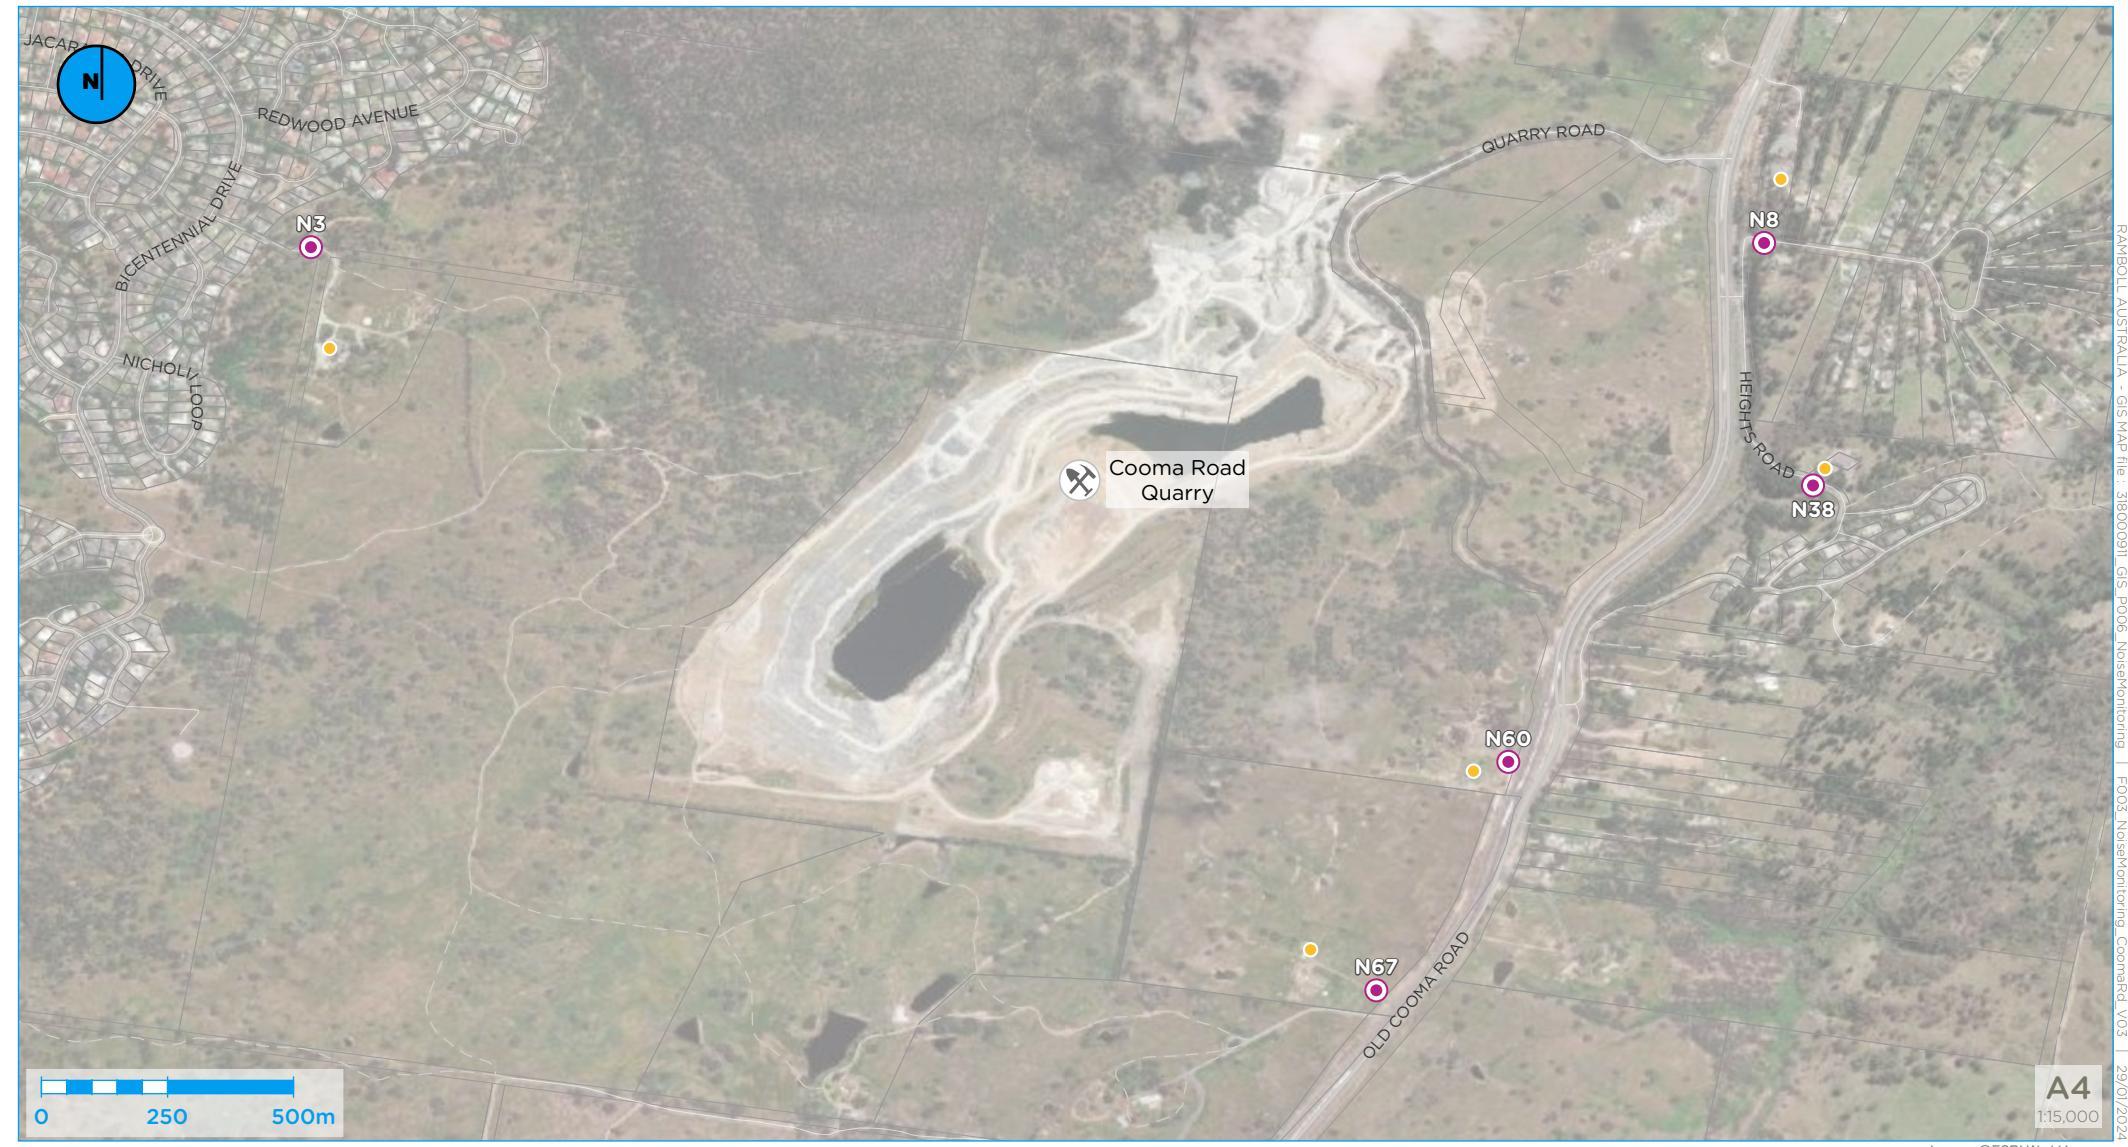
30 metres of a private residence, where possible. During this NMA, monitoring at most locations (N3, N8, N60, and N67) was undertaken where safely accessible at each property boundary which was approximately 100 to 200 metres from each property dwelling.

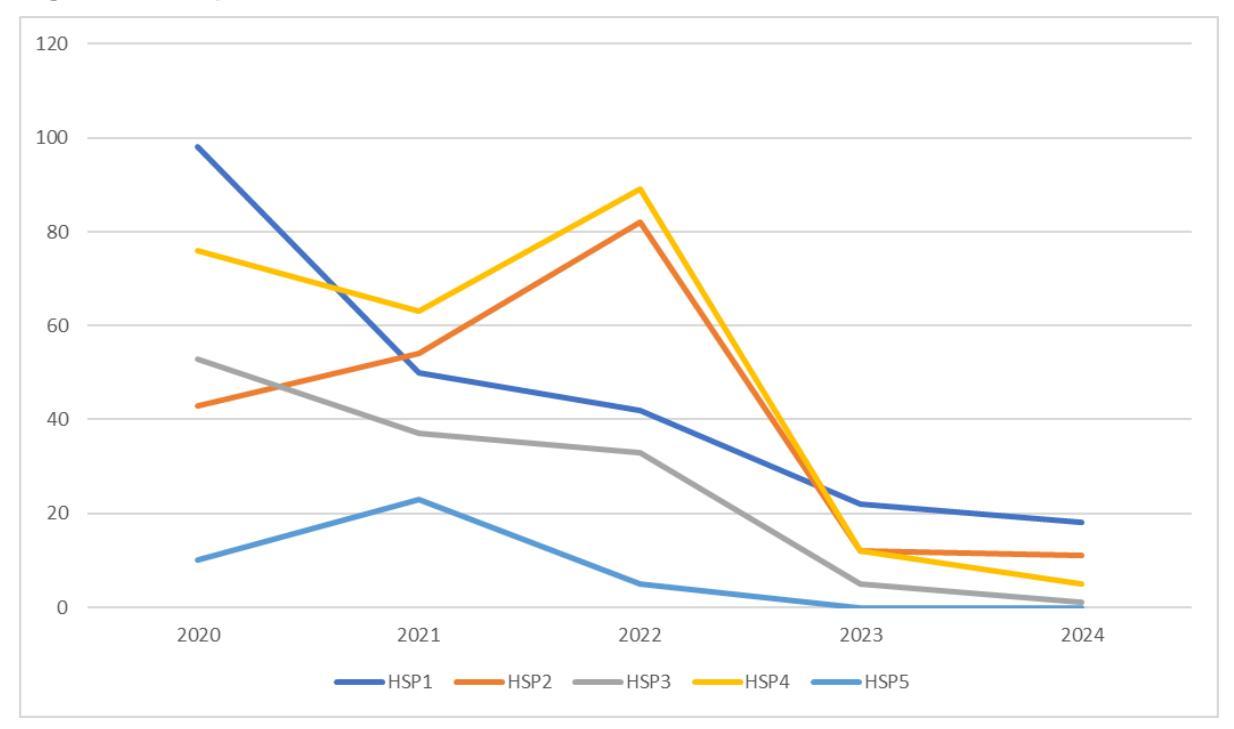
Figure 5 Graphed L. albicans var. tricolor Plot Counts over time

As shown in the above table and graph, population counts show a declining trend in all plots from the 2022 data, with counts in 2024 being the lowest since the beginning of monitoring.

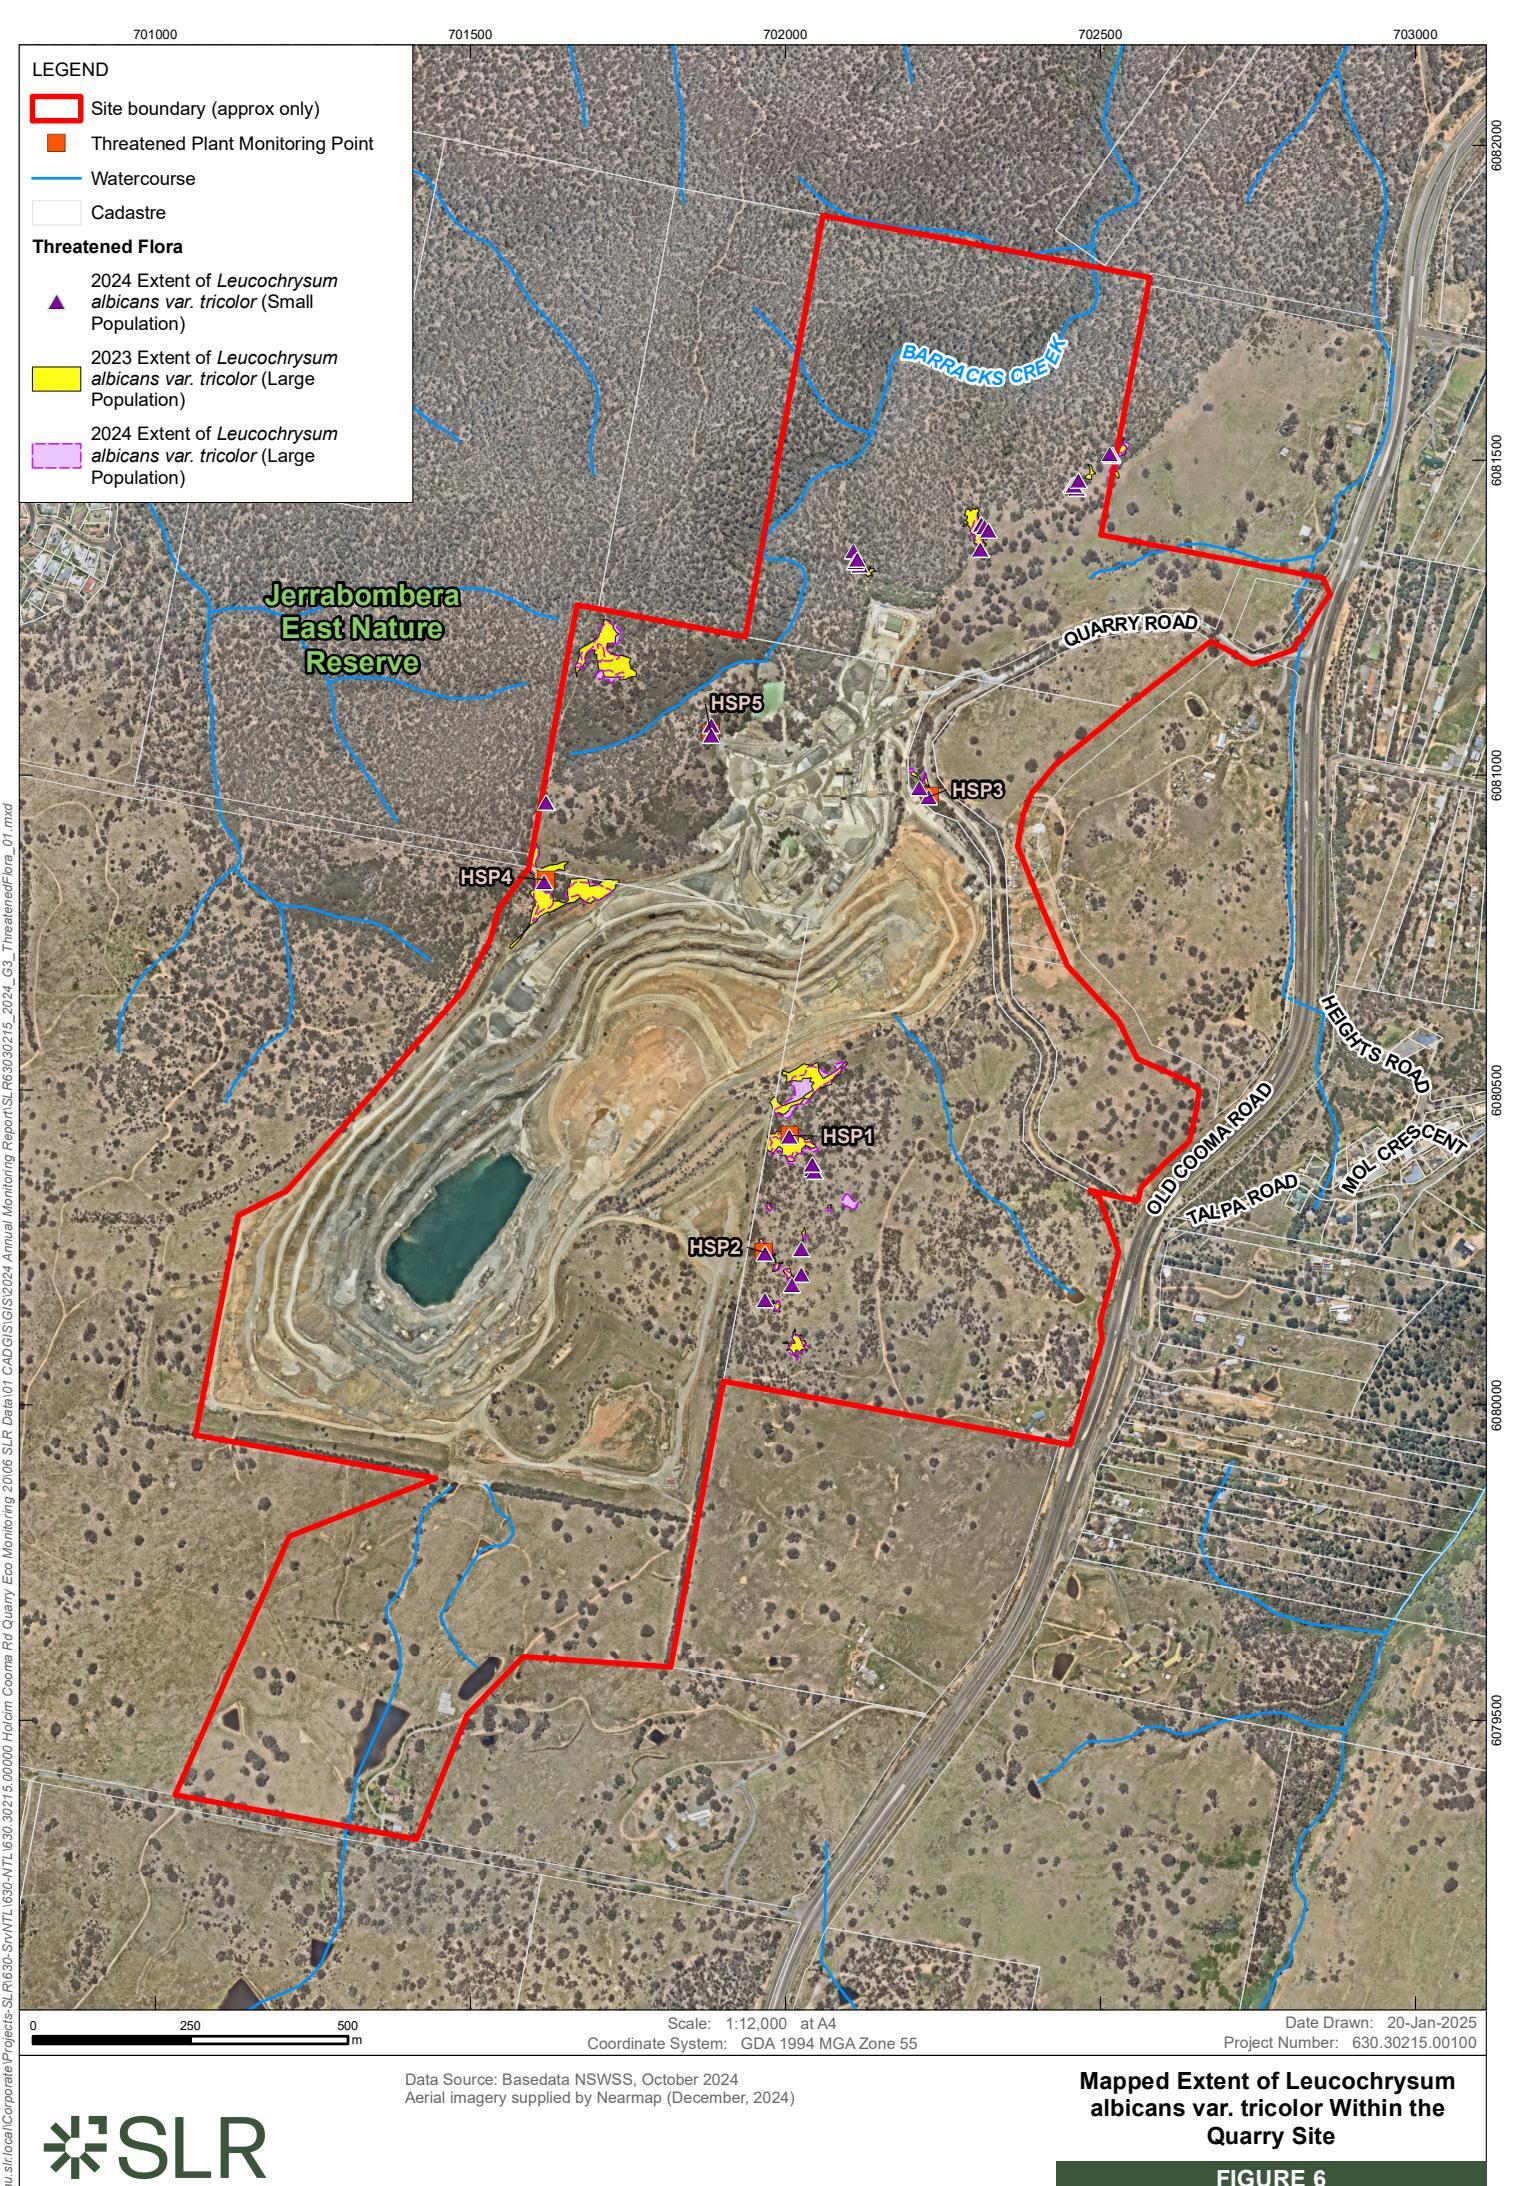
FIGURE 6

Figure 6 below shows the 2024 extent of all mapped *L. albicans* var. *tricolor* populations within the Quarry Site overlying the 2023 mapping for comparison.

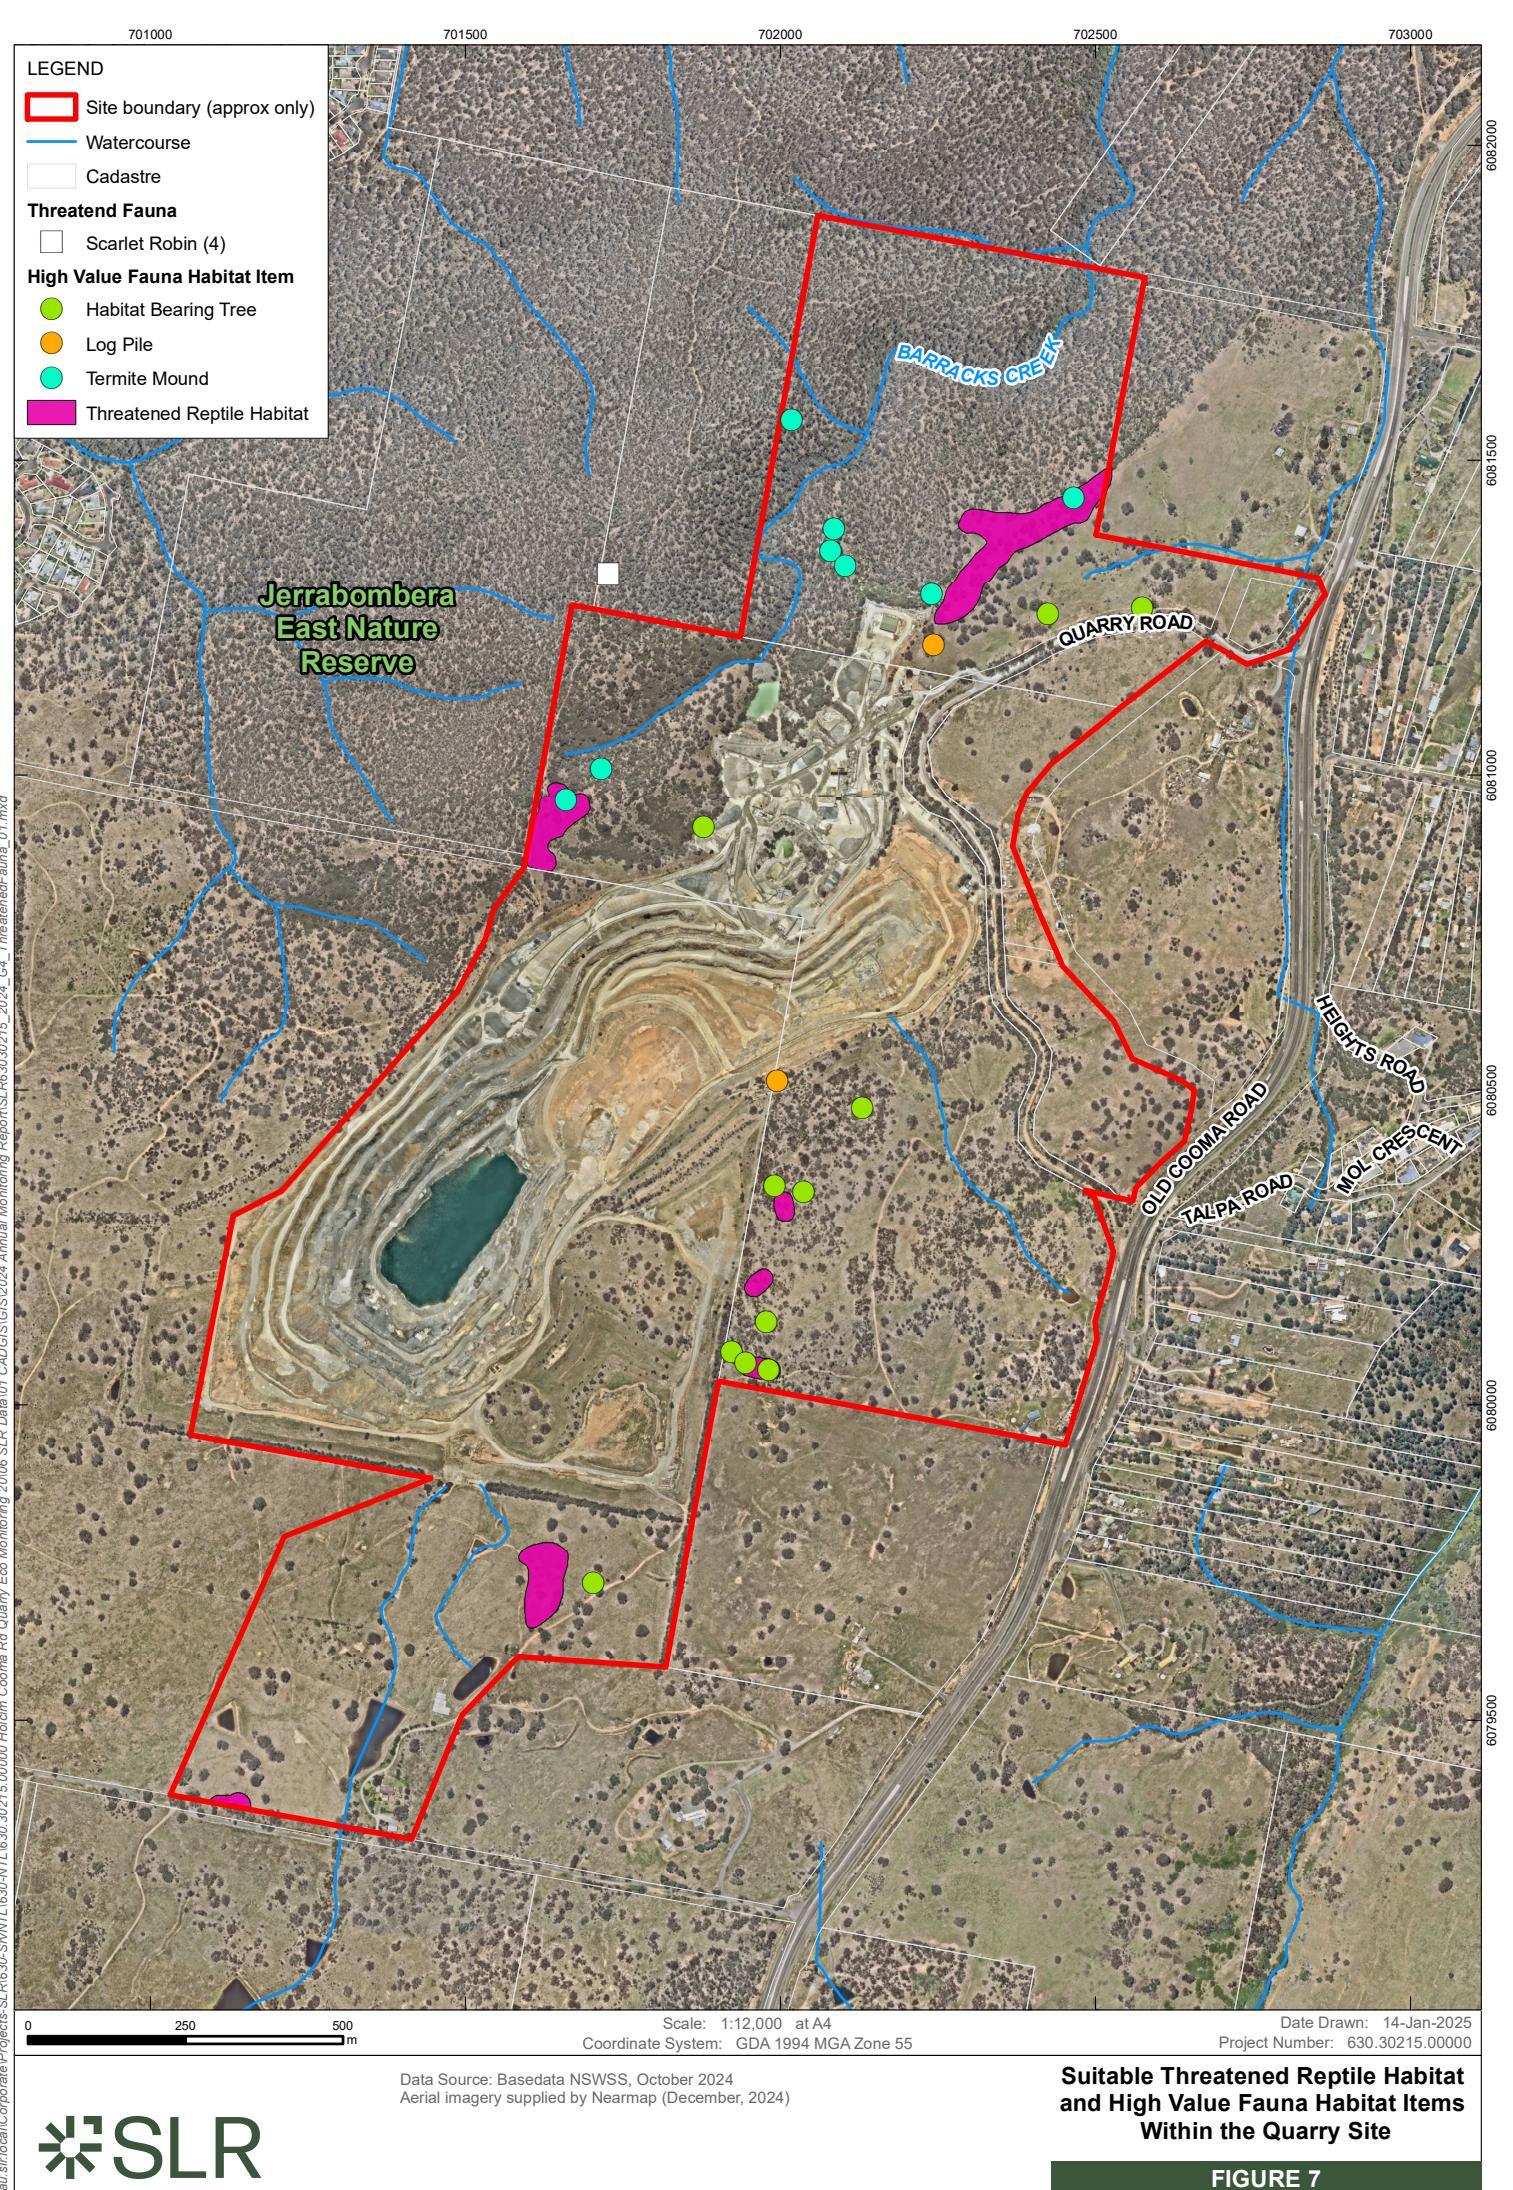
FIGURE 7

Figure 7 below shows the location of suitable threatened reptile habitat on the Quarry Site. **Figure 2** shows the locations of the four herpetological survey transects.

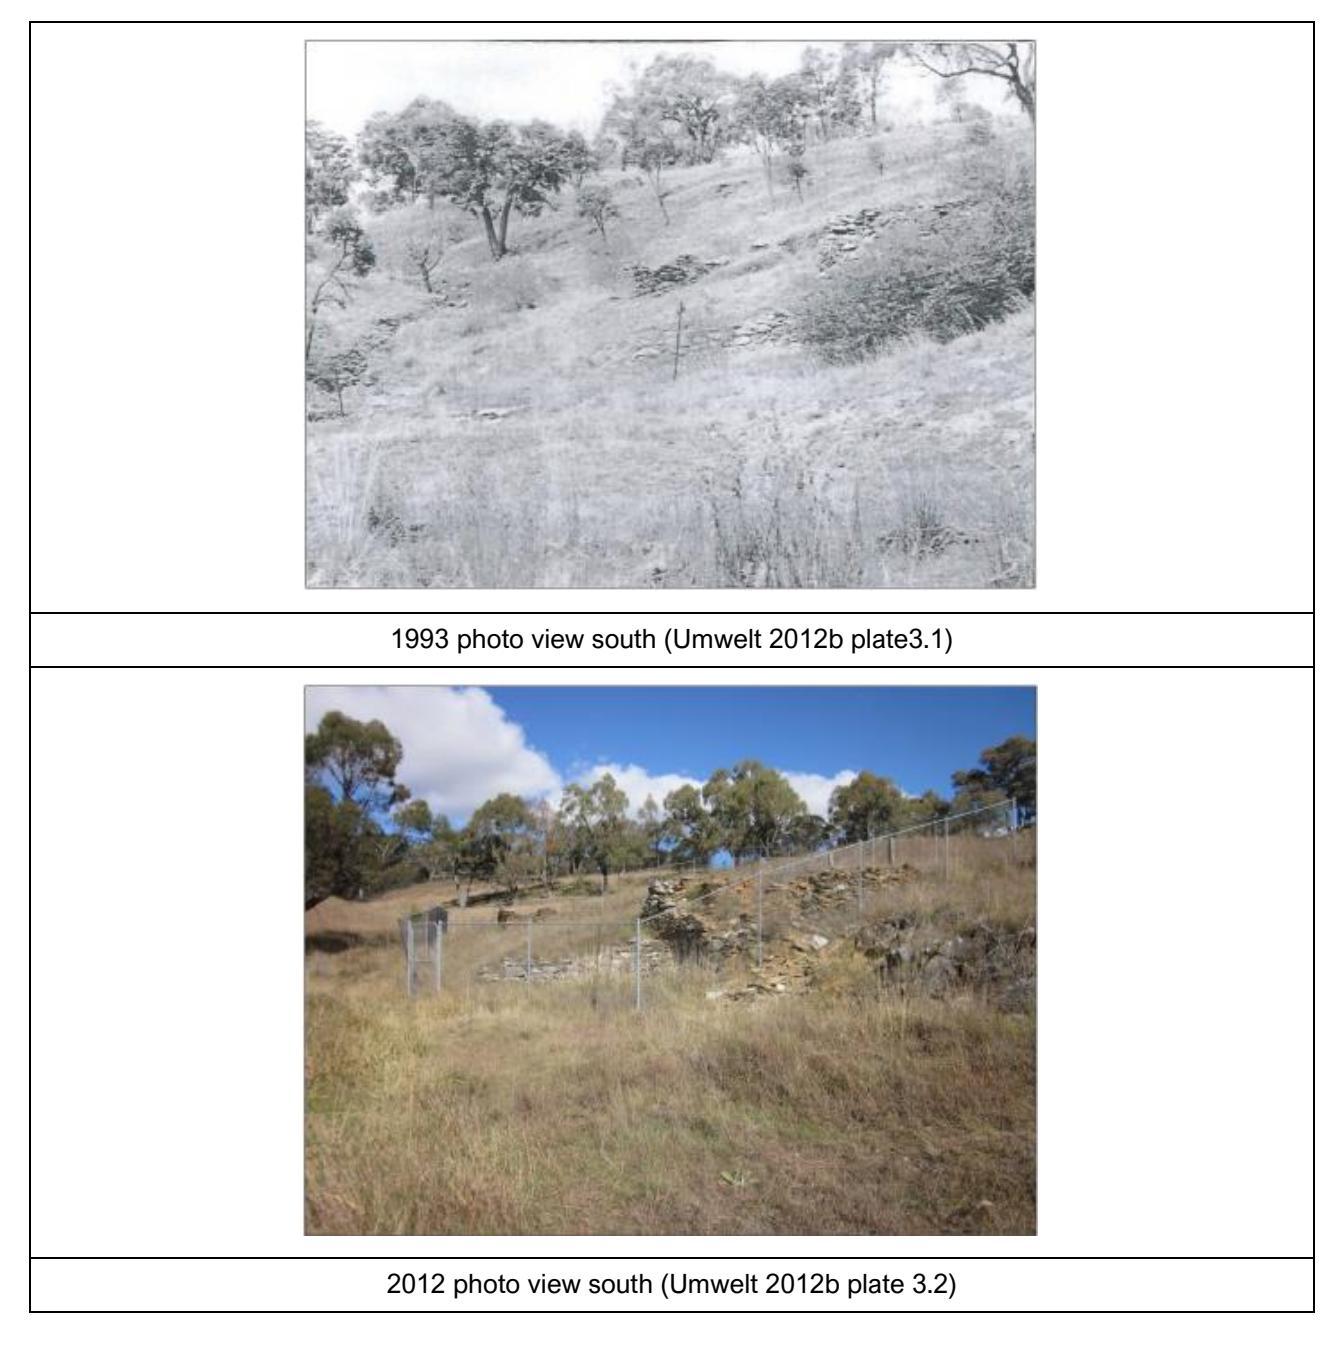
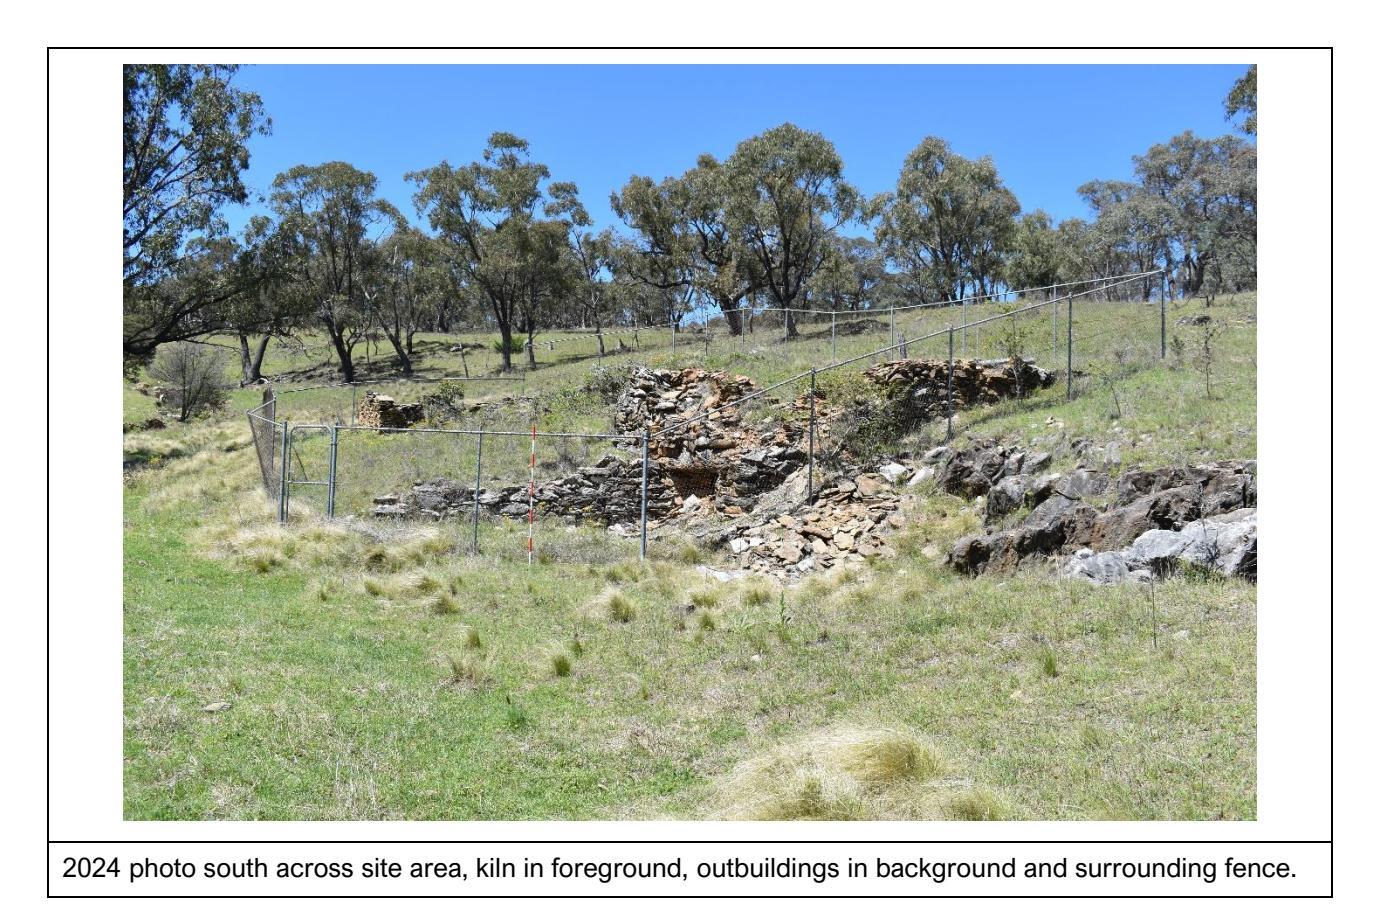
Overall site complex

The overall view of the site complex comprising the three structures is noted to be relatively intact and similar to the original (1993) and most recent (2012) photos available. The fence is intact, apart from a wombat burrow underneath a portion at the southern end of the site.

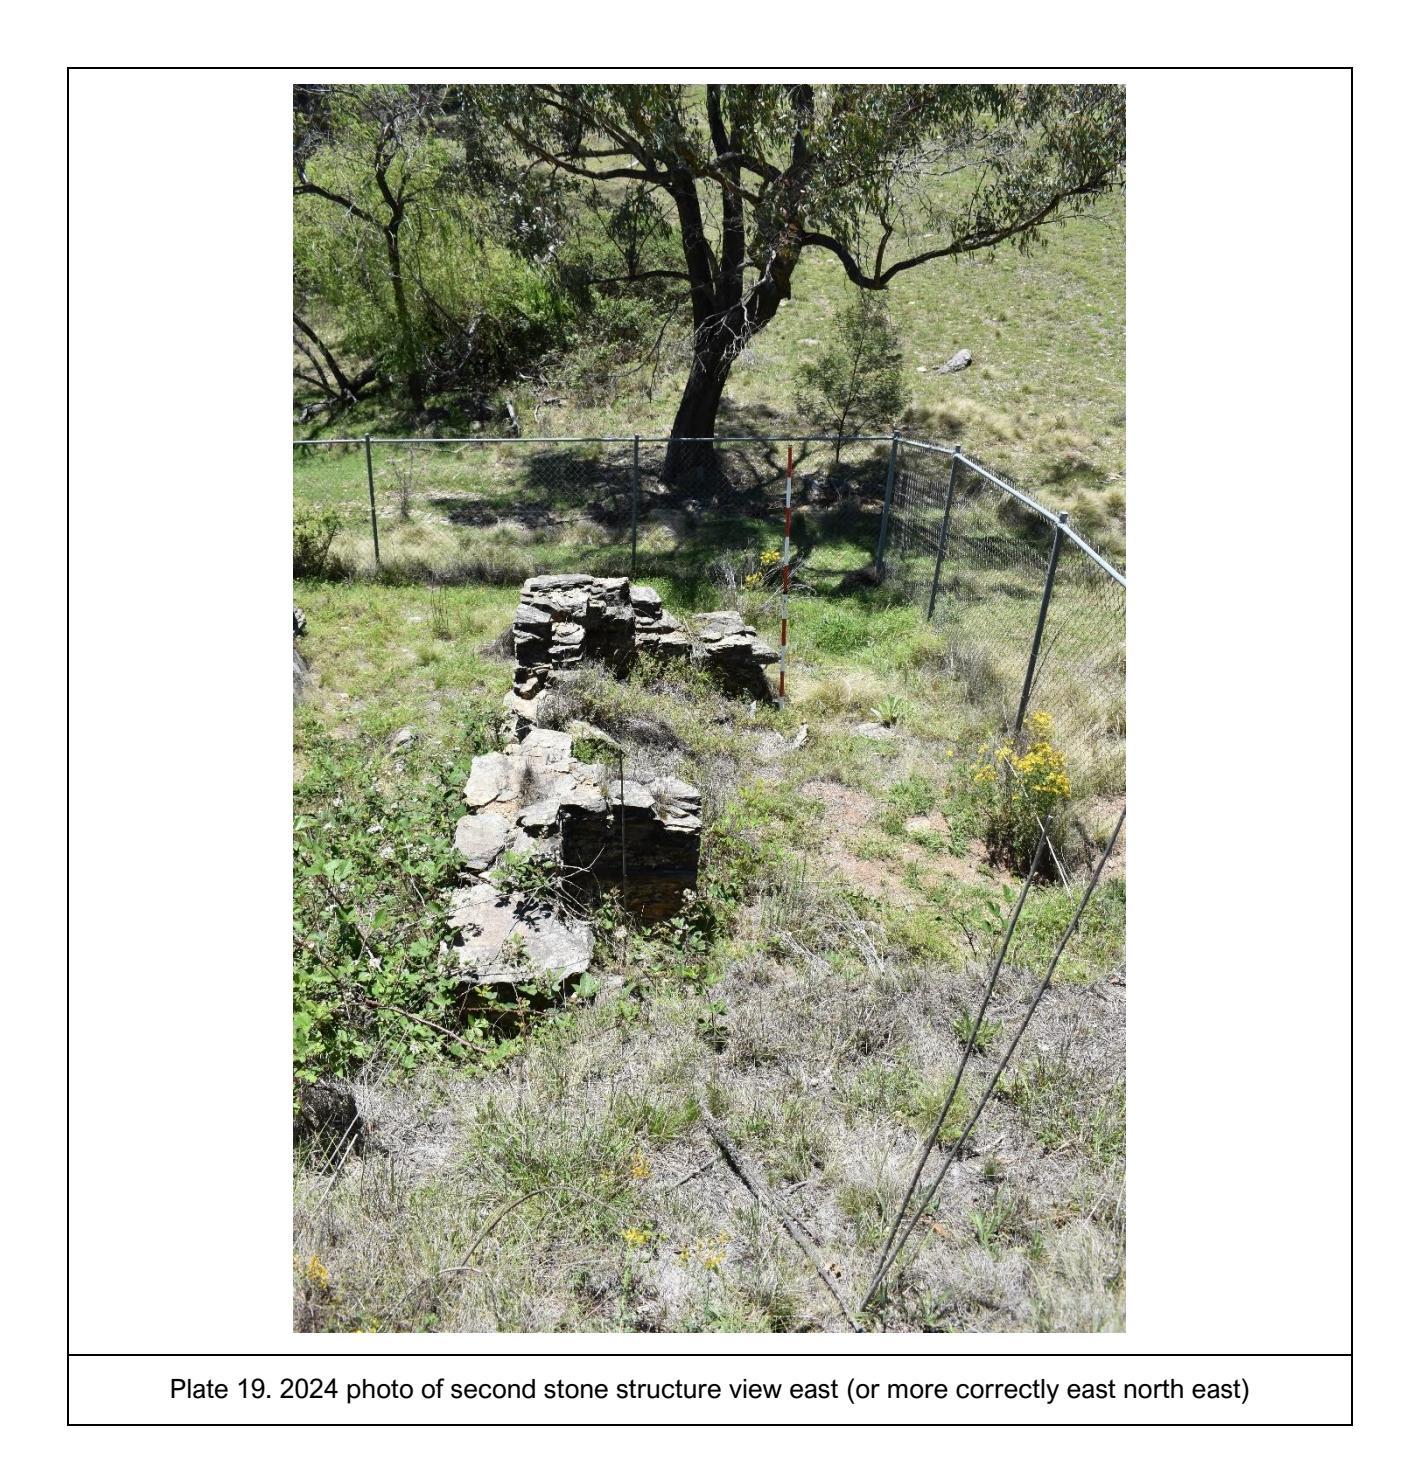
The second structure, as termed by Umwelt is the smaller, most southerly structure of the complex. The condition of this structure also appears to be the same as the 1993 and 2012 photos. There are no discernible changes in the height or condition of the walls.
