# ROOTY HILL DISTRIBUTION CENTRE

2024 Annual Review

Organisation	Holcim (Australia) Pty Ltd
Project	Rooty Hill Distribution Centre
Developmental Consent / Project Approval #	PA 05_0051
Document Title	Annual Review 2024
Document Revision	A
Author	IEMA
Project Identifier	HOL06-005
Annual review start date	1 January 2024
Annual review end date	31 December 2024

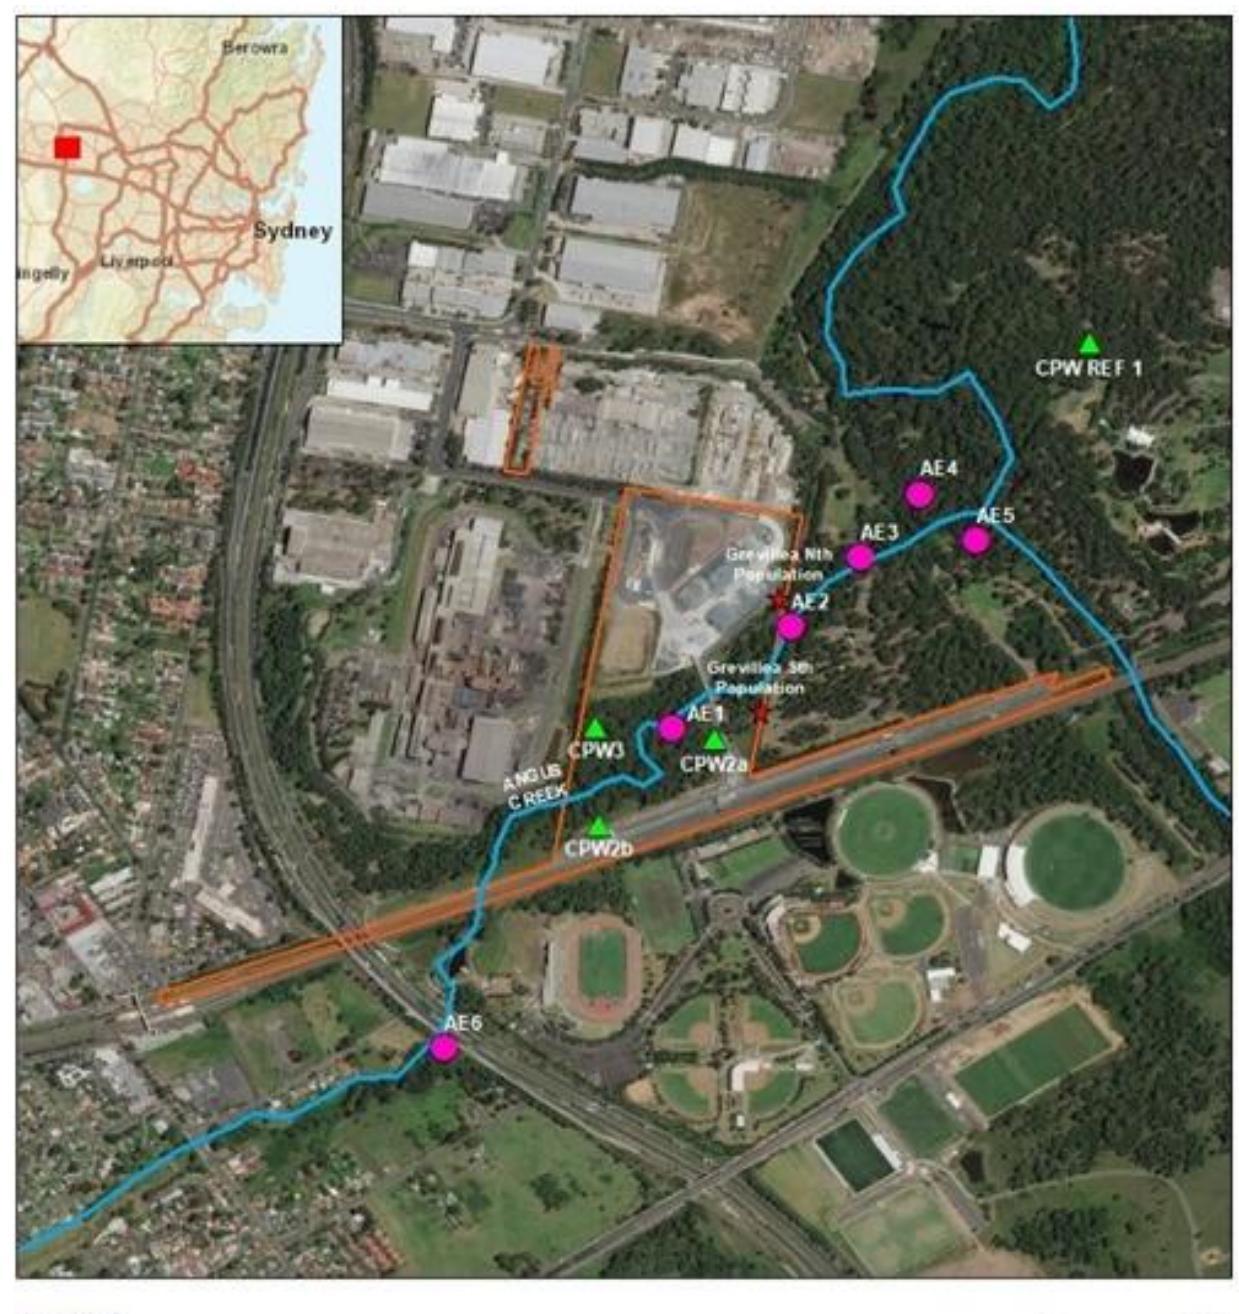
Aquatic monitoring is undertaken at the locations shown in Figure 2.

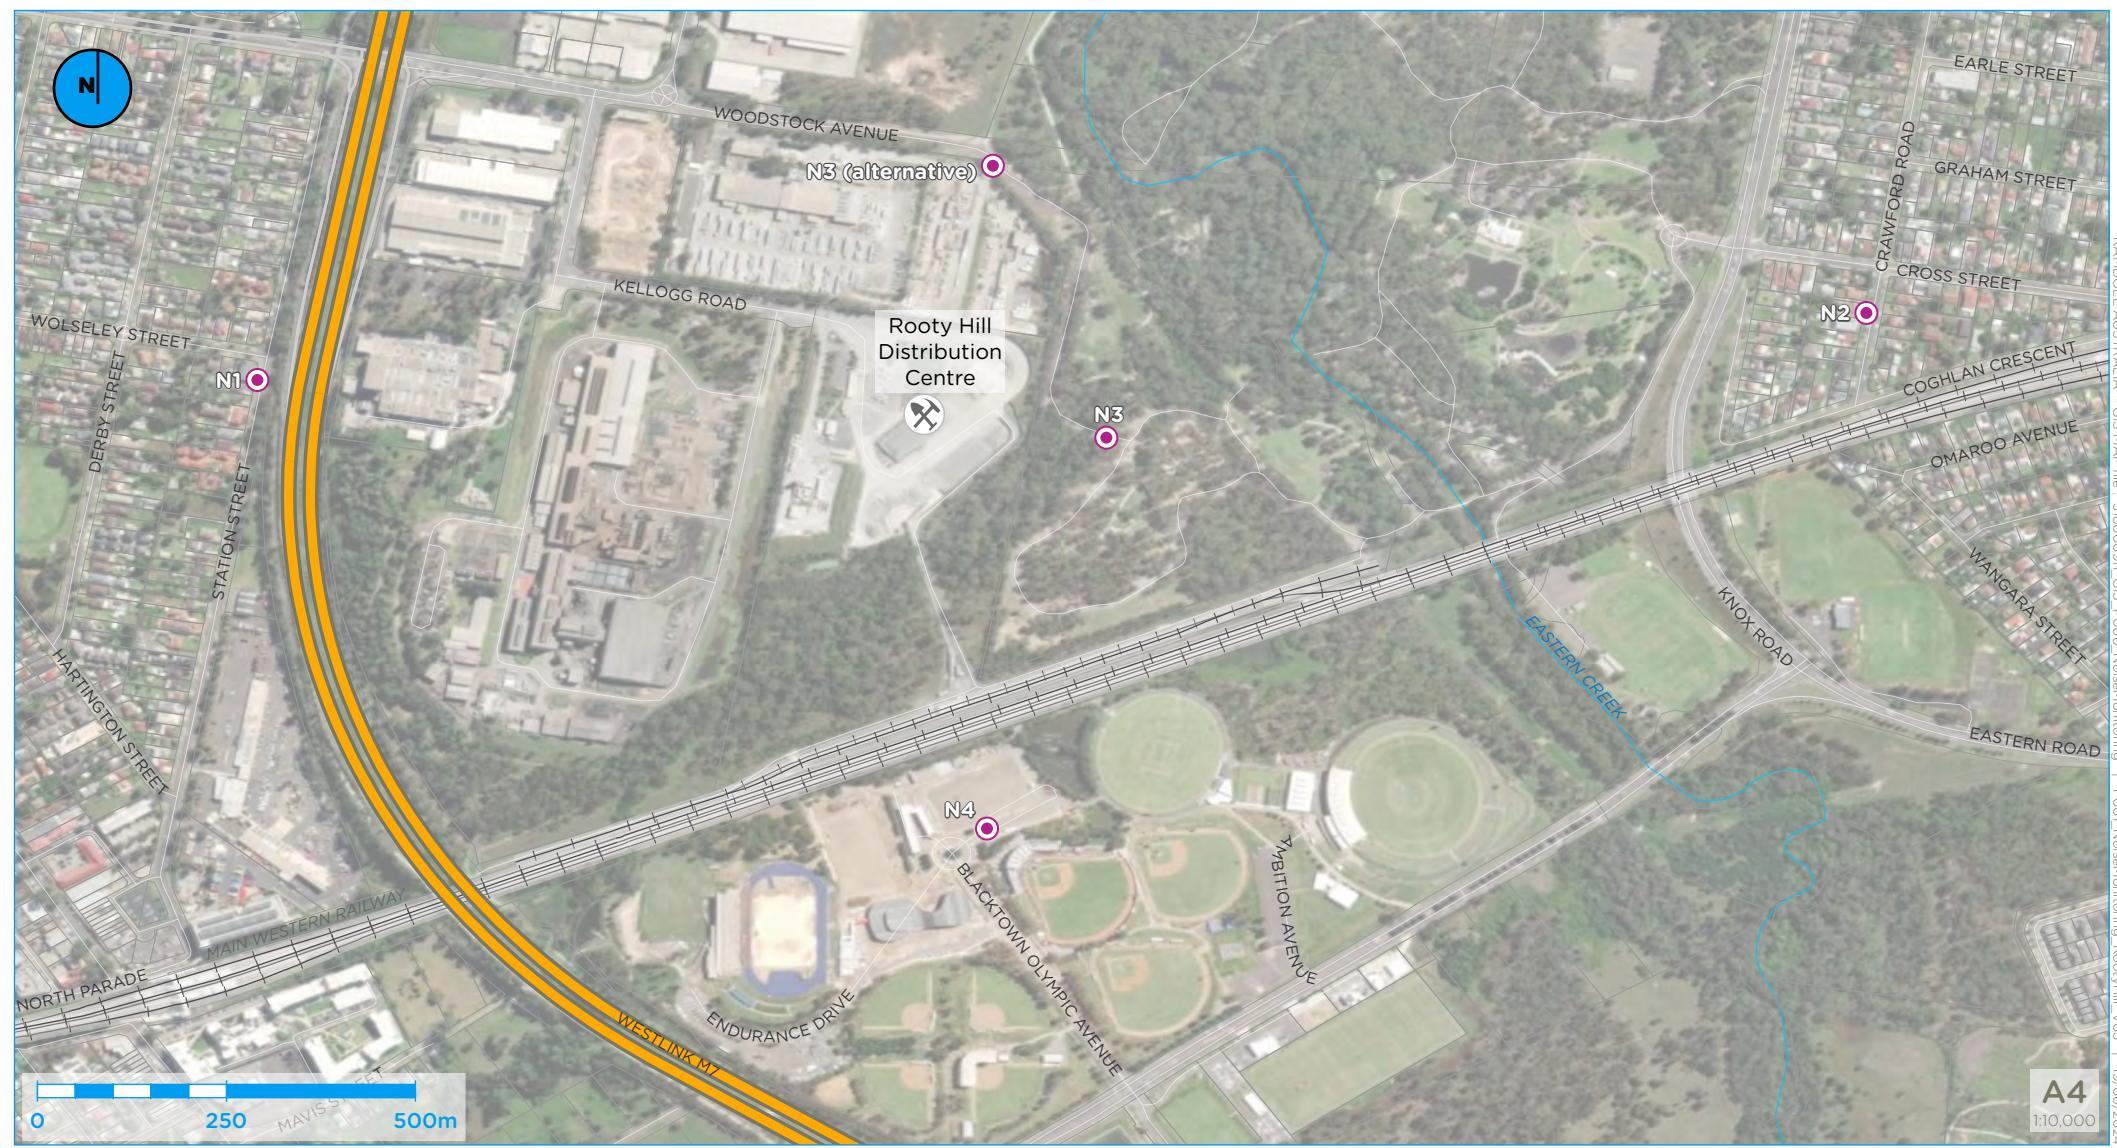
Figure 1: Noise monitoring locations at Rooty Hill Distribution Centre

Monitoring locations were selected in accordance with the NMP and are representative of the nearest noise sensitive receivers to the RHDC. The monitoring locations with respect to the RHDC and assessed receivers are presented in the locality plan in **Figure 1**.

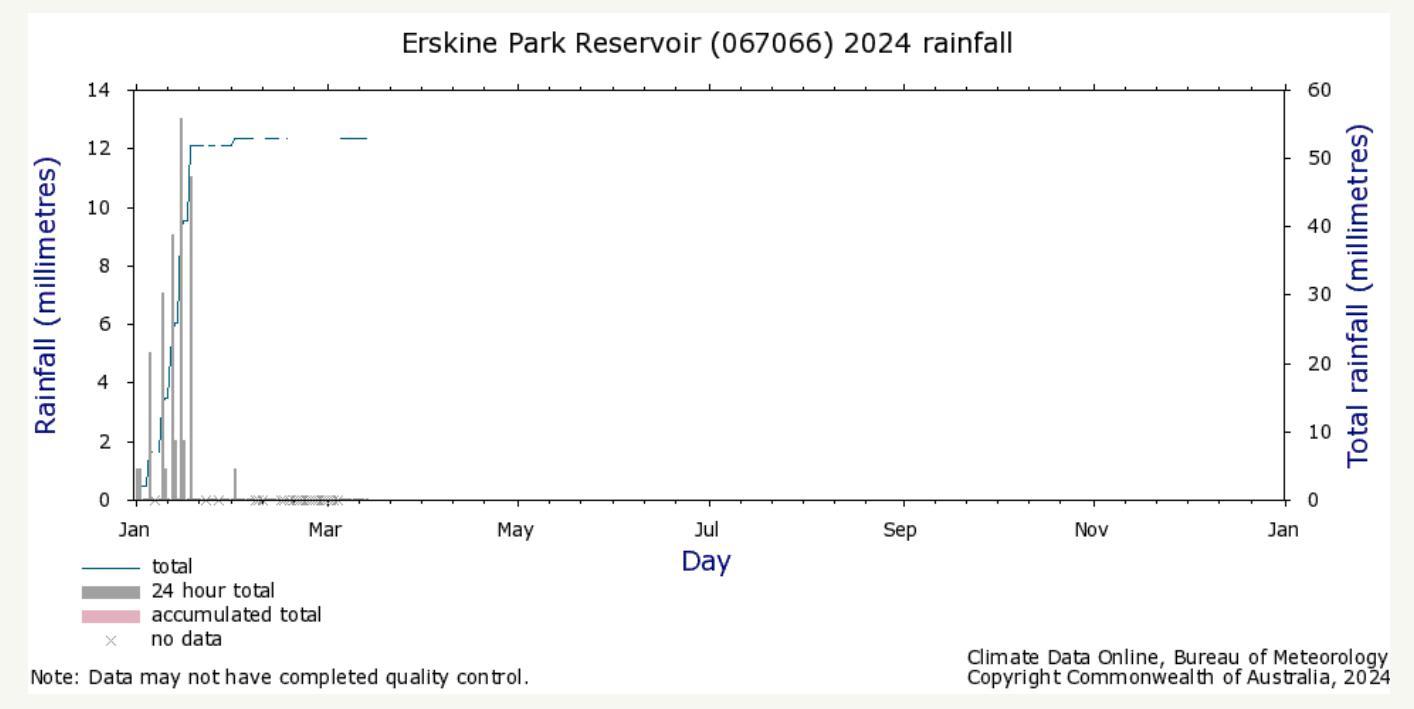
Figure 2: Rainfall January to March 2024

Antecedent rainfall from the month preceding the summer monitoring totalled 01 millimetres (mm) (Figure 2). No rain was recorded in the week leading up to the sampling. The water level at the time of sampling was low to moderate.

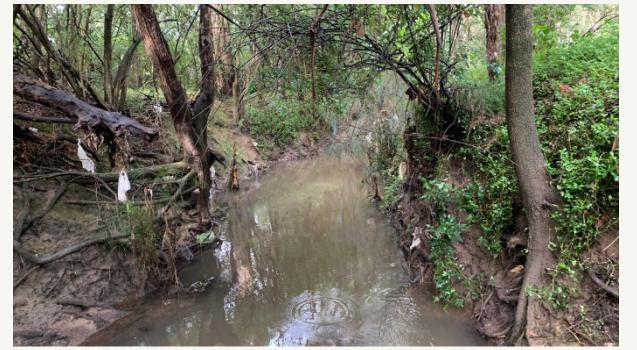
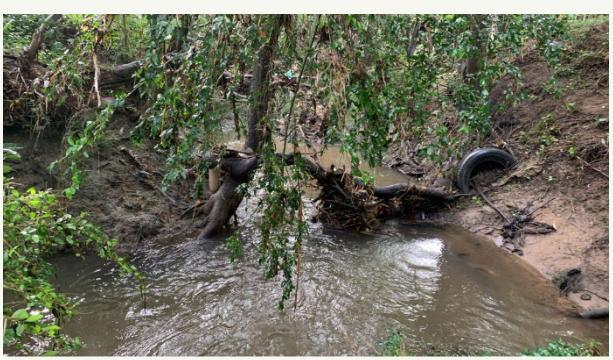
AE1: Angus Creek Upstream

Category	Attribute	AE1 Upstream		
Riparian	Vegetation	The dominant tree species comprised Swamp Oak ( <i>Casuarina glauca</i> ) and Broad-leaf Privet ( <i>Ligustrum lucidum</i> ). Groundcover was dominated by <i>Tradescantia fluminensis</i> .		
	Stream shading	Moderate shading		
	Exotic vegetation	L. lucidum and T. fluminensis		
Stream characteristics	Modal width	3 m		
	Bank condition	Slightly vegetated banks and stable. Slight erosion of lower bank.		
	Substrate	Fine sediment; silt. Hardened clay bottom.		
	Flow/depth	Moderate flow/ ~1 m		
	Macrophytes/algae	Macrophytes not present.		
	Water quality observations	Water visually turbid		
Comments	Weeds and rubbish present. Lack of organic material in channel.

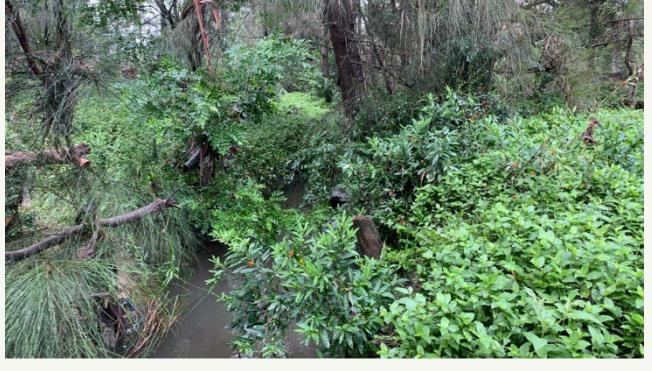
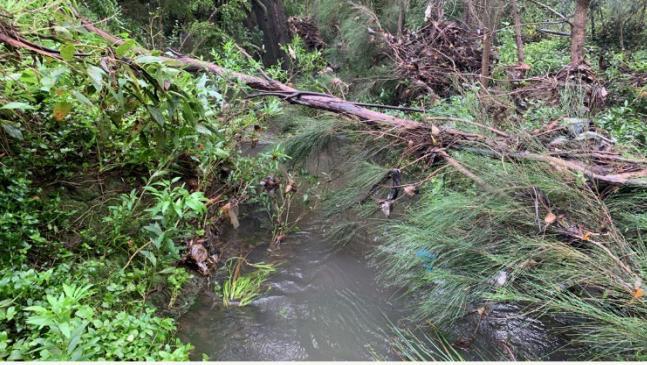
## AE2: Angus Creek

Category	Attribute	AE2 DOWNSTREAM	
Riparian	Vegetation	Dominant tree species included ( <i>C. glauca</i> ). Dominant groundcover was <i>T. fluminensis</i> and mixture of exotic and native grasses and herbs.	
	Stream shading	Moderate shading	
	Exotic vegetation	T. fluminensis and other groundcover species.	
Stream characteristics	Modal width	2 m	
	Bank Condition	Slightly unstable and heavily vegetated by groundcover	
	Substrate	Silt and bedrock	
	Flow/depth	Moderate flow/<1 m	
	Macrophytes/algae	Emergent macrophytes present - Bulrush ( <i>Typha</i> sp.), <i>Cyprus</i> sp. <i>Potamogeton crispus</i>	
	Water quality observations	Clear water	
Comments	Weeds and rubbish. Metallic rubbish in system. Concrete rubble in system.

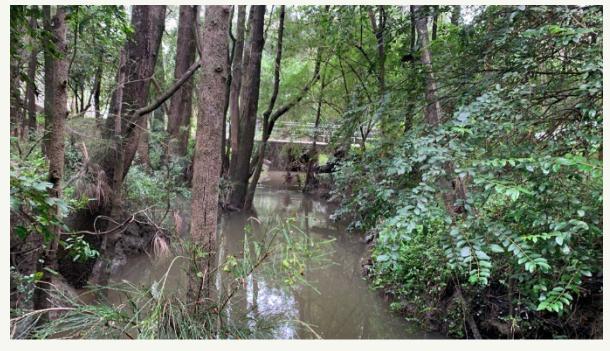
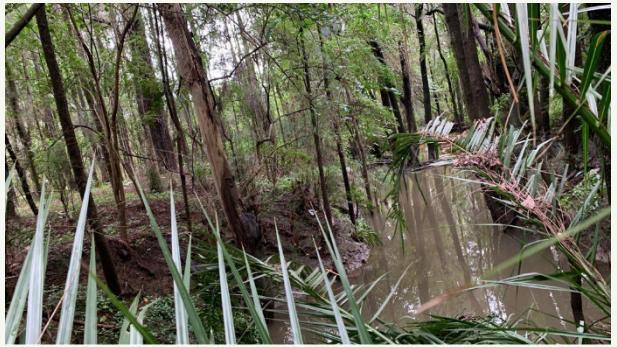
## AE3: Angus Creek Downstream

Category	Attribute	AE3 DOWNSTREAM			
Riparian	Vegetation	Dominant tree species was <i>C. glauca</i> . Dominant grass/herb species was <i>T. fluminensis</i>			
	Stream shading	Moderate shading			
	Exotic vegetation	L. Lucidum, T. fluminensis			
Stream	Modal width	l m			
characteristics	Bank Condition	Stable, steep, exposed in sections, slight visible erosion.			
	Substrate	Fine sediment, organic matter on banks			
	Flow/depth	Low flow/~1 metre			
	Macrophytes/algae	Ribbon Weed ( <i>Vallisneria</i> sp.)			
	Water quality observations	r quality Visually water appeared slightly opaque rvations			
Comments	Significant amount of plastic based rubbish in stream

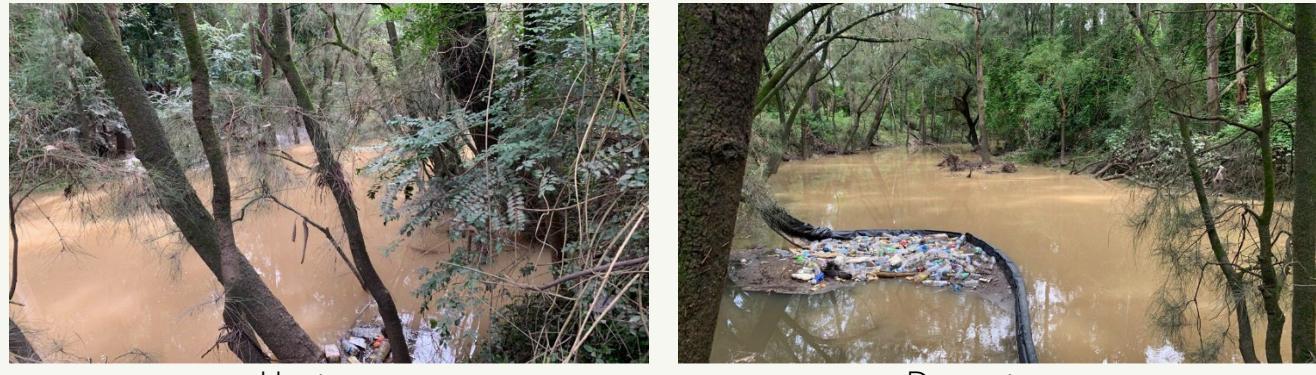
## AE4: Eastern Creek Downstream

Category	Attribute	AE4 DOWNSTREAM	
Riparian	Vegetation	Dominant canopy species included <i>C. glauca</i> and Prickly-leaved Tea Tree ( <i>Melaleuca styphelioides</i> ). Dominant mid-storey species were <i>C. glauca L. lucidum</i> . Dominant groundcover was the exotic <i>T. fluminensis</i>	
	Stream shading	Moderate	
	Exotic vegetation	L. lucidum and T. fluminensis	
Stream characteristics	Modal width	8 m	
Characteristics	Bank condition	Unstable banks	
	Substrate	Fine sediment	
	Flow/depth	Moderate flow/>1m	
	Macrophytes/algae	Macrophytes not present	
	Water quality observations	Visually Turbid	
Comments	Significant amount of plastic based rubbish in stream

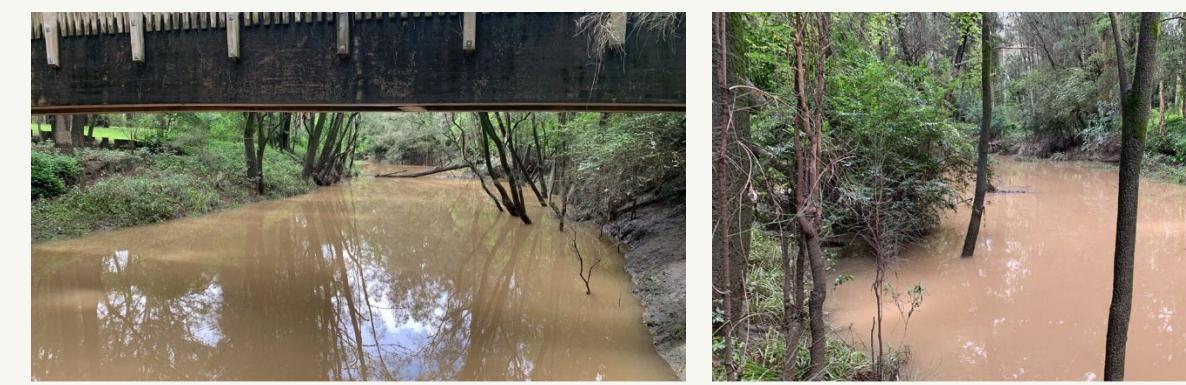
# AE 5: Eastern Creek Upstream

Category	Attribute	AE5 UPSTREAM	
Riparian	Vegetation	Dominant overstorey species was <i>C. glauca</i> . Dominant grass/herb was Lomandra ( <i>Lomandra longifolia</i> ) and groundcover <i>T. fluminensis</i> .	
	Stream shading	Moderate	
	Exotic vegetation	T. fluminensis	
Stream	Modal width	12 m	
characteristics	Bank condition	Unstable	
	Substrate	Fine sediment and large woody debris.	
	Flow/depth	Moderate flow/ >1 m	
	Macrophytes/algae	Macrophytes not present.	
	Water quality observations	Visually turbid	
Comments	Lots of large woody debris and plastic based rubbish

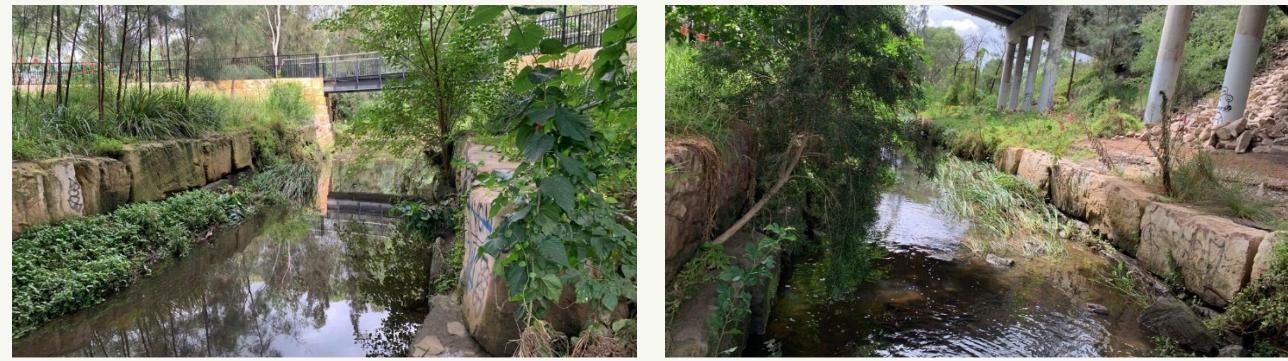
## AE 6: Angus creek Upstream

Category	Attribute	AE5 UPSTREAM	
Riparian	Vegetation	Dominant overstorey species was C. glauca. Dominant grass/herb was Lomandra ( <i>Lomandra longifolia</i> ) and groundcover T. fluminensis.	
	Stream shading	Moderate	
	Exotic vegetation	T. fluminensis	
Stream	Modal width	5 m	
	Bank condition	Stable, man made.	
	Substrate	Fine sediment and cobble	
	Flow/depth	Moderate flow/ >1 m	
	Macrophytes/algae	Macrophytes present.	
	Water quality observations	Visually clear	
Comments

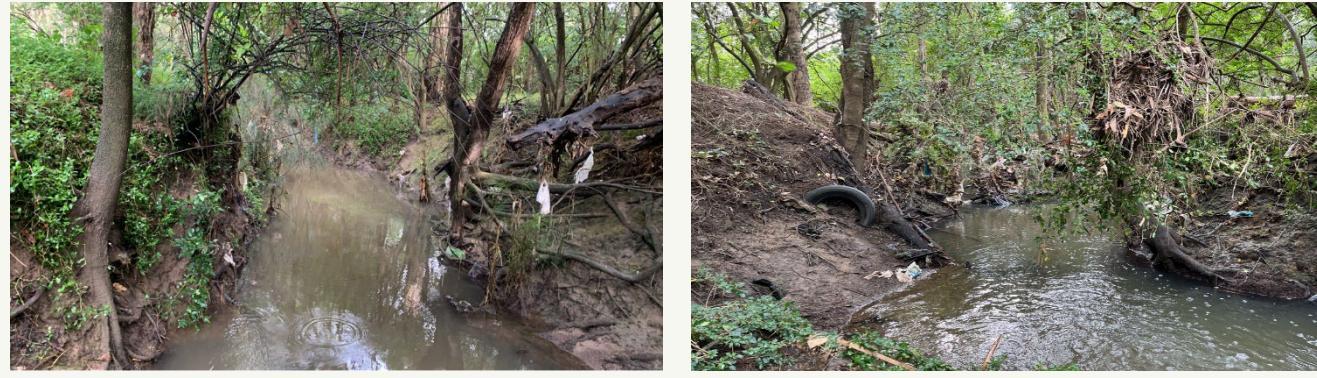
AE1: Angus Creek Upstream

Category	Attribute	AE1 Upstream				
Riparian	Vegetation	The dominant tree species comprised Swamp Oak ( <i>Casuarina glauca</i> ) and Broad-leaf Privet ( <i>Ligustrum lucidum</i> ). Groundcover was dominated by <i>Tradescantia fluminensis</i> .				
	Stream shading	Moderate shading				
	Exotic vegetation	L. lucidum and T. fluminensis				
Stream	Modal width	3 m				
characteristics	Bank condition	Slightly vegetated banks and stable. Slight erosion of lower bank.				
	Substrate	Fine sediment; silt. Hardened clay bottom.				
	Flow/depth	Moderate flow/ ~1 m				
	Macrophytes/algae	Macrophytes not present.				
	Water quality observations	Water visually clear				
Comments	Weeds and rubbish pre	sent. Lack of organic material in channel.

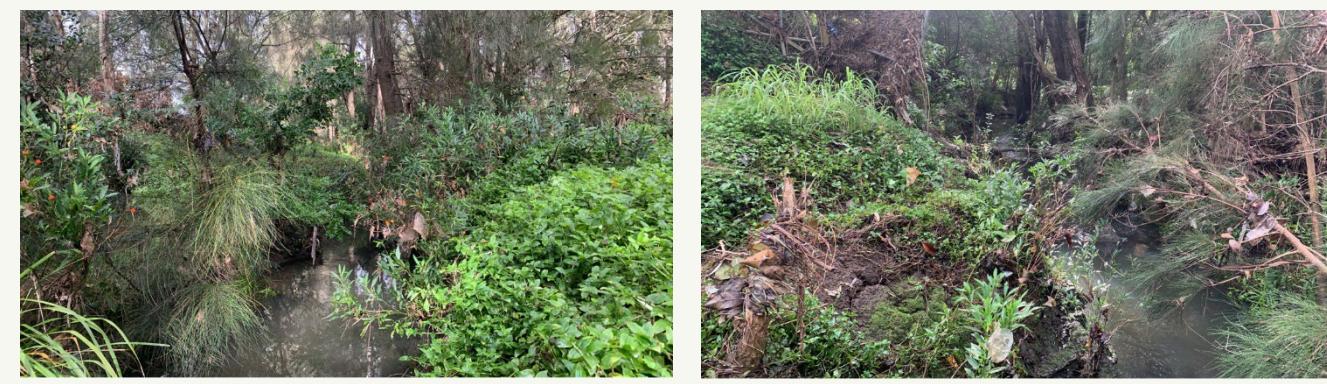
## AE2: Angus Creek

Category	Attribute	AE2 Downstream
Riparian	Vegetation	Dominant tree species included (C. glauca). Dominant groundcover was T. fluminensis and mixture of exotic and native grasses and herbs.
	Stream shading	Moderate shading
	Exotic vegetation	T. fluminensis and other groundcover species.
Stream	Modal width	2 m
characteristics	Bank Condition	Slightly unstable and heavily vegetated by groundcover
	Substrate	Silt and bedrock
	Flow/depth	Moderate flow/<1 m
	Macrophytes/algae	Emergent macrophytes present - Bulrush ( <i>Typha sp.</i> ), <i>Cyprus sp.</i> <i>Potamogeton crispus</i>
	Water quality observations	Water visually clear.
Comments	Weeds and rubbish. Me	tallic rubbish in system. Concrete rubble in system.

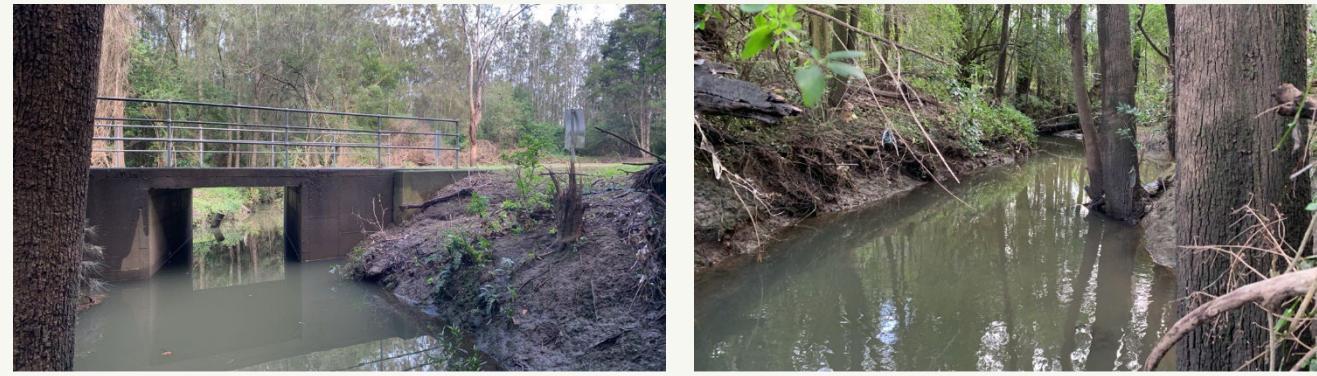
## AE3: Angus Creek Downstream

Category	Attribute	AE3 Downstream				
Riparian	Vegetation	Dominant tree species was <i>C. glauca</i> . Dominant grass/herb species was <i>T. fluminensis</i>				
	Stream shading	Moderate shading				
	Exotic vegetation	L. Lucidum, T. fluminensis				
Stream characteristics	Modal width	4 m				
	Bank Condition	Stable, steep, exposed in sections, visible erosion.				
	Substrate	Fine sediment, organic matter on banks				
	Flow/depth	Low flow/~1 metre				
	Macrophytes/algae	Ribbon Weed ( <i>Vallisneria</i> sp.)				
	Water quality observations	Visually water appeared slightly turbid.				
Comments	Significant amount of e	erosion on banks.

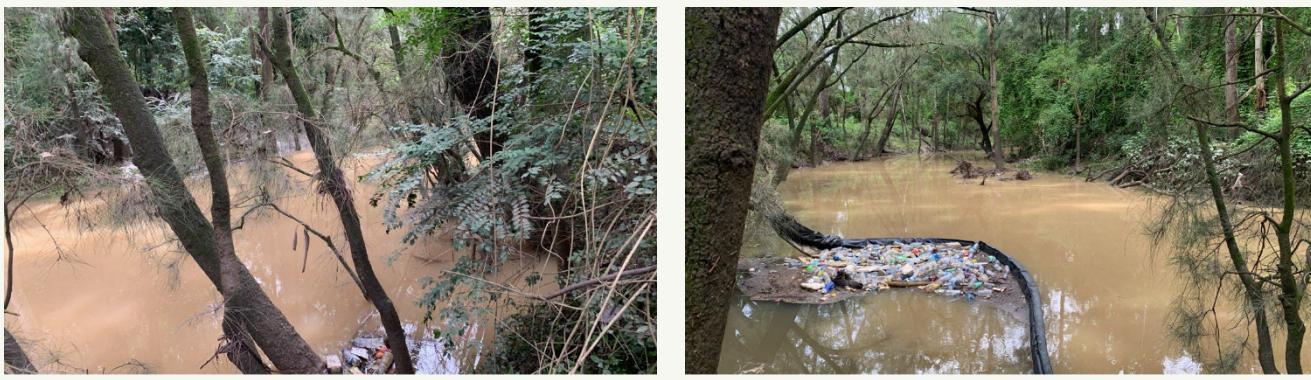
### AE4: Eastern Creek Downstream

Category	Attribute	AE4 Downstream
Riparian	Vegetation	Dominant canopy species included <i>C. glauca</i> and Prickly-leaved Tea Tree ( <i>Melaleuca styphelioides</i> ). Dominant mid-storey species were <i>C. glauca L. lucidum</i> . Dominant groundcover was the exotic <i>T. fluminensis</i>
	Stream shading	Moderate
	Exotic vegetation	L. lucidum and T. fluminensis
Stream	Modal width	8 m
Characteristics	Bank condition	Unstable banks
	Substrate	Fine sediment
	Flow/depth	Moderate flow/>1m
	Macrophytes/algae	Macrophytes not present
	Water quality observations	Visually turbid
Comments	Significant amount of p	plastic based rubbish in stream

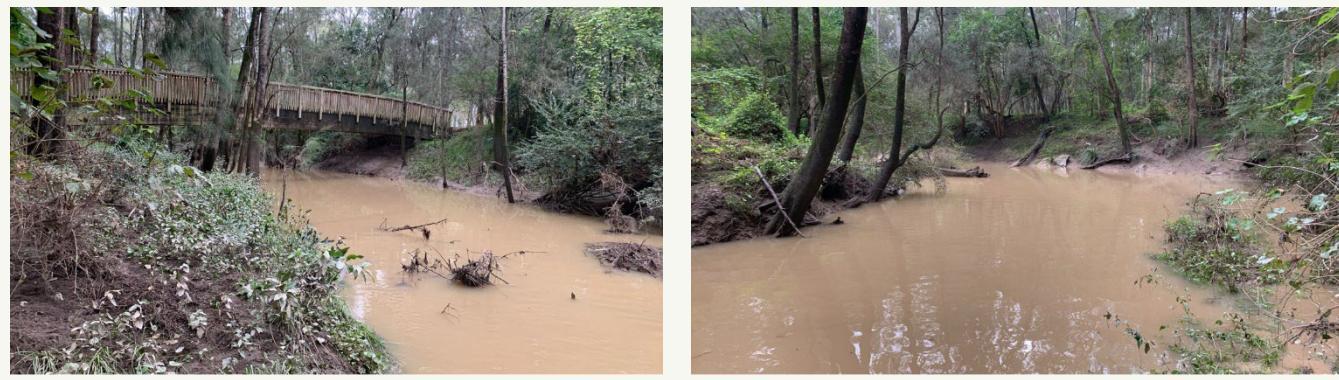
## AE 5: Eastern Creek Upstream

Category	Attribute	AE5 Upstream
Riparian	Vegetation	Dominant overstorey species was <i>C. glauca</i> . Dominant grass/herb was Lomandra ( <i>Lomandra longifolia</i> ) and groundcover <i>T. fluminensis</i> .
	Stream shading	Moderate
	Exotic vegetation	T. fluminensis
Stream characteristics	Modal width	12 m
	Bank condition	Unstable
	Substrate	Fine sediment and large woody debris.
	Flow/depth	Moderate flow/ >1 m
	Macrophytes/algae	Macrophytes not present.
	Water quality observations	Visually turbid
Comments	Lots of large woody de	bris and plastic based rubbish

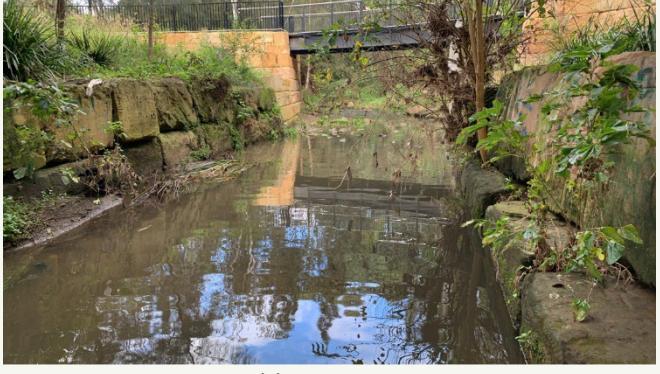
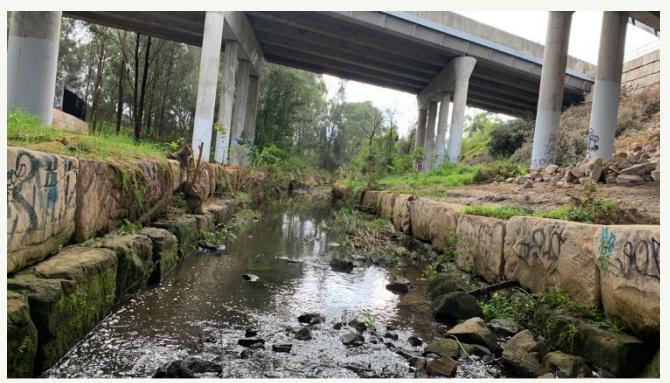
## AE 6: Angus creek Upstream

Category	Attribute	AE5 Upstream
Riparian	Vegetation	Dominant overstorey species was <i>C. glauca</i> . Dominant grass/herb was Lomandra ( <i>Lomandra longifolia</i> ) and groundcover <i>T. fluminensis</i> .
	Stream shading	Moderate
	Exotic vegetation	T. fluminensis
Stream	Modal width	5 m
characteristics	Bank condition	Stable, man-made.
	Substrate	Fine sediment and cobble
	Flow/depth	Moderate flow/ >1 m
	Macrophytes/algae	Macrophytes present.
	Water quality observations	Visually clear
Comments	Recent landscaping wor	ks have been conducted on stream edge.

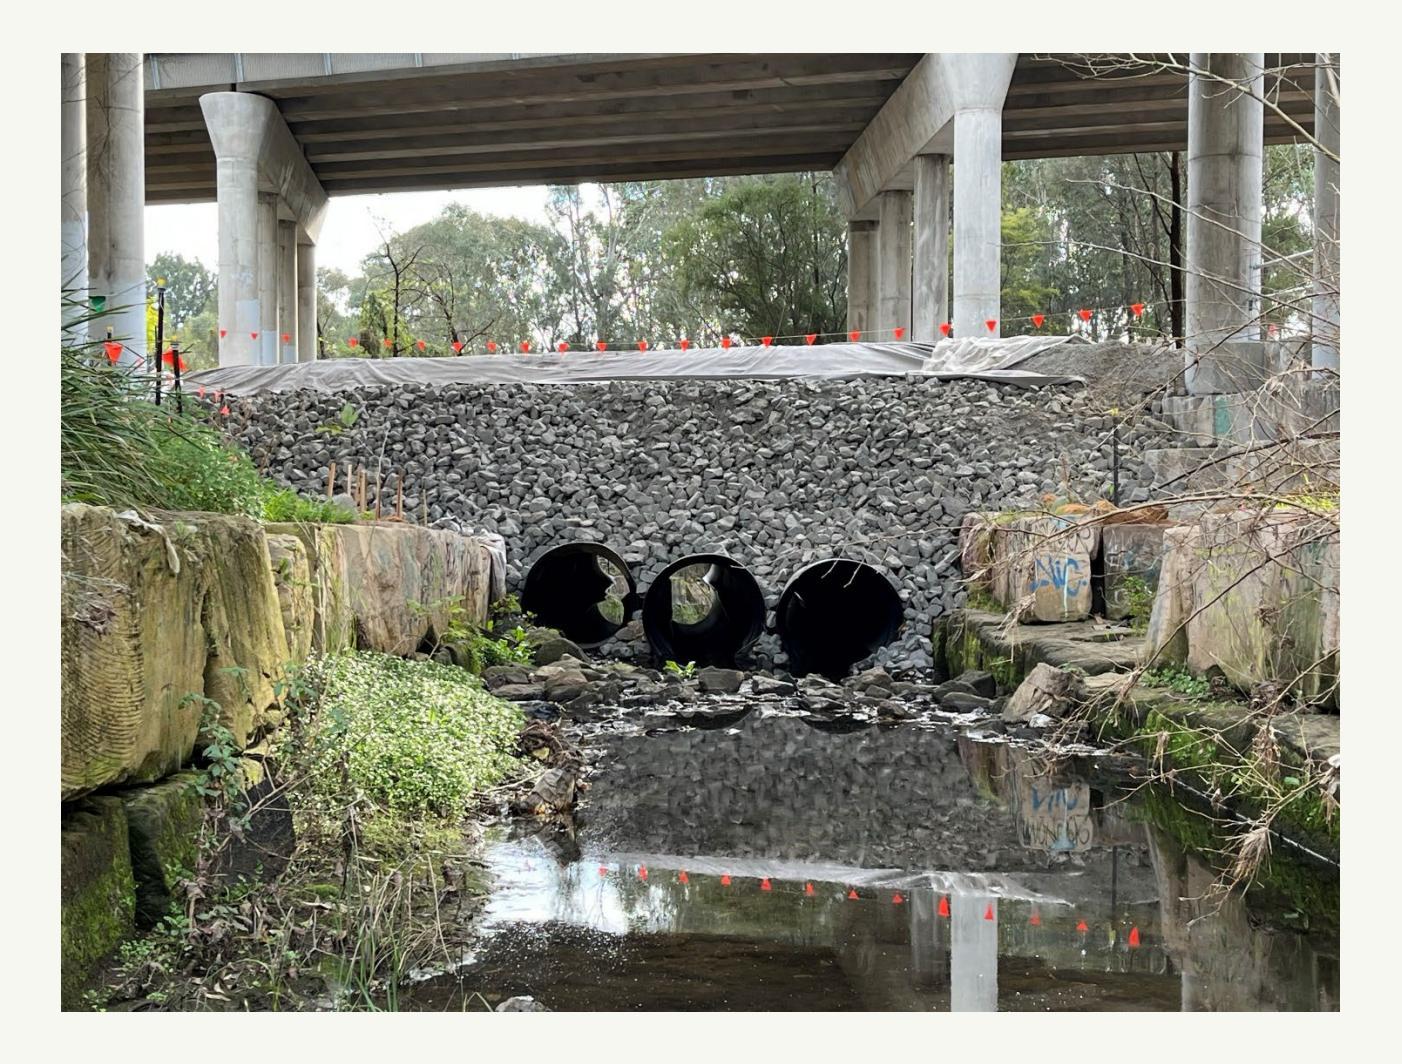
Plate 1: Angus Creek control site AE6 culvert (looking downstream)

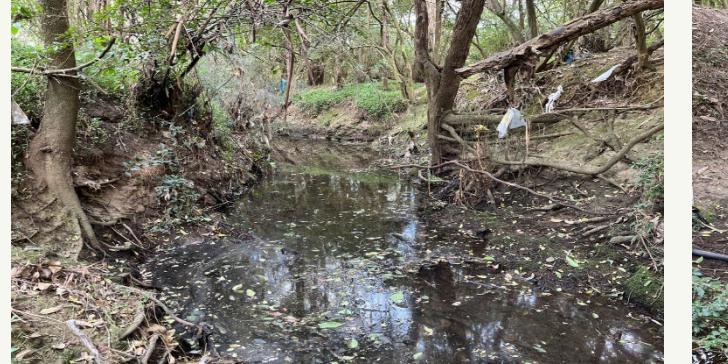
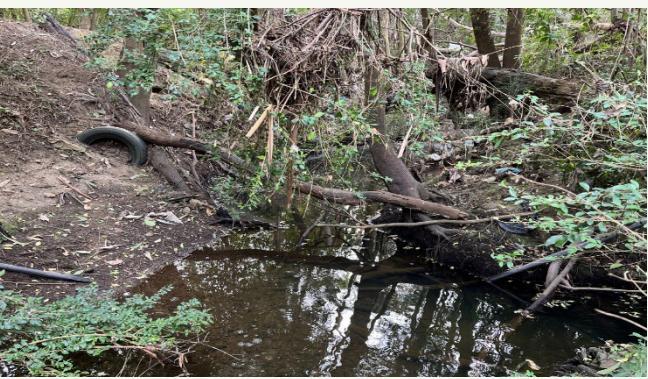
AE1: Angus Creek Upstream

Category	Attribute	AE1 Upstream
Riparian	Vegetation	The dominant tree species comprised Swamp Oak ( <i>Casuarina glauca</i> ) and Broad-leaf Privet ( <i>Ligustrum lucidum</i> ). Groundcover was dominated by <i>Tradescantia fluminensis</i> .
	Stream shading	Moderate shading
	Exotic vegetation	L. lucidum and T. fluminensis
Stream	Modal width	3 m
characteristics	Bank condition	Slightly vegetated banks and stable. Slight erosion of lower bank.
	Substrate	Fine sediment; silt. Hardened clay bed.
	Flow/depth	No visible flow
	Macrophytes/algae	Macrophytes not present.
	Water quality observations	Surface water visually clear
Comments	Weeds and rubbish present. Lack of submerged organic material in channel. Some floating leaf debris at time of sampling.

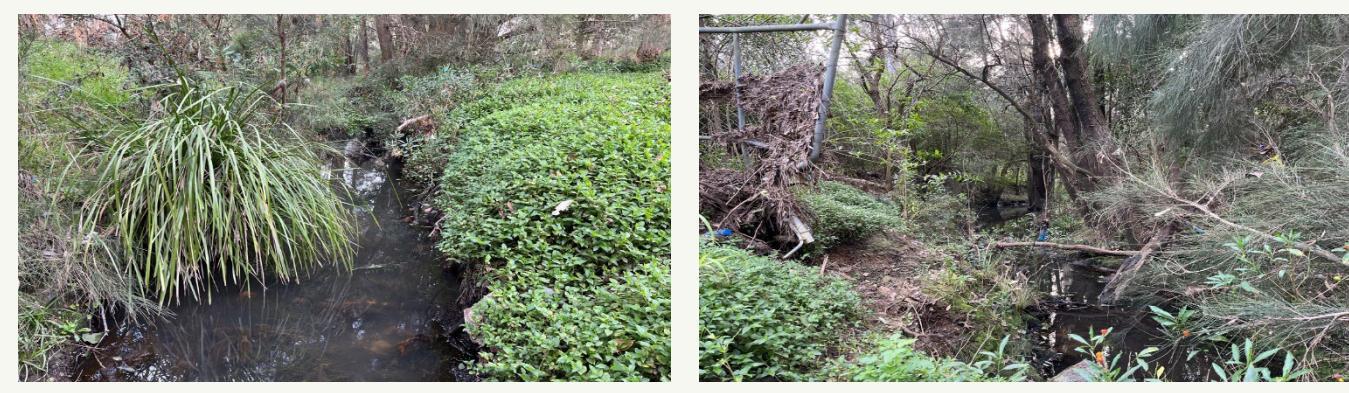
## AE2: Angus Creek

Category	Attribute	AE2 Downstream	
Riparian	Vegetation	Dominant tree species included (C. glauca). Dominant groundcover was T. fluminensis and mixture of exotic and native grasses and herbs.	
	Stream shading	Moderate shading	
	Exotic vegetation	T. fluminensis and other groundcover species.	
Stream characteristics	Modal width	2 m	
characteristics	Bank Condition	Slightly unstable and heavily vegetated by groundcover	
	Substrate	Silt and bedrock	
	Flow/depth	No visible flow	
	Macrophytes/algae	Emergent macrophytes present - Bulrush (Typha sp.), Cyprus sp. Potamogeton crispus	
	Water quality observations	Water visually clear.	
Comments	Weeds and rubbish. Metallic rubbish in system. Concrete rubble in system.

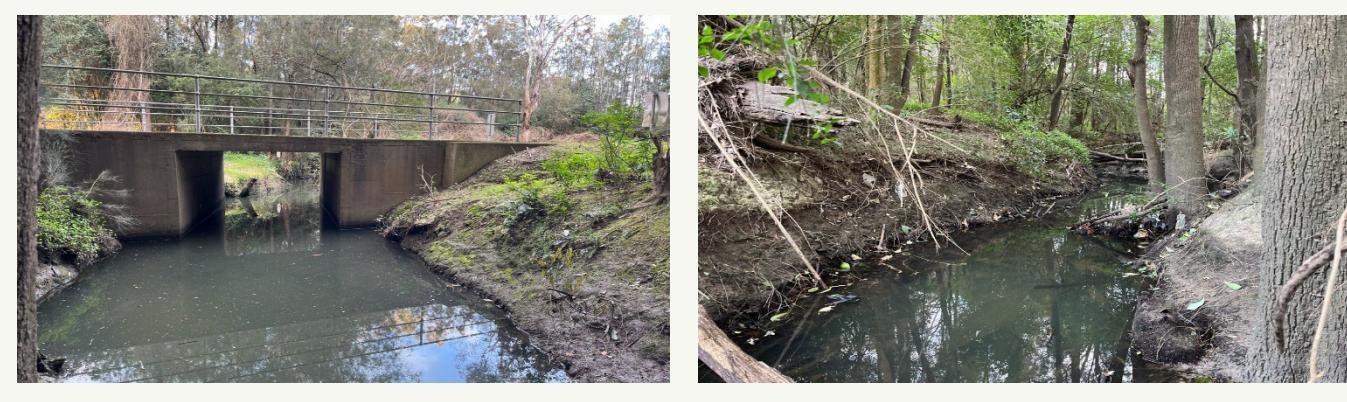
## AE3: Angus Creek Downstream

Category	Attribute	AE3 Downstream	
Riparian	Vegetation	Dominant tree species was <i>C. glauca</i> . Dominant grass/herb species was <i>T. fluminensis</i>	
	Stream shading	Moderate shading	
	Exotic vegetation	L. Lucidum, T. fluminensis	
Stream	Modal width	4 m	
characteristics	Bank Condition	Stable, steep, exposed in sections, visible erosion.	
	Substrate	Fine sediment, organic matter on banks	
	Flow/depth	No visible flow	
	Macrophytes/algae	Macrophytes not present.	
	Water quality observations	Visually water appeared slightly opaque.	
Comments	Significant amount of erosion on banks.

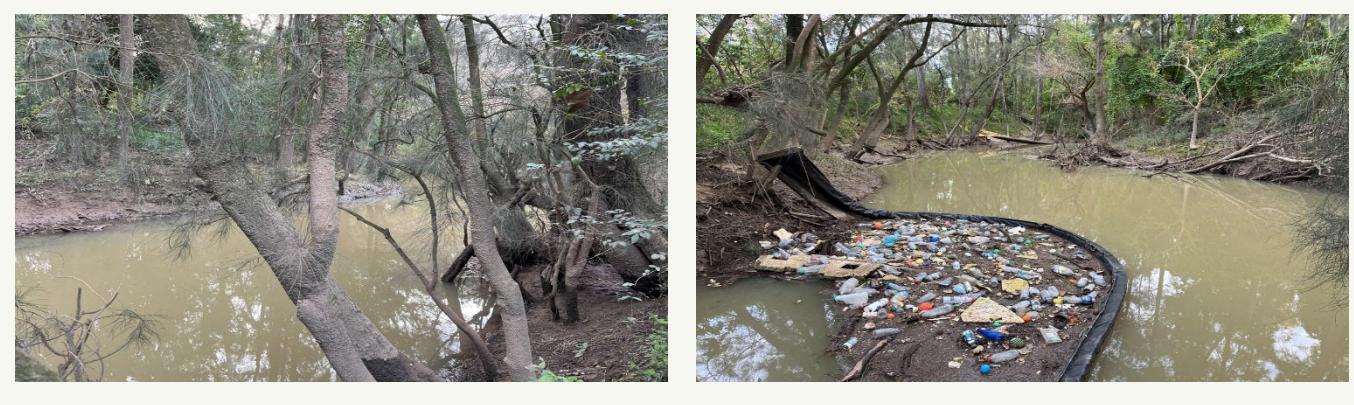
### AE4: Eastern Creek Downstream

Category	Attribute	AE4 Downstream	
Riparian	Vegetation	Dominant canopy species included <i>C. glauca</i> and Prickly-leaved Tea Tree ( <i>Melaleuca styphelioides</i> ). Dominant mid-storey species were <i>C. glauca, L. lucidum</i> . Dominant groundcover was the exotic <i>T. fluminensis</i> .	
	Stream shading	Moderate	
	Exotic vegetation	L. lucidum and T. fluminensis	
Stream	Modal width	8 m	
characteristics	Bank condition	Unstable banks	
	Substrate	Fine sediment	
	Flow/depth	No visible flow	
	Macrophytes/algae	Macrophytes not present	
	Water quality observations	Visually turbid	
Comments	Significant amount of plastic based rubbish in stream

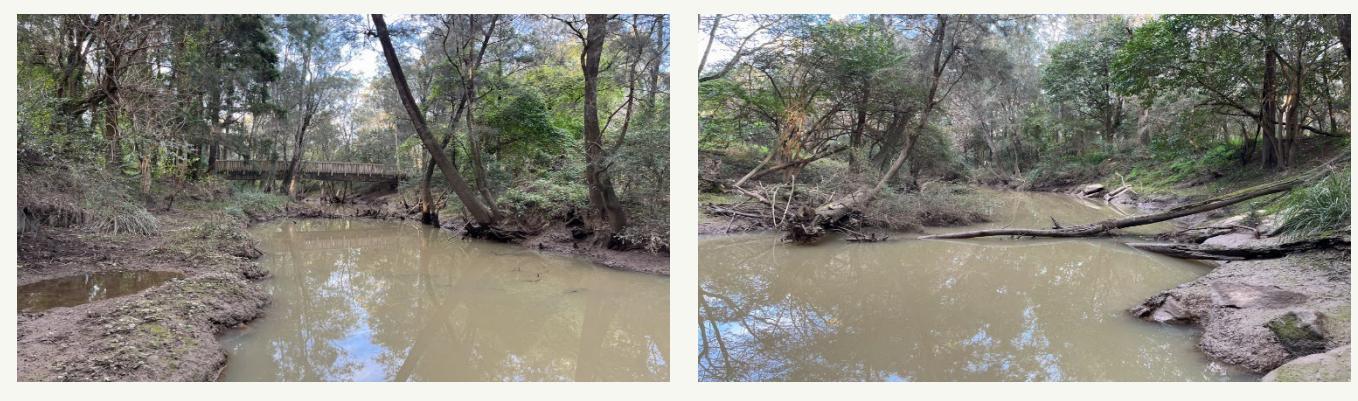
## AE 5: Eastern Creek Upstream

Category	Attribute	AE5 Upstream
Riparian	Vegetation	Dominant overstorey species was <i>C. glauca</i> . Dominant grass/herb was Lomandra ( <i>Lomandra longifolia</i> ) and groundcover <i>T. fluminensis</i> .
	Stream shading	Moderate
	Exotic vegetation	T. fluminensis
Stream	Modal width	12 m
Characteristics	Bank condition	Unstable
	Substrate	Fine sediment and large woody debris.
	Flow/depth	Low/no flow
	Macrophytes/algae	Macrophytes not present.
	Water quality observations	Visually turbid
Comments	Lots of large woody de	bris and plastic based rubbish

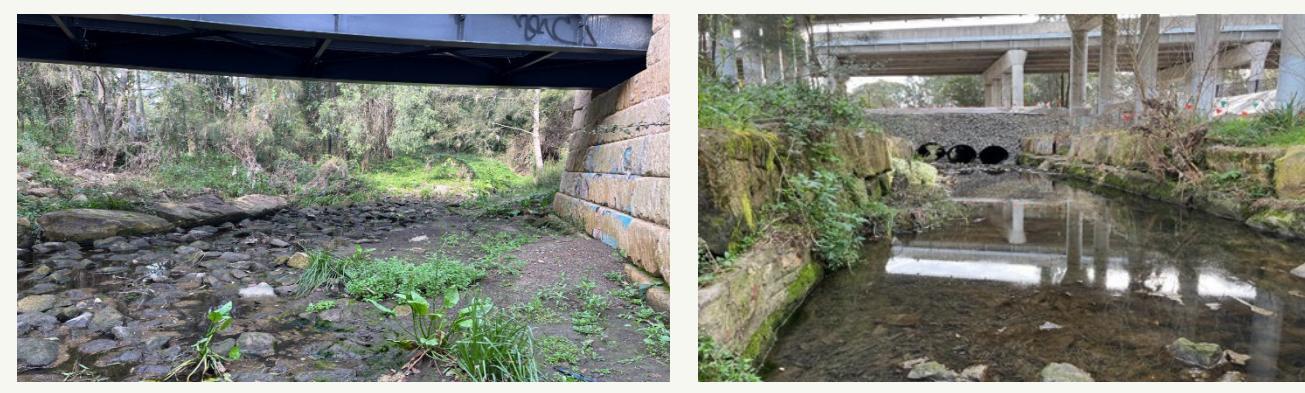
# AE 6: Angus creek Upstream

Category	Attribute	AE5 Upstream	
Riparian	Vegetation	Dominant overstorey species was <i>C. glauca</i> . Dominant grass/herb was Lomandra ( <i>L. longifolia</i> ) and groundcover <i>T. fluminensis</i> .	
	Stream shading	Moderate	
	Exotic vegetation	T. fluminensis	
Stream characteristics	Modal width	5 m	
	Bank condition	Stable, man-made.	
	Substrate	Fine sediment and cobble	
	Flow/depth	No visible flow	
	Macrophytes/algae	Macrophytes present.	
	Water quality observations	Visually clear	
Comments	Recent landscaping works have been conducted on stream edge. With major instream works including the addition of a culvert being built within the stream.

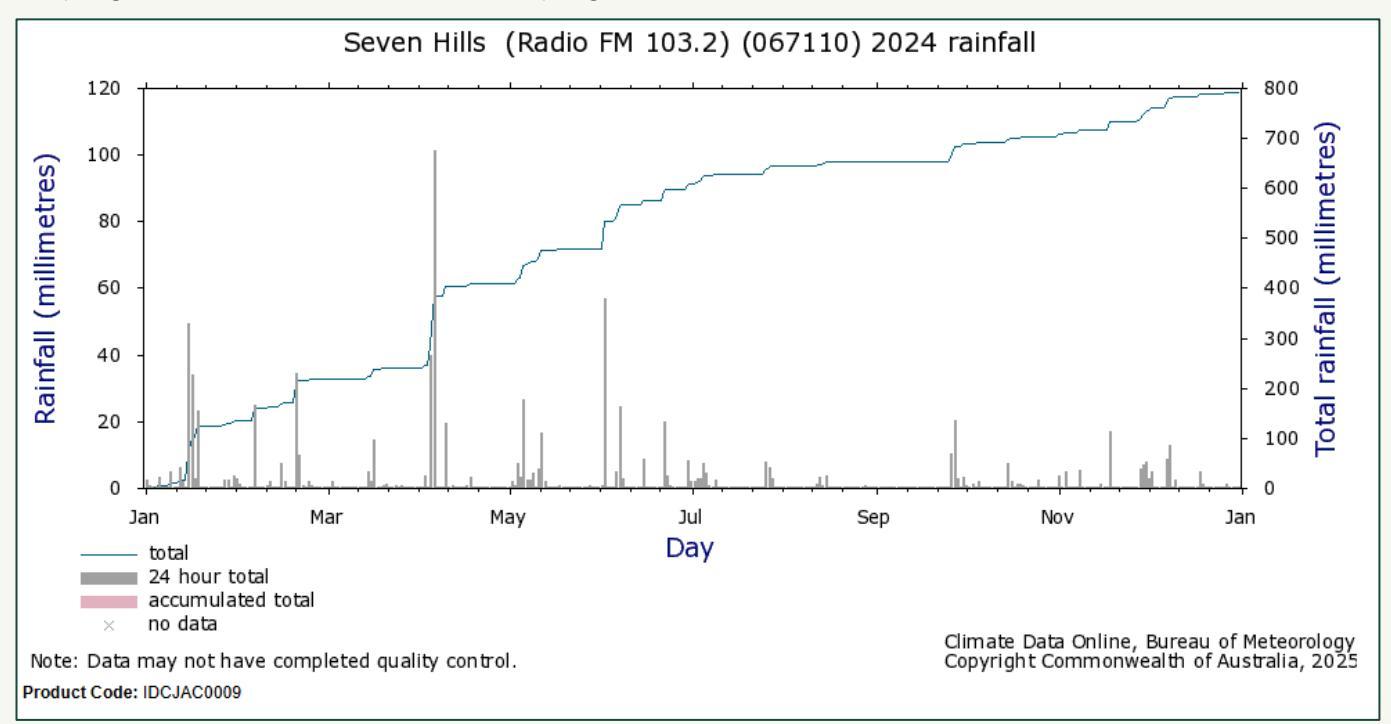
Figure 2: Rainfall January to December 2024

Antecedent rainfall from the month preceding the spring monitoring totalled 49 millimetres (mm) (Figure 2). 26 mm of rain was recorded in the week leading up to the sampling. No rain was recorded for two days before sampling. The water level at the time of sampling was low to moderate.

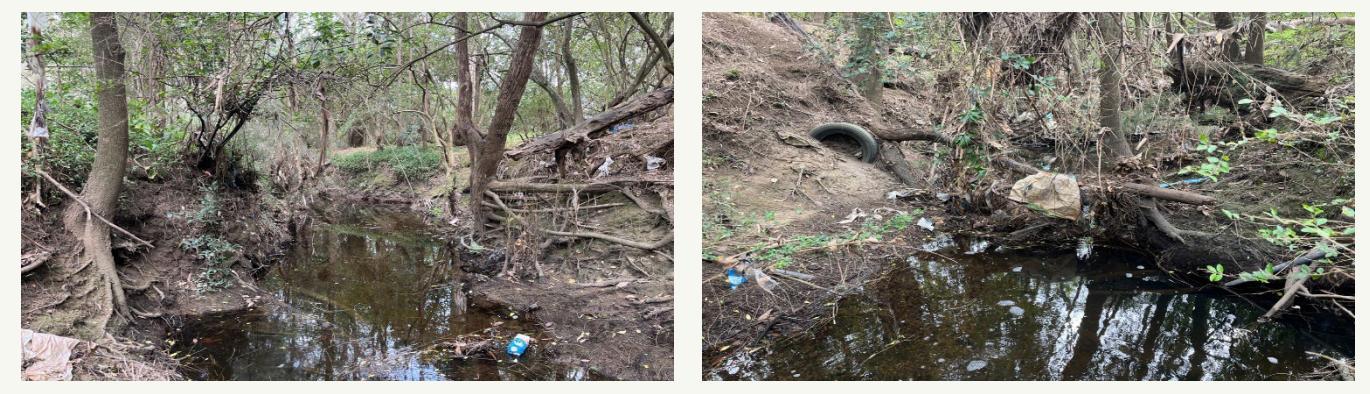
AE1: Angus Creek Upstream

Category	Attribute	AE1 Upstream	
Riparian	Vegetation	The dominant tree species comprised Swamp Oak ( <i>Casuarina glauca</i> ) and Broad-leaf Privet ( <i>Ligustrum lucidum</i> ). Groundcover was dominated by <i>Tradescantia fluminensis</i> .	
	Stream shading	Moderate shading	
	Exotic vegetation	L. lucidum and T. fluminensis	
Stream characteristics	Modal width	3 m	
	Bank condition	Slightly vegetated banks and stable. Slight erosion of lower bank.	
	Substrate	Fine sediment; silt. Hardened clay bottom.	
	Flow/depth	Moderate flow/ ~1 m	
	Macrophytes/algae	Macrophytes not present.	
	Water quality observations	Water visually clear	
Comments	Weeds and rubbish present. Lack of organic material in channel.

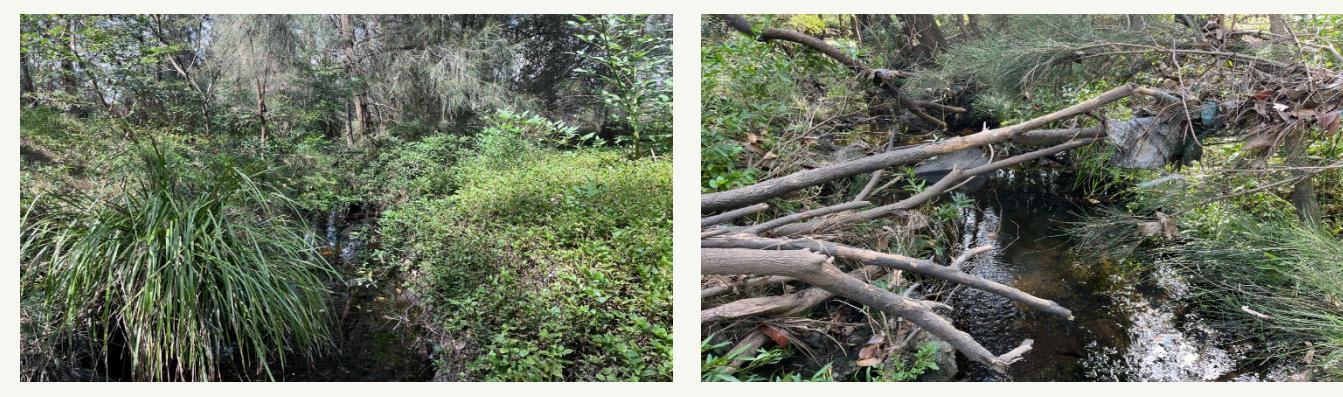
## AE2: Angus Creek

Category	Attribute	AE2 Downstream		
Riparian	Vegetation	Dominant tree species included (C. glauca). Dominant groundcover was T. fluminensis and mixture of exotic and native grasses and herbs.		
	Stream shading	Moderate shading		
	Exotic vegetation	T. fluminensis and other groundcover species.		
Stream characteristics	Modal width	2 m		
	Bank Condition	Slightly unstable and heavily vegetated by groundcover		
	Substrate	Silt and bedrock		
	Flow/depth	Moderate flow/<1 m		
	Macrophytes/algae	Emergent macrophytes present - Bulrush (Typha sp.), Cyprus sp. Potamogeton crispus		
	Water quality observations	Water visually clear.		
Comments	Weeds and rubbish. Metallic rubbish in system. Concrete rubble in system.

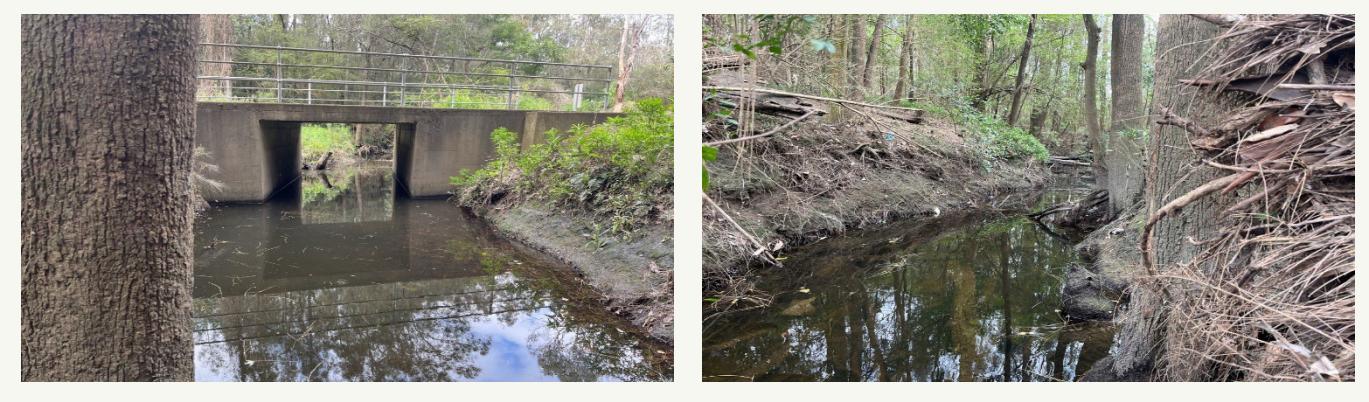
## AE3: Angus Creek Downstream

Category	Attribute	AE3 Downstream			
Riparian	Vegetation	Dominant tree species was <i>C. glauca</i> . Dominant grass/herb species was <i>T. fluminensis</i>			
	Stream shading	Moderate shading			
	Exotic vegetation	L. Lucidum, T. fluminensis			
Stream characteristics	Modal width	4 m			
	Bank Condition	Stable, steep, exposed in sections, visible erosion.			
	Substrate	Fine sediment, organic matter on banks			
	Flow/depth	Low flow/~1 metre			
	Macrophytes/algae	Ribbon Weed ( <i>Vallisneria</i> sp.)			
	Water quality Visually water appeared slightly turbid. observations				
Comments	Significant amount of erosion on banks.
