# ROOTY HILL DISTRIBUTION CENTRE

2024 Annual Review

Organisation	Holcim (Australia) Pty Ltd
Project	Rooty Hill Distribution Centre
Developmental Consent / Project Approval #	PA 05_0051
Document Title	Annual Review 2024
Document Revision	A
Author	IEMA
Project Identifier	HOL06-005
Annual review start date	1 January 2024
Annual review end date	31 December 2024

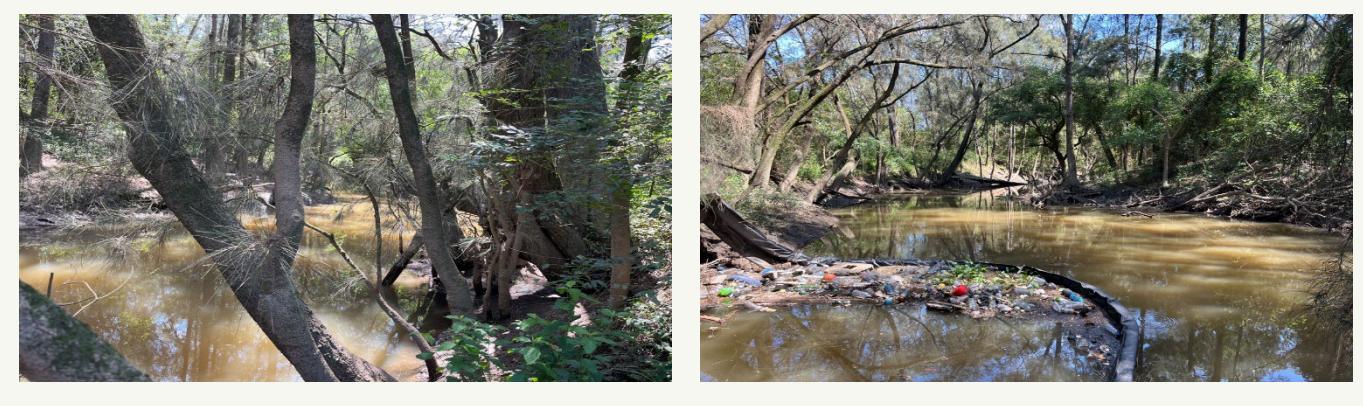
#### AE4: Eastern Creek Downstream

Category	Attribute	AE4 Downstream		
Riparian	Vegetation	Dominant canopy species included <i>C. glauca</i> and Prickly-leaved Tea Tree ( <i>Melaleuca styphelioides</i> ). Dominant mid-storey species were <i>C. glauca L. lucidum</i> . Dominant groundcover was the exotic <i>T. fluminensis</i>		
	Stream shading	Moderate		
	Exotic vegetation	. lucidum and T. fluminensis		
Stream characteristics	Modal width	8 m		
	Bank condition	Unstable banks		
	Substrate	Fine sediment		
	Flow/depth	Moderate flow/>1m		
	Macrophytes/algae	Macrophytes not present		
	Water quality observations	Visually turbid		
Comments	Significant amount of plastic based rubbish in stream

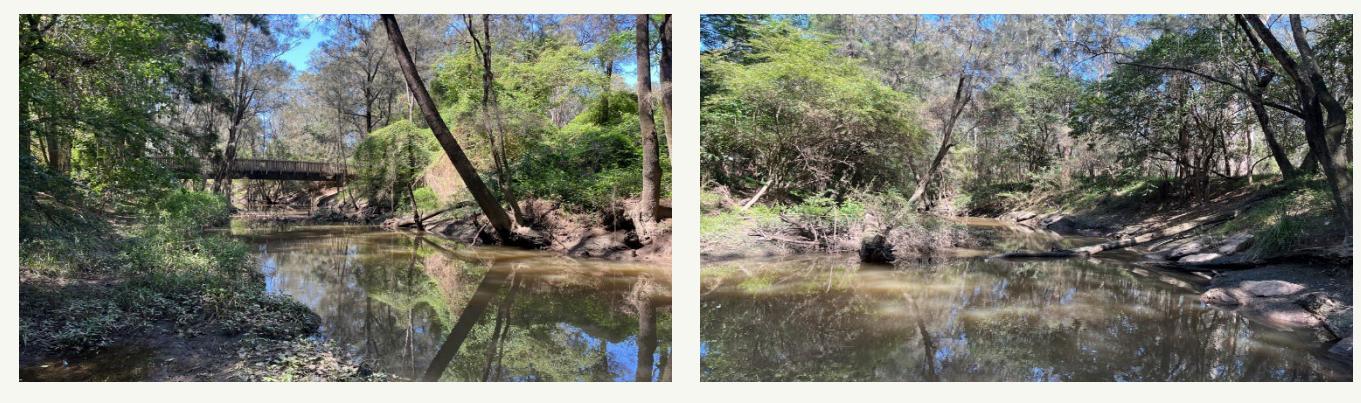
## AE 5: Eastern Creek Upstream

Category	Attribute	AE5 Upstream		
Riparian	Vegetation	Dominant overstorey species was <i>C. glauca</i> . Dominant grass/herb was Lomandra ( <i>Lomandra longifolia</i> ) and groundcover <i>T. fluminensis</i> .		
	Stream shading	Moderate		
	Exotic vegetation	T. fluminensis		
Stream characteristics	Modal width	12 m		
	Bank condition	Unstable		
	Substrate	Fine sediment and large woody debris.		
	Flow/depth	Moderate flow/ >1 m		
	Macrophytes/algae	Macrophytes not present.		
	Water quality observations	Visually turbid		
Comments	Lots of large woody debris and plastic based rubbish

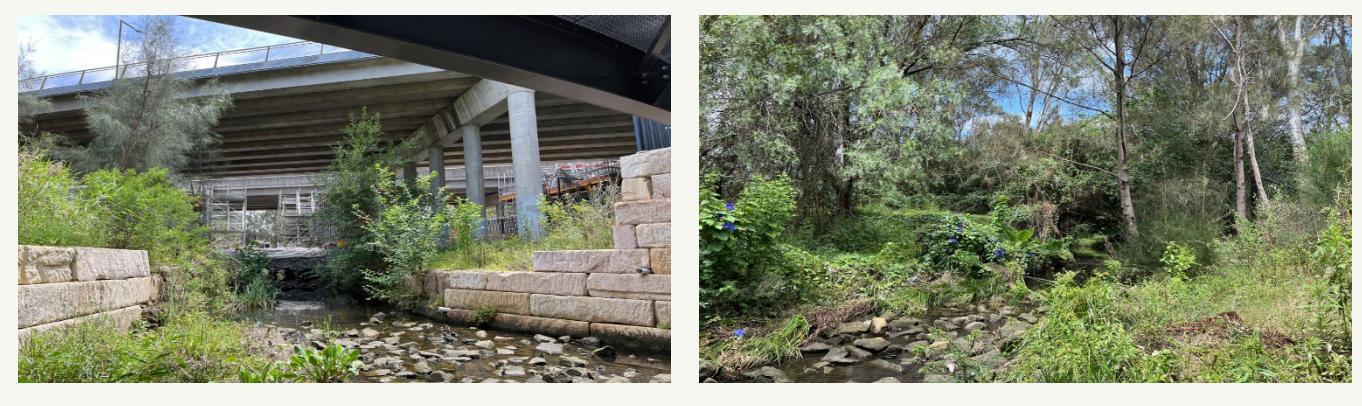
## AE 6: Angus creek Upstream

Category	Attribute	AE5 Upstream	
Riparian	Vegetation	Dominant overstorey species was <i>C. glauca</i> . Dominant grass/herb was Lomandra ( <i>Lomandra longifolia</i> ) and groundcover <i>T. fluminensis</i> .	
	Stream shading	Moderate	
	Exotic vegetation	T. fluminensis	
Stream characteristics	Modal width	5 m	
	Bank condition	Stable, man-made.	
	Substrate	Fine sediment and cobble	
	Flow/depth	Moderate flow/ >1 m	
	Macrophytes/algae	Macrophytes present.	
	Water quality observations	Visually clear	
Comments	Recent landscaping works have been conducted on stream edge.
