TEVEN QUARRY

2024 Annual Review

Organisation	Holcim (Australia) Pty Ltd
Project	Teven Quarry
Developmental consent / project approval #	SSD 6422
Document Title	Annual Review 2024
Document Revision	Α
Author	IEMA
Project Identifier	HOL04-005
Annual review start date	1 January 2024
Annual review end date	31 December 2024

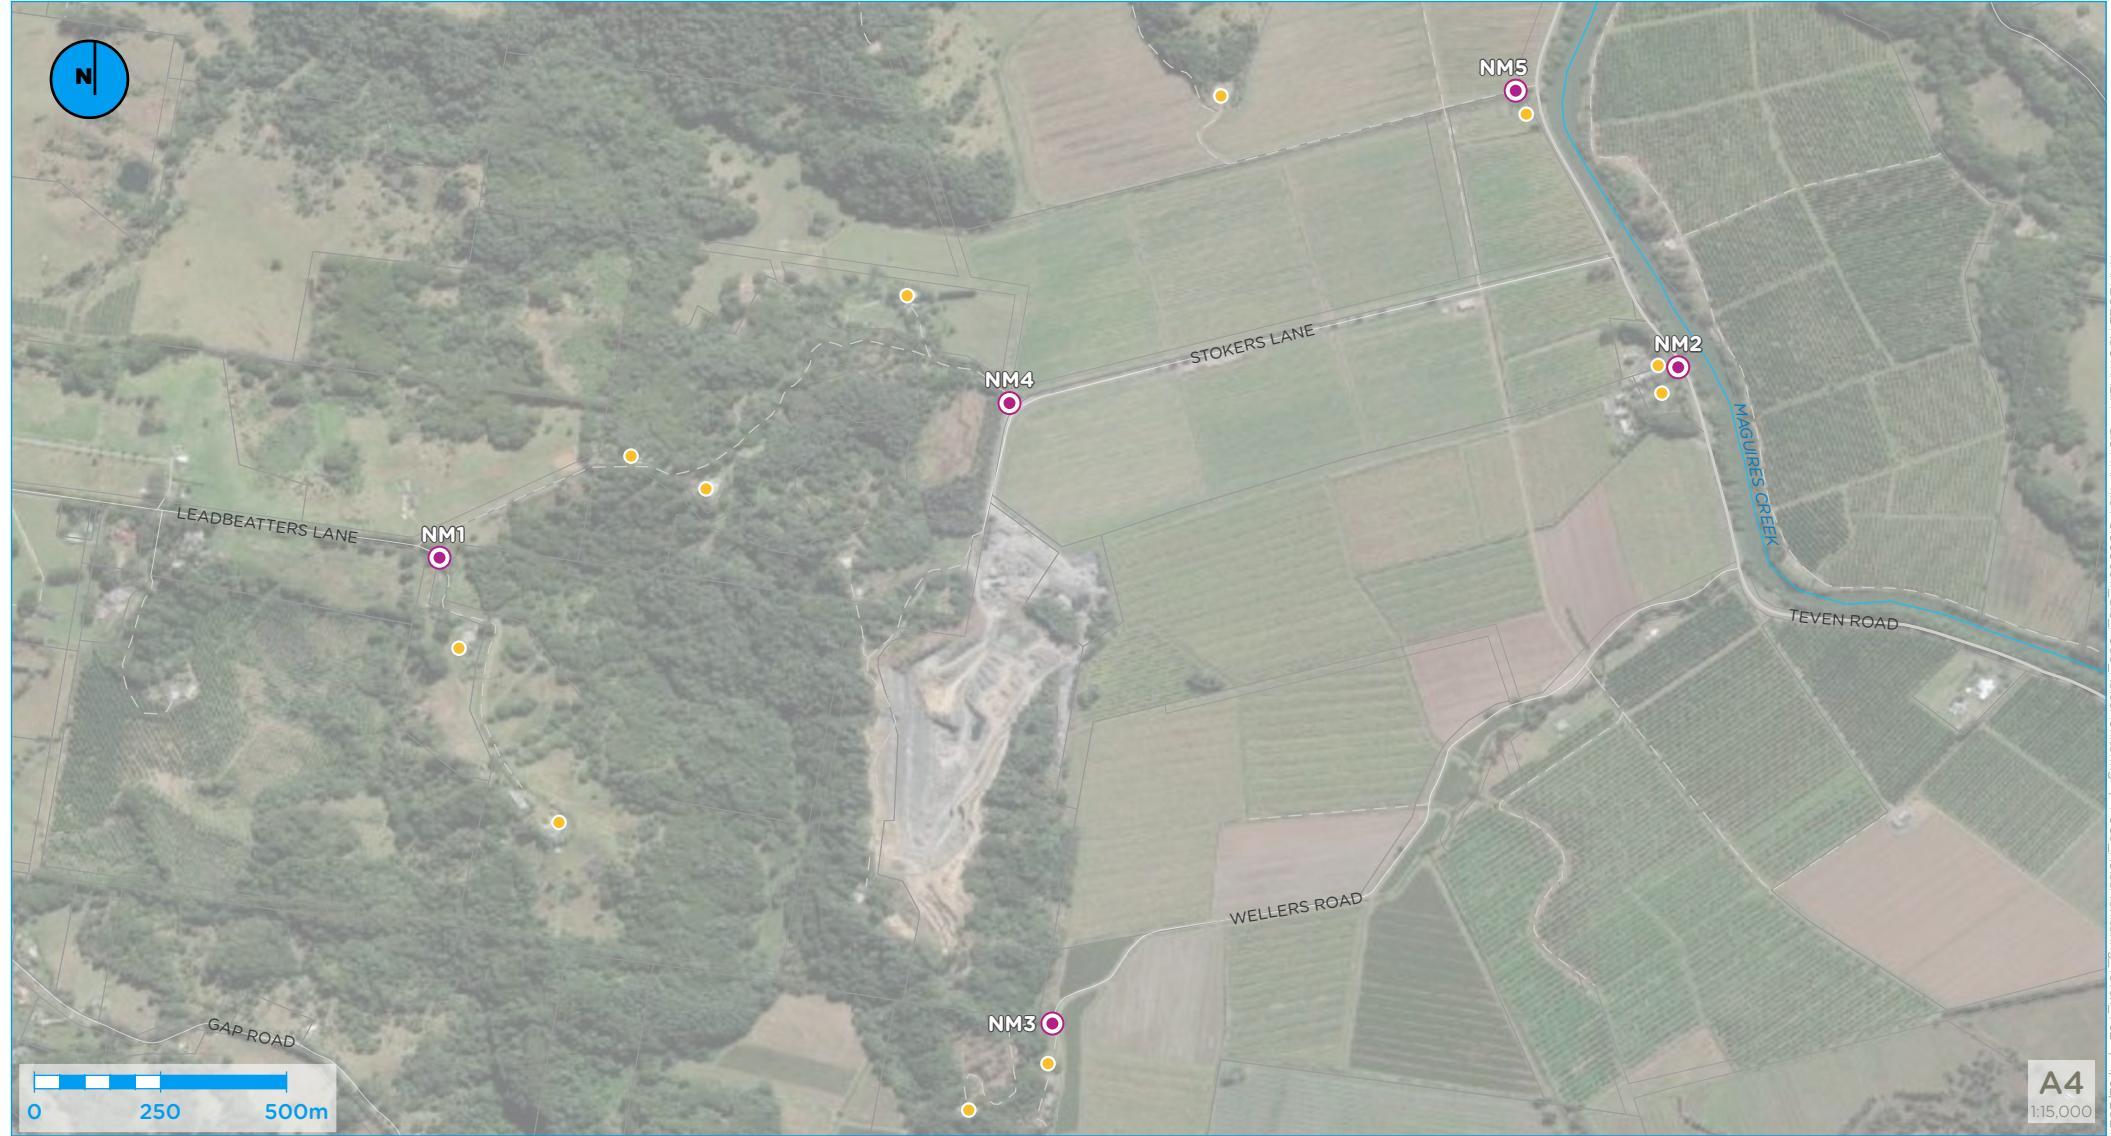
The monitoring locations with respect to the quarry and assessed receivers are presented in the locality plan shown in **Figure 1**.

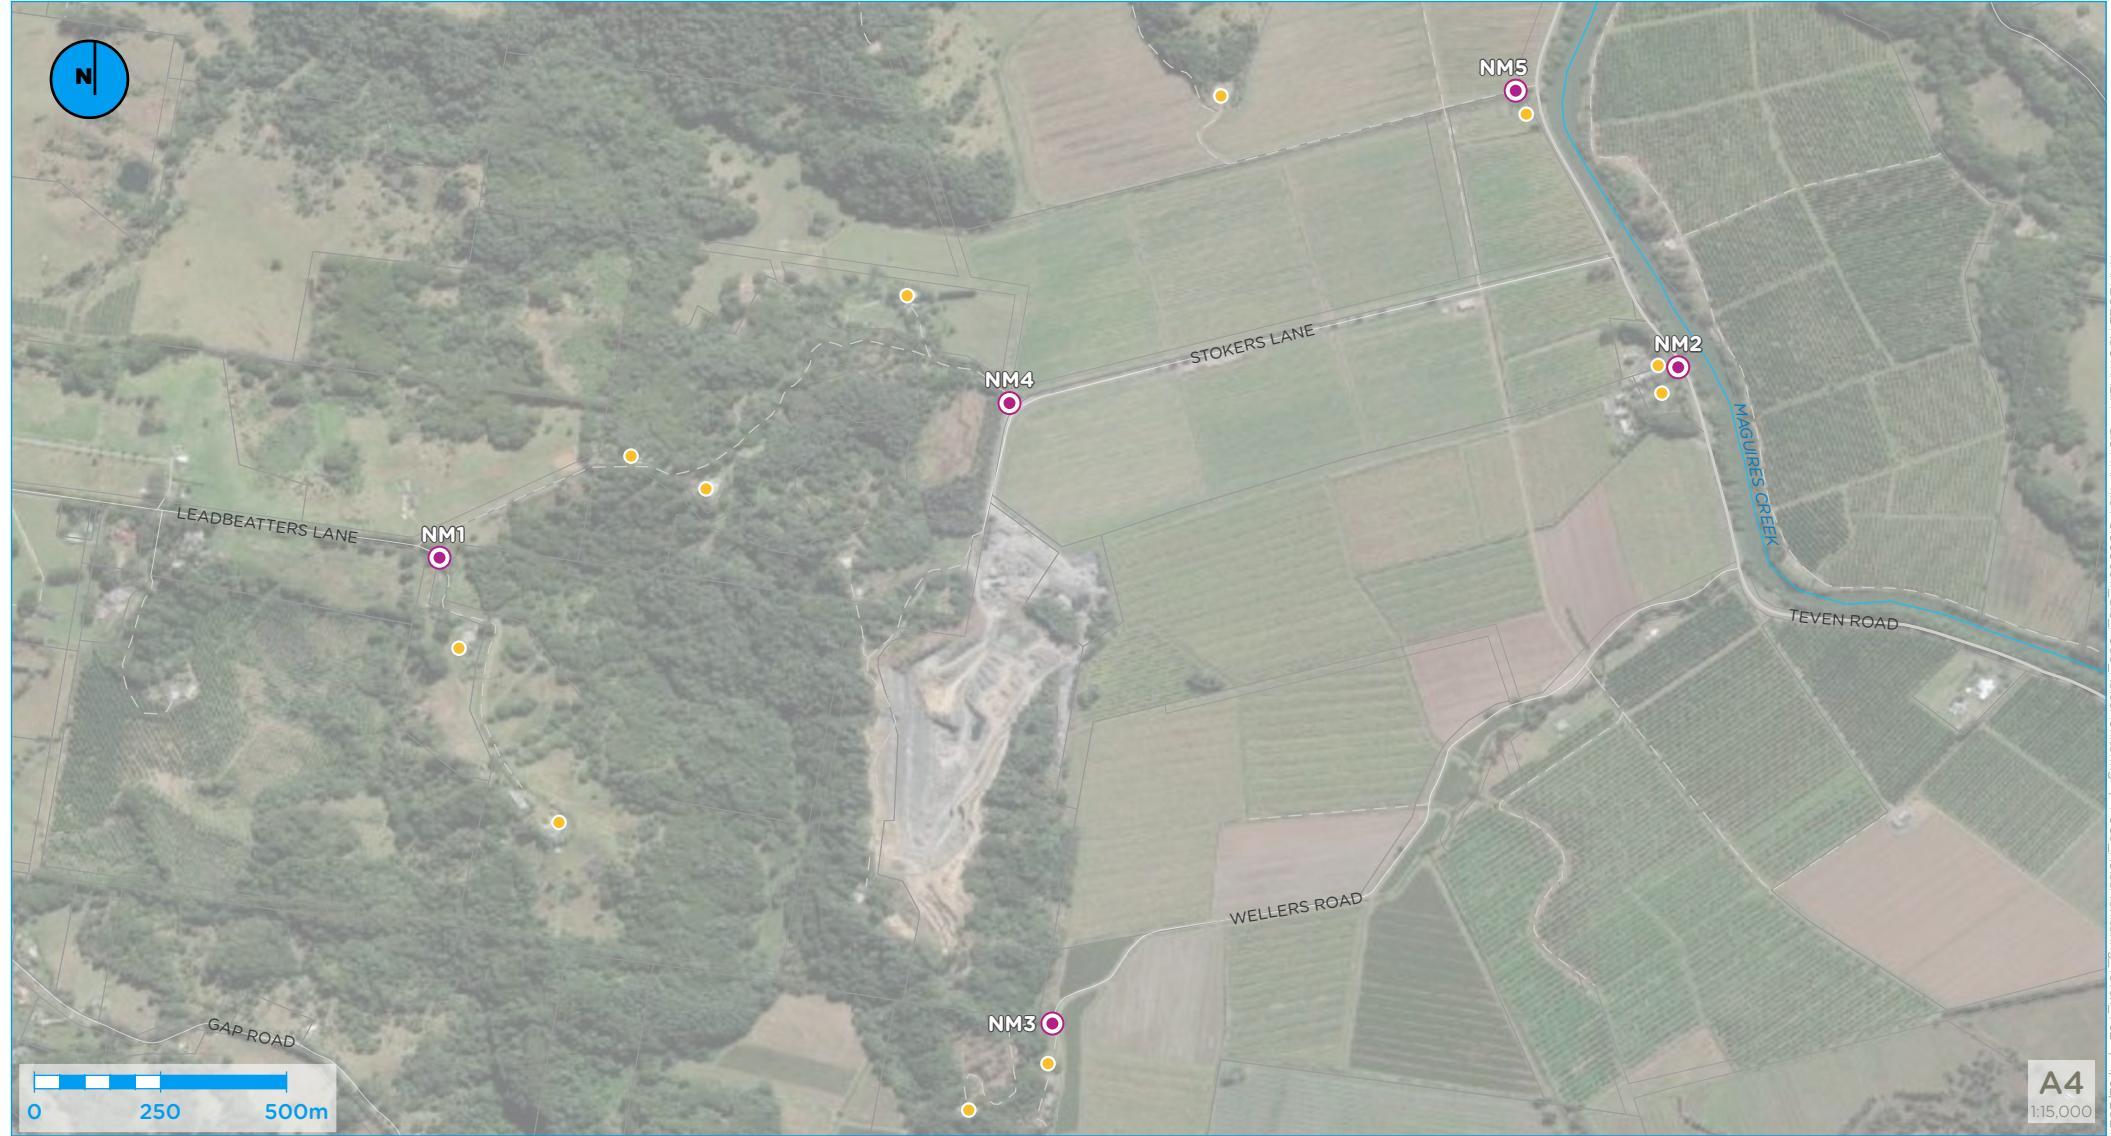
The monitoring locations with respect to the quarry and assessed receivers are presented in the locality plan shown in **Figure 1**.

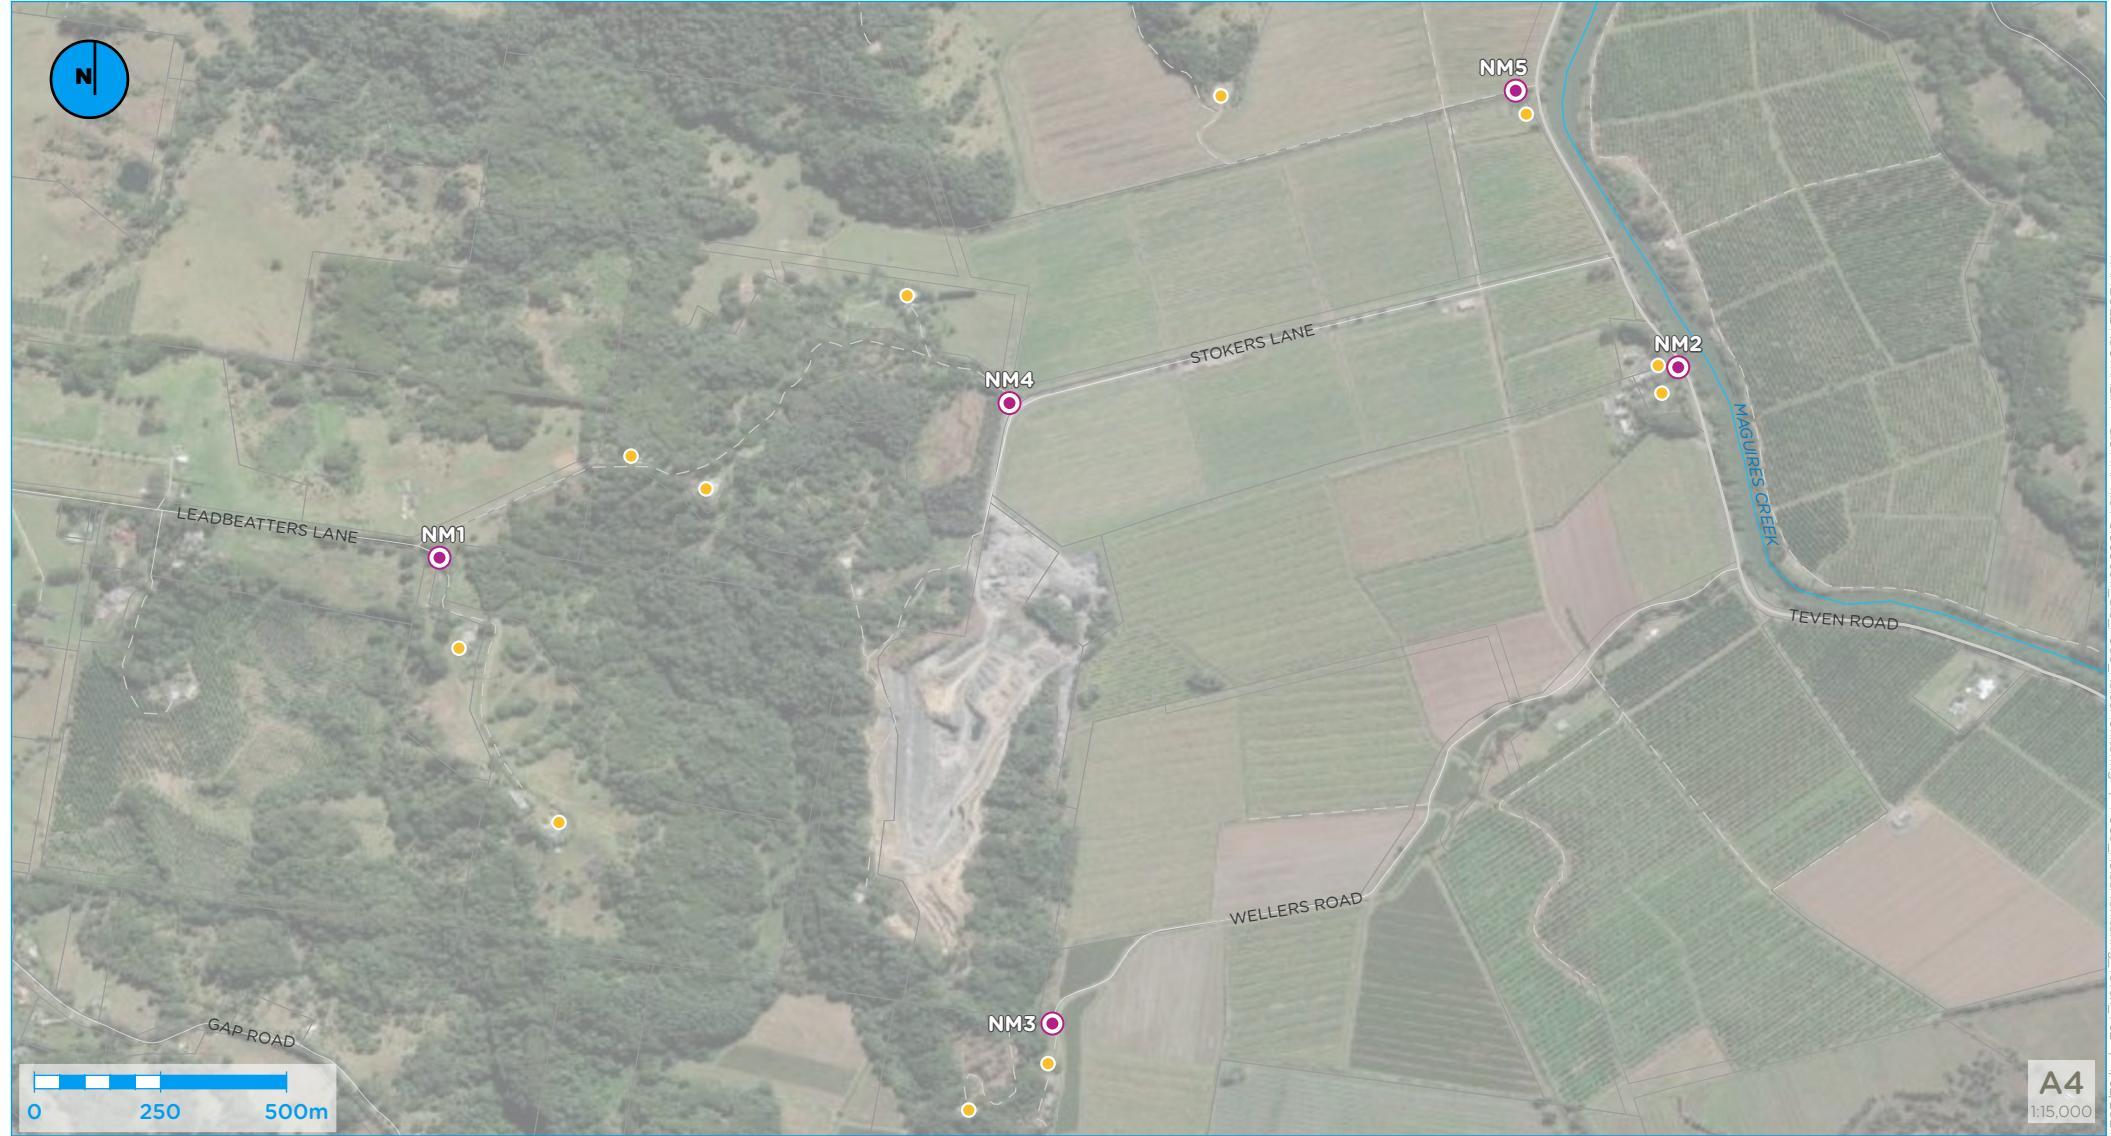
The monitoring locations with respect to the quarry and assessed receivers are presented in the locality plan shown in **Figure 1**.

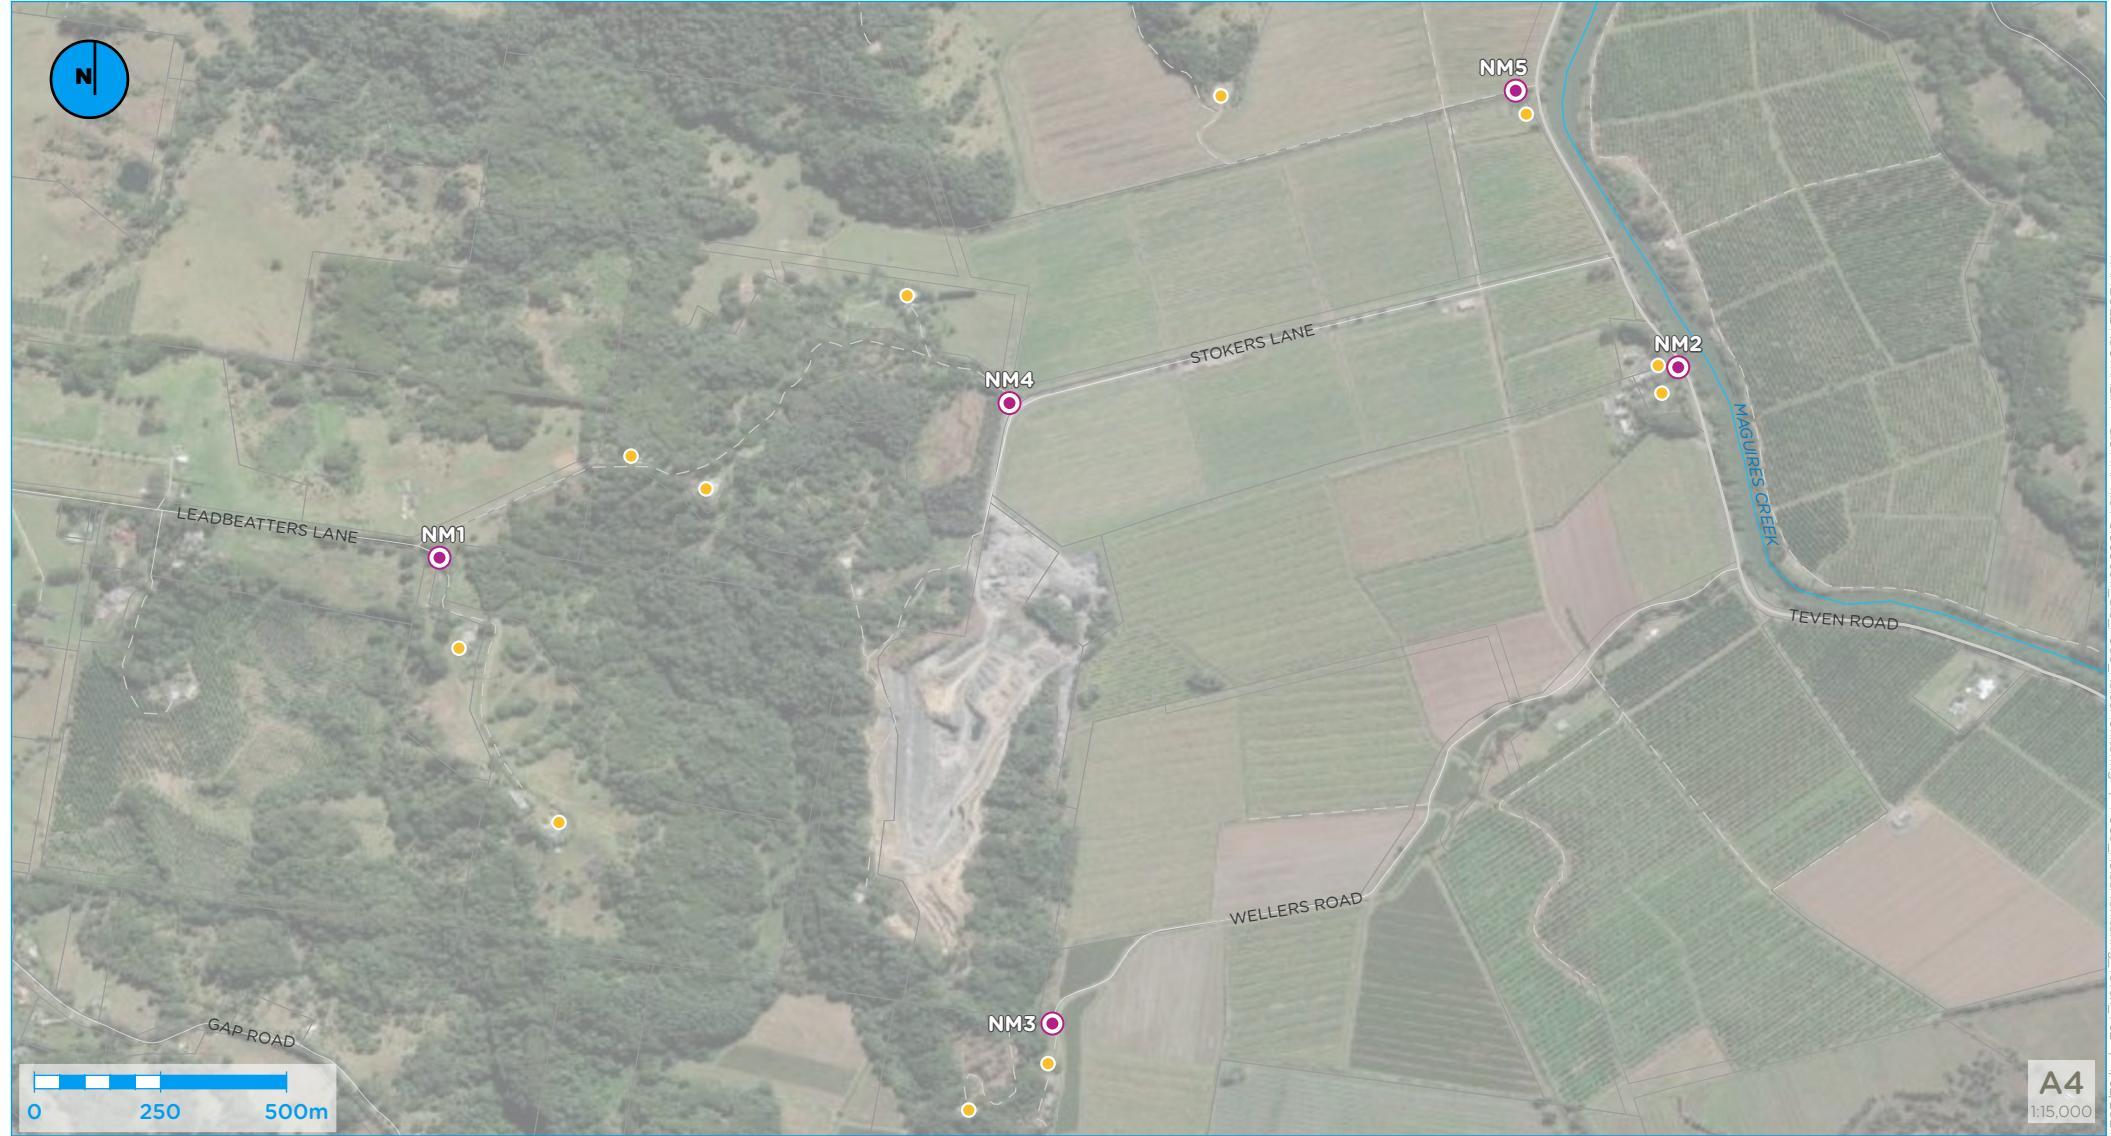
The monitoring locations with respect to the quarry and assessed receivers are presented in the locality plan shown in **Figure 1**.

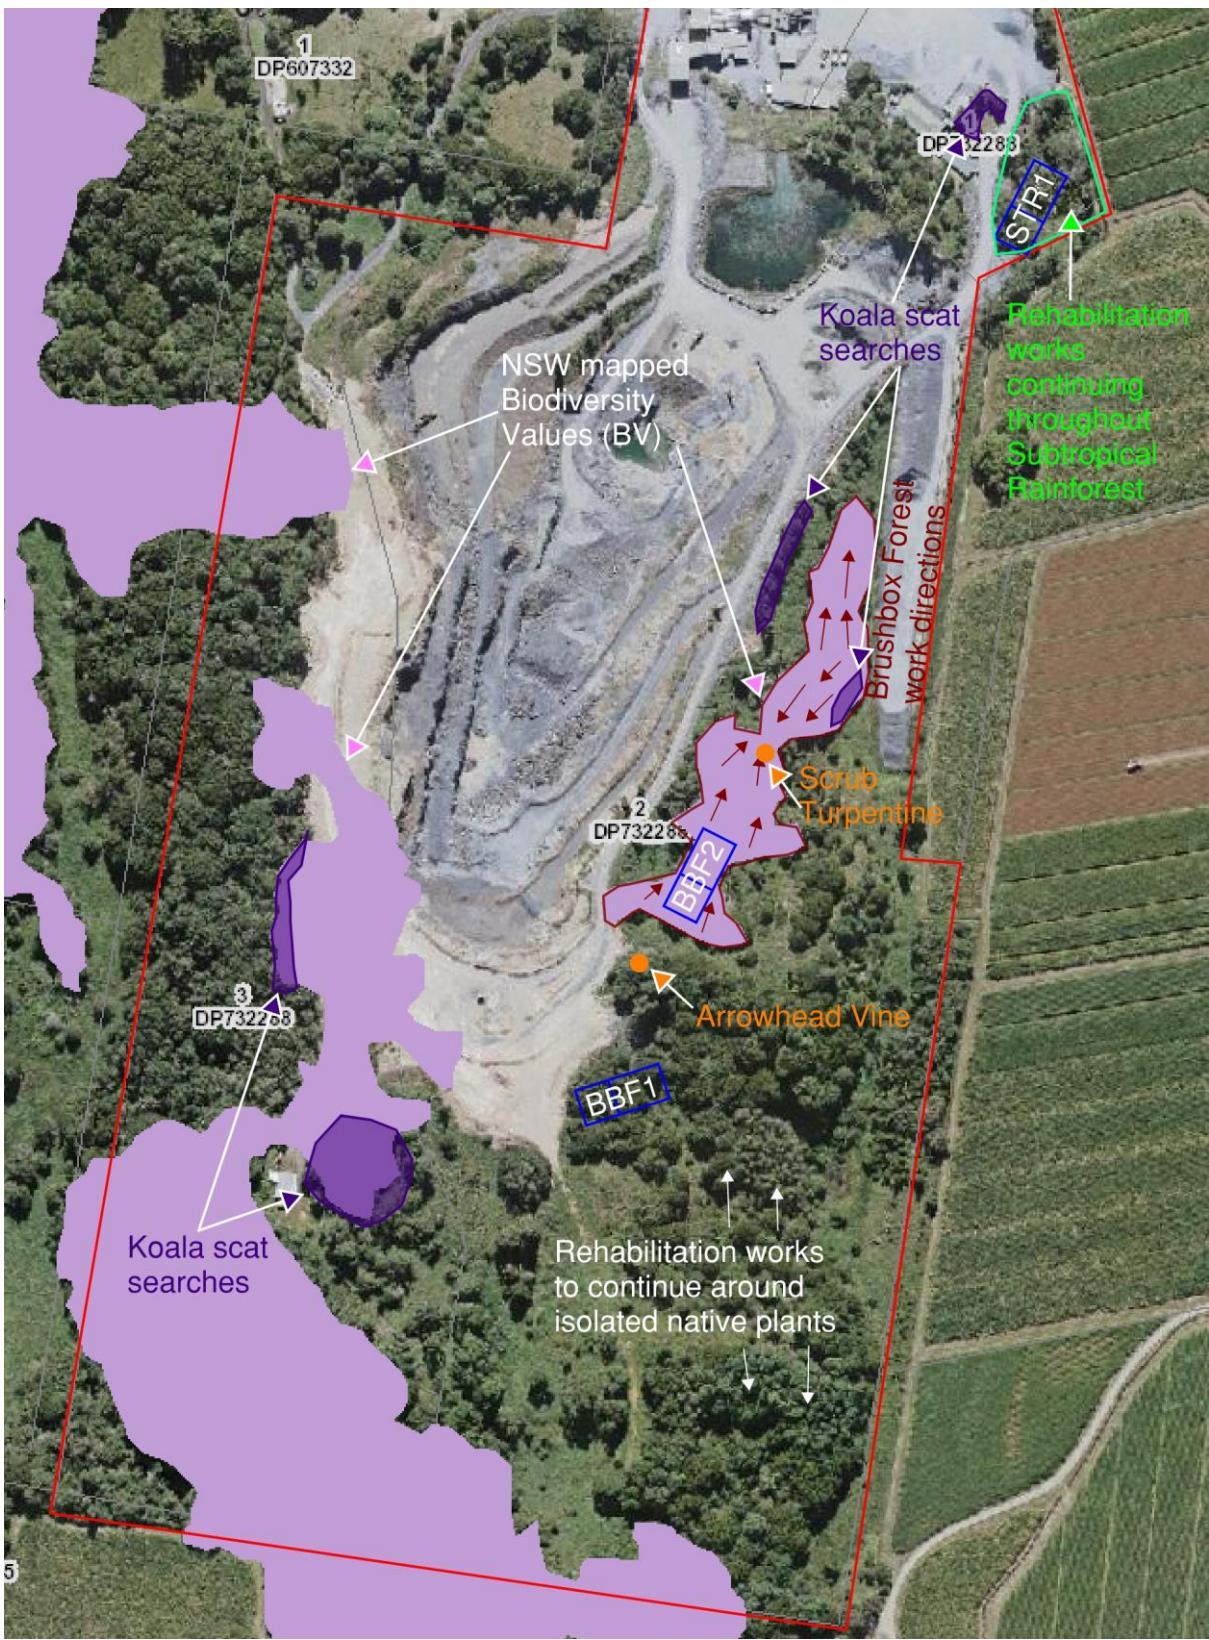
Figure 1. Locations of priority work zones; vegetation monitoring plots; environmentally sensitive features detected; NSW mapped Biodiversity Values; and Koala scat search locations.
