Noise Monitoring Assessment

Teven Quarry, Teven, NSW
Quarter 2 Ending June 2022

Prepared for: Holcim (Australia) Pty Ltd

Prepared by: Muller Acoustic Consulting Pty Ltd

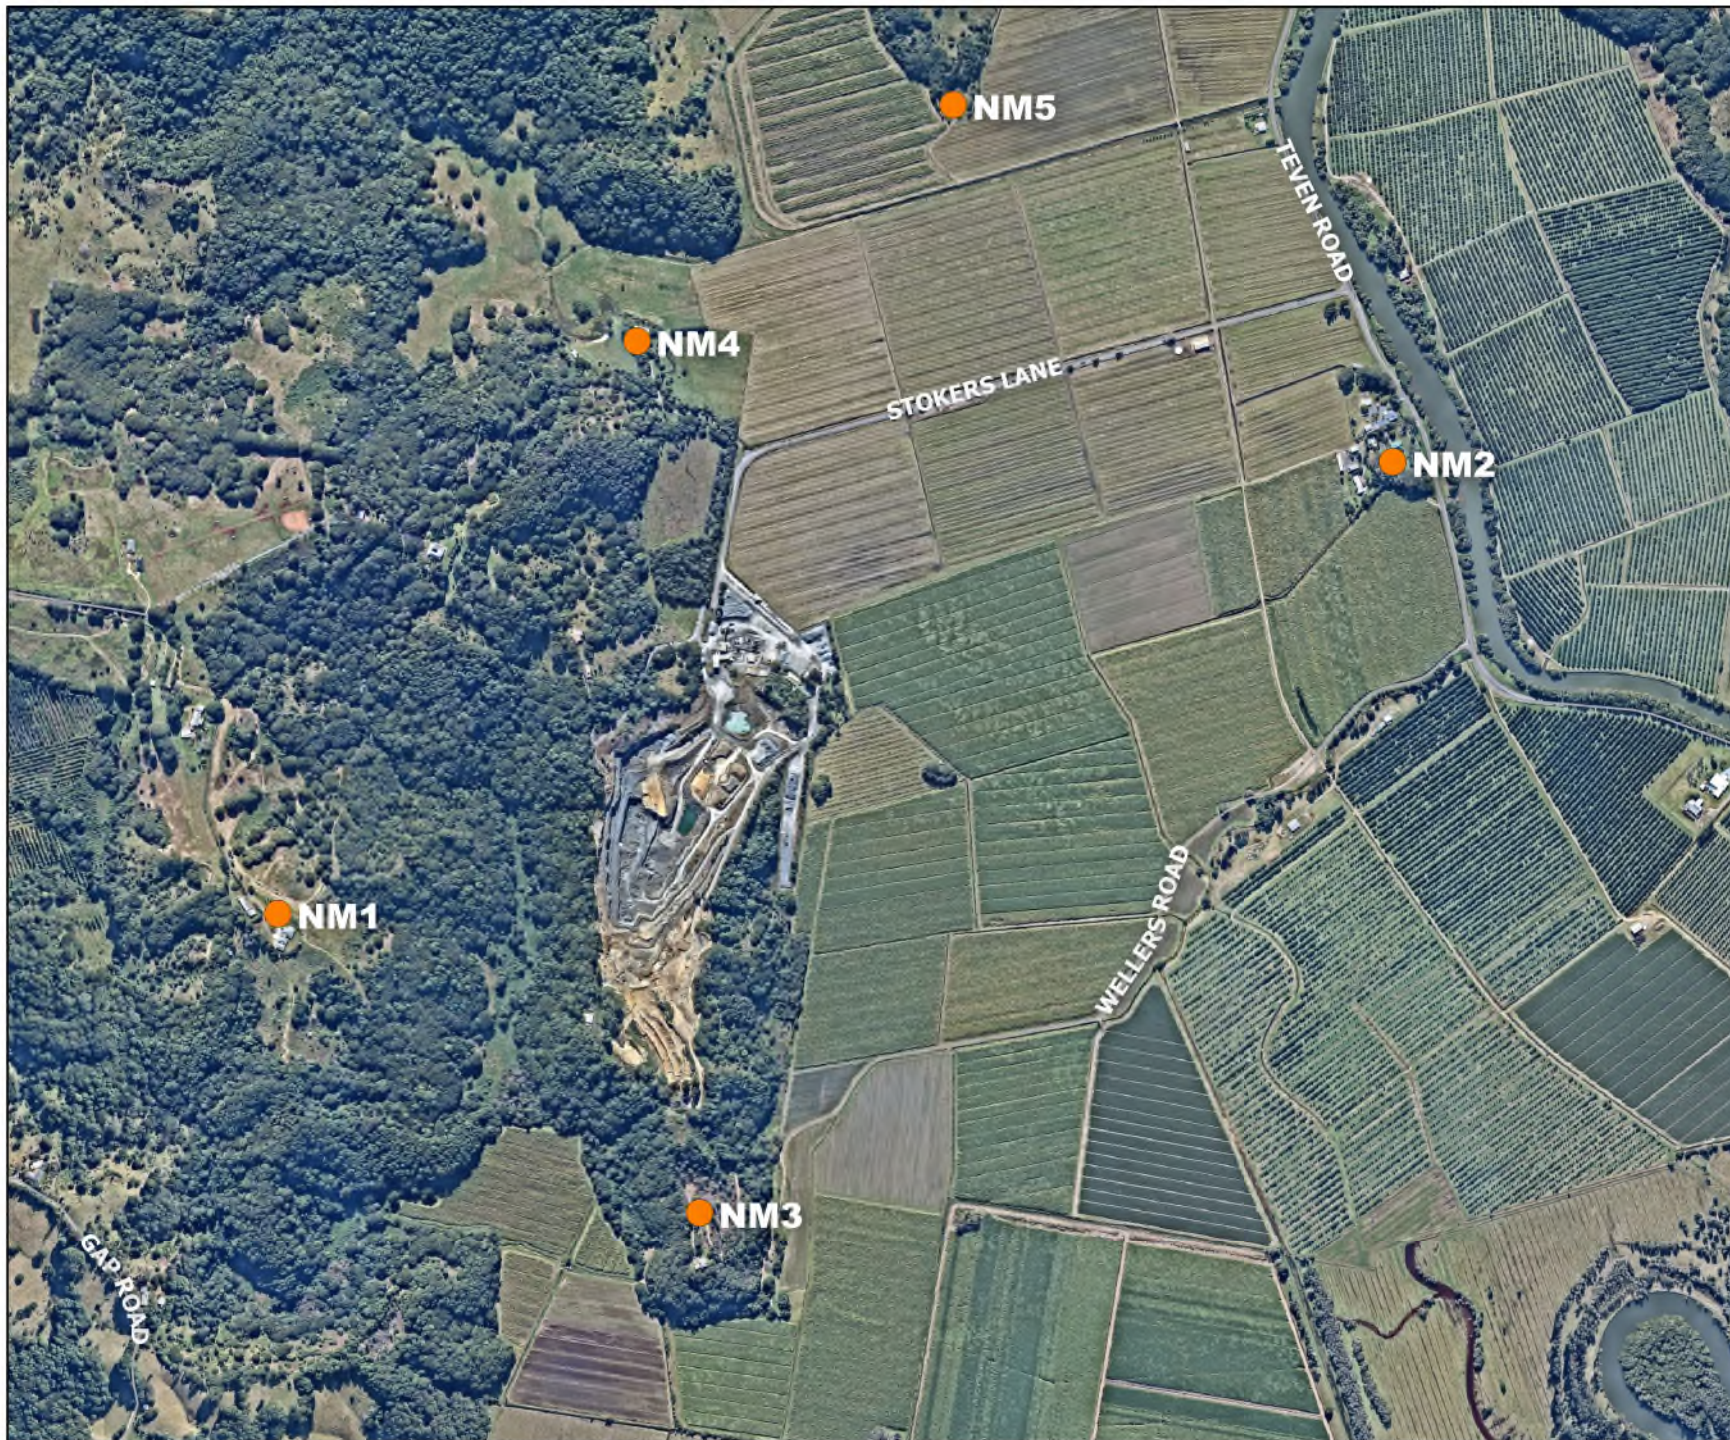
FIGURE 1
Site Locality
MAC180611-06
Holcim Teven Quarry

The quarry is located in Teven, NSW approximately 7km west of Ballina, NSW. Receivers in the locality surrounding the quarry are primarily rural residential. The surroundings of the quarry are primarily rural. The monitoring locations with respect to the quarry are presented in the locality plan shown in **Figure 1**.

Five monitoring locations have been selected as part of the NMA in accordance with the NMP. The selected monitoring locations are presented in **Table 2** along with the noise sensitive receivers they represent.

Table 2 Monitoring Locations (MGA56 Coordinates)			
Location	Nearest Receiver	Easting, m	Northing, m
NM1	R7	546737	6809918
NM2	R3/R4	548892	6810285
NM3	R2	547781	6808991
NM4	R10	547576	6810379
NM5	R14	548100	6810792

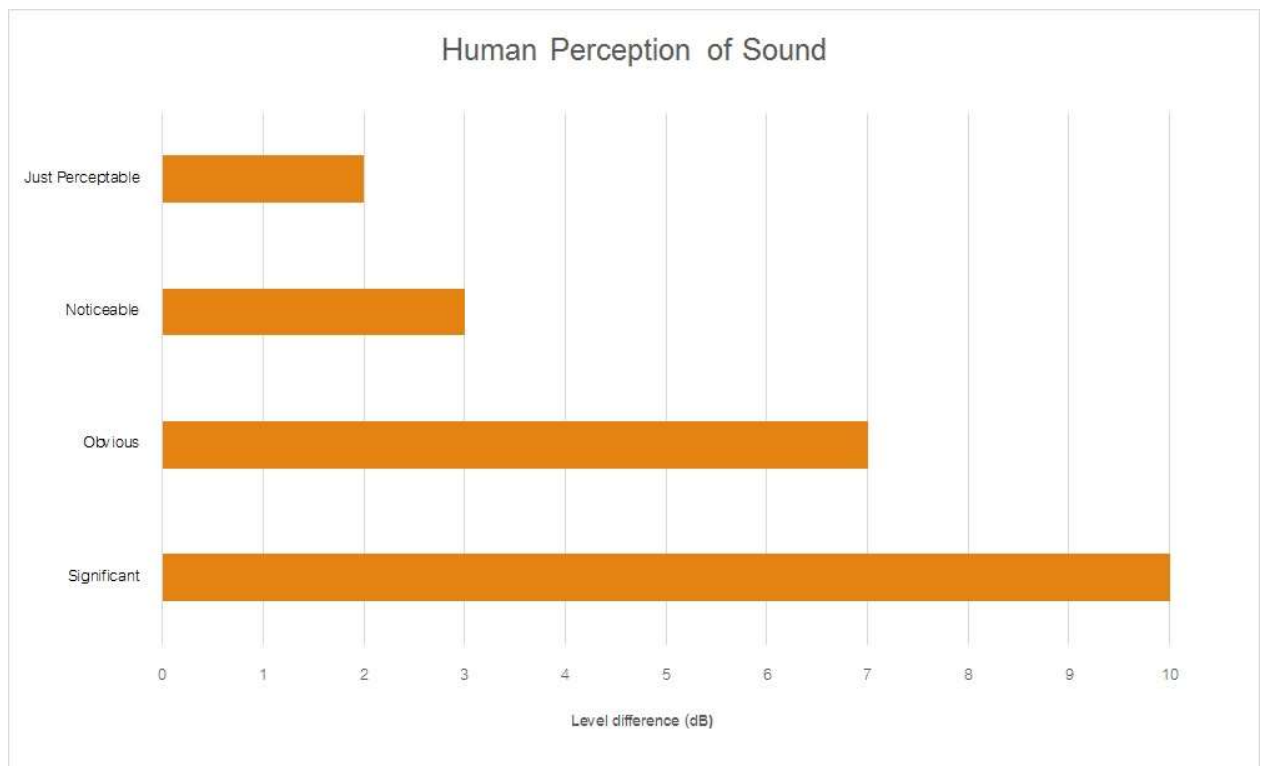
Figure A1 – Human Perception of Sound

Table A2 provides a list of common noise sources and their typical sound level.

Table A2 Common Noise Sources and Their Typical Sound Pressure Levels (SPL), dBA	
Source	Typical Sound Level
Threshold of pain	140
Jet engine	130
Hydraulic hammer	120
Chainsaw	110
Industrial workshop	100
Lawn-mower (operator position)	90
Heavy traffic (footpath)	80
Elevated speech	70
Typical conversation	60
Ambient suburban environment	40
Ambient rural environment	30
Bedroom (night with windows closed)	20
Threshold of hearing	0
