QUARTERLY NOISE MONITORING ASSESSMENT – QUARTER 4 2022 COOMA ROAD QUARRY, GOOGONG, NSW

Project name	Quarterly Noise Monitoring Assessment for Cooma Road Quarry – Quarter 4
	2022
Project no.	318000911
Recipient	David Manning
Document type	Report
Version	1
Date	24/01/2023
Prepared by	Jake Bourke, Nathalie Tomson
Checked by	Patrick Murray
Approved by	Greer Laing
Description	Data collected on 7 and 8 December 2022 for the quarterly period ending
	December 2022 at Googong, NSW, as part of the noise monitoring program

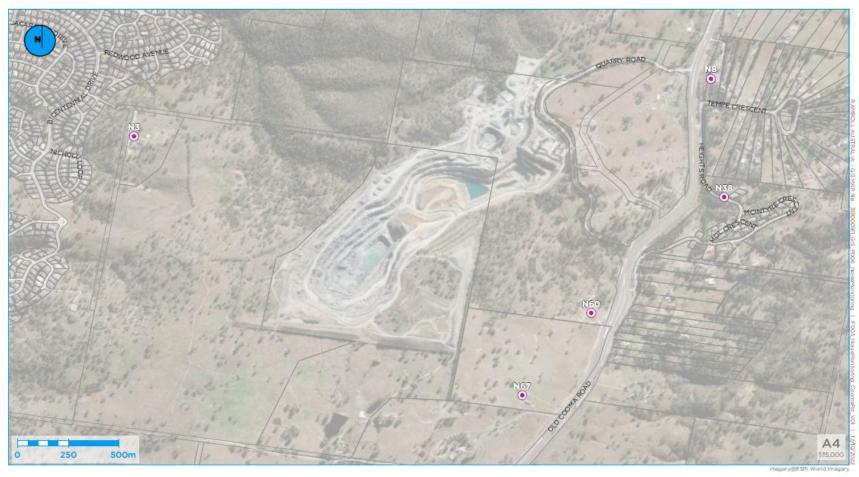
Figure 1: Noise monitoring locations at Cooma Road Quarry

The monitoring locations with respect to the quarry and assessed receivers are presented in the locality plan shown in **Figure 1**.
