2025 Quarterly Report

Mt Shamrock
Environmental Management Plan
3 Monthly Progress Update

Prepared for Mt Shamrock Quarry Environmental Review Committee

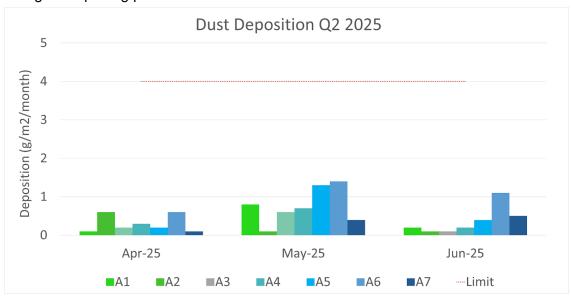
Figure 2 - Dust Deposition Q2 2025. (Limit 4.0g/m2/mth)

Dust depositional results have been graphed below for the reporting period. No exceedances during the reporting period.

Deposition results presented are Ash analysis test, rather than Total Solids, representing true mineral dust deposition generated by quarry activities.

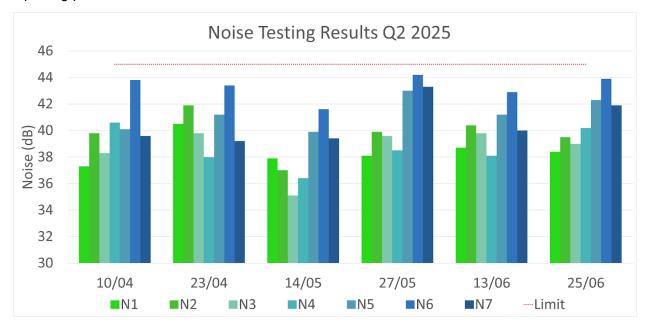
Figure 3 - Noise Testing Results Q2 2025. (Limit is 45dB under normal operating conditions)

Average noise levels for the 2nd Quarter 2025 are shown below. No exceedances during the reporting period.

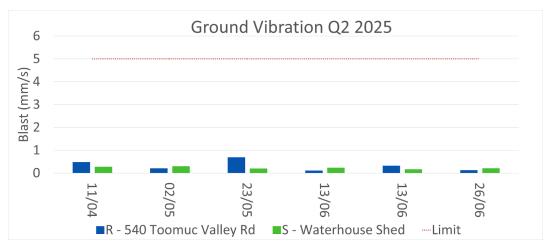
Figure 4 - Blasting; Ground Vibration Results Q22025 (Limit is 5mm/s for 95% of blasts in a 12 month period).

No ground vibration exceedances during the reporting period. 2 blasts on the 13th June.

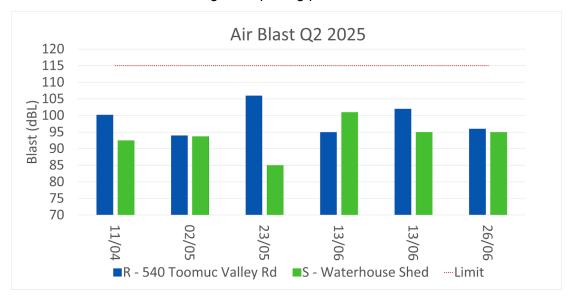
Figure 5 - Blasting; Air Blast Results Q2 2025 (Limit is 115 dBL for 95% of blasts in a 12 month period)

No air blast exceedances during the reporting period. 2 blasts on the 13th June.

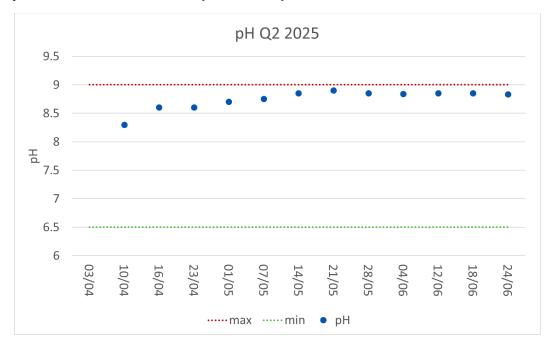
Figure 6 - Discharge Water pH results Q2 2025

pH – A measure of the Acidity or Alkalinity of the water limit 6.5 to 9.0.

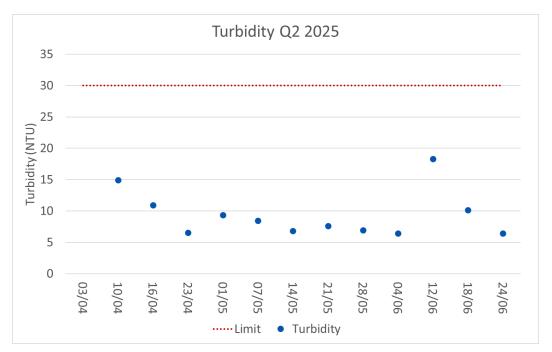
Figure 7 - Discharge Water Turbidity results Q2 2025

Turbidity – Clarity of water Maximum 30NTU.

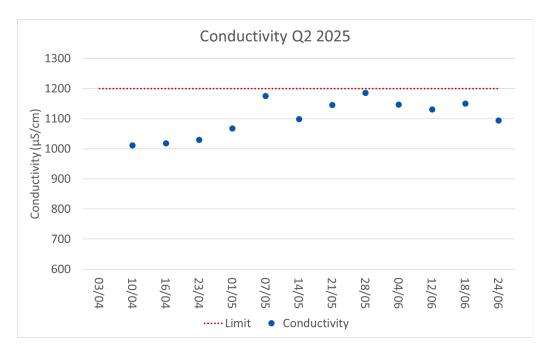
Figure 8 - Discharge Water Conductivity results Q2 2025

Conductivity – A measure of the water's capability to pass electrical current. Limit 1200µS.

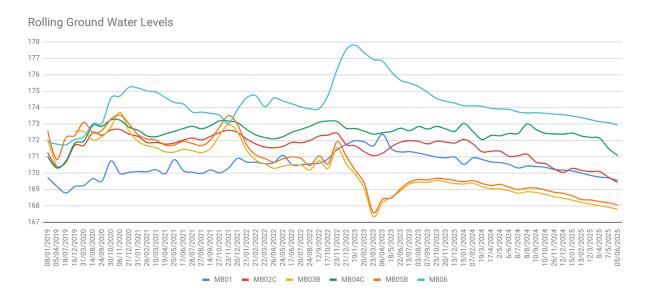
Figure 9 - Groundwater levels 2019 to present.

Bore Water Measurements

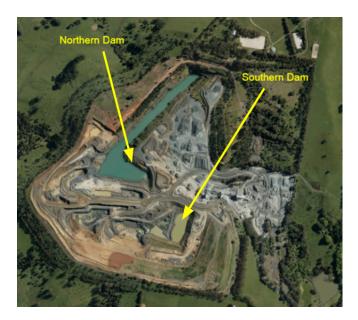
Figure 10 - In Pit Water Identification

In 2020, Holcim committed to begin and report the in pit water dam levels quarterly, to aid in the annual beneficial use analysis. This was formed as part of the revised EMP submission. Location and naming conventions are shown in the map for reference. All measurements are in RL's (the same unit as ground water levels)
