**2024  
Rehabilitation  
Report**

**Holcim Quarry  
Mt Shamrock**

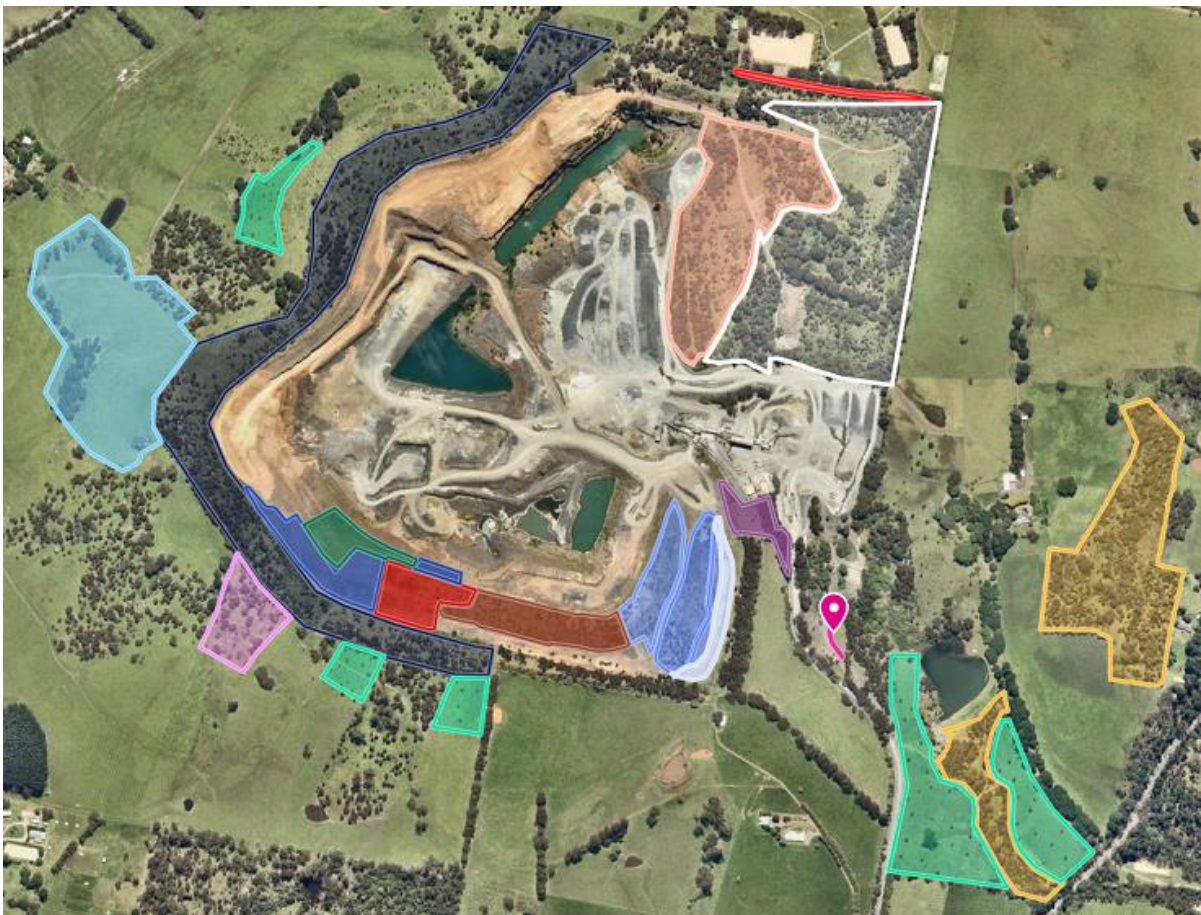
**Figure 1:** Scope of report and individual sites at Holcim Mt Shamrock Quarry.

Works were undertaken in the following areas depicted in Figure 1:

- Net Gain (Yellow)
- Phase C (White)
- South-East Extraction Backslope (Cream)
- 0.8 Hectare (Dark Red)
- 2023 Planting Area (Dark Green)
- Landslip (Pink)
- Southern Hillside (Purple)
- Chilean Needle Grass Monitoring & Control (Sky Blue)
- Extraction (Peach)
- South-East Extraction (Blue)
- Southern Extraction (Brown)
- 1.2 Hectare (Dark Blue)
- Phase A&B (Ash)
- Paddock Replacement (Turquoise)
- Northern Boundary (Bright Red)
- Lower Car Park (Hot Pink Marker)

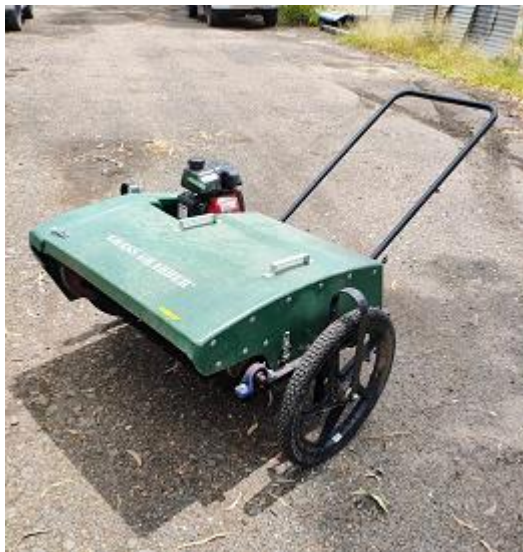
**Picture 1.** Grass Grabber, a manually propelled seed harvester

When harvesting areas with viable weed seed are to be avoided where possible. Harvesting should occur when the maximum amount of native grass seed is ripe and easily dislodged. This should ideally be done in dry conditions when machinery performs best and unnecessary volumes of native grass thatch that can get caught in moving parts of the harvester in damp conditions can be avoided.

Even when dry freshly harvested native grass seed will still contain enough moisture that seed will need to be spread out and allowed to fully dry to avoid rot. This will usually take one to two weeks. Seed can then be re-bagged and stored in a secure dry location protected from insects and rodents until use.

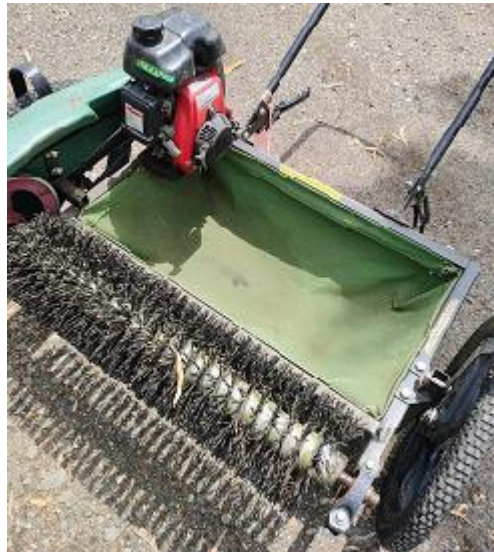
**Picture 2.** Grass Grabber, showing canvas collection bag and brush head

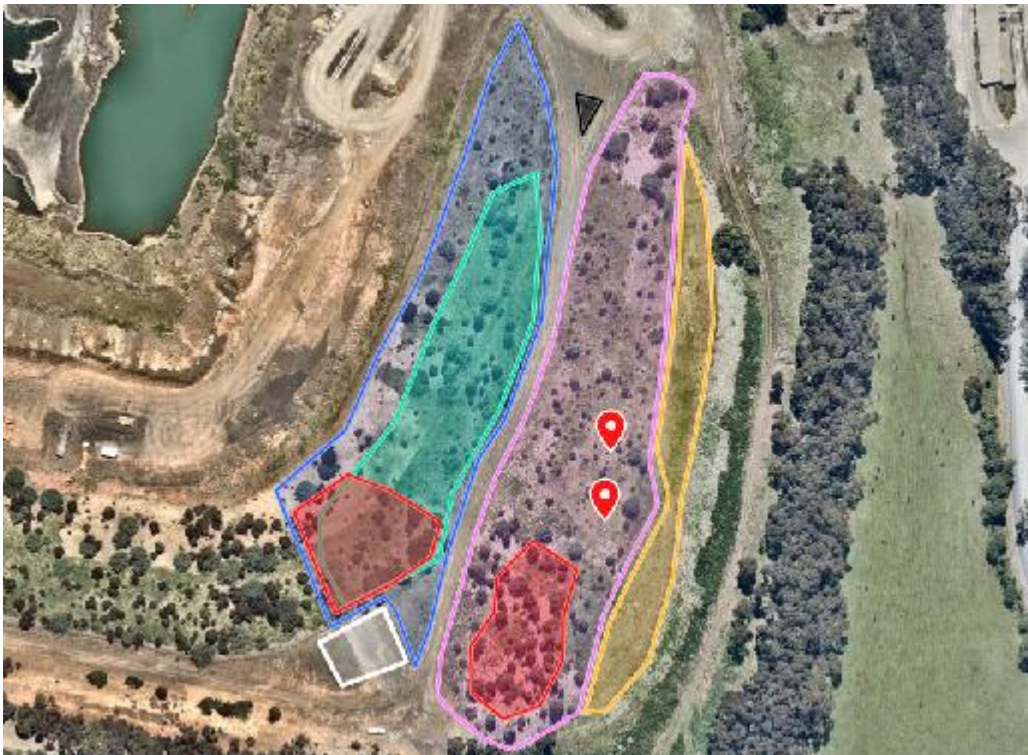
South-East extraction is split into three sections depicted in Figure 2; Bottom Half (blue), Top Half (pink) and Ridgeline (yellow). This area contains some of the driest sections in the quarry, namely Top Half (north and east), Bottom Half (northern end near Boot Hold Point) and Ridgeline (all parts). This was the second area of the quarry to be direct seeded and planted by Naturelinks after Extraction.

**Figure 2:** South East Extraction. Bottom Half (blue), Top Half (pink), Ridgeline (yellow), Boot hold point (black), Viewing platform (white), Scattered Chilean Needle Grass infestations (turquoise), individual Chilean Needle Grass clusters (red marker), Area of greatest tree coverage and canopy (red)

Survival of tree and shrub plantings along the Ridgeline past the first year of their planting has only been modest. Here collision with guards by kangaroos is probably the highest amongst all sites causing many plants main stem to snap and the plant to die. Grazing by rabbits adds some further pressure to trees and shrubs (species depending) following guard dislodgment from Kangaroos. Additionally, strong winds are amongst the worst and soil conditions the driest.

The recommendations for the south-eastern extraction area include:

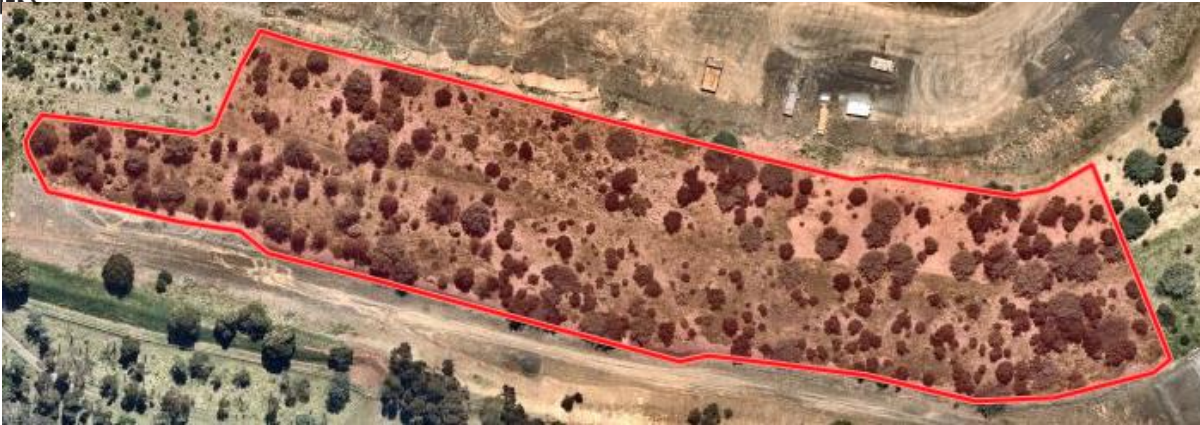
**Figure 3: Southern Extraction**

Southern Extraction is a north facing slope that borders South Eastern Extraction to the east and 0.8 hectare to the west. It is not as dry as SE Extraction and has the most developed canopy of the direct seeded and planted quarry sites on the Southern and Eastern slopes.

Weeping grass (*Microtena stipoides*) has expanded coverage in shaded areas. Wallaby Grass (*Rytidosperma* spp.) is present in low numbers due to largely unfavourable conditions. Wallaby Grass remains in scattered pockets across the site and in a higher density at the bottom on the northern edge where it is exposed to sunny and drier conditions. Scattered plantings of Common Tussock-grass (*Poa Labillardierei* var. *labillardierei*) and Purplesheath Tussock-grass (*Poa ensiformis*) from this and previous years plantings are doing well.

The recommendations for the Southern Extraction area include:

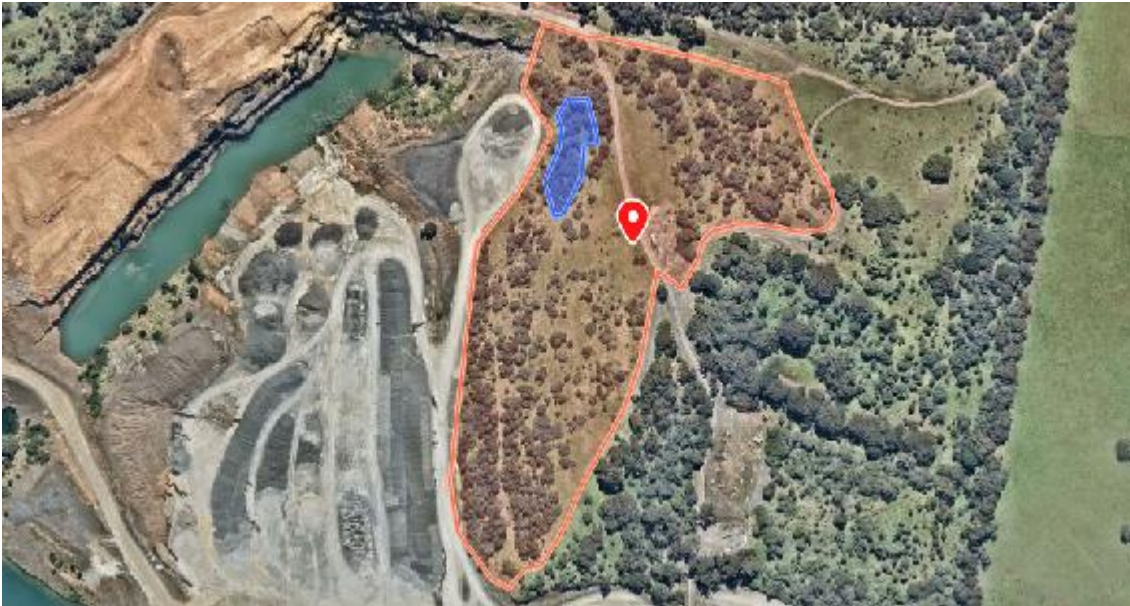
The Extraction site is south facing starting from the ridgeline of the northern side of the quarry through to the base of current operational area. This is the first zone that Naturelinks direct seeded with native grass and planted.

Extraction is the wettest of the direct seeded and revegetation zones its sites conditions best match EVC 16 Lowland Forest. However, a rise south of the main access track that divides the site in half opposite and to the east of the cargo container is somewhat drier.

**Figure 4:** Extraction area. Planting area (blue), Chilean Needle Grass cluster (red marker).

The recommendations for the Extraction area include:

- Targeting broad leaf exotic species with herbicide application by knapsack.
- Targeting blackberry with herbicide application by knapsack and cut and paint with glyphosate where there is a risk of damage to native vegetation.
- Hand-weeding and disposal of any seeding Chilean Needle Grass and Serrated Tussock followed up by herbicide spraying of younger plants. Maintain vigilance for any new infestations
- Removal of Coastal wattle (*Acacia longifolia*) along with any germinates and hybrids.

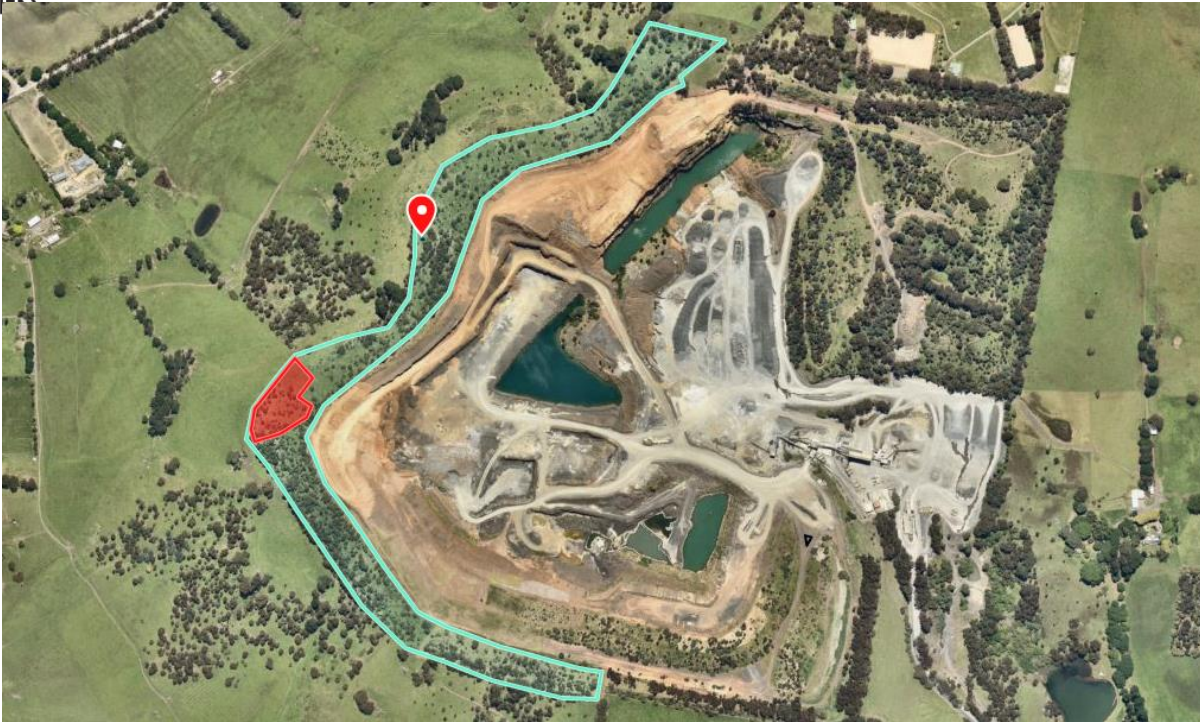
The Phase A and B site encompasses a planted area bordering the outer quarry fence-line that acts as a visual barrier and screen for noise and dust pollution.

**Figure 5:** Phase A & B (teal). Chilean Needle Grass infestation (red), new Chilean Needle grass outbreak (red marker)

Broadleaf weeds were controlled by knapsack spraying except for area around the SW corner where thistle germination formed large stands that required tanker spraying. Broadleaf weed spraying was undertaken in two spray runs in Winter and early summer preventing nearly all weeds from seeding. The broadleaf herbicide Associate (active ingredient Metsulfuron Methyl) was added to Kamba M (active ingredients MCPA & Dicamba) to enable the successful control of Wild Carrot where Kamba alone had previously failed.

Deer are continuing to cause damage to softwood trees and shrubs, noting that a deer control program has been initiated. Damage includes removing bark and or otherwise damaging and breaking the main stem, they are also continuing removing some guards from newly planted trees.

The recommendations for Phase A & B include:

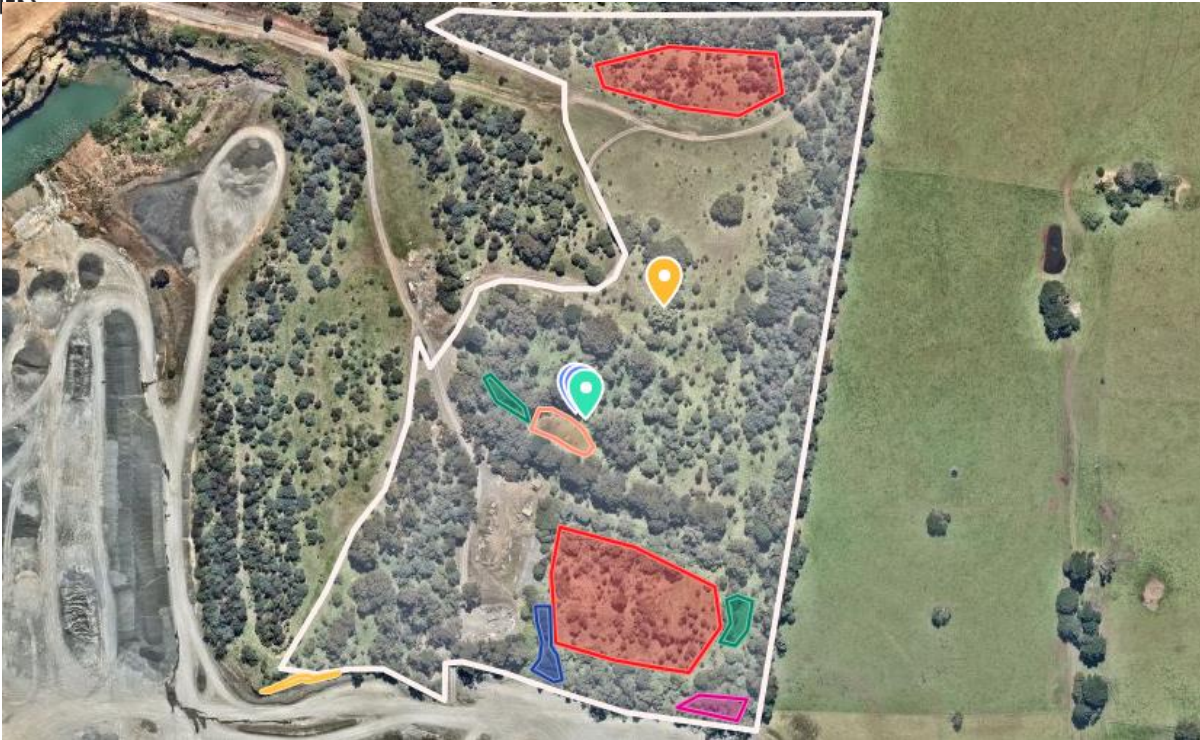
The Phase C site comprises of disturbed land that has both naturally regenerated and been replanted, it borders the Extraction site to the west. Following high rainfall, a gully fills with water (orange figure 7) that provides a breeding ground for large numbers of native frogs. Just north of the gully are two adult remnant Rough Tree-ferns (*Cyathea australis*) (blue markers figure 7) and a single remnant Clover Tree (*Goodia lotifolia*) (Green marker figure 7).

East of the Graveyard and North of Extraction are two areas with scattered Tall Sword-sedge (*Lepidosperma elatius*) (red figure 7). This species cannot be supplied from indigenous nursery's due to the difficulty of its propagation. Native fern species including a small number of Rough Tree ferns (*Cyathea australis*) are recruiting naturally below the east/west Graveyard track (green figure 7).

**Figure 6:** Phase C. Gully (orange), tree ferns (blue marker), clover tree (green marker), fox den (yellow marker), Tall sword sedge (red), recruiting tree ferns (green), Pampas grass (yellow), treated Willows (dark blue), sprayed English ivy (hot pink).

A fox den was observed under a large Weeping Willow (*Salix babylonica*) (yellow marker figure 7) located in centre of the site three or four fox cubs were observed darting away on approach.

The recommendations for Phase C include:

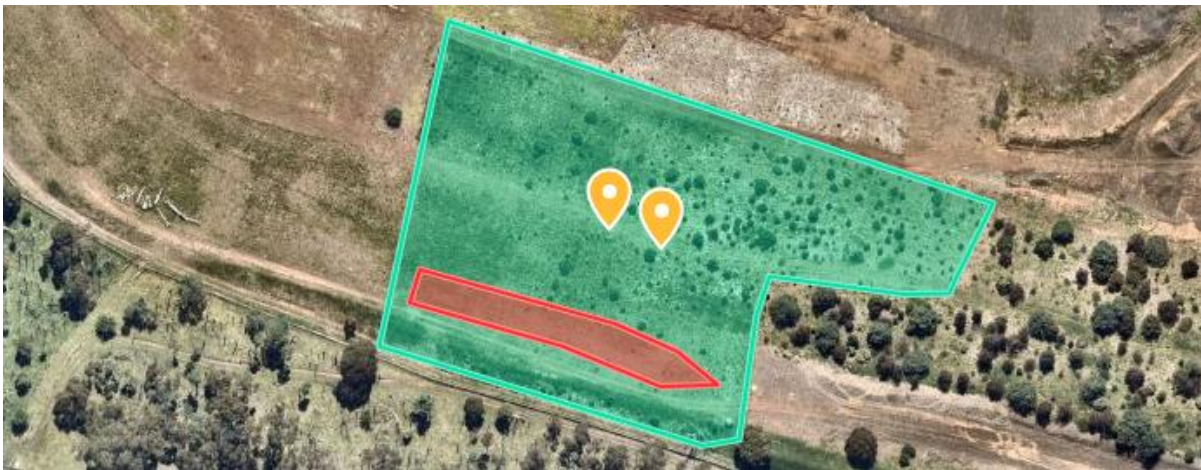
The 0.8 Ha site is north facing slope adjacent to Southern Extraction to the east with 1.2 Hectare and 2023 Planting area to the west. This site was first direct seeded and planted in 2021. Overall survival and growth for planted trees and shrubs has been good except for the very top of the site at its southern end. This part of the site is much drier, the ground hard and the top soil layer appearing to be thinner. A canopy particularly from the bottom half of the site down is starting to develop in some areas.

**Figure 7:** .8 Hectare Revegetation Site. Drier area (red), Chilean Needle Grass clusters (yellow markers)

The recommendations for 0.8 hectare include:

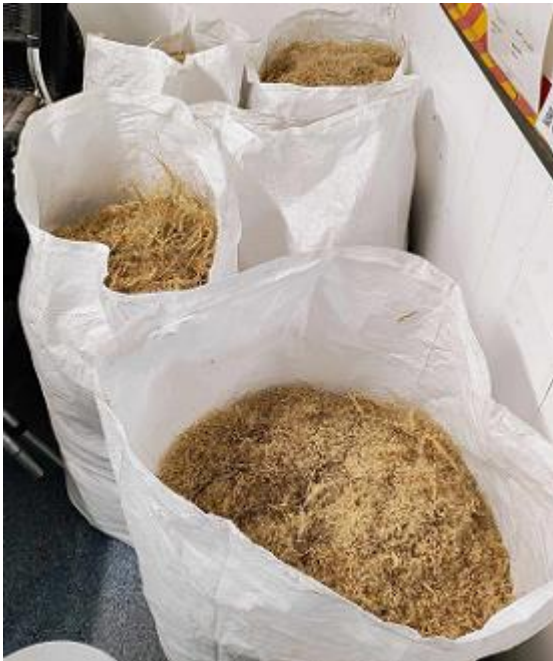
**Picture 3.** Harvested Wallaby Grass from 0.8- & 1.2-Hectare site.

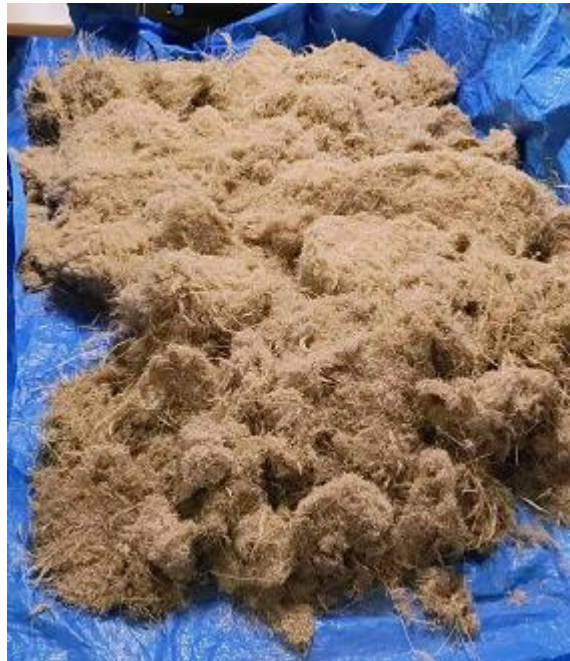
**Picture 4.** Harvested Wallaby Grass drying over Christmas & new year period.

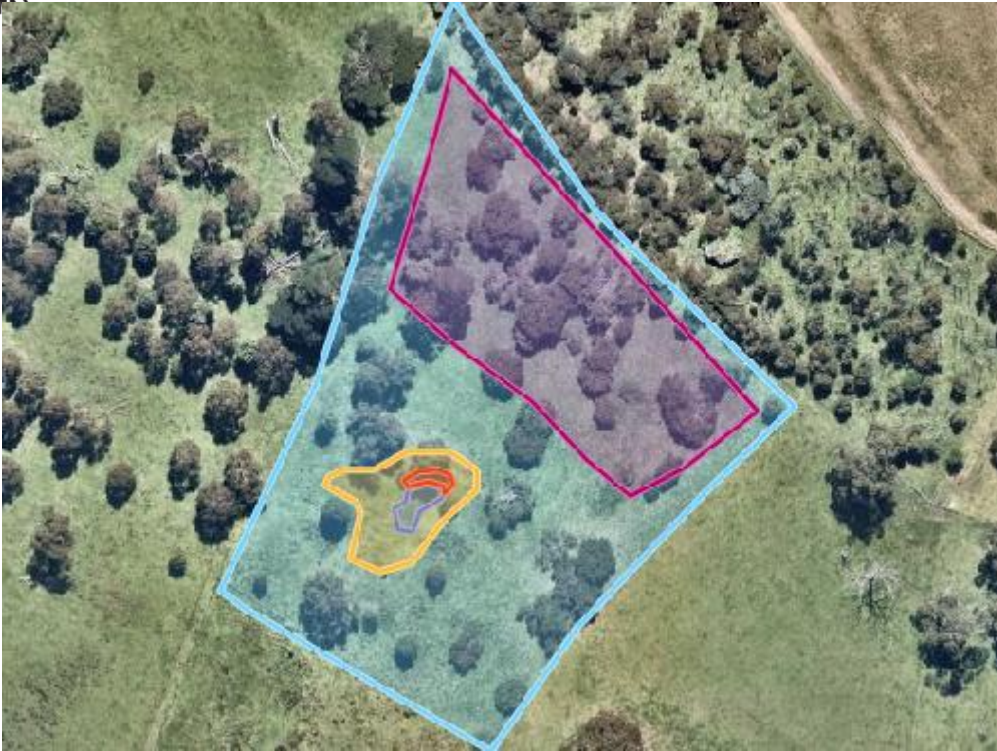
In 2024 work was conducted at Mass 4. This site contains a seasonal natural seasonal spring, south of the quarry in a fenced area surrounded by grazing paddocks to the east, south and west, phase A&B to the north. Semi mature and mature trees have been sparsely planted throughout the site. Just above the natural spring is a circular failure. To prevent further collapse Tussock-grass (*Poa* sp.), Spiny-headed Mat-rush (*Lomandra longifolia* var. *longifolia*) and a mixture of tree and shrub species has been planted above, below and around the failure to stabilise the ground.

**Figure 8:** Mass 4. Circular failure (red), natural spring (blue), natural spring planting zone (yellow), northern planting zone (purple)

In 2023 a brief site inspection of Mass 4 was undertaken. Substantial damage by grazing deer was evident along with the removal of many guards and muddying of large areas of ground. These effects led to the senescing of many the 2022 plantings and further damage to plantings from earlier years.

Deer control measures have been initiated during 2024. Large stands of blackberry have been successfully sprayed, months later dead canes were brush cut down with a blade. Thistles and other broadleaf weeds have been successfully controlled with herbicide. Broken and loose stakes and guards have been removed.

The areas around the failure and natural spring below have been successfully been replanted where necessary with additional infill planting also taking place. A total of 250 native Tussock Grasses (*Poa* sp.), 100 Spiny-headed Mat-rush (*Lomandra longifolia* var. *longifolia*) and 50 native trees and shrubs were planted in and around Mass 4.

The recommendations for Landslip plantings include:

- Herbicide treatment of blackberry stands and Spear thistles Mass 4.
- Additional trees and shrubs to be planted throughout the site as per request from quarry management (Table 11).
- Continue to monitor deer activity and any damage caused to plantings

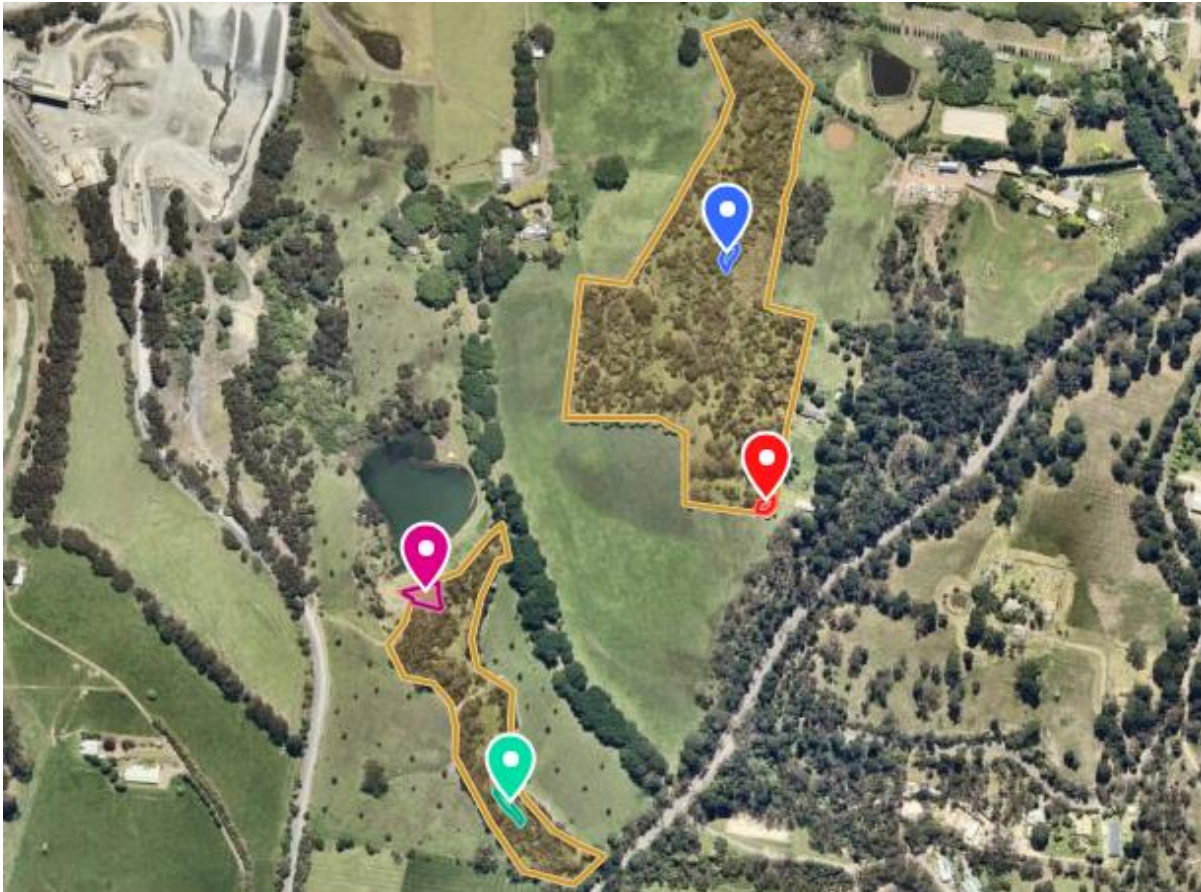
The Net Gain Site is located at the Donazzan's Property' 415 Pakenham Road (Quarry owned) comprises of two offset zones Northern and Southern section. Net gain both North & South Revegetation Zones fall within EVC 16 Lowland Forest and EVC 83 Swampy Riparian Woodland. This is the most species diverse of all the sites with the highest amount of remnant vegetation.

**Figure 10:** Net Gain: North (top) & South (bottom) both marked in yellow, Winter heliotrope (blue marker), eradicated St Augustine Grass (red marker), Wild carrot (dark pink marker), Muttonwood plantings (green marker).

The recommendations for Net Gain include:

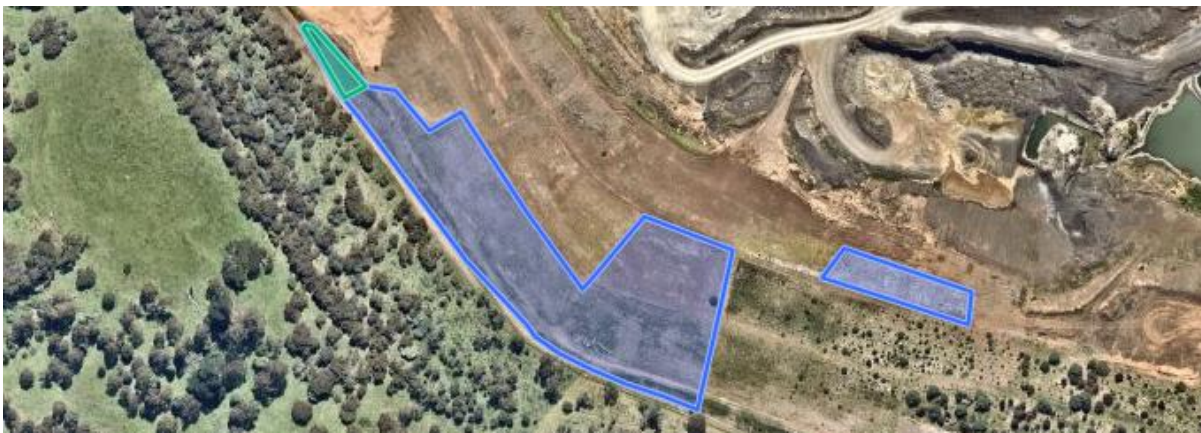
The 1.2 Ha site is directly to the west 0.8 Revegetation Site sharing similar environmental conditions such as north facing, mostly dry with occasional high winds.

**Figure 11:** 1.2 Hectare site. NW corner direct seeded by hand (green)

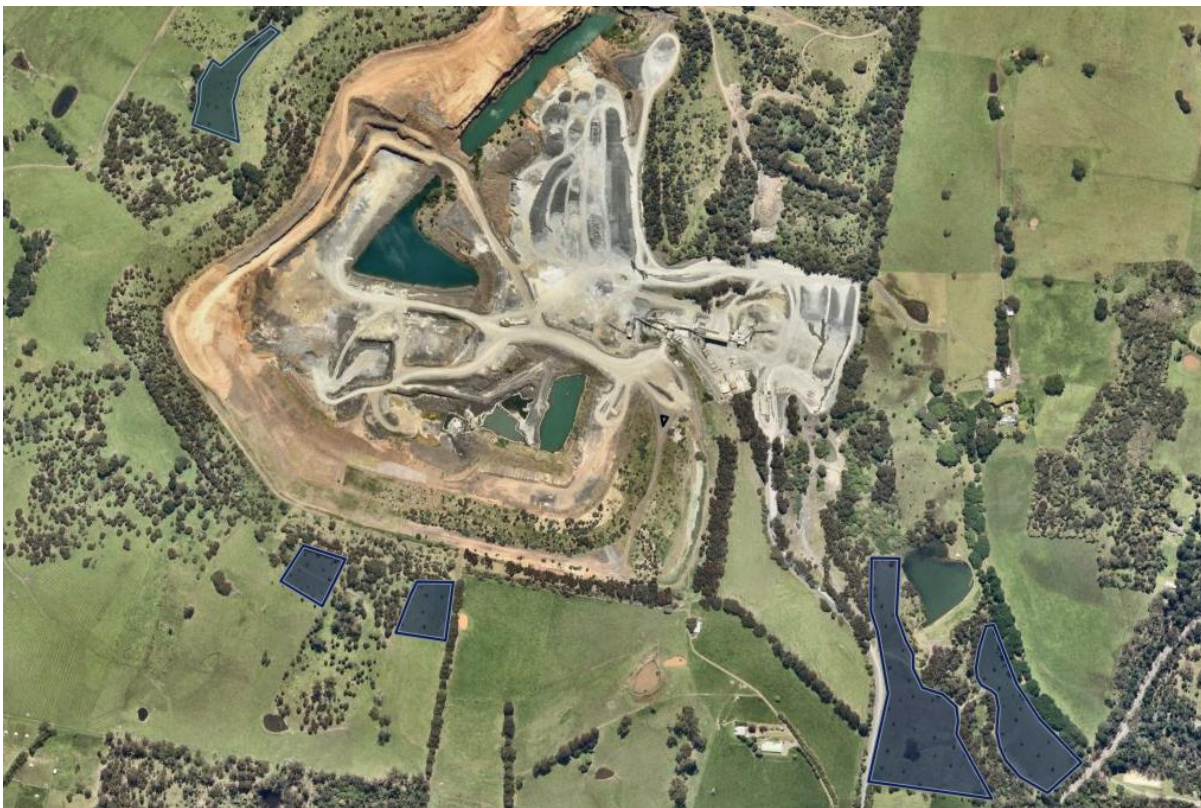
This site encompasses 5 separate paddock areas that are grazed by cattle. Stock proof fencing has been erected around 150 approximately 1.5m<sup>2</sup> quadrants in which Eucalyptus were originally planted in 2018.

**Figure 12:** Paddock Replacement 5 zones (ash)

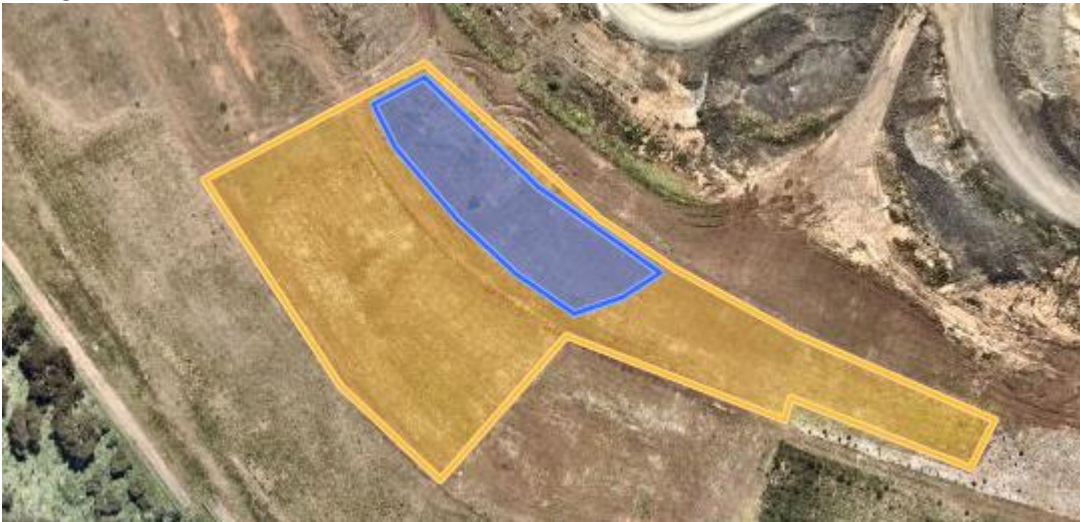
2023 Planting Area sits directly below 1.2 Hectare Revegetation Site, north facing subject to occasional dry winds but with a higher degree of fluctuation in site conditions than adjacent areas. It can be similarly dry during hot periods but its lower elevation also accentuates wet conditions. This variability will pose difficulties for establishing some species particularly during early years of revegetation.

**Figure 13:** 2023 Planting Area, seasonally wet areas (blue)

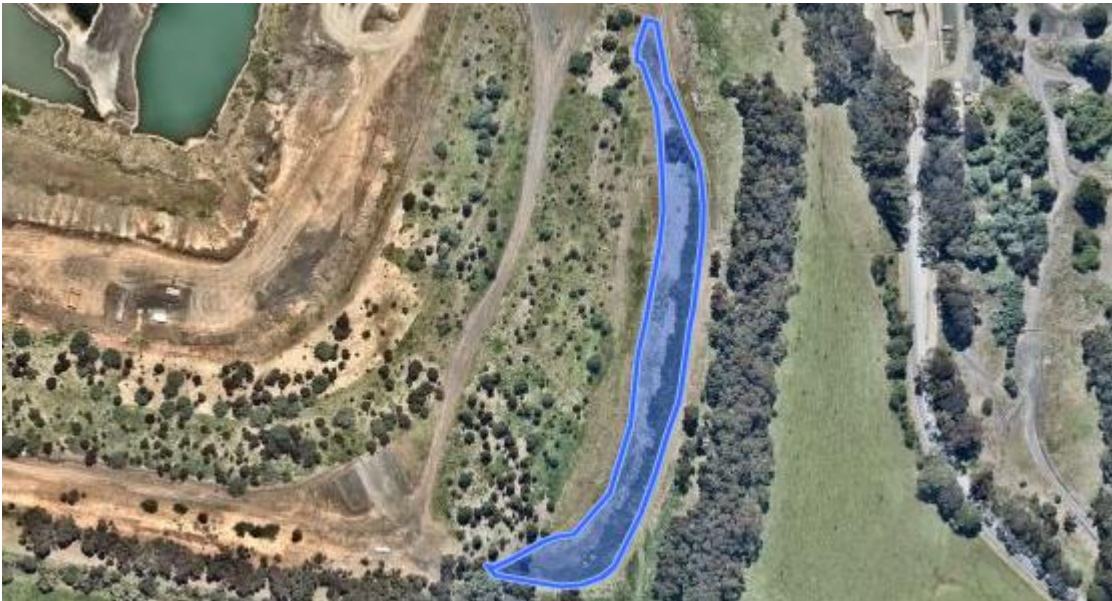
**Figure 14:** South East Extraction Backslope

This site borders South East Extraction to its west starting from the back end of the ridgeline to the track that borders the bottom of the hillside. Many sections of this site are steep with deep soft soil making planting and spray works difficult in wet conditions.

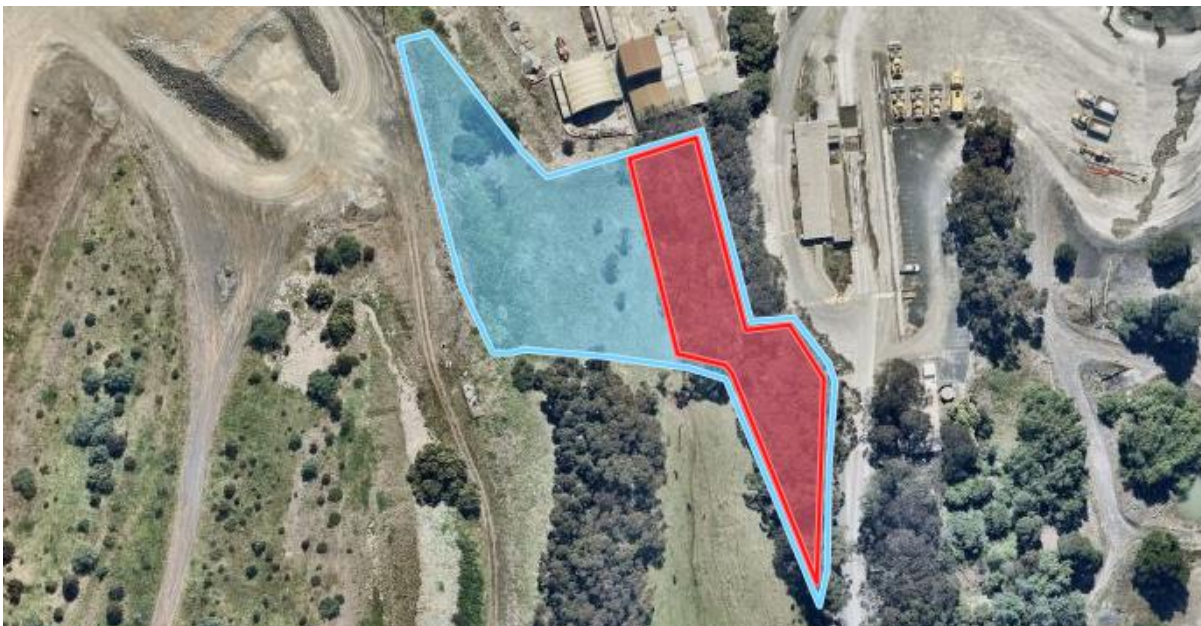
This site runs south of the road bordering quarry administration, east of the workshop and west of a grazing paddock, going up the hillside to the track that runs along the base of South East Extraction Backslope. Lower levels of disturbance and the presence of a fair degree of remnant vegetation are likely due to the slope's topography. Some of the remnant species present are Kangaroo Grass (*Themeda triandra*), Austral Bracken (*Pteridium esculentum*), Native Raspberry (*Rubus parvifolius*), Common Tussock-grass (*Poa Labillardierei*), Weeping grass (*Mircrolena Stipoides*) and Wallaby grass (*Rytidosperma* sp.).

**Figure 15:** Southern Hillside. Priority area for seasonal brush cutting (red)

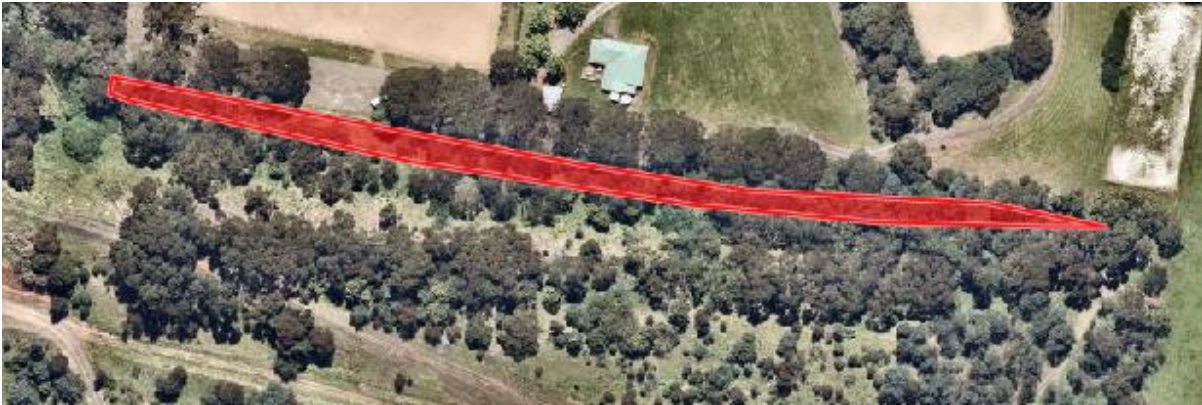
**Figure 16:** Northern Boundary

The Northern Boundary borders the Pakenham Pony Club and lies to the north of Phase C. An established canopy is present but a shrub/understory layer largely absent. Naturelinks was directed by quarry management to plant a row of shrubs along the boundary to act as a visual screen.

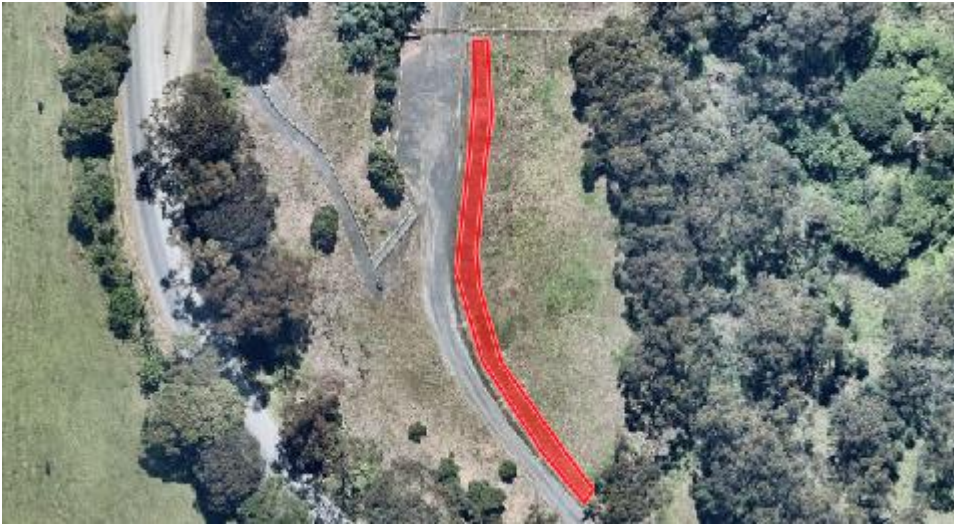
Lower car park refers to the North-South Road that goes to and from the lower car park east of Mt Shamrock Road. Naturelinks was directed to plant a line of trees to offer protection to the vehicles parked in this car park from the elements.

**Figure 17:** Lower car park plantings (red).

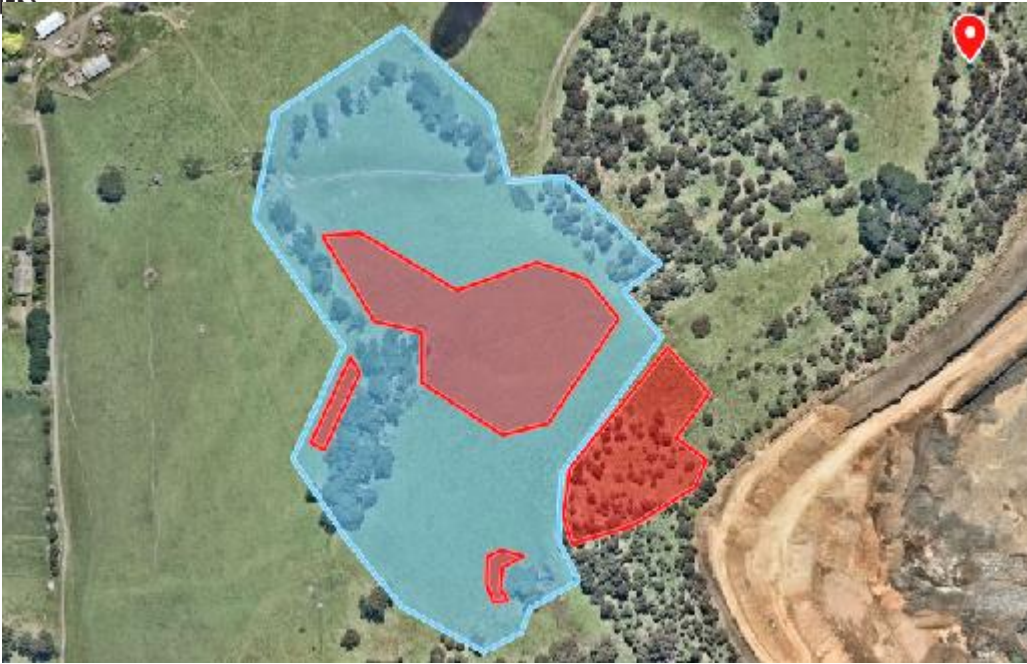
Chilean Needle Grass (*Nassella neesiana*, CNG) is a highly invasive species that presents threats to both natural environments and agriculture. While this species is widespread in the northern and western regions of Melbourne, it is currently found only in limited areas of the outer eastern suburbs. Eradicating Chilean Needle Grass in locations where it has not yet established should be prioritized. Naturelinks recommends that efforts be made to pursue this objective.

**Figure 18:** Surveyed Chilean Needle Grass infestation (blue), areas of high infestation (red), new outbreak (red marker).

In 2022, a large infestation of CNG) was discovered in a paddock beyond the quarry boundary fence-line, but still within quarry land. Naturelinks concluded that it was likely source of Chilean Needle Grass then spreading within southern revegetation zones under their management. In 2023 Naturelinks conducted a survey in and around all areas that the grass had been located, to properly define the extent of the weed's infestation (shown figure 18).
