Teven Quarry Quarterly Noise Monitoring Assessment

Quarter 1 2024

Project name **NSW Environmental Monitoring 2023-2024**
Project no. **318001799**
Recipient **Matt Kelly**
Document type **Report**
Version **1**
Date **06/05/2024**
Prepared by **Jake Bourke, Matilda Englert**
Checked by **Arnold Cho**
Approved by **Belinda Sinclair**
Description **Data collected on 10 January for Teven Quarry during Quarter 1 2024 in Teven, NSW, as part of the noise monitoring program**

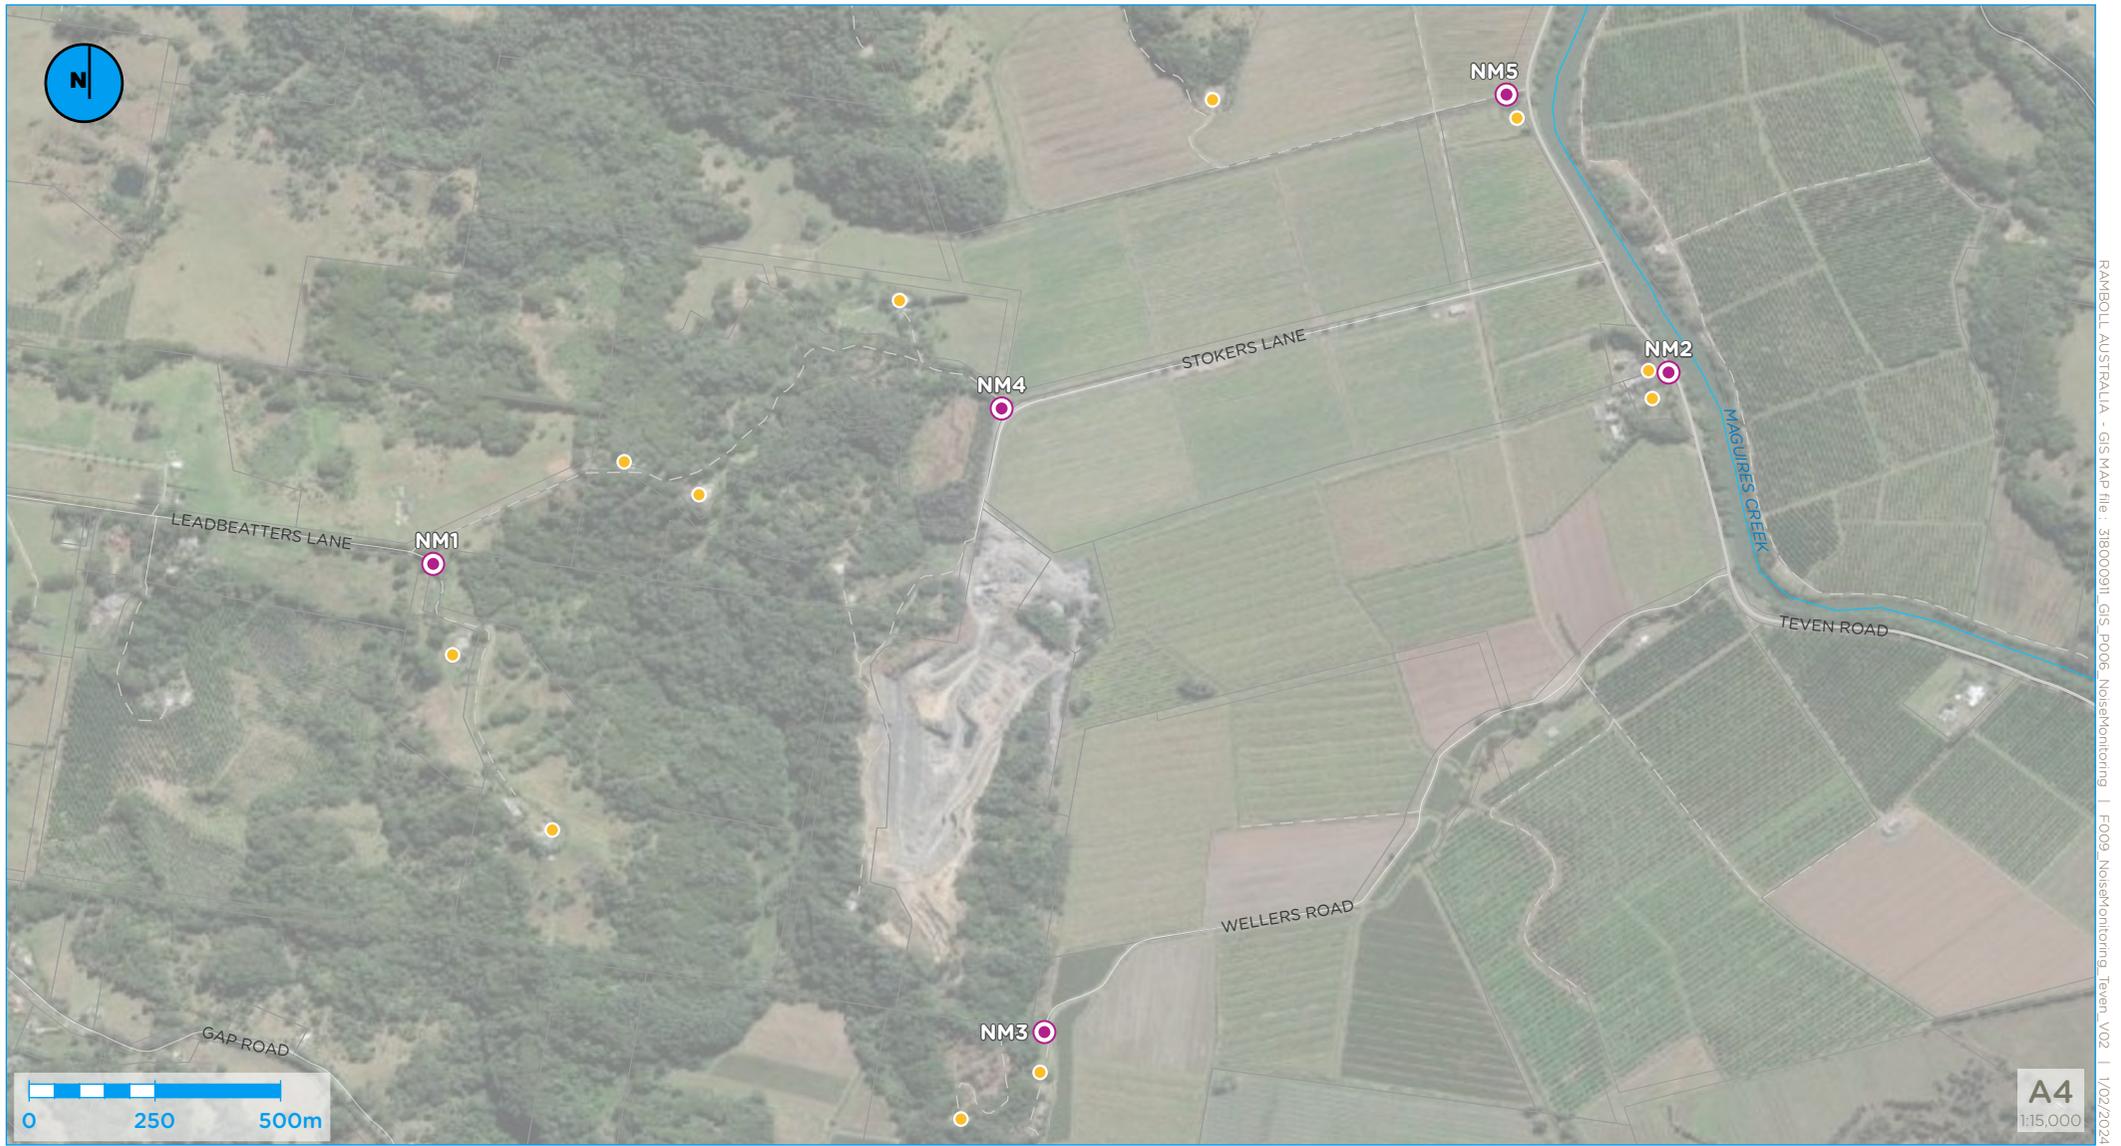
Figure 1: Noise monitoring locations at Teven Quarry

The monitoring locations with respect to the quarry and assessed receivers are presented in the locality plan shown in **Figure 1**.

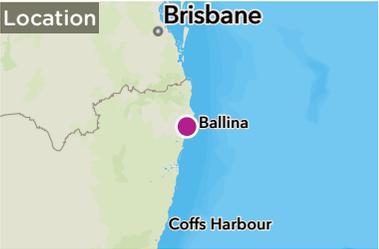
- Noise monitoring location
- Residential receiver location

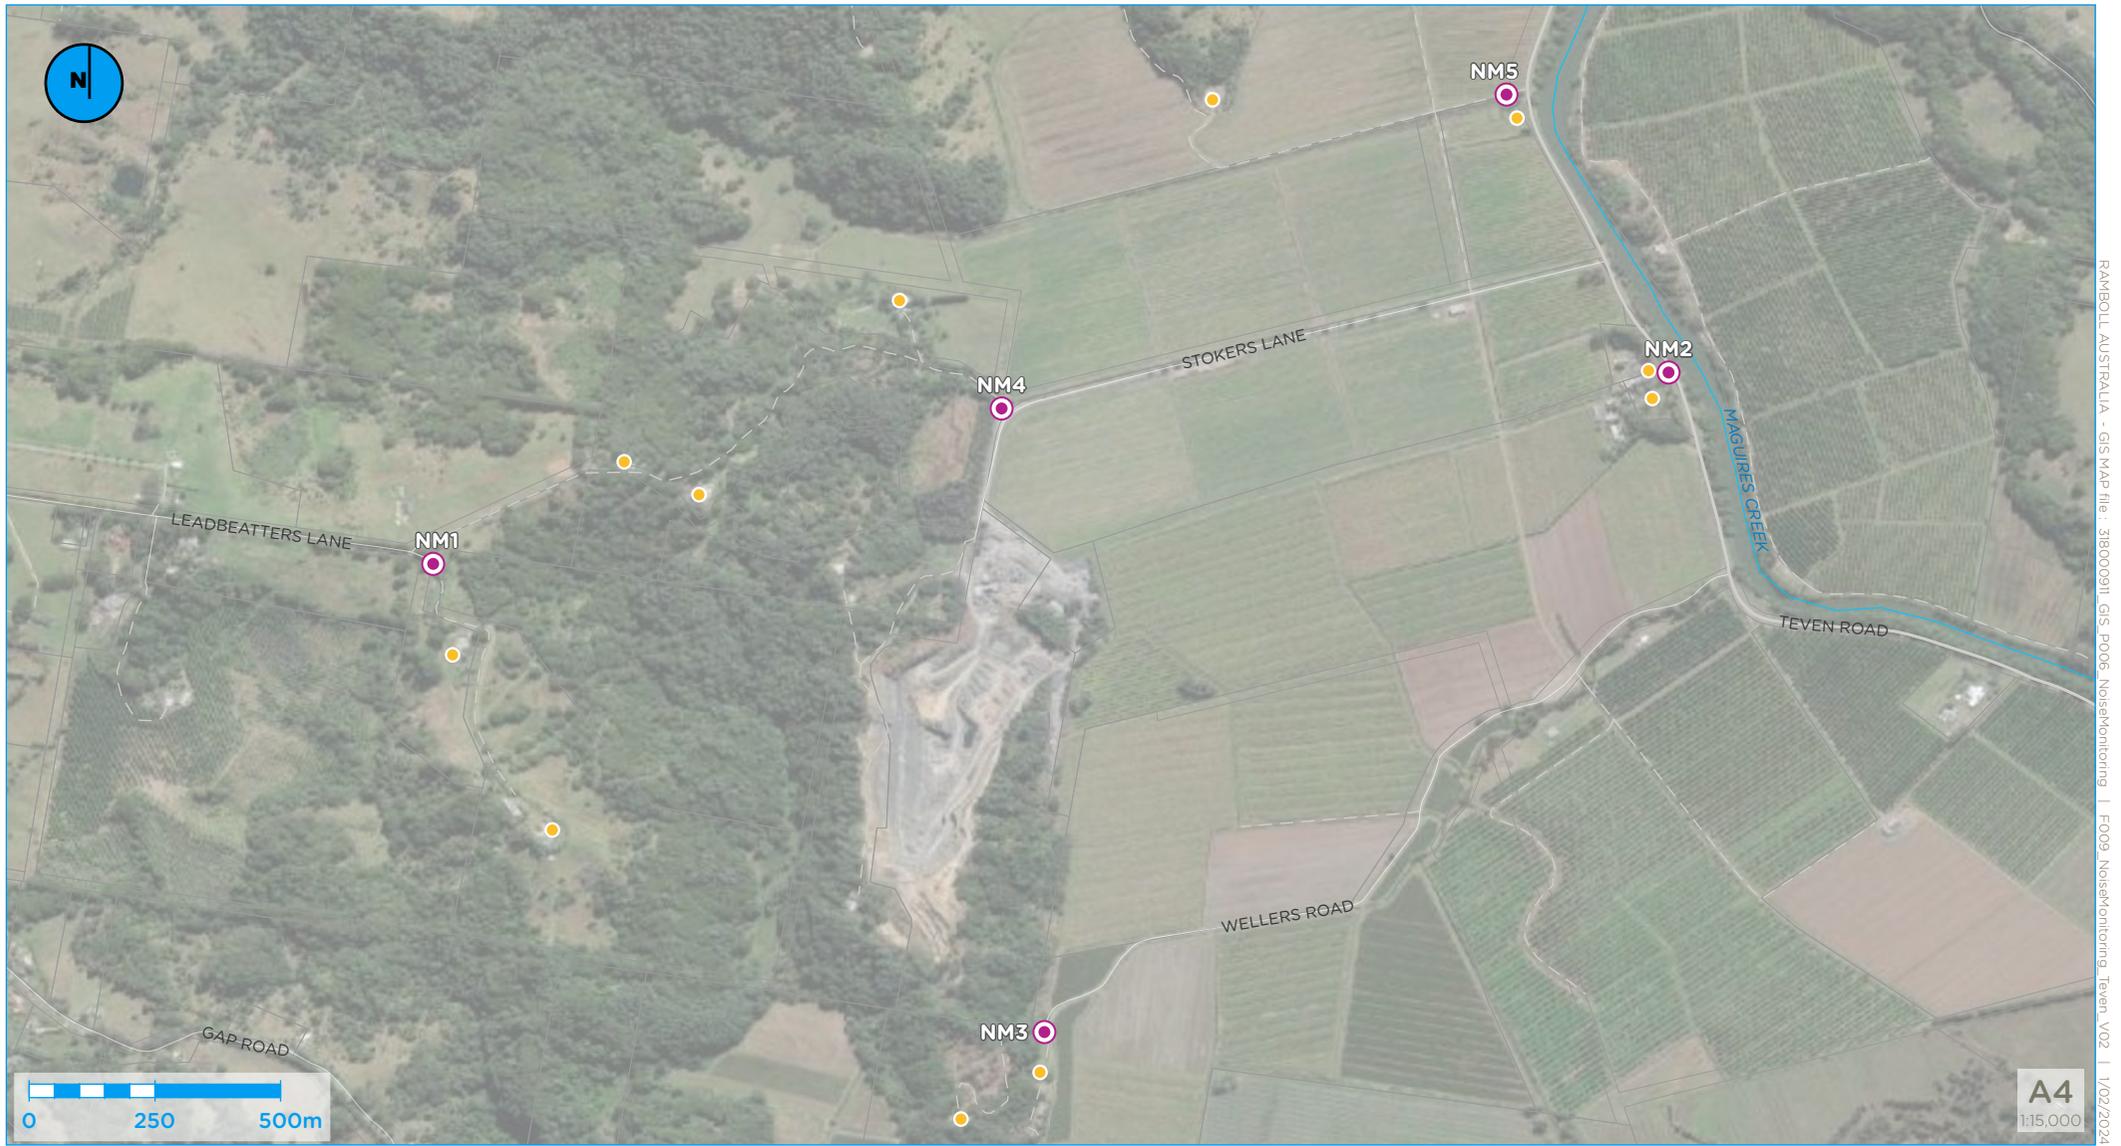
Figure 1: Noise monitoring locations at Teven Quarry

The monitoring locations with respect to the quarry and assessed receivers are presented in the locality plan shown in **Figure 1**.
