ROOTY HILL REGIONAL DISTRIBUTION CENTRE
MONTHLY ENVIRONMENTAL MONITORING REPORT

Aspect	Air Quality, Construction Noise and Meteorology
Date	October 2013

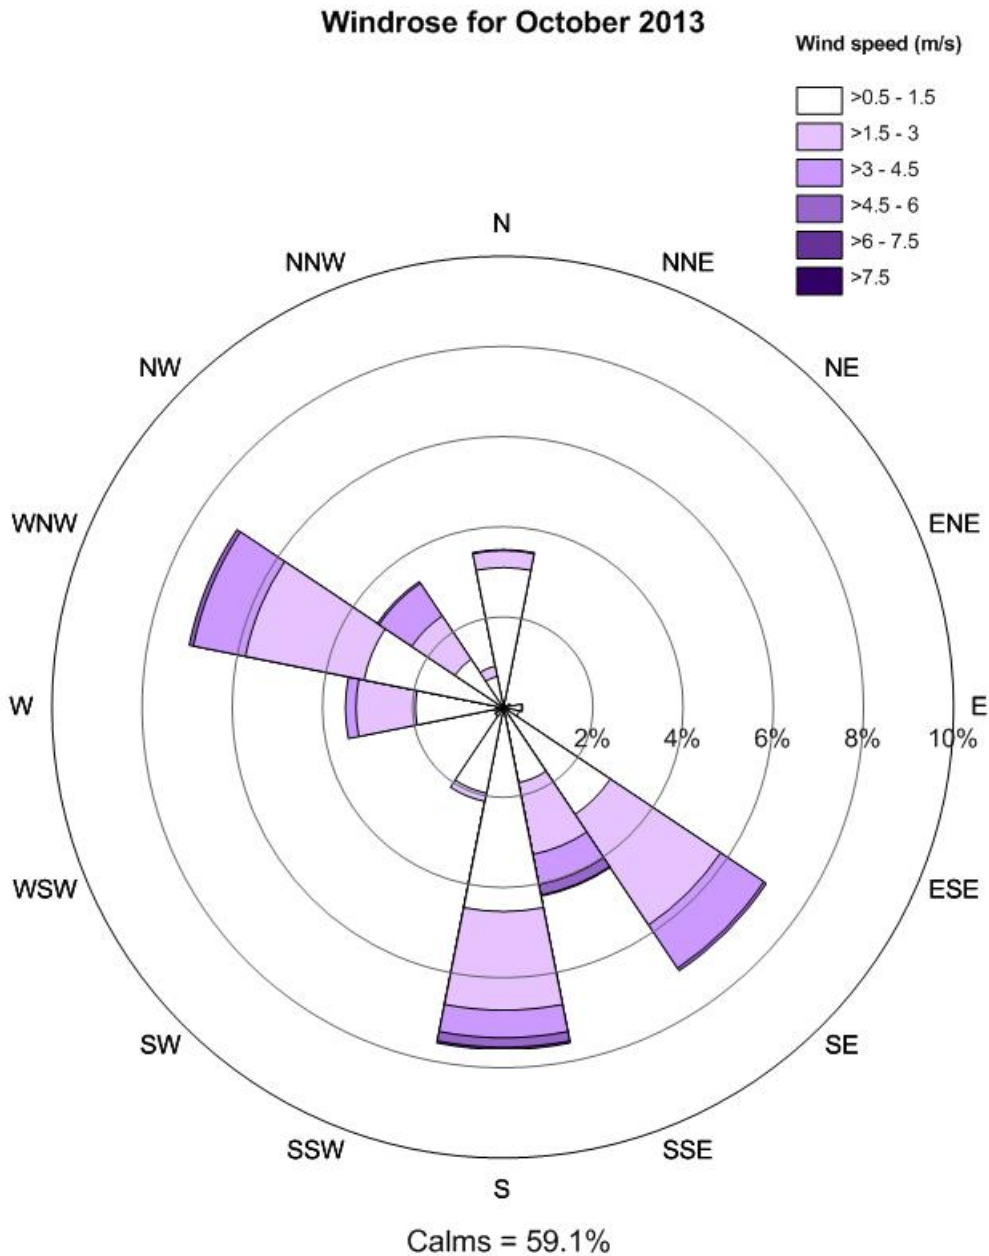
A wind rose showing the proportion of direction and strength of winds throughout the reporting period is below. A complete data set, including, humidity, temperature and rainfall is provided in software form.

The results of the wind rose show that areas to the north west and south east of the site were the most likely to be impacted by construction generated dust. This area includes the industrial areas on Kellogg Road and southern areas of the Nurragingy reserve and the railway line.
