Noise Monitoring Assessment

Dunloe Quarry, Pottsville, NSW

Quarter 3 Ending September 2019

Prepared for: Holcim (Australia) Pty Ltd

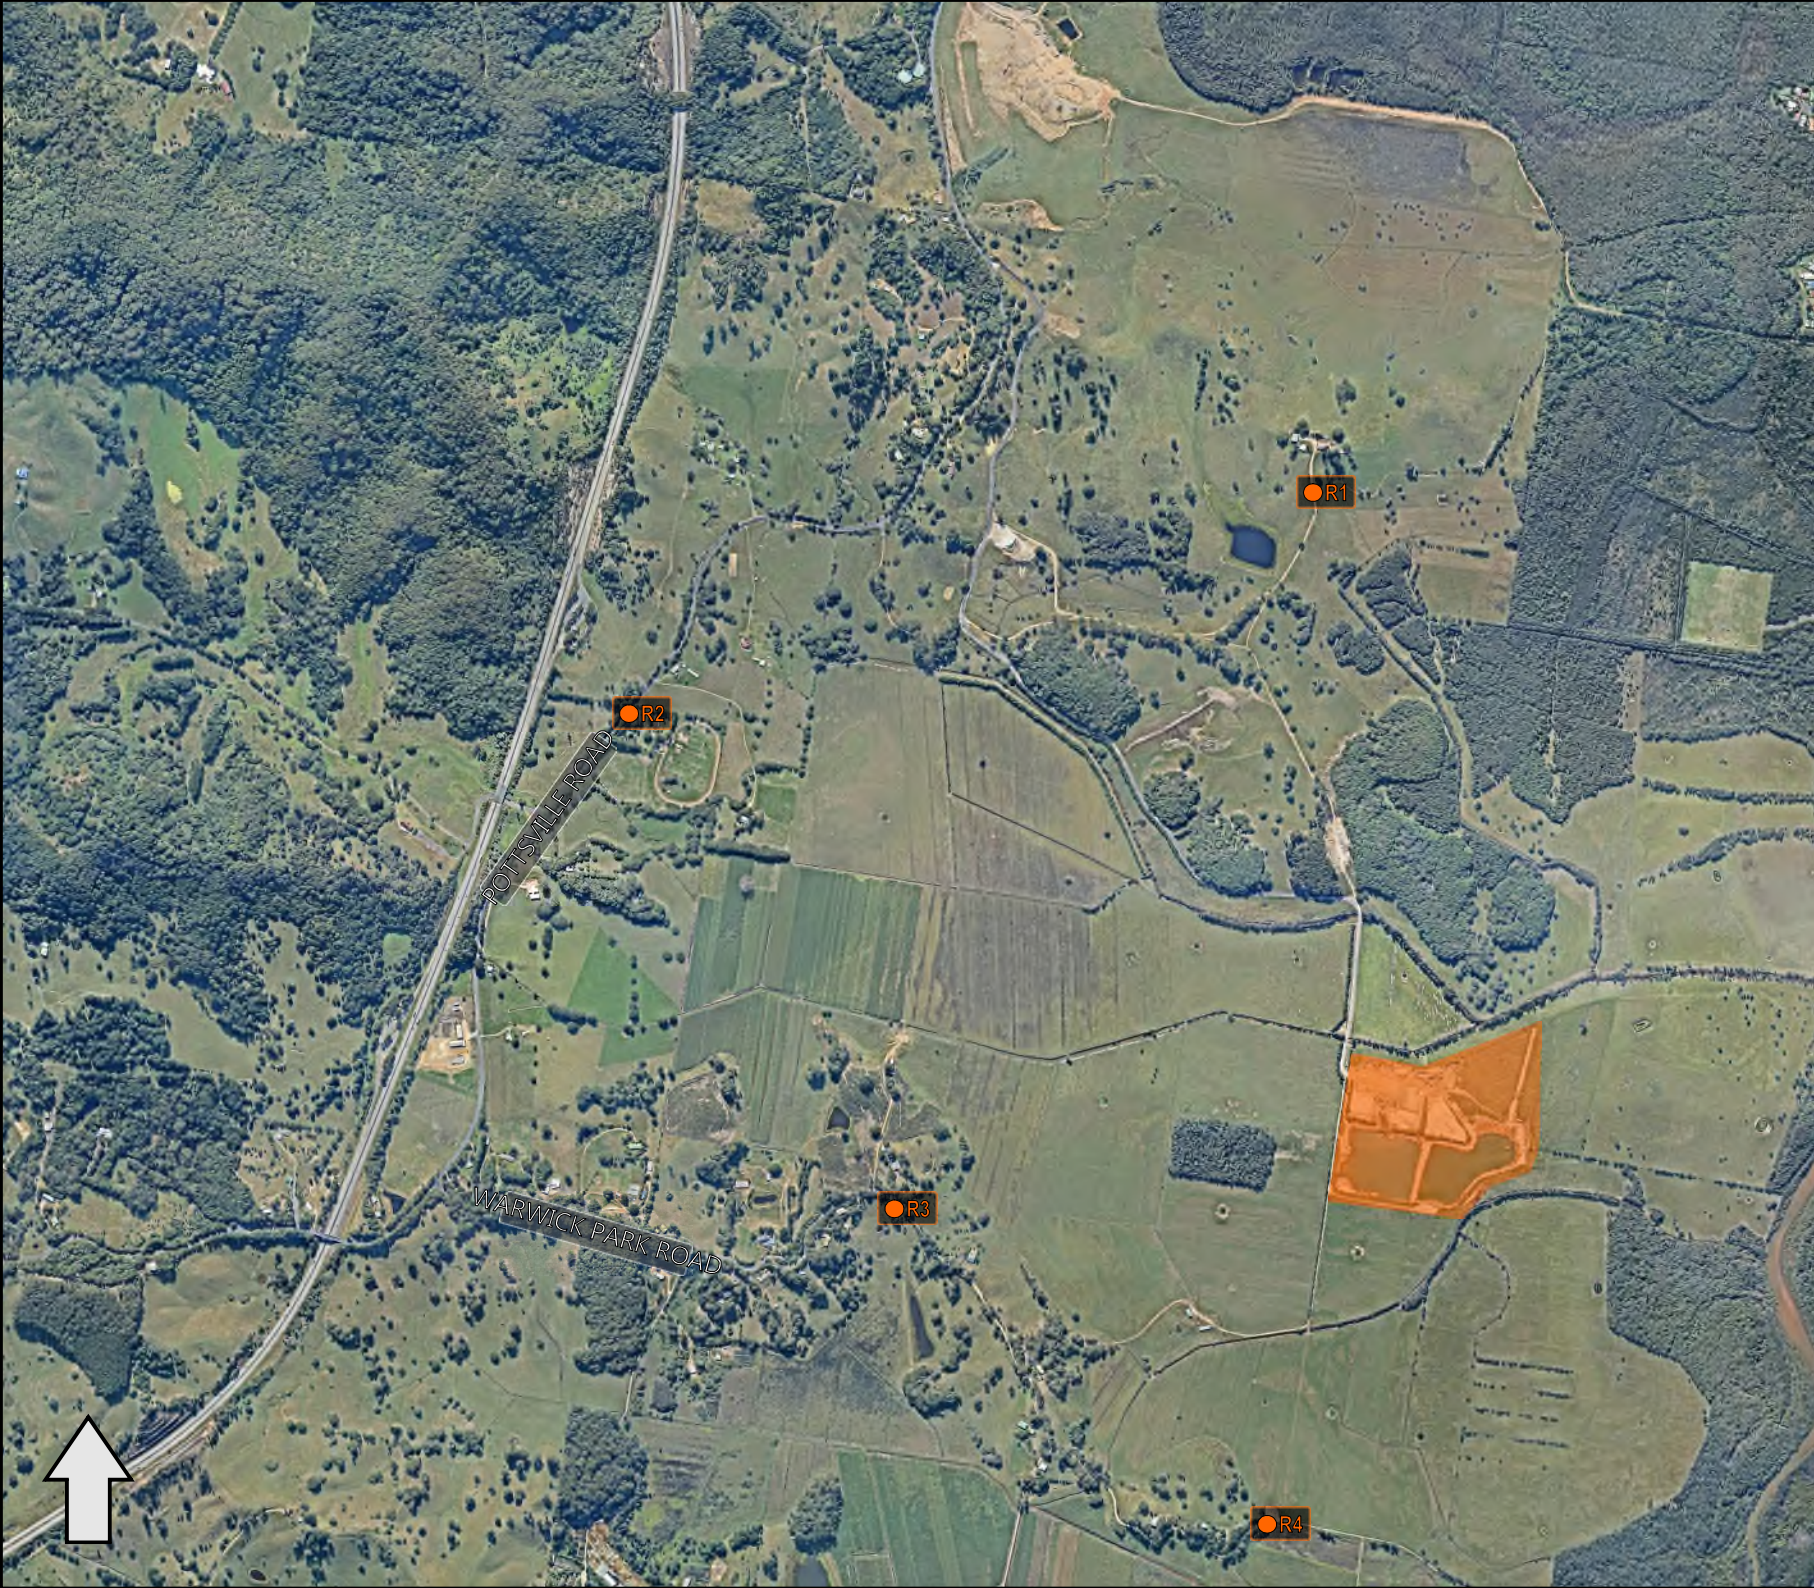
FIGURE 1
LOCALITY PLAN
REF: MAC180611-07

The quarry is approximately 2.5km south west of Pottsville, NSW. Receivers surrounding the quarry are primarily rural/residential situated in coastal bushland with elevated and undulating topography. The monitoring locations with respect to the quarry and assessed receivers are presented in the locality plan shown in **Figure 1**.

- R1 is located at the property on Kellehers Road situated north of the quarry;
- R2 is located west of the quarry on the boundary of 574 Pottsville Road;
- R3 is located to the south-west of the quarry at the address of 122 Warwick Park Road; and
- R4 is located at 265 Warwick Park Road, south of the quarry.
