Noise Monitoring Assessment

Teven Quarry, Teven, NSW
Quarter 2 Ending June 2021.

Prepared for: Holcim (Australia) Pty Ltd

Prepared by: Muller Acoustic Consulting Pty Ltd

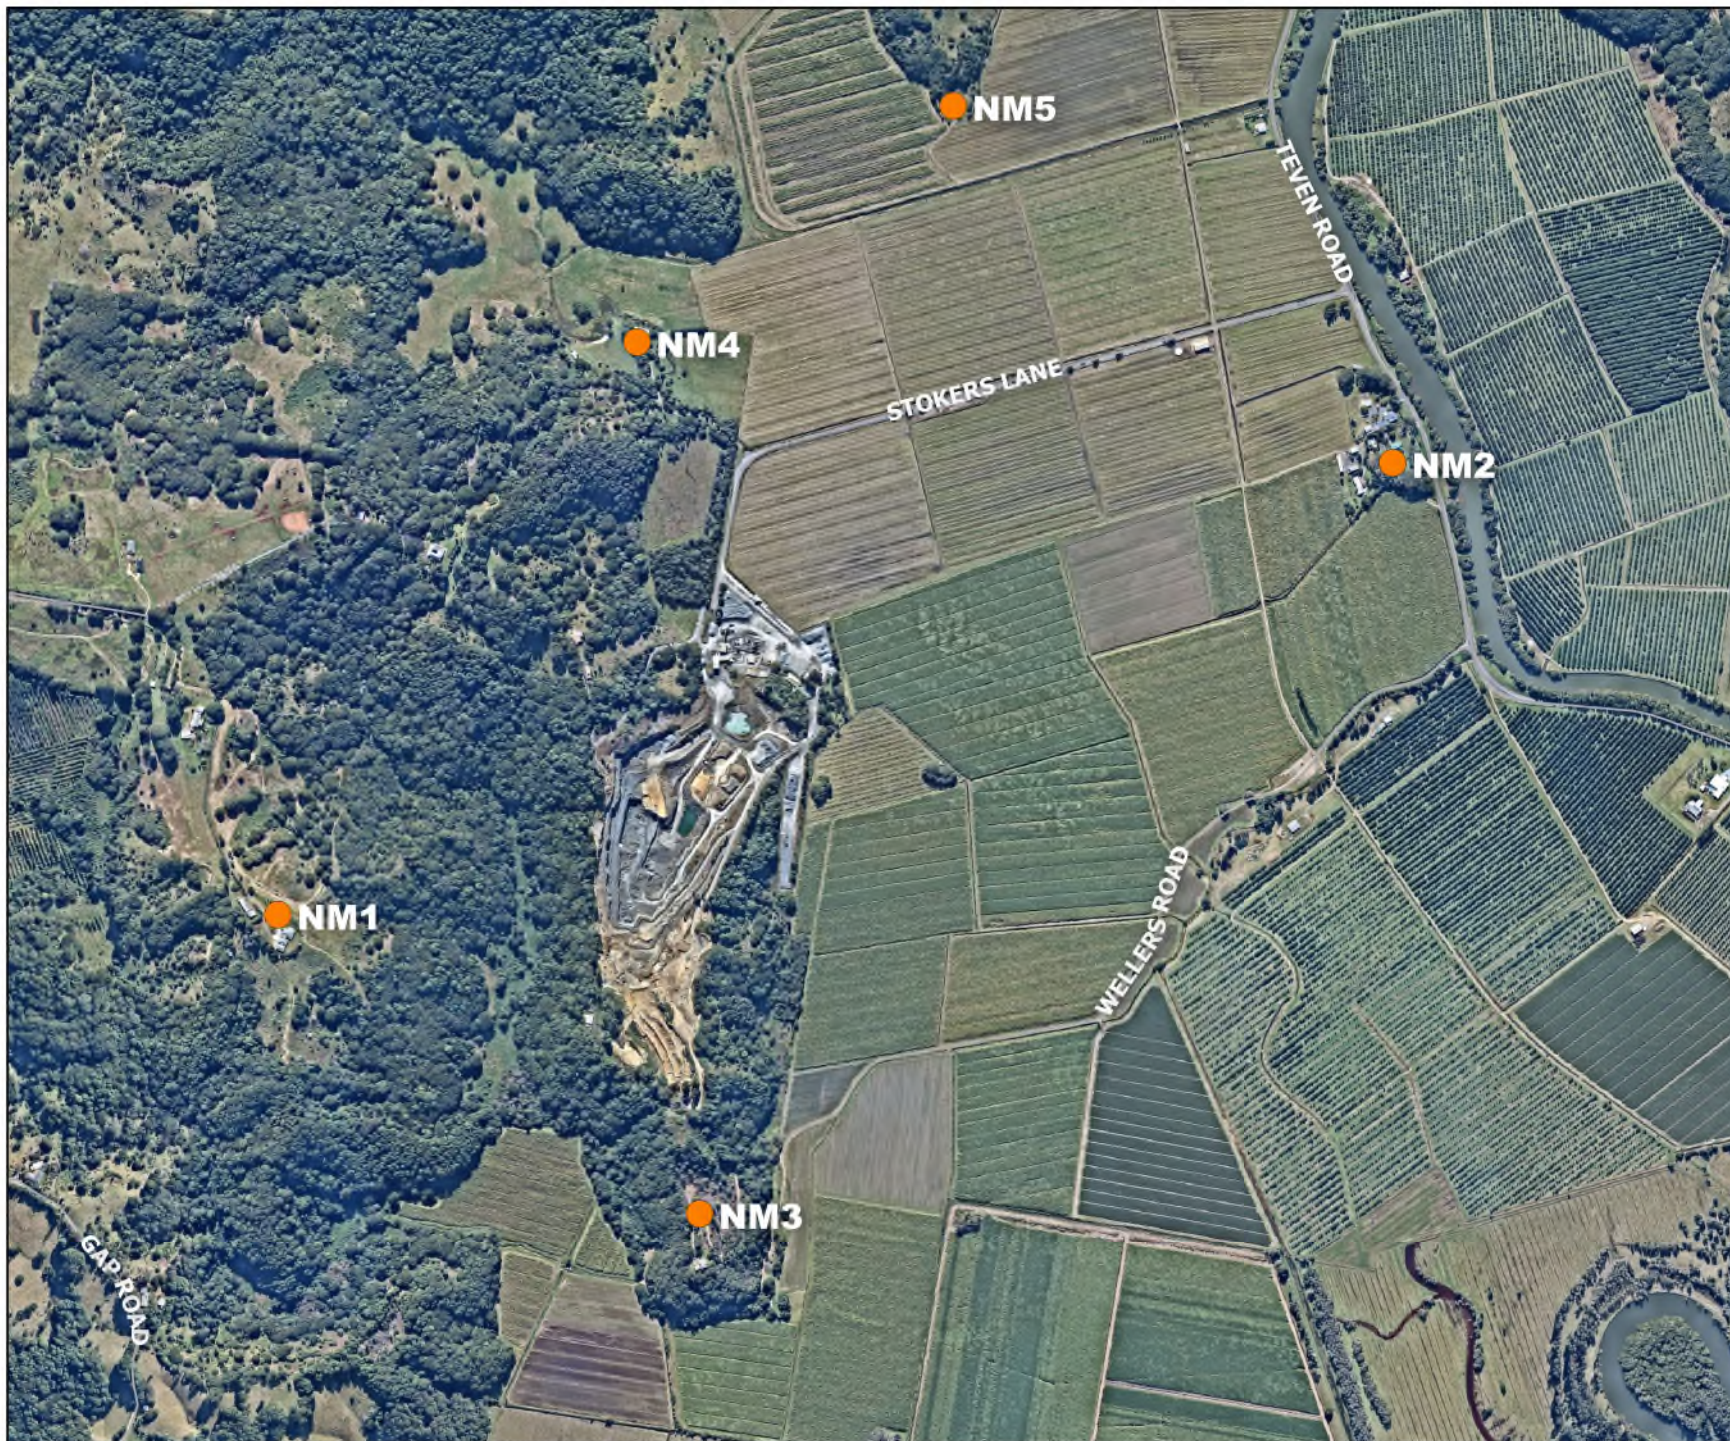
FIGURE 1
Site Locality
MAC180611-06
Holcim Teven Quarry

The quarry is located in Teven, NSW approximately 7km west of Ballina, NSW. Receivers in the locality surrounding the quarry are primarily rural residential. The surroundings of the quarry are primarily rural. The monitoring locations with respect to the quarry are presented in the locality plan shown in **Figure 1**.

Five monitoring locations have been selected as part of the NMA in accordance with the NMP. The selected monitoring locations are presented in **Table 2** along with the noise sensitive receivers they represent.

Table 2 Monitoring Locations (MGA56 Coordinates)			
Location	Nearest Receiver	Easting, m	Northing, m
NM1	R7	546737	6809918
NM2	R3/R4	548892	6810285
NM3	R2	547781	6808991
NM4	R10	547576	6810379
NM5	R14	548100	6810792
