# Noise Monitoring Assessment

Teven Quarry, Teven, NSW  
Quarter 4 Ending December 2021.

## Noise Monitoring Assessment

Prepared for: Holcim (Australia) Pty Ltd

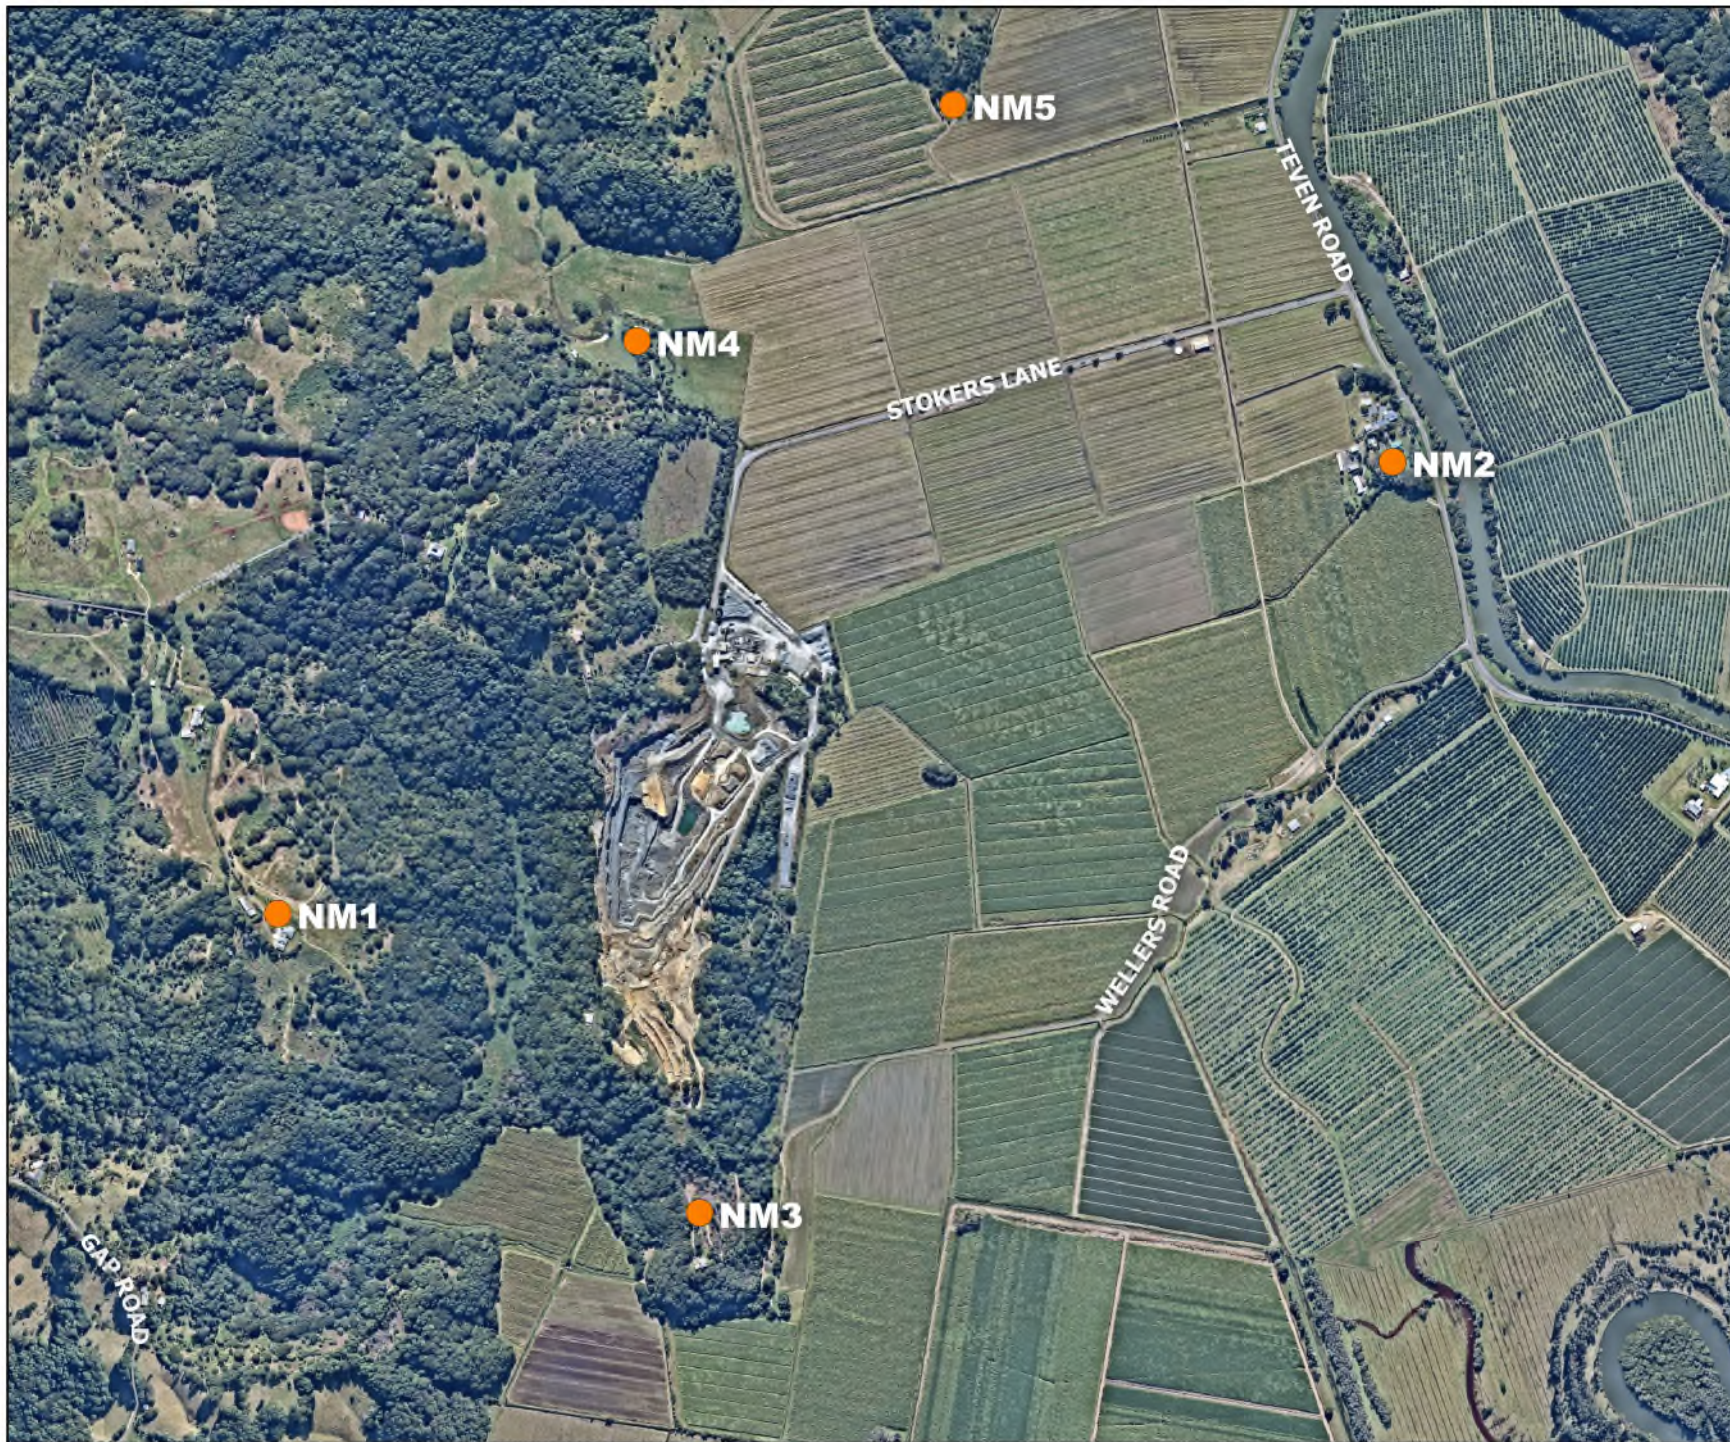
FIGURE 1

The quarry is located in Teven, NSW approximately 7km west of Ballina, NSW. Receivers in the locality surrounding the quarry are primarily rural residential. The surroundings of the quarry are primarily rural. The monitoring locations with respect to the quarry are presented in the locality plan shown in **Figure 1**.

Site Locality

● Noise Monitoring Locations

Table 2 Monitoring Locations (MGA56 Coordinates)			
Location	Nearest Receiver	Easting, m	Northing, m
NM1	R7	546737	6809918
NM2	R3/R4	548892	6810285
NM3	R2	547781	6808991
NM4	R10	547576	6810379
NM5	R14	548100	6810792

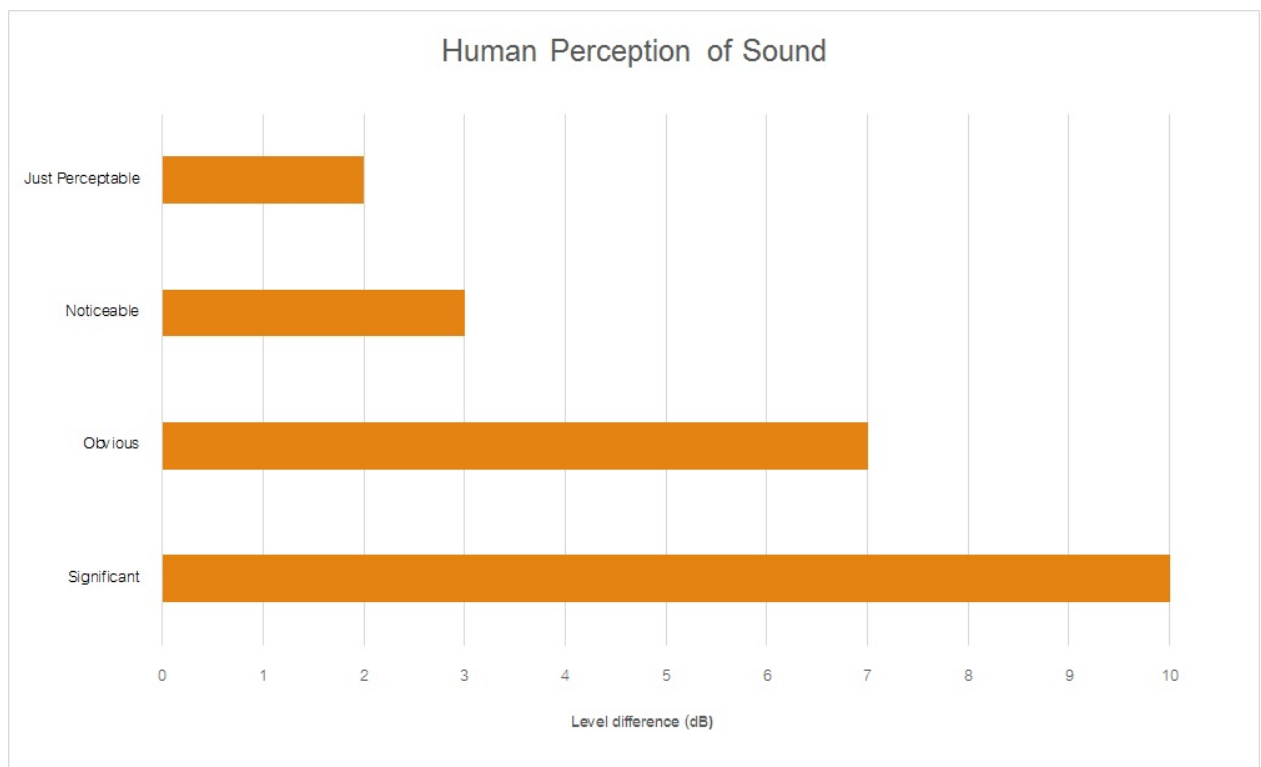
Figure A1 – Human Perception of Sound

Table A2 Common Noise Sources and Their Typical Sound Pressure Levels (SPL), dBA	
Source	Typical Sound Level
Threshold of pain	140
Jet engine	130
Hydraulic hammer	120
Chainsaw	110
Industrial workshop	100
Lawn-mower (operator position)	90
Heavy traffic (footpath)	80
Elevated speech	70
Typical conversation	60
Ambient suburban environment	40
Ambient rural environment	30
Bedroom (night with windows closed)	20
Threshold of hearing	0
